**COUNTY OF INYO
WATER DEPARTMENT**

December 26, 2013

SUBJECT: Groundwater Conditions in West Bishop

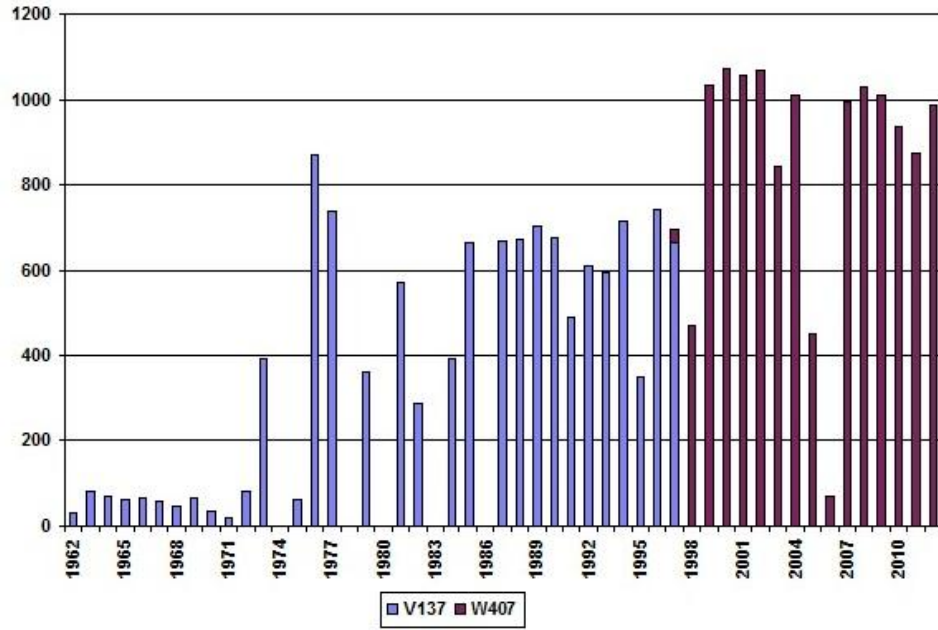
Well W407 is a LADWP production well located north of Sunset Drive and east of Barlow Lane and is within a few thousand feet of Highland Drive (Figure 1). W407 pumps into A-1 Drain and typically runs from April through September (approximately 180 days) to supply irrigation and stock water to LADWP leases and use permit holders in the south Bishop area. W407 was installed in February 1998 and an aquifer test was done in February 1998. W407 replaced W137, which was installed in 1931. The capacity of W407 is about 2.8 cubic feet per second (cfs), and the amount of water pumped annually from W407 has generally been higher than pumpage from V137 (Figure 2). During years of high runoff, less water is pumped due to the availability of surface water to supply uses on the Bishop Cone (e.g., Figure 2; 1983, 1986, 2005, and 2006). After W407 was installed, V137 was converted to a monitoring well.

Figure 2. Pumping from Wells V137 and W407. Vertical axis is acre-feet per year.

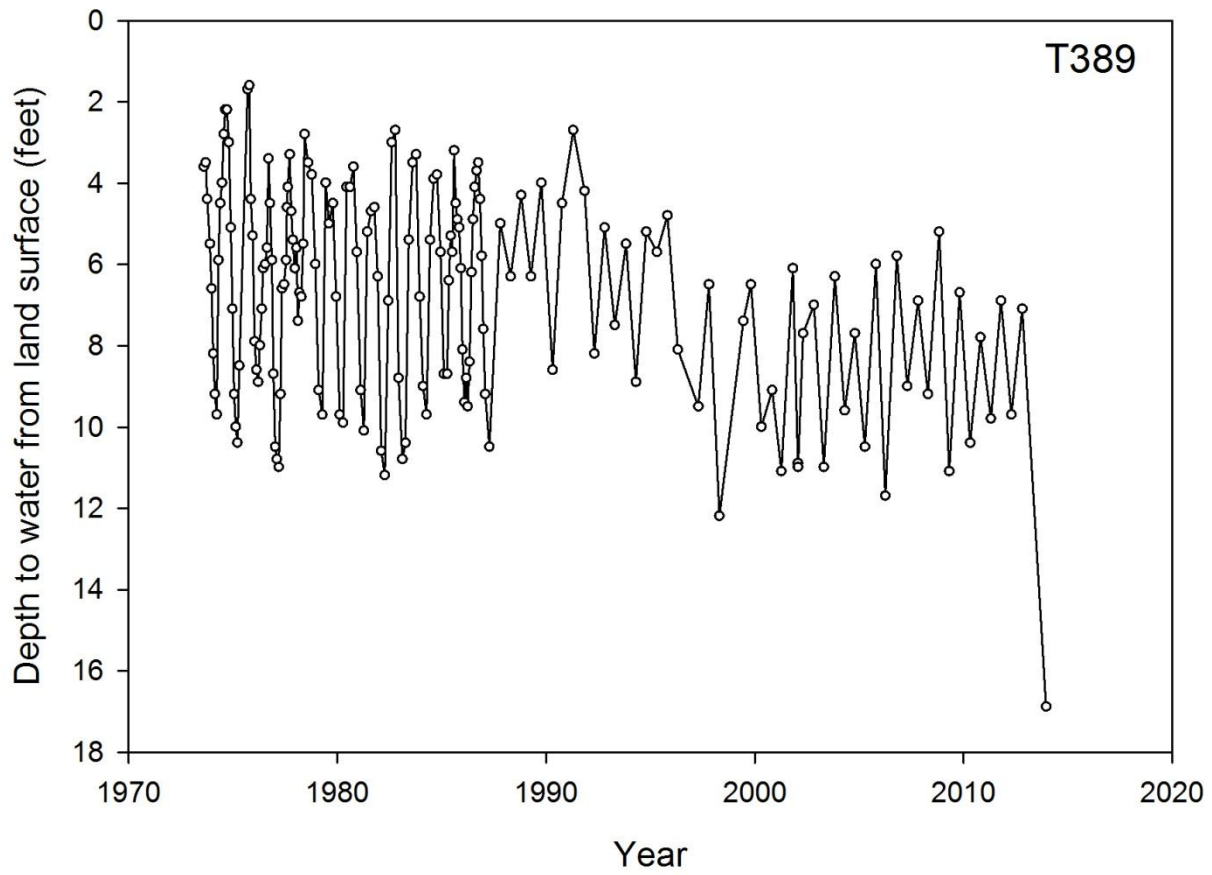
Figure 3 shows the history of water levels in T389. It is evident from Figure 3 that the water table at this site has historically increased about 3 to 6 feet over the summer, followed by a period of decline in the fall and winter. This seasonal pattern is caused by recharge from ditches and irrigation during the summer followed by a declining water table when ditch flows are reduced in the fall and winter (if this seasonal change depth to water were from pumping, it would decline in the summer and recover in the fall and winter – the opposite of what is observed). The average depth to water in T389 increased by a few feet in the late-1990's (Figure 3), possibly due to the increased pumpage from W407 compared to V137 (Figure 2). T389 showed no discernible response to reduced pumping in 2005 and 2006. The most recent measurements (taken by LADWP and the Water Department) shows depth to water over 16 feet, which is about 4 feet deeper than typical late-winter/early-spring low water table observed in prior years (Figure 3). Clearly, something unusual is occurring. Using the results from the 1998 aquifer test, we calculated the amount of additional drawdown that would occur at T389 due to extending the period of operation of W407 from 180 days to 250 days. This rough calculation showed that drawdown at T389 would increase by about one foot. The amount of additional drawdown that would result on Highland Drive would be less because it is further from W407.

1. Groundwater levels are at the lowest levels in the S. Barlow/Highland Dr. area since the early 1970's, as shown by Figure 3.
2. This year, W407 was operated for longer into the fall than is usual, but the resulting additional drawdown is not large enough to be the cause of problems occurring with domestic wells on or near Highland Drive.

Figure 3. Depth to water in monitoring well T389.
