DEPARTMENT OF WATER RESOURCES

Shallow Groundwater Conditions in West Bishop: Carol Lane, Sunrise Drive, and
Mountain View Road Neighborhoods

EXECUTIVE SUMMARY

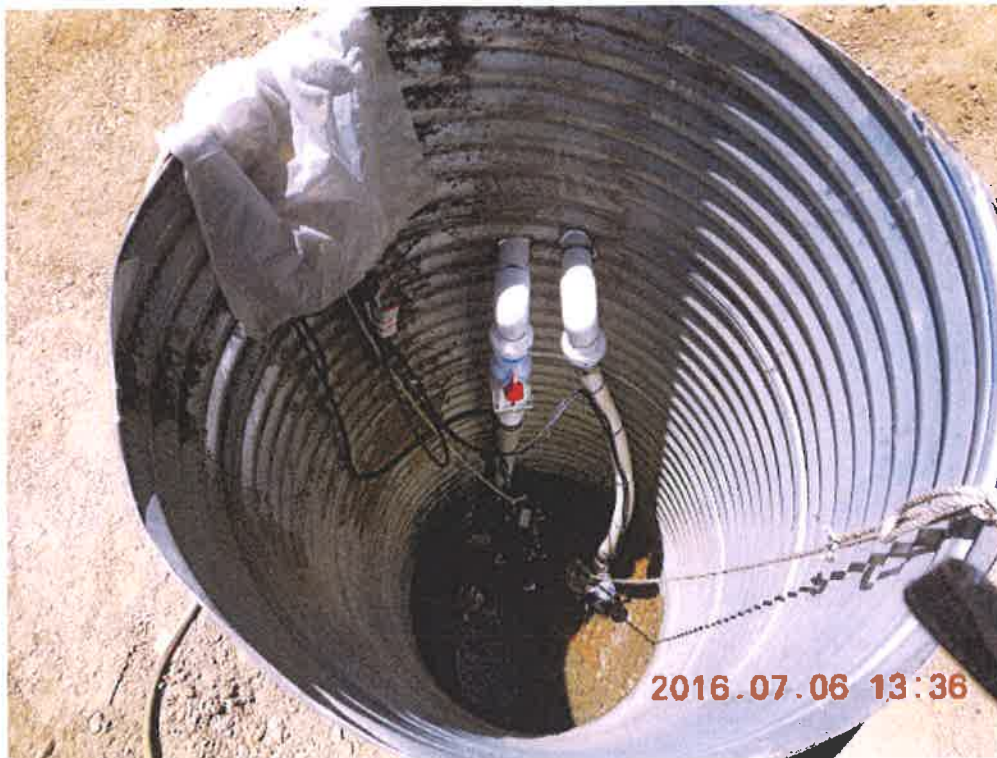
The first stop during the field reconnaissance of the study area was 375 North Mountain View Road. The resident was not at home and instead the next door neighbor, who was familiar with the standing water conditions, escorted the Field Team to the backyard of the property. The neighbor explained that shallow groundwater had infiltrated into the home and into the detached garage, and that standing water had been observed pooling around a newly installed well. In an effort to mitigate the condition, the home owner had installed two sumps to dewater the shallow groundwater (Photos 1 and 2). Two sump pumps were placed in hand dug holes by the property owner in the northwest corner of the parcel, and plumbed with PVC pipe which directs the pumped groundwater back into a landscaping pond at the northwest corner of the property. The pond is connected to the Mason Ditch System (Photo 3).

Photo 1: View of the sump pump system installed at the 375 Mountain View Road Property. The sump pumps are set to turn on when water levels are too high.

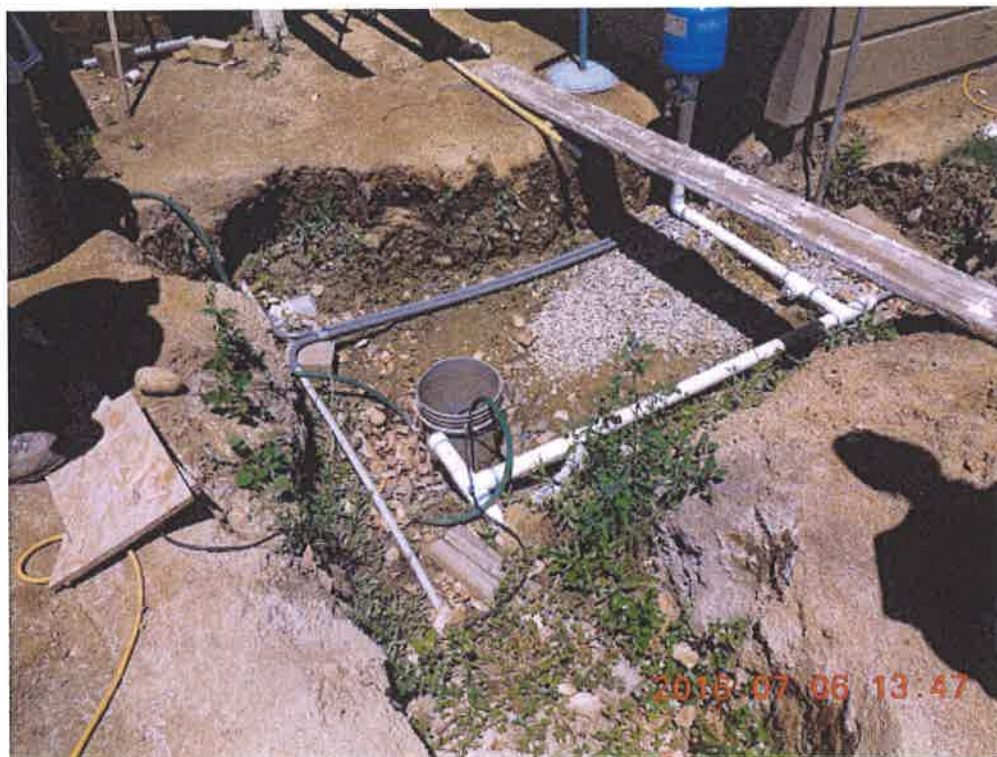
Photo 2: View north of the second sump installed at 375 Mountain View to alleviate standing water at the corner of the detached garage.

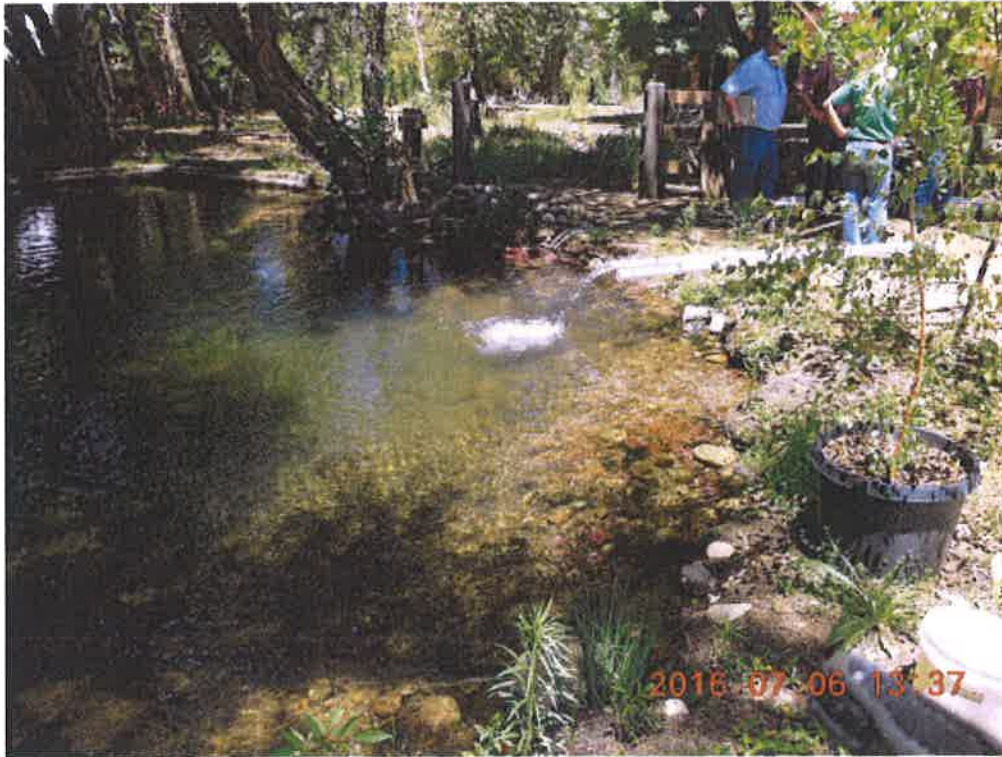
The bottom of the pond was observed to consist of coarse grained sediments. The pond was also observed to be set at nearly the same grade as the backyard of the property and no evidence of a plastic or

clay liner was observed. According to personnel from the County of Inyo, the property is located in the topographic low of the Mountain View Road neighborhood.

Photo 3: View north of the pond and drain system at 375 Mountain View Road. While on site, the sump in photo 1 was constantly running and discharging excess water to the pond.

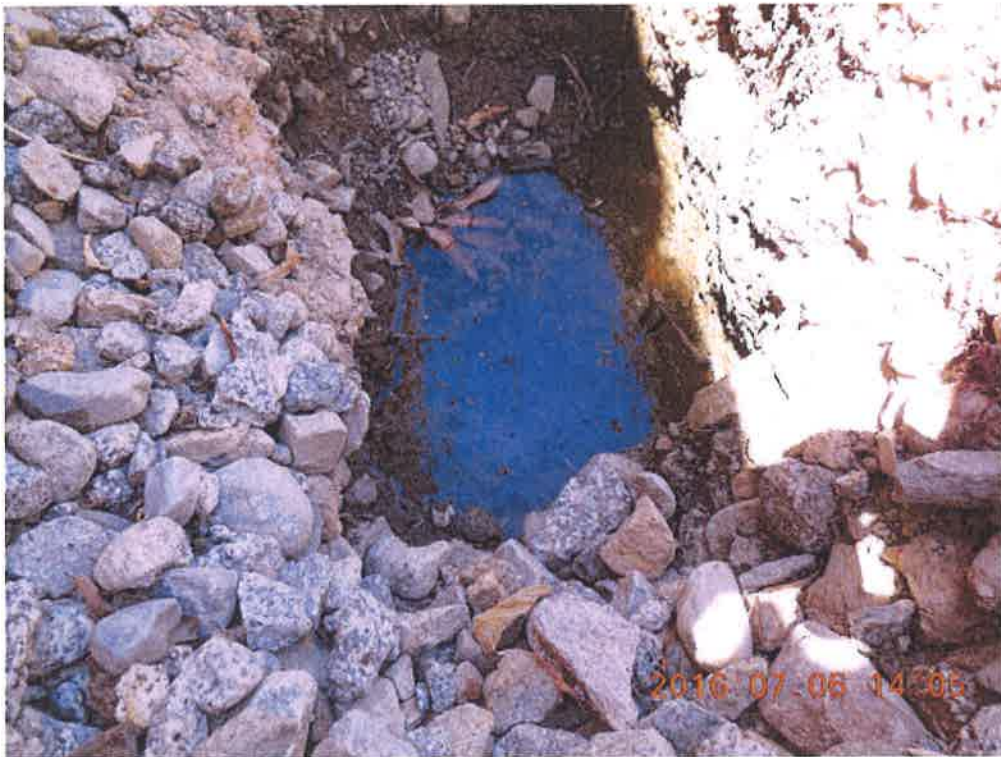
Photo 4: View of hand dug hole at the 2342 Sunrise residence. The water table is approximately 6 inches below the ground surface.

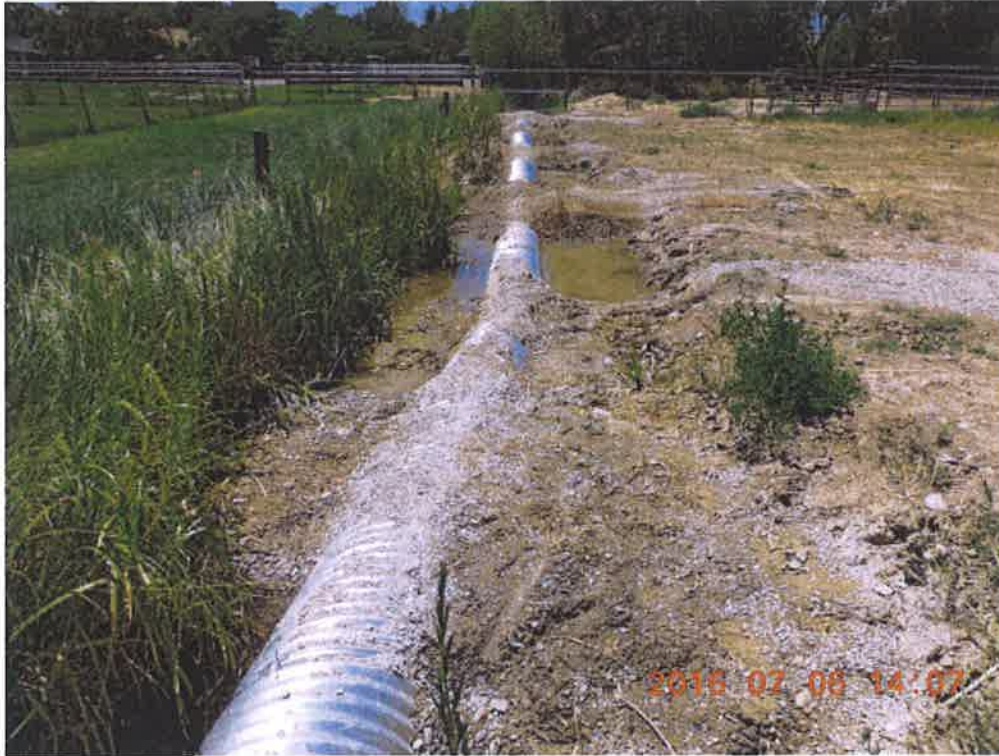
The property owners met with the Field Team to discuss the pooling of water in a crawl space beneath the residence located at 2342 Sunrise Drive. General observations of the property and adjacent areas showed the presence of moist soils at the surface and standing water that was visible in sprinkler boxes and hand-dug observation holes that were approximately six inches deep (Photo 4). The property owners stated they believed the issue originated on the adjacent undeveloped property, so with permission from BCWA, the 2342 Sunrise Drive property owner installed a steel culvert on the undeveloped property in the South Indian Ditch channel in an effort to alleviate the standing water and saturated soils (Photo 5).

Photo 5: View west of a corrugated metal pipe installed to enclose the South Indian Ditch on a vacant property adjacent to the west of the residence at 2342 Sunrise Drive. The culvert pipe was installed to mitigate flooding issues along the drainage, but was not successful as evidenced in the photo.

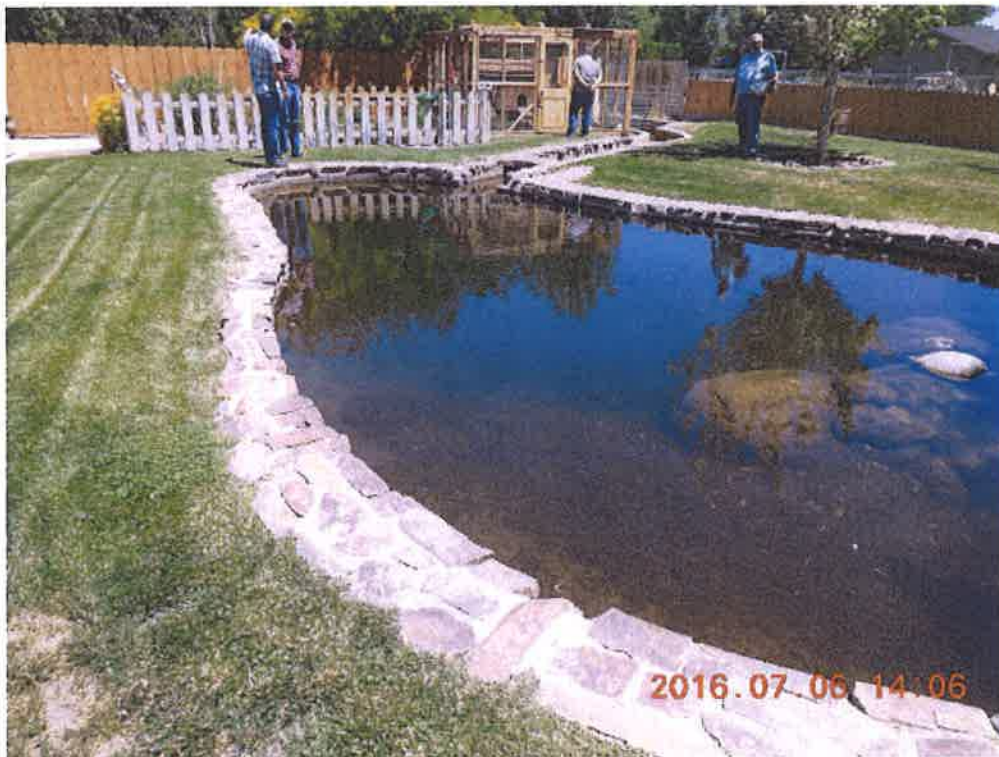
Photo 6: View east of the decorative pond at the 2342 Sunrise residence. The pond is not lined, despite the finished nature of the pond edges. The check gate at the back of the pond cycles pond water back into the South Indian Ditch.

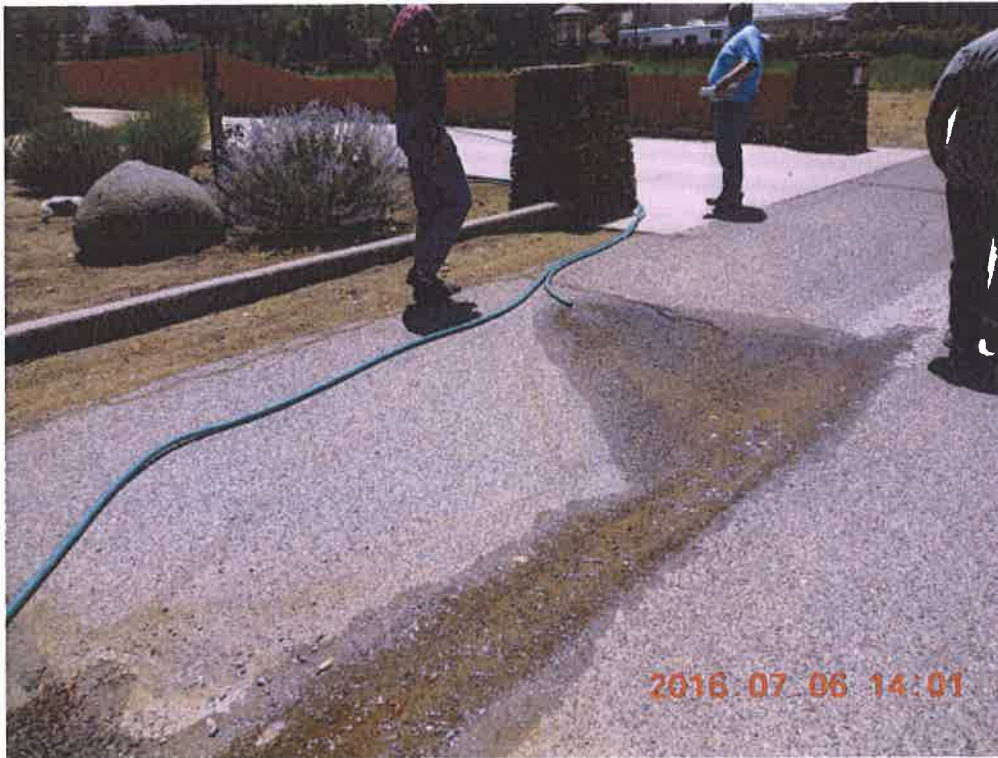
The property owner directed the Field Team to the residence where standing water was observed in the crawl space beneath the first floor. The property owner installed a sump pump in the crawl space to remove excess water. The pumped water was discharged onto the street through a garden hose (Photo 7). The property owner told the Field Team that the sump pump is operated during the day while the on-site domestic well is set to pump continuously to help alleviate the shallow groundwater the issues. Excess water from the well is pumped through a second garden hose onto Sunrise Drive and allowed to flow into the street.

Photo 7: View west at the effluent discharge lines set up at the 2342 Sunrise Drive residence. Note the soil conditions in the landscaping, were moist to wet, despite the outside temperatures ranging around 90 to 95 degrees Fahrenheit during the site visit and several weeks prior.

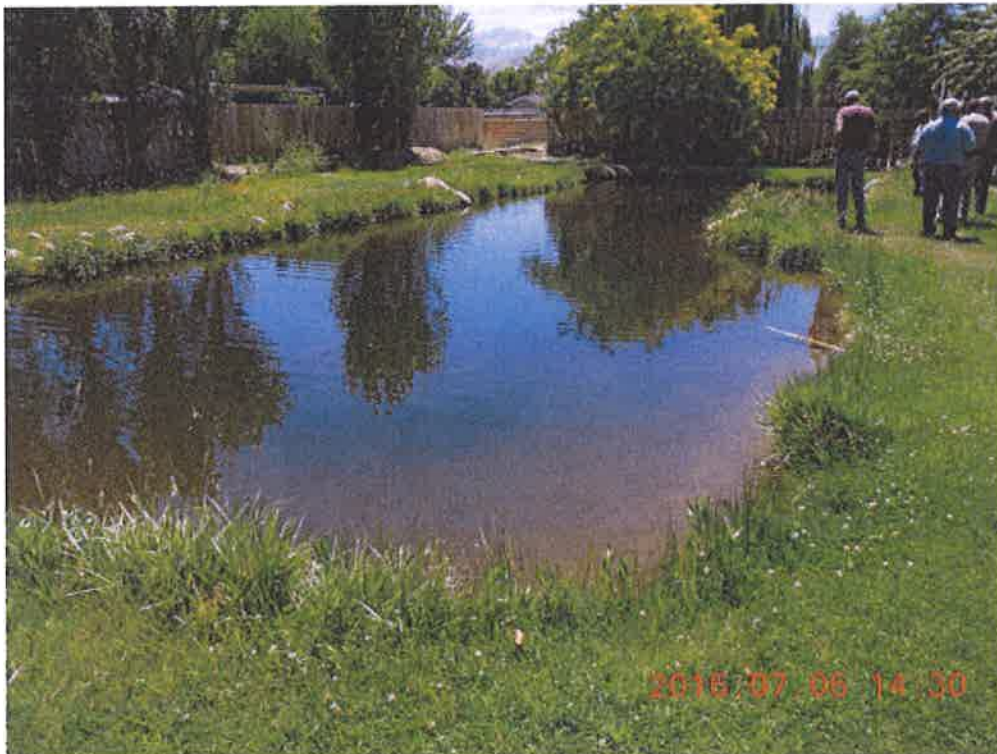
During the reconnaissance at 2342 Sunrise Drive, the homeowner of 2320 Sunrise Drive arrived, stated that similar issues persisted at his residence as well, and offered a tour to the Field Team. A large pond was located near the south end of the 2320 Sunrise Drive parcel and was not lined according to the homeowner (Photo 8). Standing water conditions in the crawl space beneath the residence were similar to the conditions observed at the 2342 property. The homeowner stated he closed the check gate to stop water from flowing into the pond, a few weeks prior to the visit and that it took about one week for the pond to drain completely. The homeowner stated that there was no change in the amount of water beneath the residence after the pond was empty.

Photo 8: View west of the landscaping pond at 2320 Sunrise Drive, adjacent to the east of residence experiencing flooding at 2342 Sunrise Drive. The South Indian Ditch check gate for the pond is at the rear of the photo. Like the 2342 property pond, this pond is also unlined and the owner is experiencing flooding issues beneath the home.

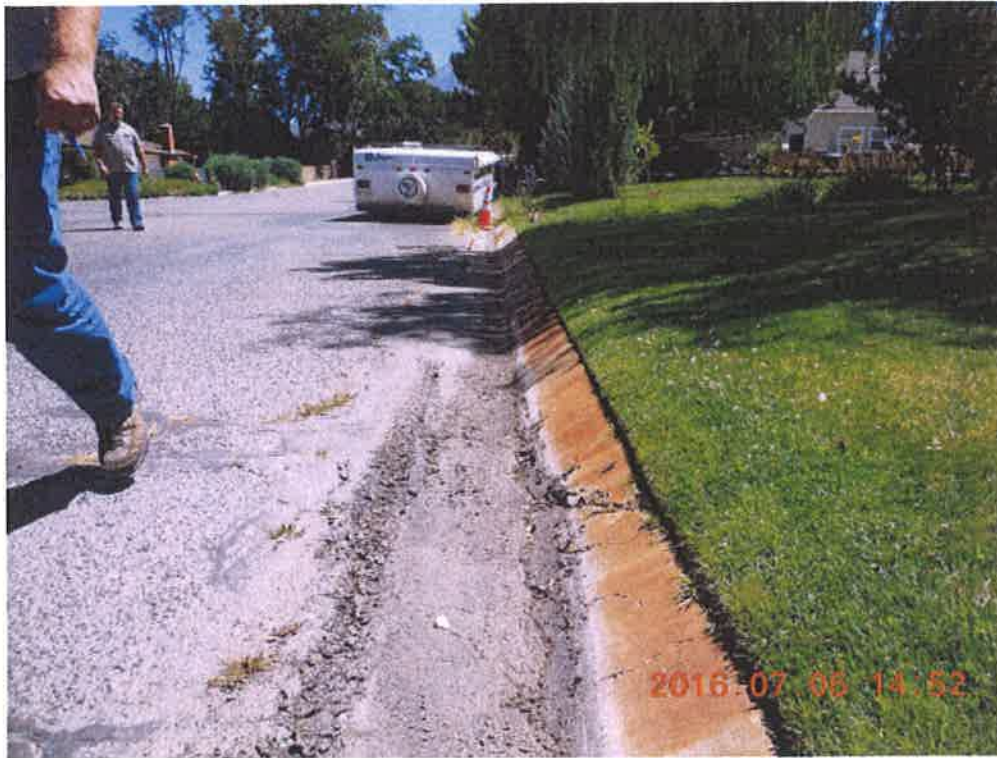
Photo 9: View south of the staining on the curb at 723 Orinda Drive as a result of periodic groundwater seepage from the lawn.

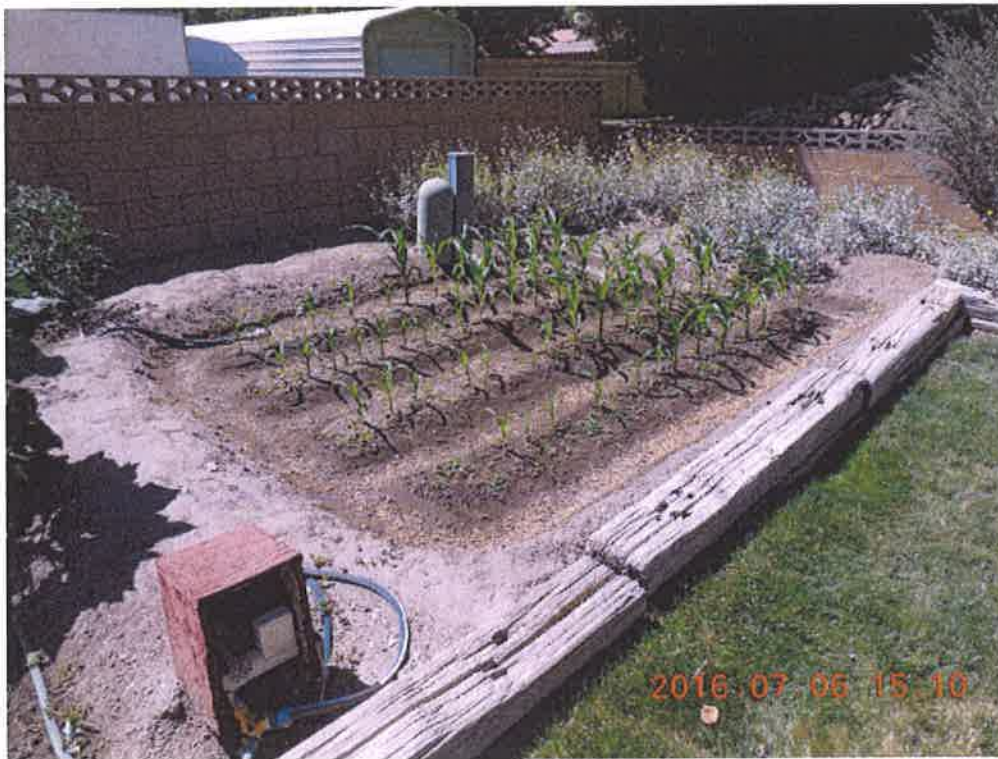
The next stop for the Field Team included meeting with three homeowners on Orinda Drive who had been experiencing similar shallow groundwater conditions. The homeowner at 723 Orinda Drive described the surfacing of groundwater in their lawn as slow and nearly continuous, and stated that it does not occur when the ditch system is not distributing water. Stained concrete and dried algae observed on the curb and gutter seemed to indicate previous flowing conditions (Photo 9). However, water was not flowing from the lawn at the time of the reconnaissance. Additionally, the street surface along the trace of sewer lines appeared to have been damaged and settled as a result of shallow groundwater. A small decorative pond was observed in the front yard of the property and was set near the same grade as the residence. Surface soils in the backyard were observed to be moist (Photo 10).

Photo 10: View northwest at the small garden maintained in the backyard by the 723 Orinda Drive property owner. No irrigation water was being applied to the garden as the groundwater was too shallow to require it.

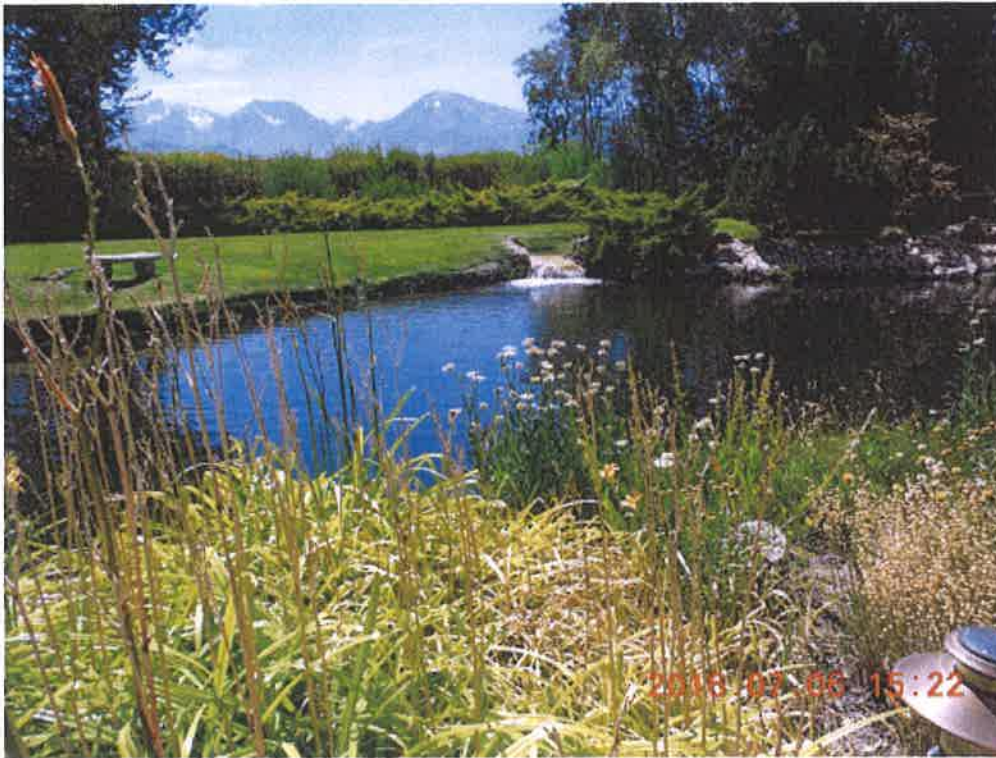
Photo 11: View southwest of the one of six decorative ponds at 2842 Sierra Vista Lane. The Orinda Drive properties affected by shallow groundwater are located to the east (downgradient) of this property.

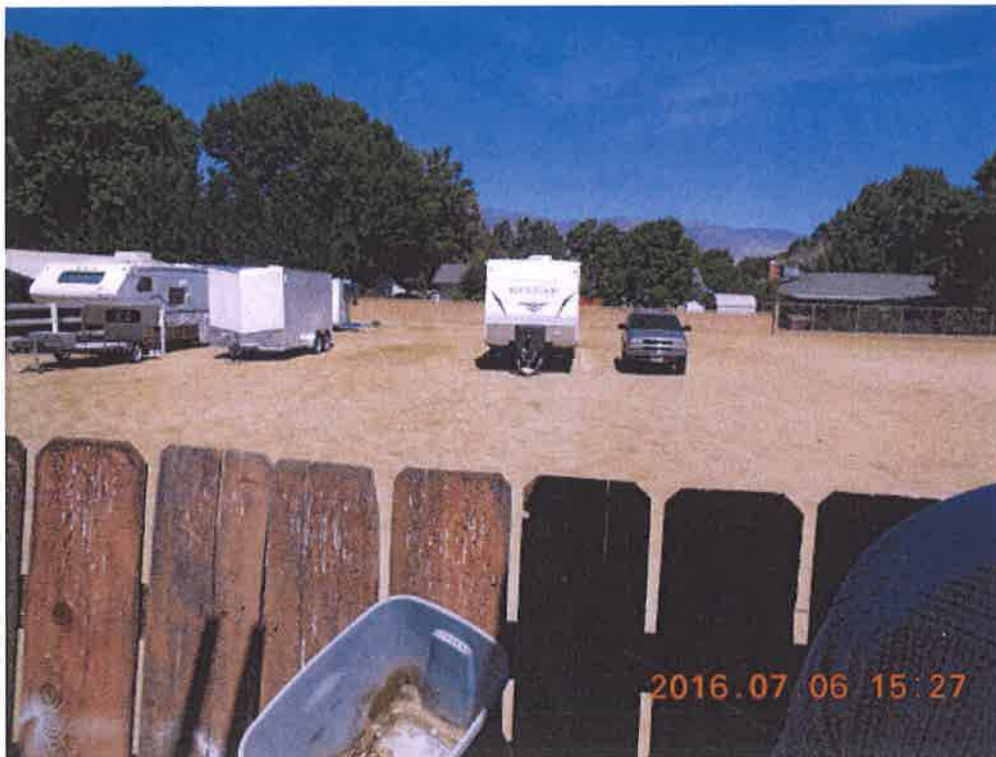
The Sierra Vista Way property is located west of the property that was observed during Location 3 at 723 Orinda Drive. Moist soil conditions at the surface were observed in a vacant lot located between the two properties (Photo 12). The Hall Ditch and the South Indian Ditch traverse through the southern portion of the parcel.

Photo 12: View east of a lot that separates the affected residences on Orinda Drive from the residence on Sierra Vista Lane with the 6 ponds. The rear of the affected residence on Orinda Drive are pictured at the back of the photo.

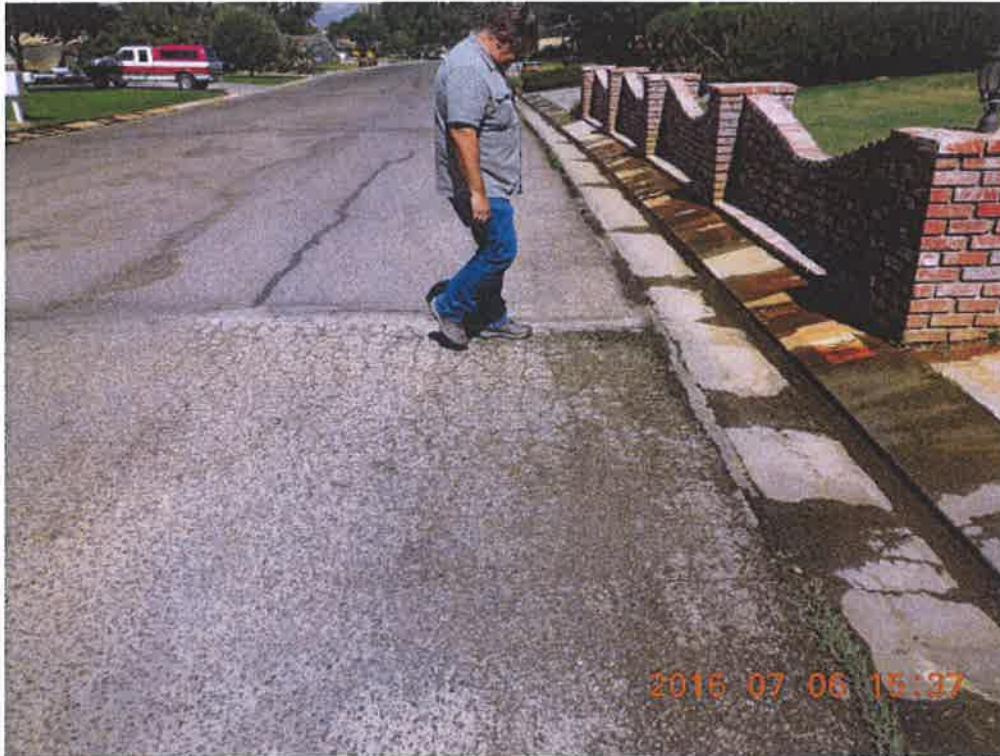
Upon arrival at 2742 Carol Lane, water was observed seeping from landscaping areas and lawns and over the street curbs for several homes on both sides of Carol Lane. According to Inyo County's Public Works Department, the high water has damaged the roadway (Photo 13). The property owner stated that the seepage of groundwater increased when the ditch flow increases (Photo 14). Like many other property owners affected, the owner constructed a homemade sump in the landscaping area adjacent to the curb to alleviate the shallow groundwater conditions (Photo 15).

Photo 13: View east of Carol Lane. Note the heavy damage to the roadway from shallow groundwater conditions and the active groundwater seepage emanating from the landscaping and overtopping the curb.

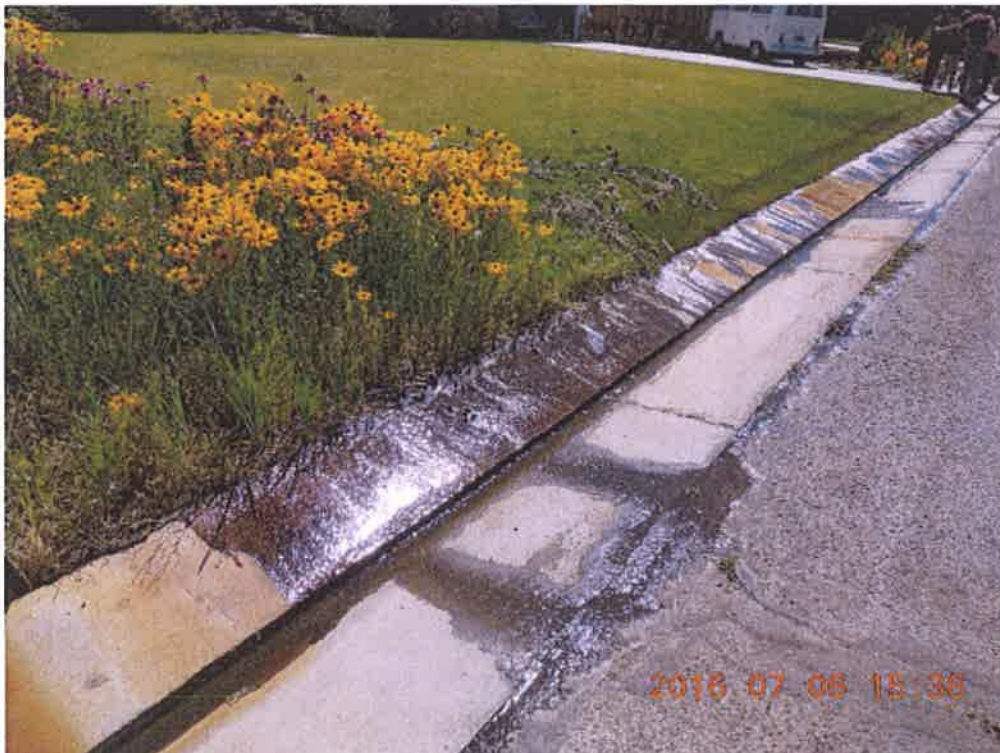
Photo 14: View southwest at the active groundwater seepage emanating from the landscaping and overtopping the curb of the 2743 Carol Lane property.

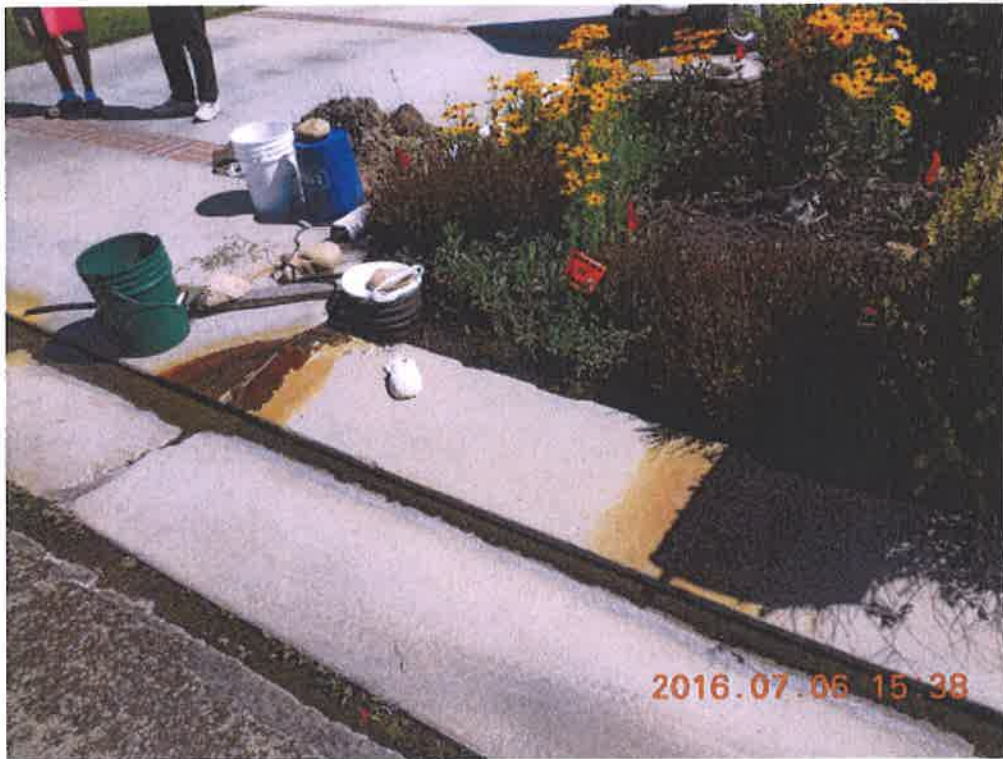
Photo 15: View southeast at the homemade sump installed in the landscaping at 2743 Carol Lane to alleviate the shallow groundwater conditions.

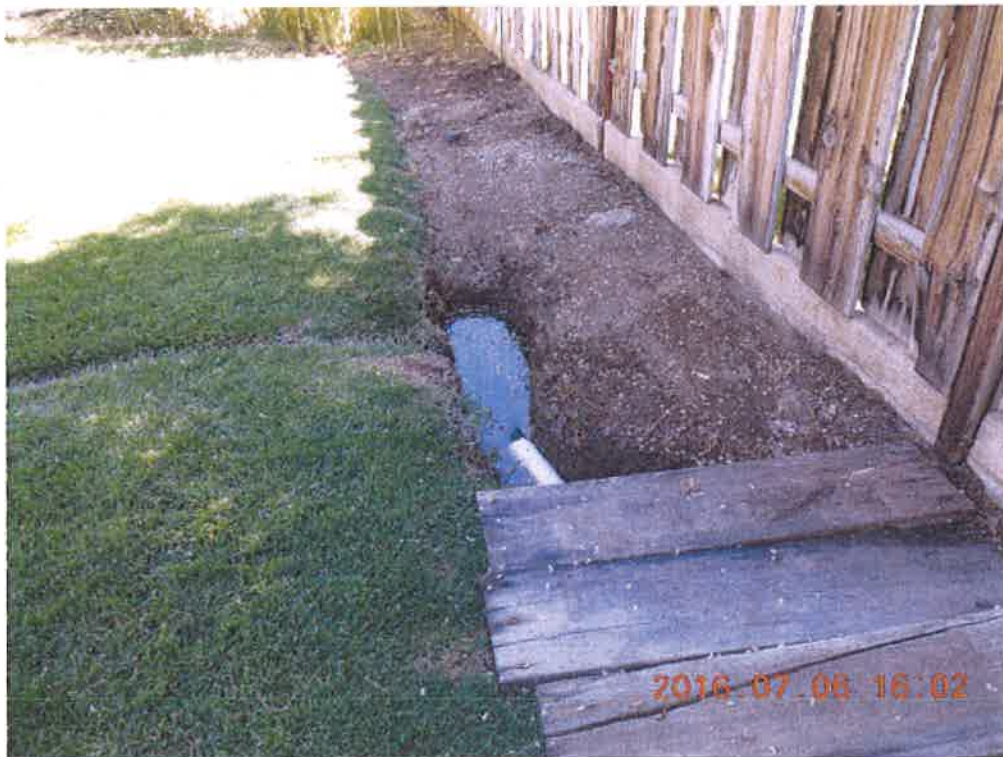
Photo 16: View south of the homemade French drain constructed by the homeowner at 2652 Sunset Road to remove standing water from the back yard.

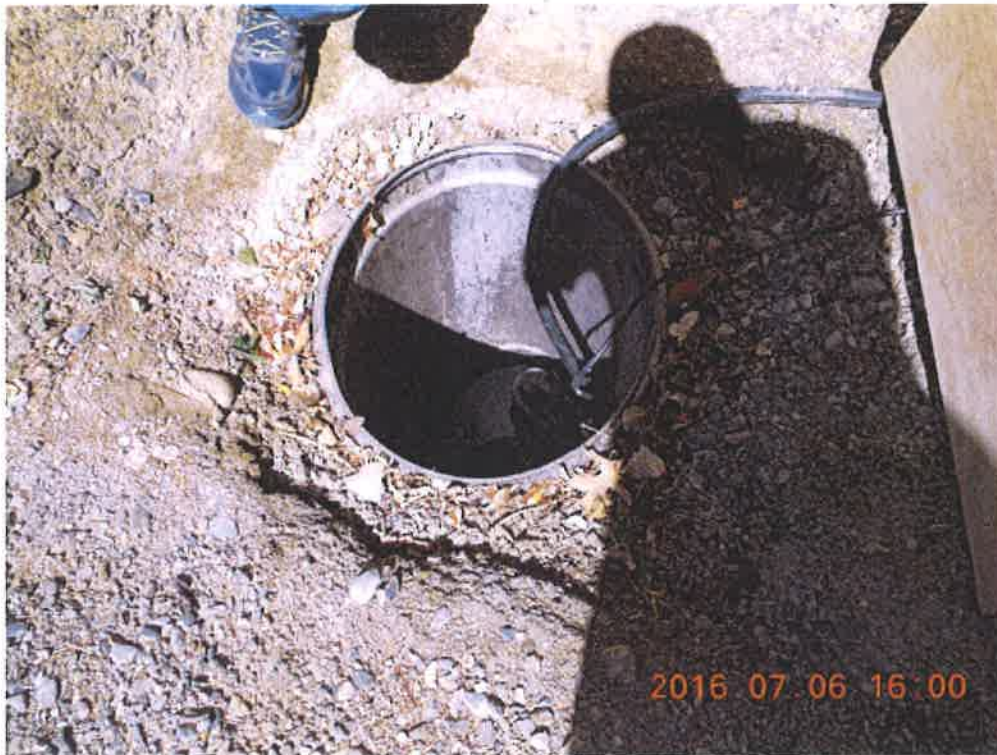
Photo 17: View of the homemade sump constructed by the homeowner at 2652 Sunset Road to alleviate shallow groundwater around the residence.

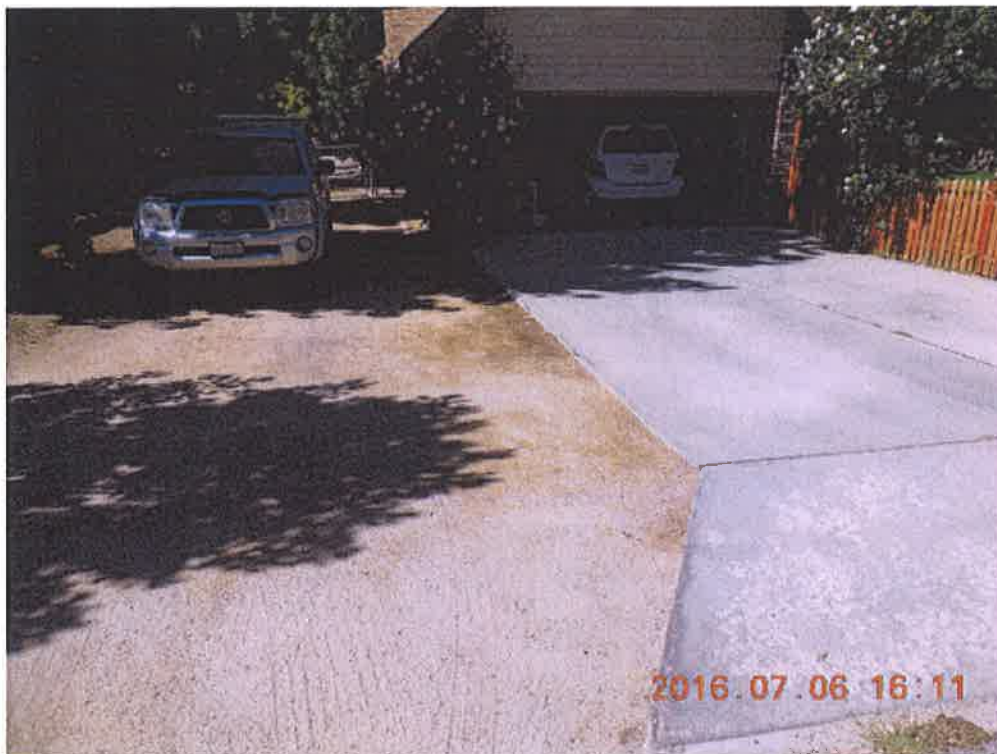
Photo 18: View north of the soil conditions at the property to the north of 2652 Sunset Road. Note the moist conditions, despite the elevated summer temperatures.

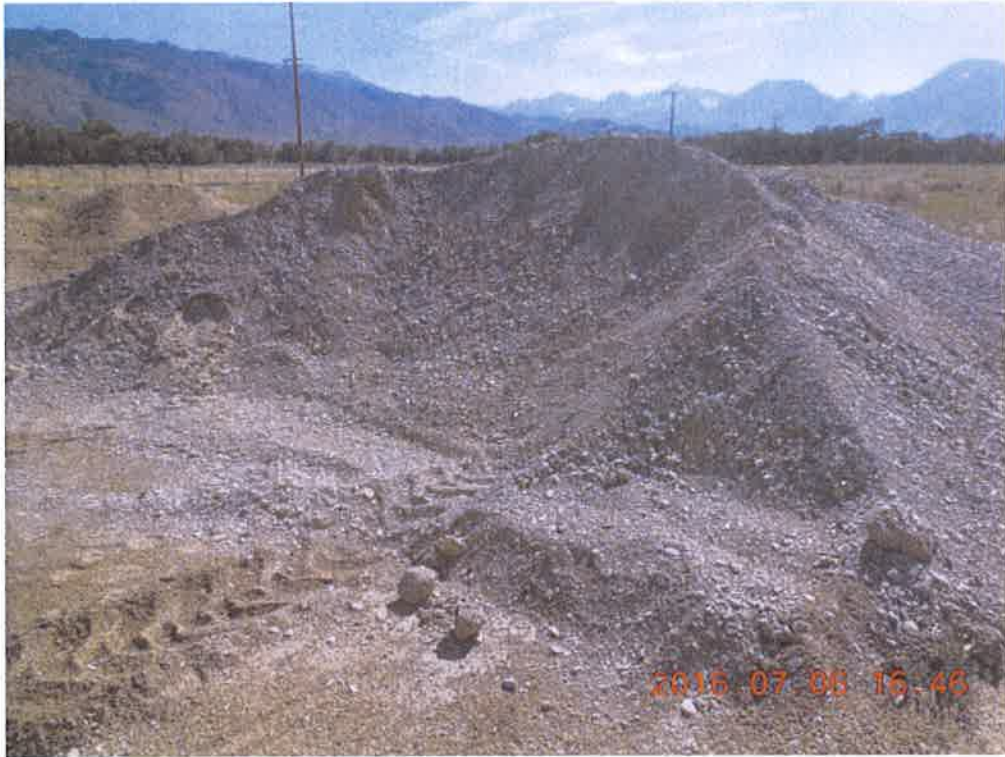
Photo 19: View southwest at the pile of material made available by LADWP to use as a lining material for the decorative ponds in the three neighborhoods.

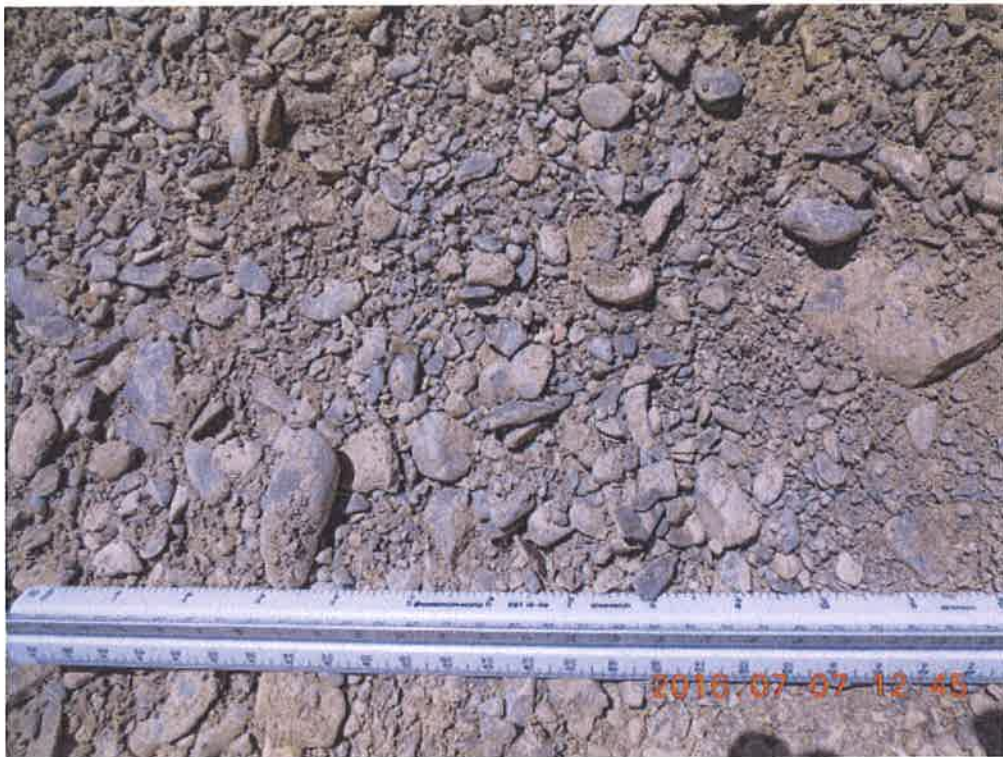
Photo 20: Close up photo of pond liner material made available for use by LADWP.
