This report includes Los Angeles Department of Water and Power's (LADWP) proposed Owens Valley operations plan for the first six months of the 2015-16 runoff year, an update on Owens Valley conditions, the current status of LADWP's environmental mitigation projects, and the status of other studies, projects, and activities.

In accordance with the 1997 MOU Section III.H, LADWP and Inyo County are required to prepare an annual report describing environmental conditions in the Owens Valley and the associated studies, projects, and activities conducted under the Water Agreement and the 1997 MOU. Sections 3 through 7 of this report are intended to fulfill that requirement.

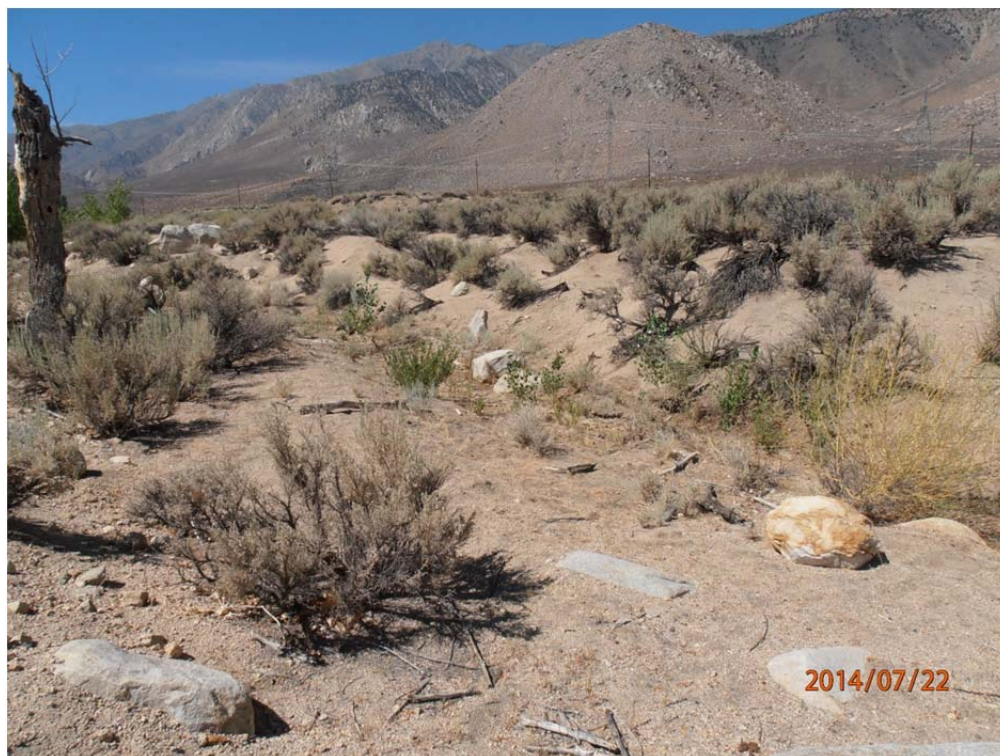
Three saltcedar plants (*Tamarix ramosissima*) were observed along the upper reach of dry wash two. Along dry wash one, three Fremont cottonwood (*Populus fremontii*) and 11 Red willow (*Salix laevigata*) seedlings from 2013 are healthy and steadily growing, ranging from 1.5-3 feet tall. Additionally, new seedlings are emerging along the wash, including nine Fremont cottonwood, 19 Red willow and one Narrowleaf willow (*Salix exigua*). Fourteen Fremont cottonwood and 29 Red willow seedlings observed in 2013 in dry wash two are alive and healthy, ranging from 2-4 feet tall. Additional seedling recruitment was also noted including five Fremont cottonwoods and four Red willows. Some of these seedlings were captured in new photo points in 2013 so that survivability can continue to be assessed in the future.

Freeman Creek Dry Wash Two depicting healthy willow and cottonwood recruitment, July 2014.

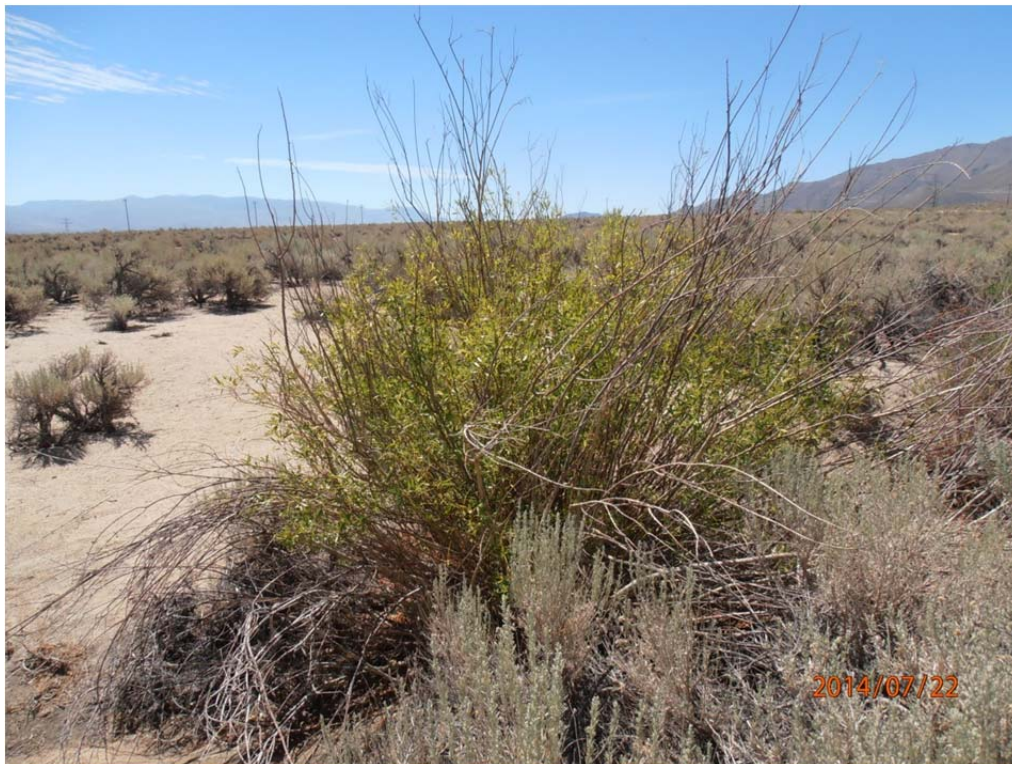
Along Freeman Creek there is a short reach of nine Red willows that died back in 2013. The cause of this die-back is unknown; however, in 2014, new healthy sprouts have emerged out of the trunks of five individuals (refer to photos below).

**Freeman Creek willow die-back showing new emerging sprouts
July, 2014**

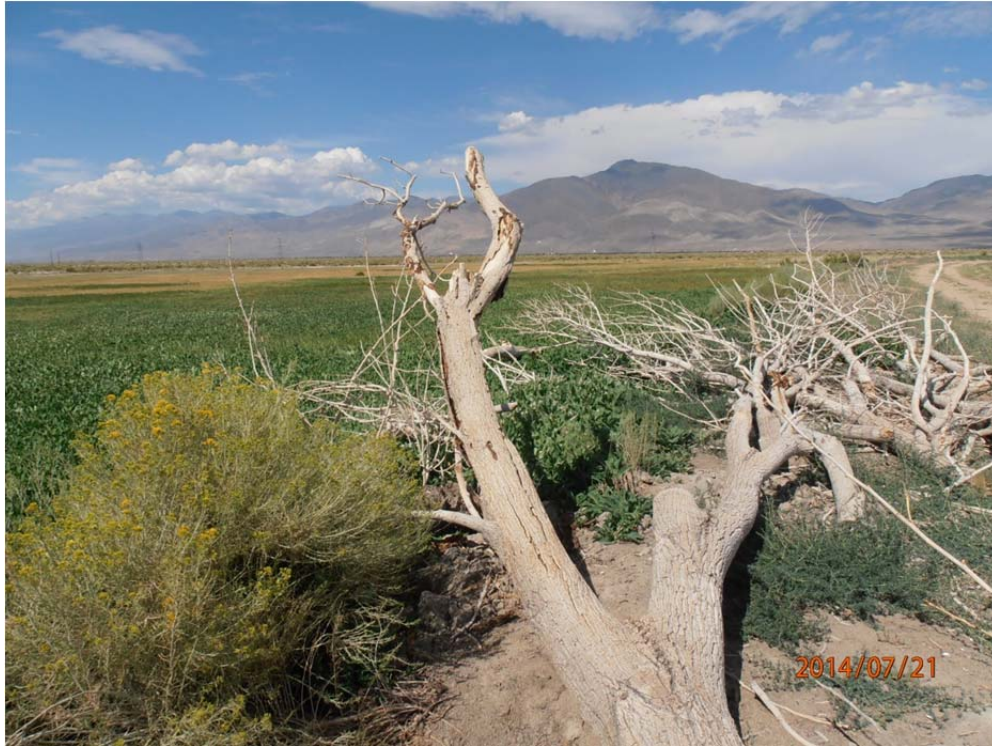
Photo points were established in April 2011 and were recaptured at the peak of the growing seasons in 2012-2014. These photos can be made available upon request. One old cottonwood at the “Warren Canal South” photo point location has fallen and was cleared to the north side of the road (see photos below).

“Warren Canal South” photo point depicting fallen cottonwood, July 2014

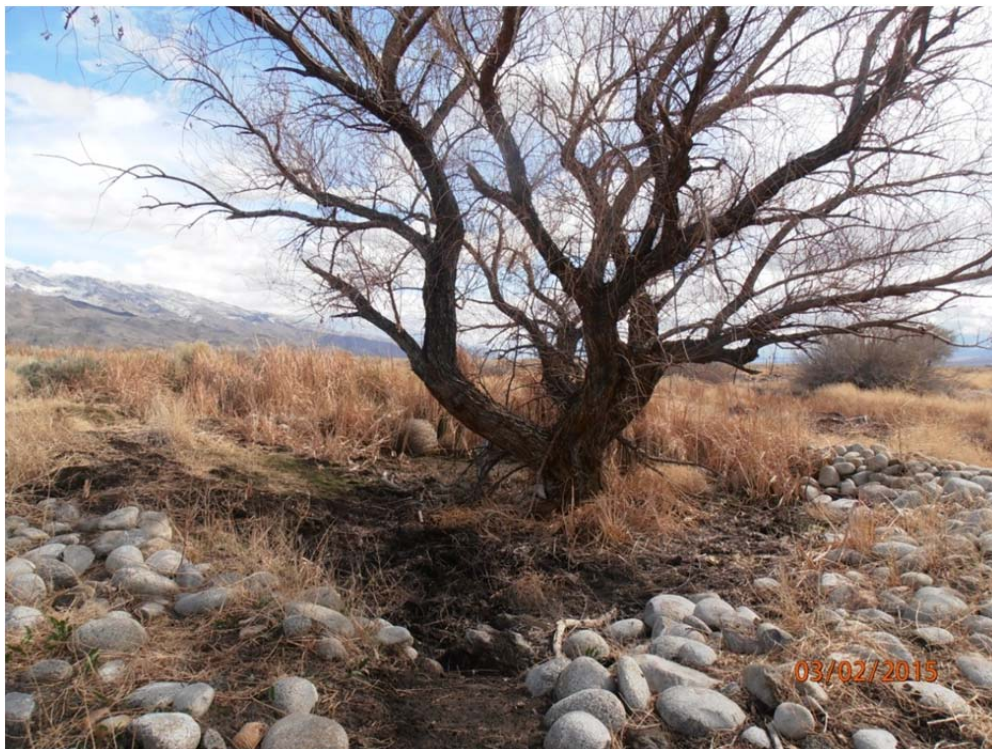
Multiple berms have been constructed between the large red willow and the pipe outfall to attempt to direct flows around the tree to reduce ponding and ensure the trees survival. Most constructed berms failed; however, the most recent construction of packed rock and earthen berm in late summer of 2014 appears to have been successful, with minimal seepage through the barrier to the south (see photo below).

Hines Well 355 depicting berm to the left near pipe outflow and red willow, March 2015.

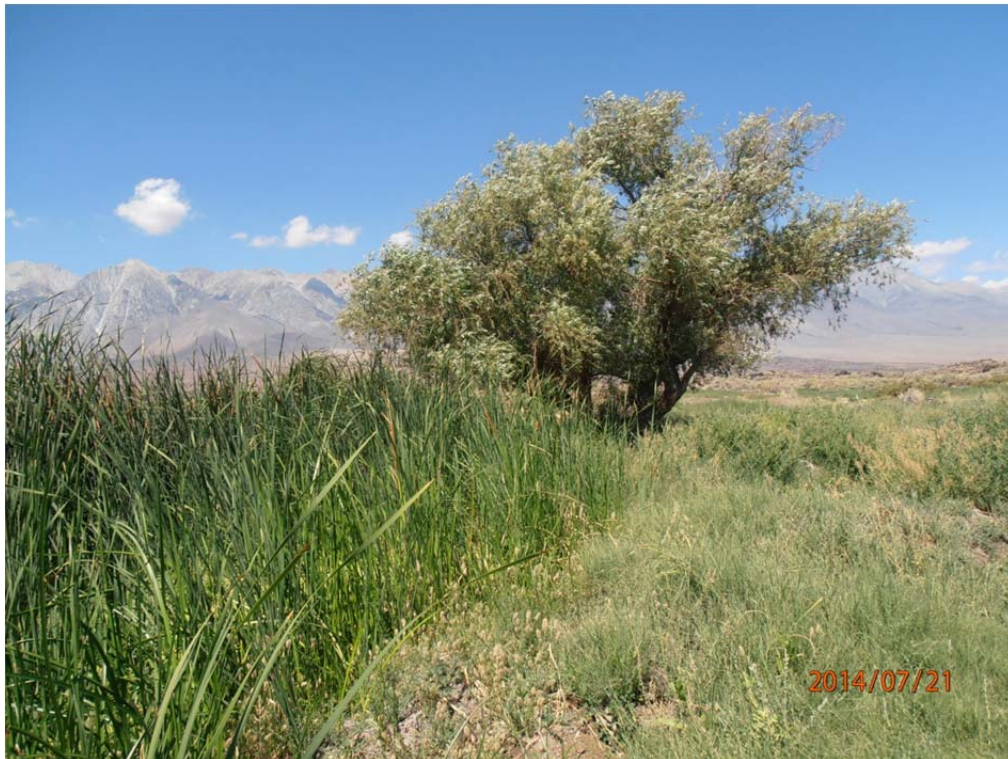
There are three red willow seedlings established near the pipe outfall. Additionally, there are two more red willow seedlings growing on the west side of the ponded area. There is also abundant recruitment of desirable non-woody species throughout the project area. The main spring channel banks below the pipe outfall is exhibiting healthy and vigorous growth of Alkali sacaton (*Sporobolus airoides*), Saltgrass (*Distichlis spicata*), Salt heliotrope (*Heliotropium curassavicum*), Beardless wildrye (*Leymus triticoides*), Rabbit-foot grass (*Polypogon monspeliensis*) and Showy milkweed (*Asclepias speciosa*) (see photo below).

Hines Well 355 main spring channel below pipe outfall, July 2014

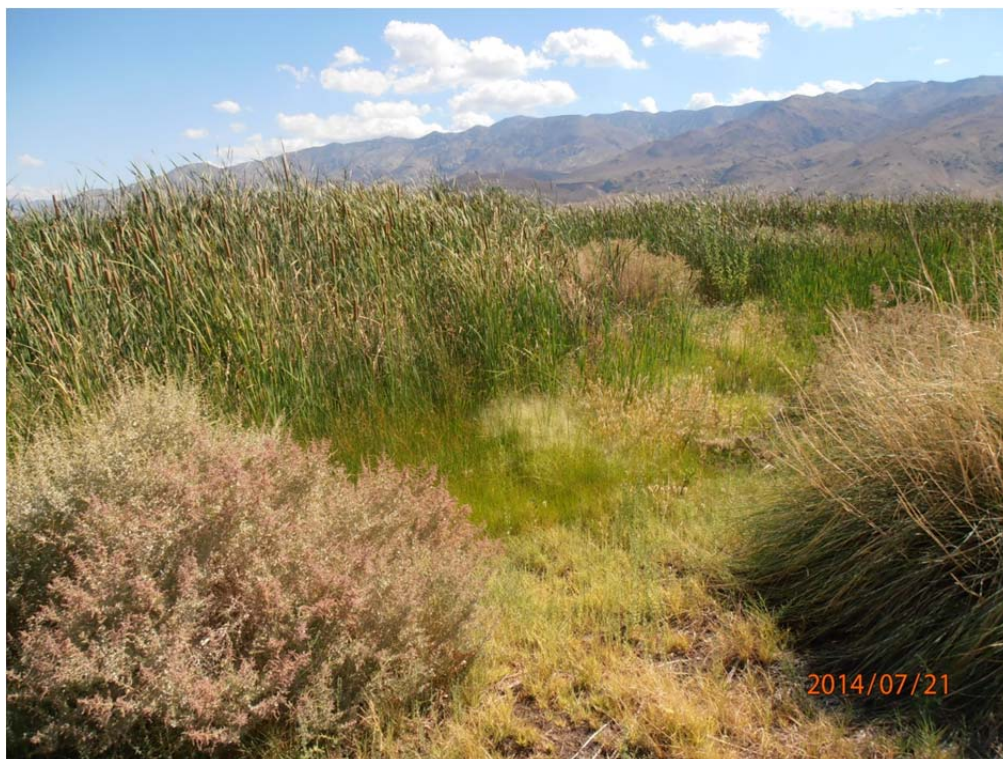
Additionally, Baltic rush (*Juncus balticus*), Bulrush (*schoenoplectus spp.*) and Monkey flower (*mimulus guttatus*) are healthy and abundant in the spring channel and ponded areas (see photo below).

Hines Well 355 ponded area depicting desirable non-woody vegetation growth, July 2014.

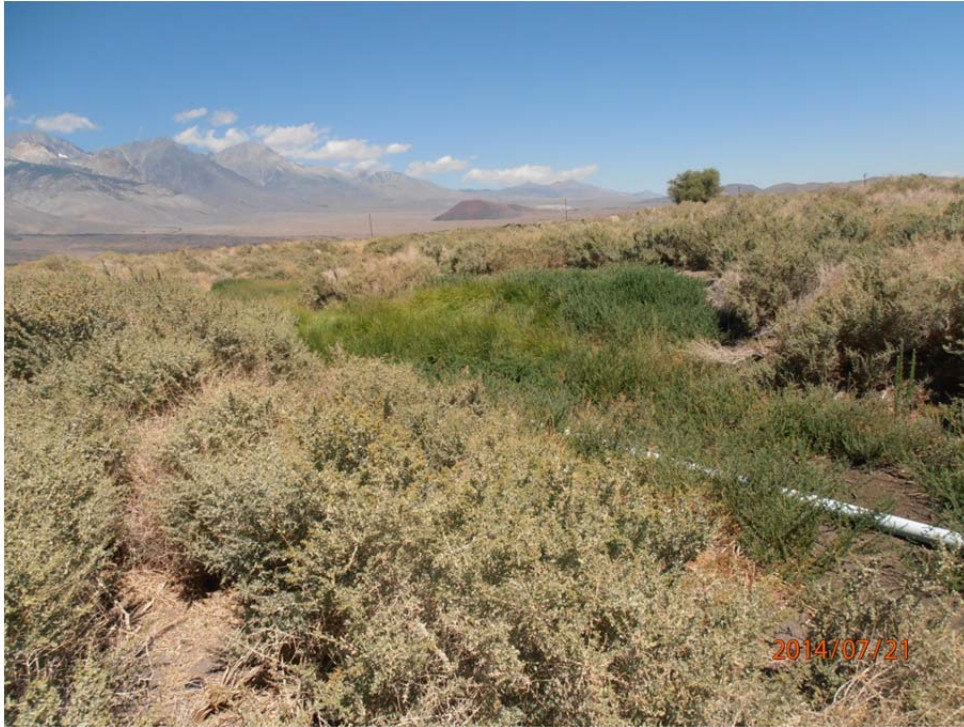
Continuous problems with sinkholes have also occurred. To alleviate this issue, LADWP extended a pipe down the channel into different soil types and locations from 2012-2014 and monitored the pipe outfall, anticipating soil conditions would stabilize for surface water to flow downstream. However, due to a lack of available surface water to supply to the project, the Aberdeen Ditch was dry in July 2014 but resumed again from September 2014 through March 2015 (see photos below). Unfortunately, sinkholes continue to be problematic for this channel.

Aberdeen Channel, July 2014.

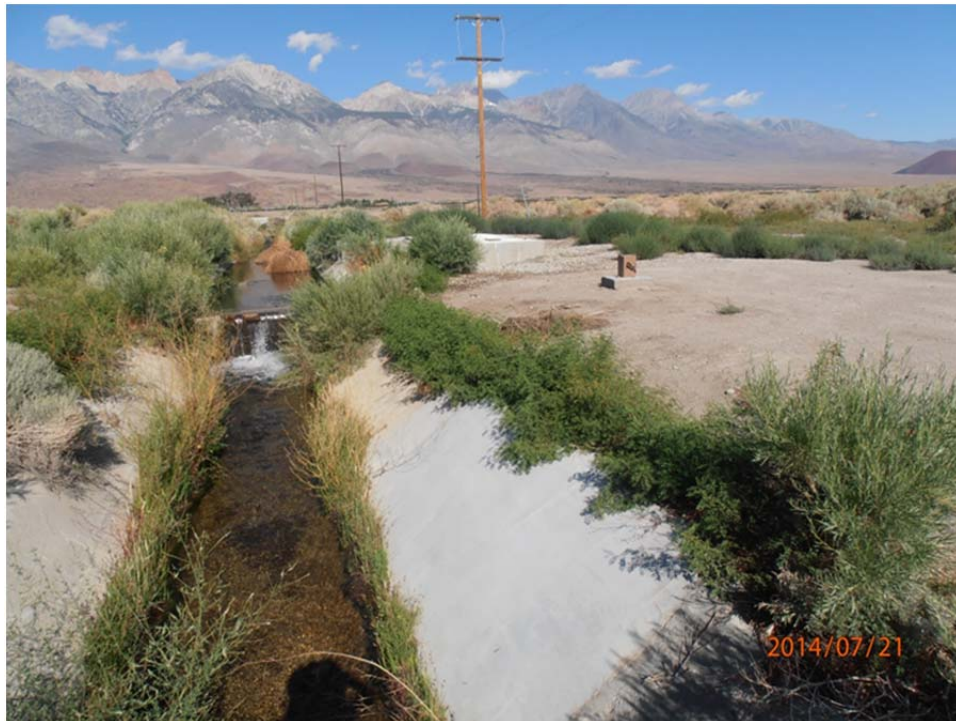
Two new Narrowleaf willow seedlings were observed growing along the Aberdeen Ditch intake structure during project monitoring and existing Narrowleaf willows are healthy and growing vigorously. Russian thistle and Fivehorn smotherweed are growing outside of the channel banks and are beginning to encroach in the channel; however, recruitment of desirable non-woody species are establishing throughout the project area, such as American licorice, Monkeyflower, Sedges (*Carex spp.*) and Beardless wildrye. These species are increasing along the Aberdeen Ditch intake structure, filling in prior barren gaps (see photo below).

Aberdeen Intake Structure depicting woody and non-woody species recruitment, July 2014

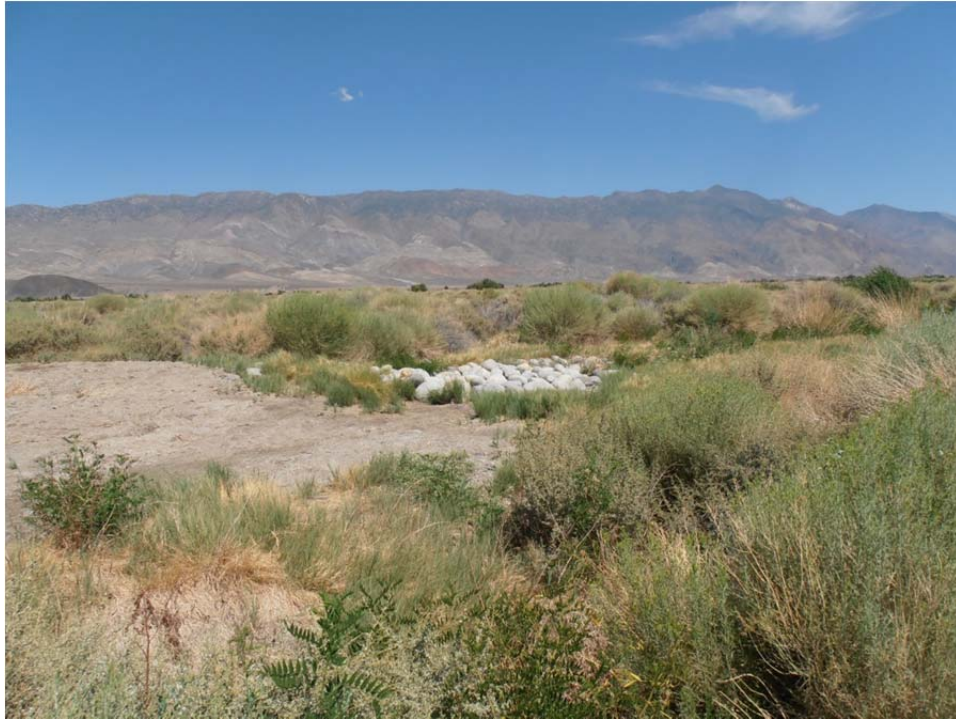
Saltcedar shoots have established and are growing along the ditch of the “flooded area” photo point. There is also one saltcedar that has established approximately 15 feet downstream of the pipe outfall. No new native woody recruitment was noted during 2014 project monitoring. However, there is abundant recruitment of desirable native non-woody species in/near the exclosure and pipe outfall extending east into the project area. Saltgrass and American licorice (*Glycyrrhiza lepidota*) are particularly abundant in this area (see photo below). Some native species, although patchy, are also beginning to establish along the pipeline berm. These include Salt heliotrope, Sacred datura (*Datura wrightii*), and Torrey’s saltbush (*Atriplex torreyi*). Even though this project area is notably drier than last year, woody vegetation and non-woody vegetation remains vigorous.

North of Mazourka pipe outfall, July 2014

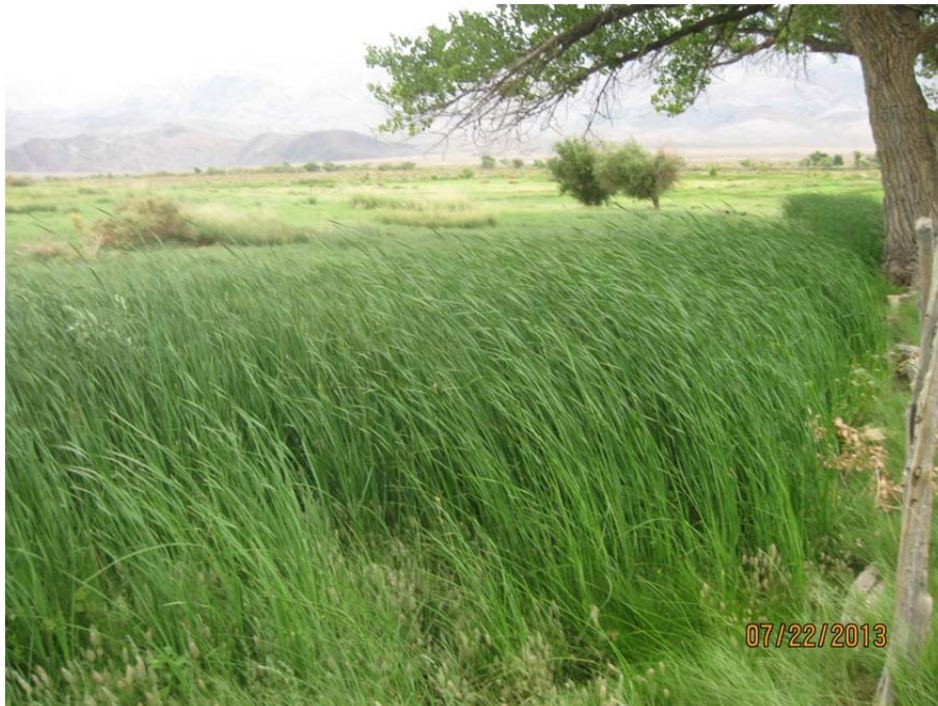
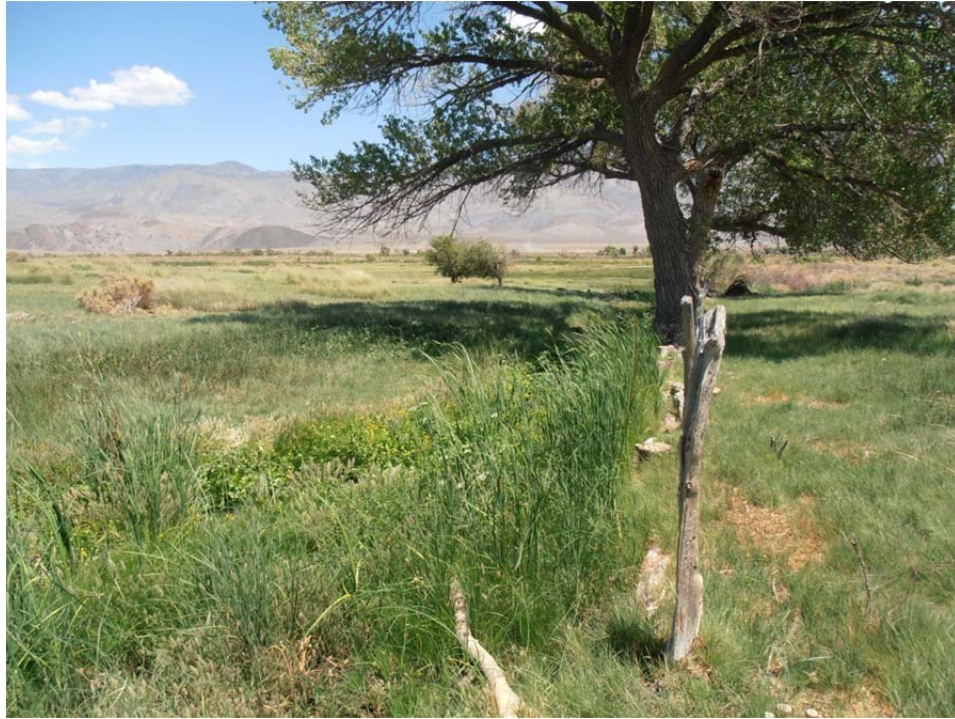
The non-woody vegetation along the main spring channel is well established. Cattle grazing appears to have positively influenced the spring channel by reducing cattails that dominated the channel last year, thereby opening the channel to allow for wetland obligate species to establish (see photos below).

Homestead main spring channel, July 2013

Homestead main spring channel, July 2014

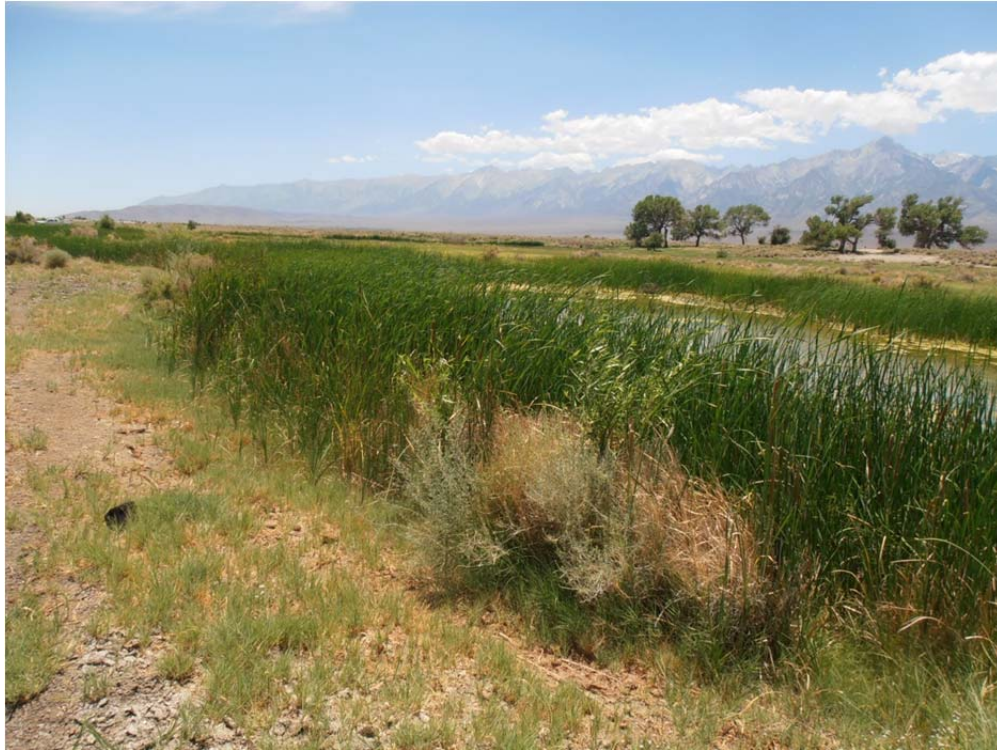
The surface area of the pond continues to be dominated by cattails; however, non-woody vegetation is well established and healthy. There are three healthy 4-foot tall Red willows growing amongst the cattails on the pond shoreline (see photo below). Following the shoreline south there is additional recruitment of 15 Red and Narrowleaf willows between 1 and 2 feet tall. Where the berm meets the road there is also a 4-foot tall Fremont cottonwood that was not observed in 2013. Saltgrass recruitment has increased and continues to fill in bare gaps on the berm along the east side of the pond. There is also a saltcedar tree with sprouts approximately 150 feet from the road heading north on the berm.

Homestead pond depicting red willow recruitment, July 2014

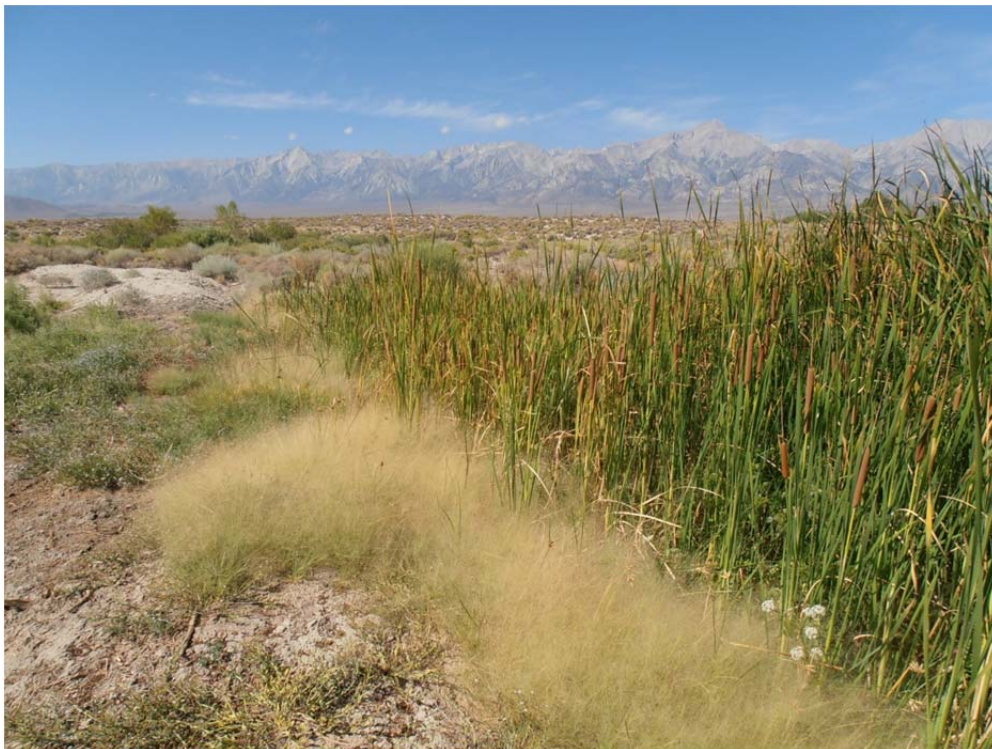
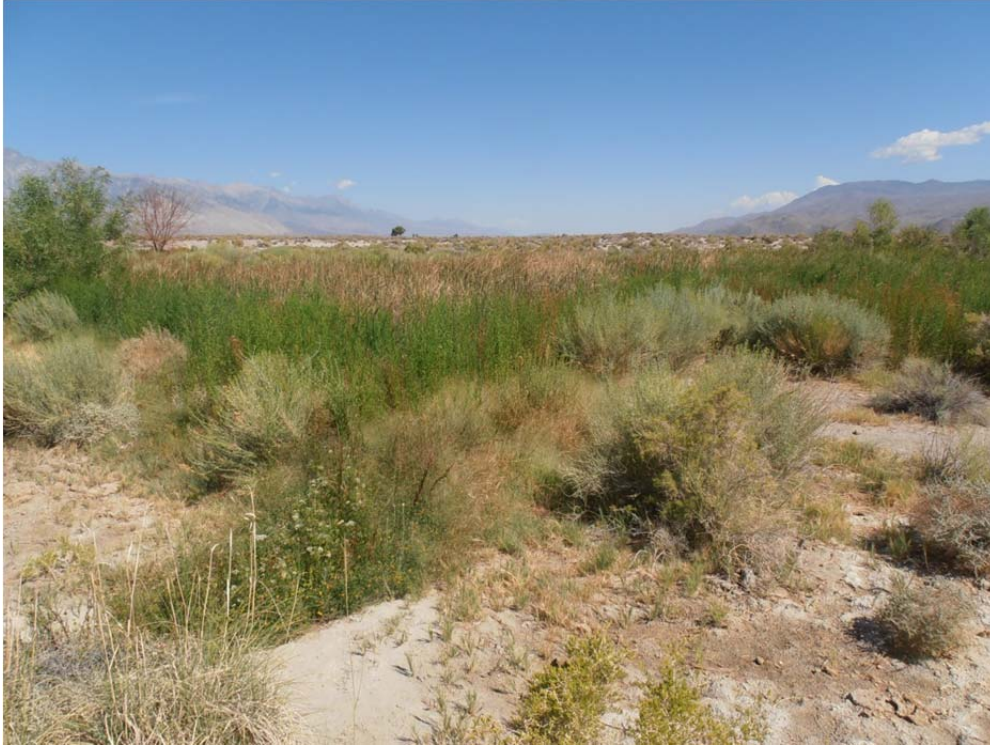
Vegetation along the eastern berm remains patchy but recruitment of Scratchgrass (*Muhlenbergia asperifolia*), Saltgrass and Salt heliotrope has increased compared to last year and is healthy and thriving. Native riparian vegetation on the banks of the pupfish marsh is dense and vigorous; however, open water within the pupfish marsh has been inundated with Cattails. Cattails continue to significantly increase within the project area (see photos below).

Well 368 eastern berm, July 2014

Well 368 pupfish marsh, July 2014

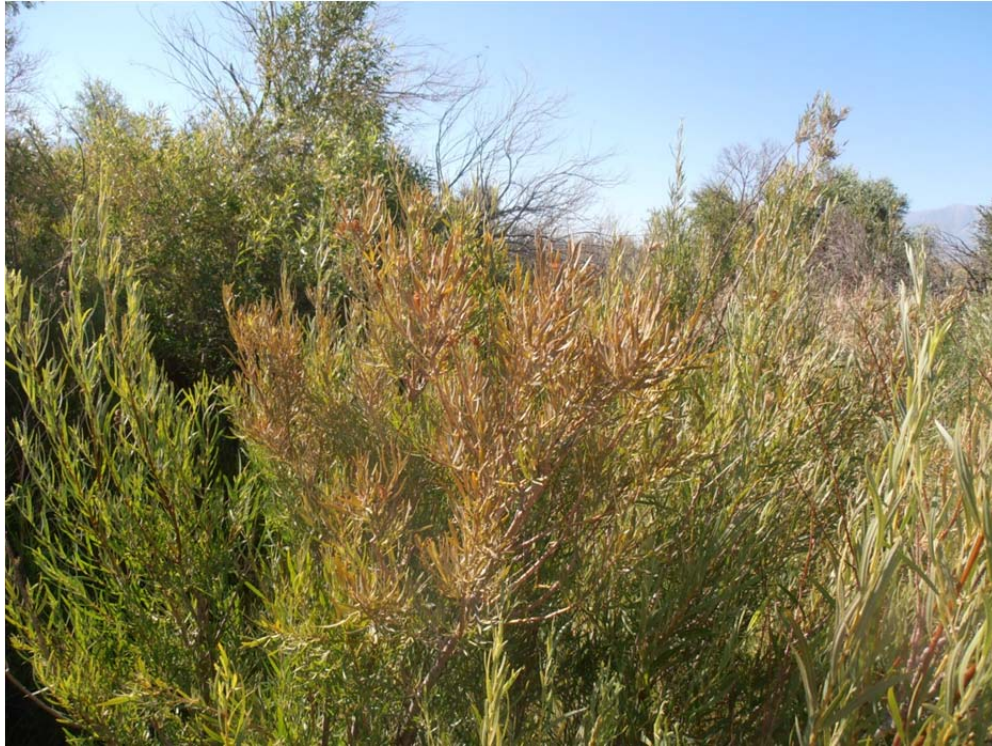
Narrowleaf willow recruitment is occurring throughout the project area, particularly south of the pipe outfall and in the road depression that receives overflow from the pupfish pond. The lower pond area is dry but riparian vegetation is still thriving and new Narrowleaf willow recruitment is occurring throughout this area as well. New seedlings and growth from this year appear healthy; however, one concentrated section of Narrowleaf willows to the west of the pipe outfall continues to be stressed as they did last year. Some of these willow branches and leaves have browned and under a microscope foliar damage has occurred (see photos below). Upon closer examination, small scale bugs were found clinging to the sides of branches and nodules of leaves. Scale bugs extract sap from plant tissues and target the undersides of leaves and leaf joints, which could explain the foliar damage. Speaking with Master Gardener experts in the Owens Valley, the dieback pattern on the willows with the addition of leaf curl and damage to the outer bark indicates the presence of cankers. Willow cankers are a fungal disease caused by stress, such as drought, frost and nitrogen deficiencies and develop at wound sites made by insects, such as scale bugs in this case. The bark on the branches of these willows exhibited lesions, which shrivel and crack at the junction between living and dead tissue. Management to control the canker is recommended before it reaches the root zone of the plants.

Stressed narrowleaf willow west of pipe outfall, July 2014

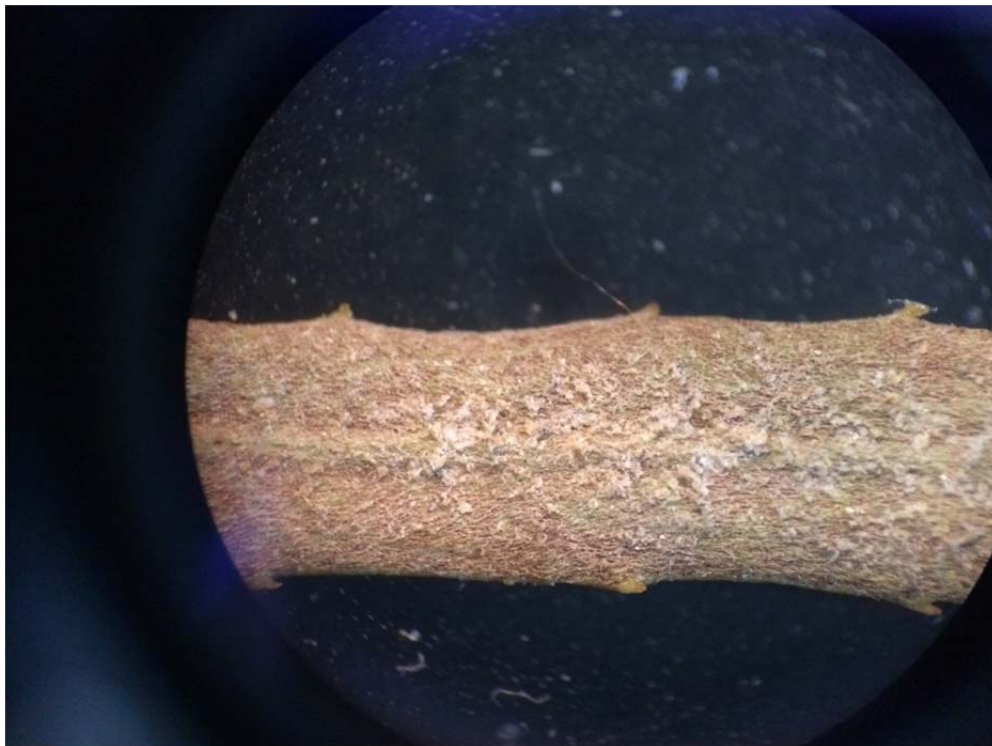
Narrowleaf willow depicting foliar damage under microscope, July 2014

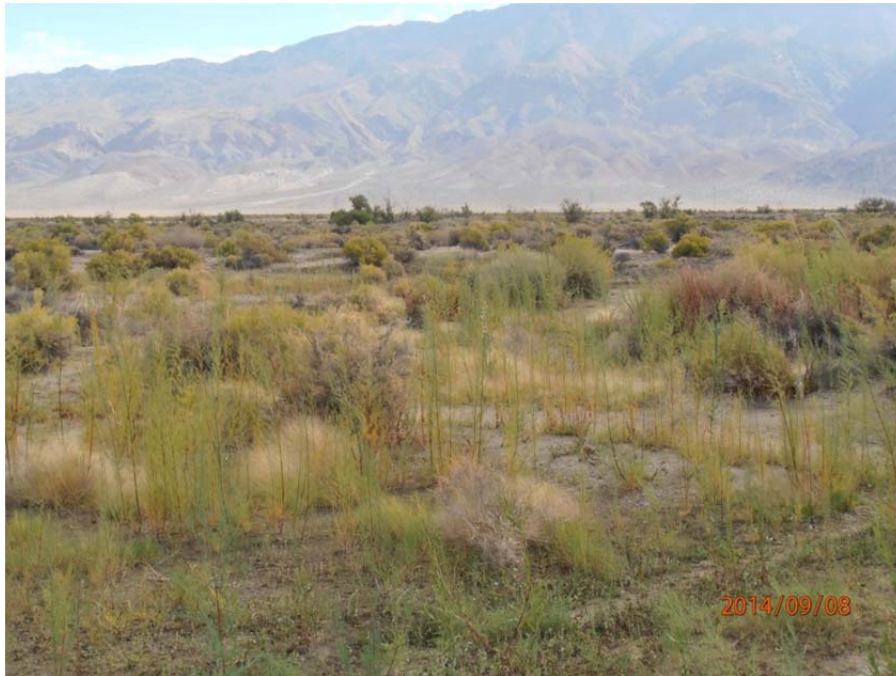
The road depression that receives overflow from the pupfish pond became inundated with saltcedar seedlings throughout the summer months of 2014. In September 2014, LADWP biologists manually removed an estimated 700 seedlings from this area (see photos below).

Before saltcedar removal at road depression crossing, September 2014

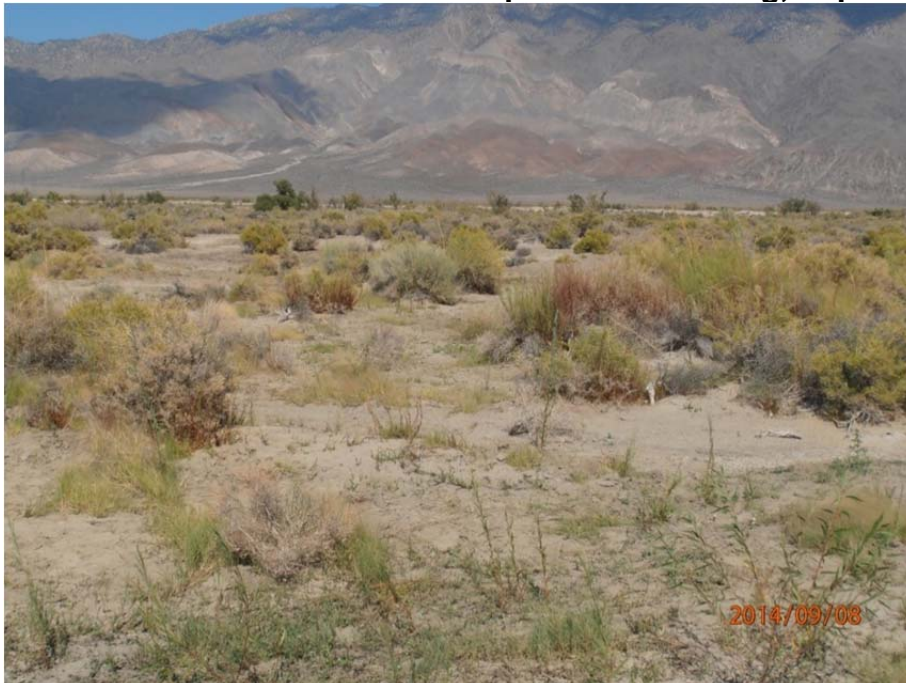
After saltcedar removal at old road dip crossing, September 2014

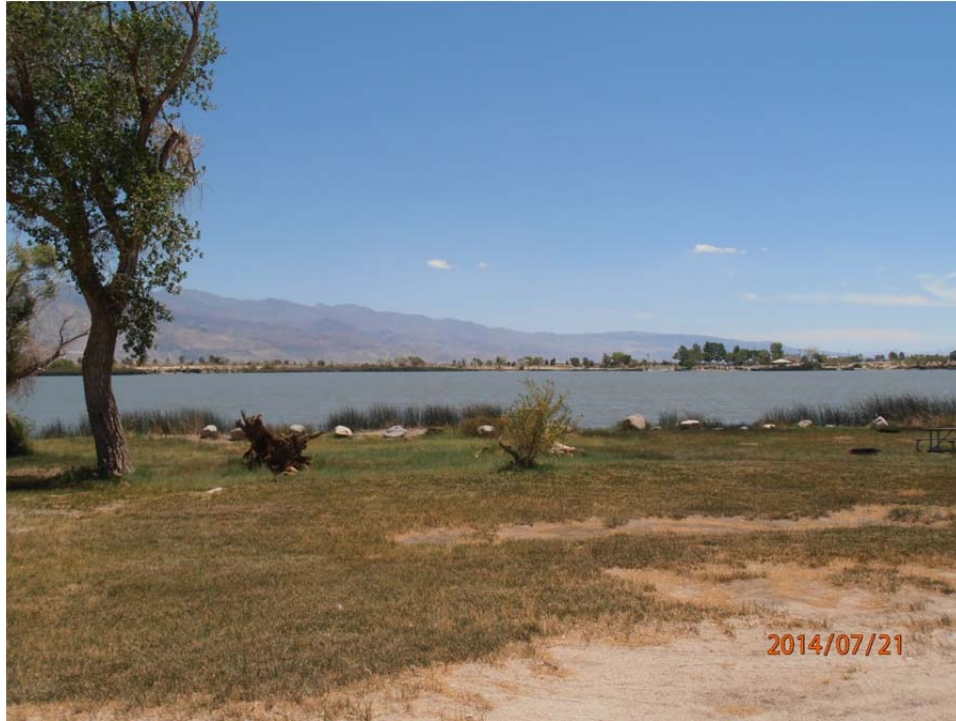
The lake shore was monitored for pepperweed. No pepperweed was observed but saltcedar and Russian olive are present on the northeastern shore. One saltcedar was observed on the mid-west shore. Large boulders were placed around the lake shore in 2012 to block boat access to prevent the spread of the invasive quagga and zebra mussels. There were no signs of vandalism to these barriers and signage appeared to be in good condition. Photos were taken of the boulders and signs blocking boat access around the lake (see photo below).

Diaz Lake depicting rock barriers in good condition, July 2014

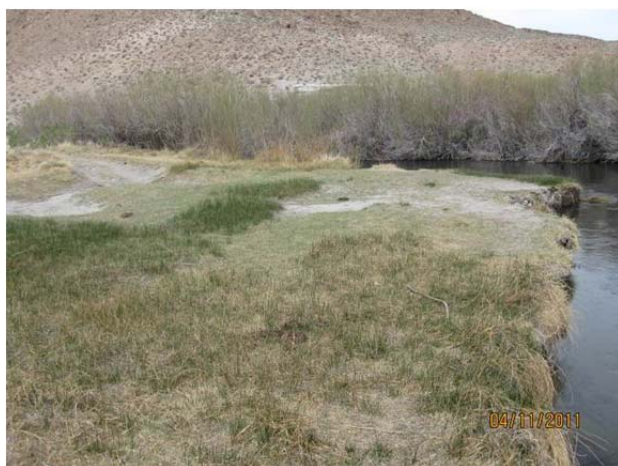
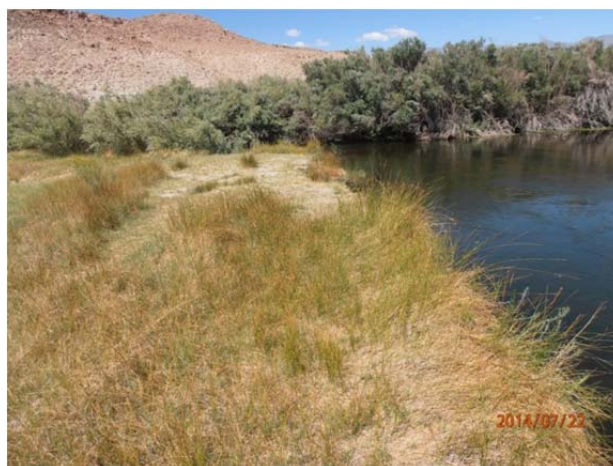
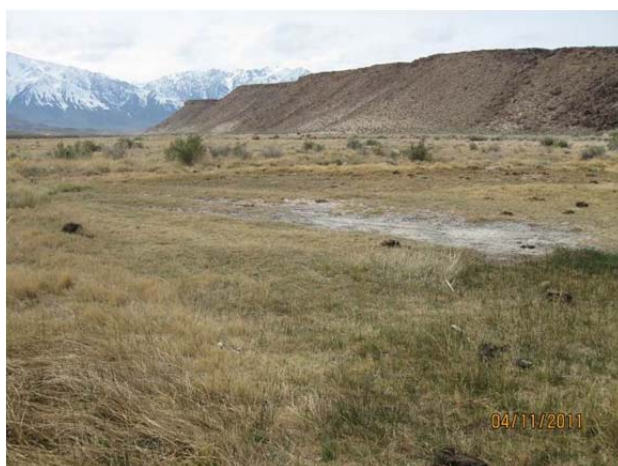
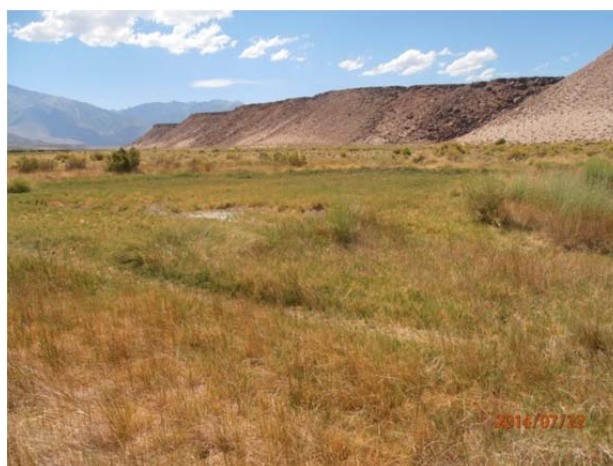
LADWP installed fencing along this section of the river in 2008. Parking areas outside the riparian corridor were established and walkthroughs were installed. The photos below show conditions following implementation of riparian fencing compared to the past growing season (both locations shown below are now fenced off from vehicular access). Saltgrass (*Distichlis spicata*) and Baltic rush (*Juncus balticus*) recruitment looks healthy and has established in the disturbed road areas.

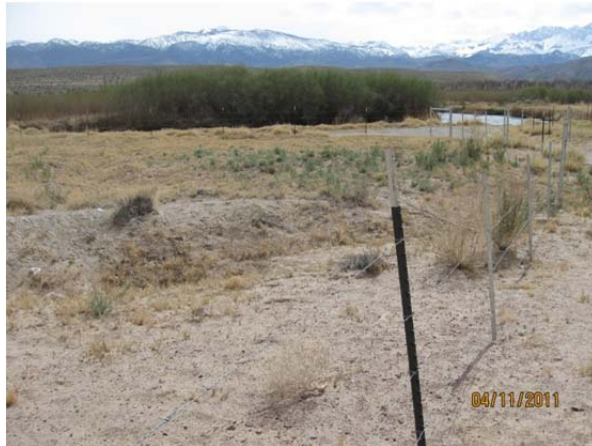
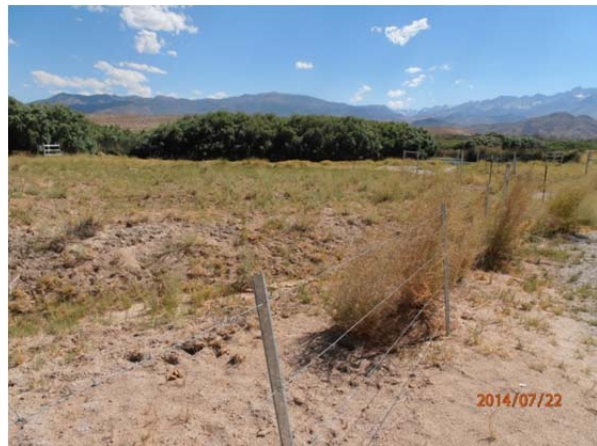
Saltgrass and Alkali sacaton (*Sporobolus airoides*) recruitment looks healthy and has established well over the old road at handicap access area 1. No photo points have been established at handicap access area 2. However, native recruitment at this area is also well established and healthy.

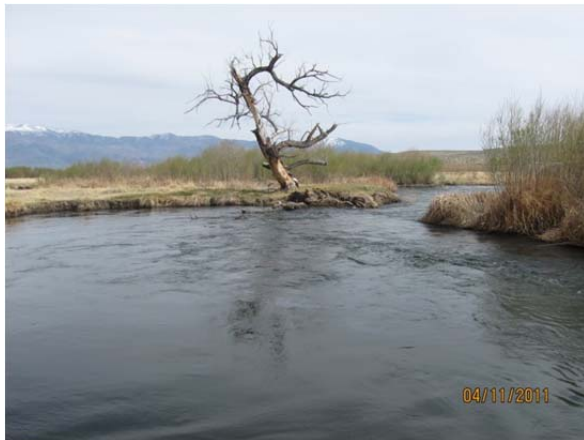
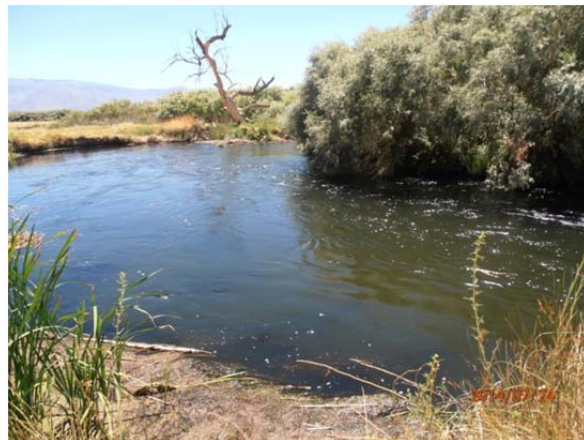
Saltgrass and Alkali sacaton recruitment looks healthy and has established well over disturbed areas. As depicted below, narrow leaf willows (*salix exigua*) have grown and extended further out on the south bank.

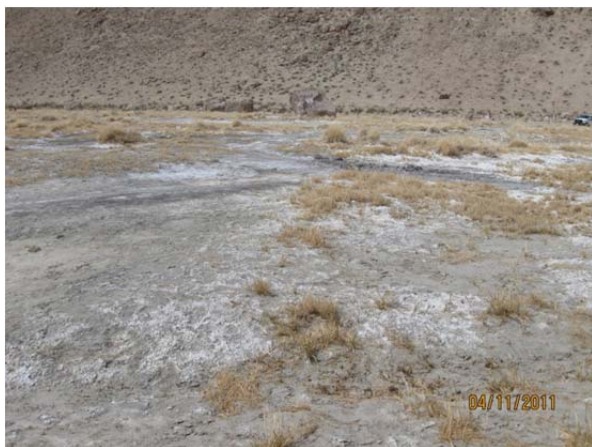
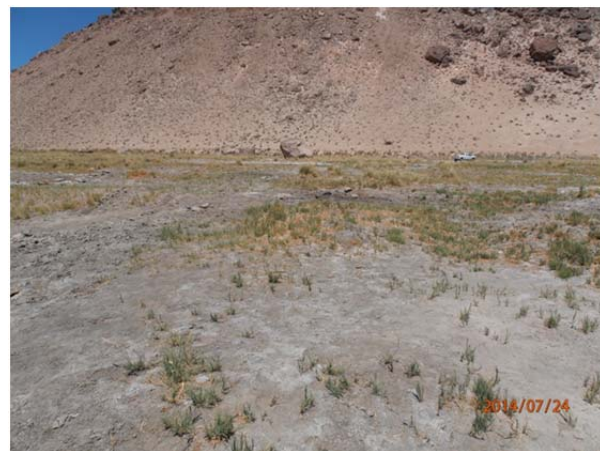
Vegetation recruitment at this location is not as prominent as the other managed recreation sites but the saltgrass seed source is abundant. Vegetation depicted in photo points in the summer of 2014 appear similar to those taken in the spring and summer of 2011. LADWP tilled compacted soil in this area in the fall of 2013 to promote growth of saltgrass that is currently present on site. To date, recruitment of saltgrass continues to be gradual.

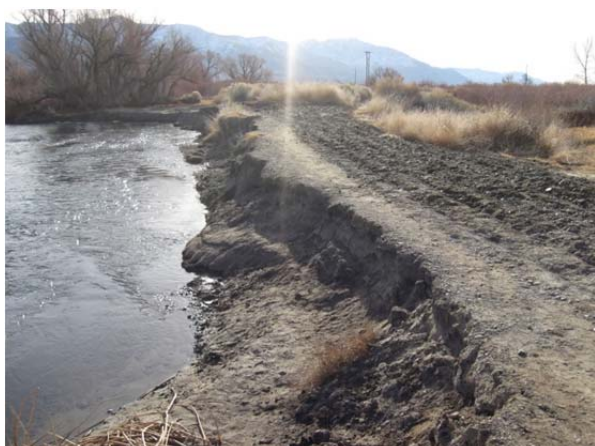
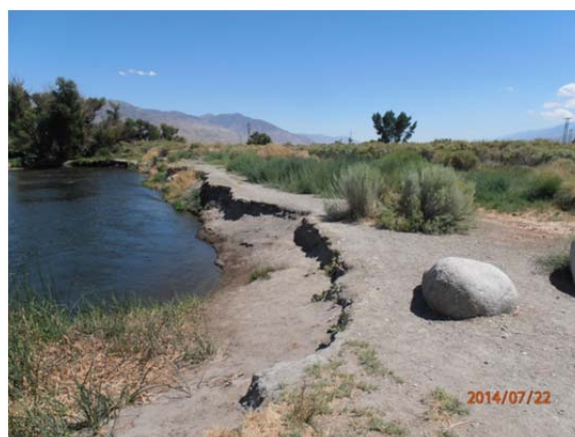
Broadleaf pepperweed (*Lepidium latifolium*) is a very invasive and prolific plant and is present on the east bank of this area. Fivehorn smotherweed (*Bassia hyssopifolia*) has also increased in abundance over the pathway compared to 2013. However, recruitment of a native species, Salt heliotrope (*Heliotropium curassavicum*) has also increased in this area. Torrey's saltbush (*Atriplex Torreyi*) and Rubber rabbitbrush (*Ericameria nauseosa*) are abundant and healthy throughout the site. No signs of vandalism were observed.

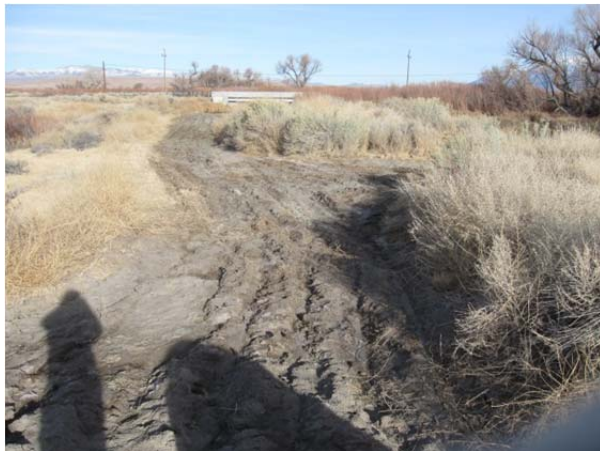
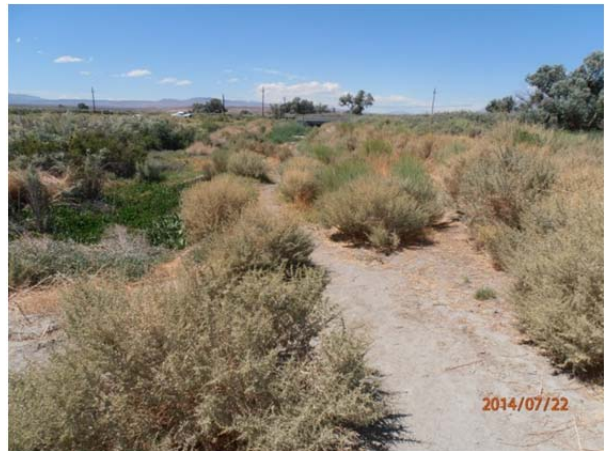
Fivehorn smotherweed has died back from 2013. Torrey's saltbush and American licorice have established where Fivehorn smotherweed was previously dominant. No signs of vandalism were present.

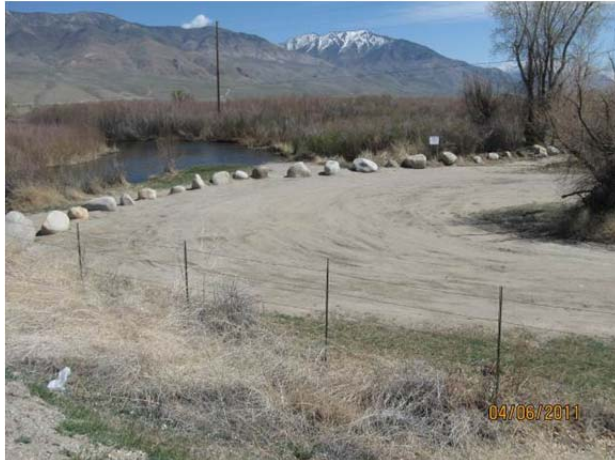
The photos below show conditions following the placement of boulders at East Line Street as well as conditions this past growing season. Overall vegetation looks healthy and is comparable to last year. Fivehorn smotherweed has taken over the guardrail but has died back on the hill between the fence and guardrail. The boulders remain in good condition and even though this is a popular location for river floats, there was minimal trash present and no signs of vandalism.

East Line Street, April 2011

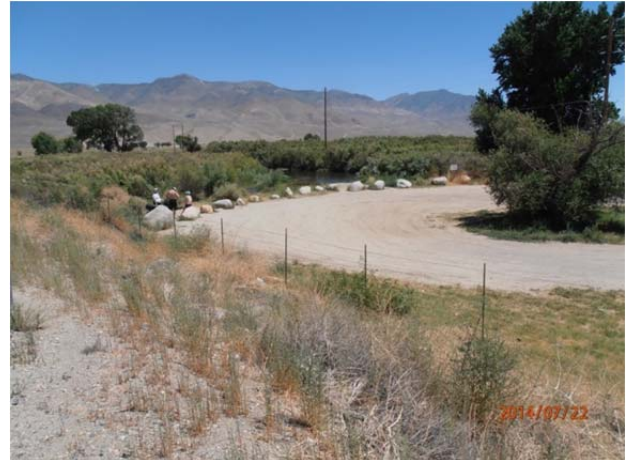
East Line Street, July 2014

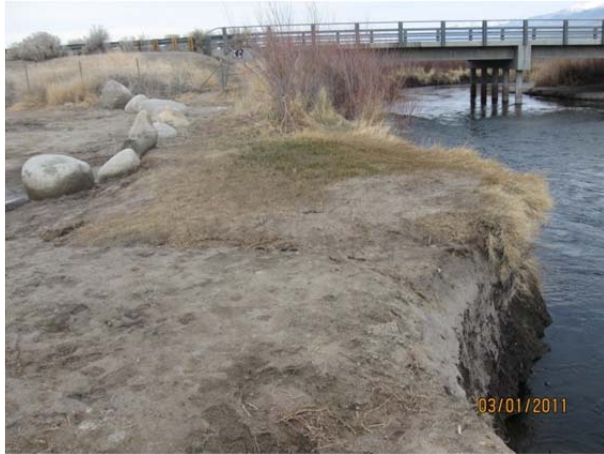
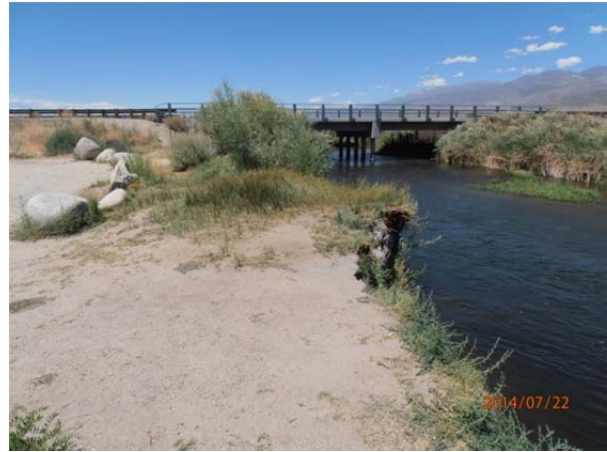
Baltic rush has become more prominent along the bank and Fivehorn smotherweed has died back. No signs of vandalism were present.

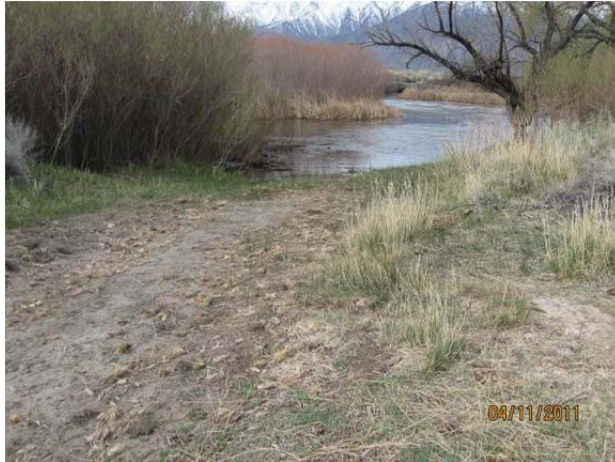
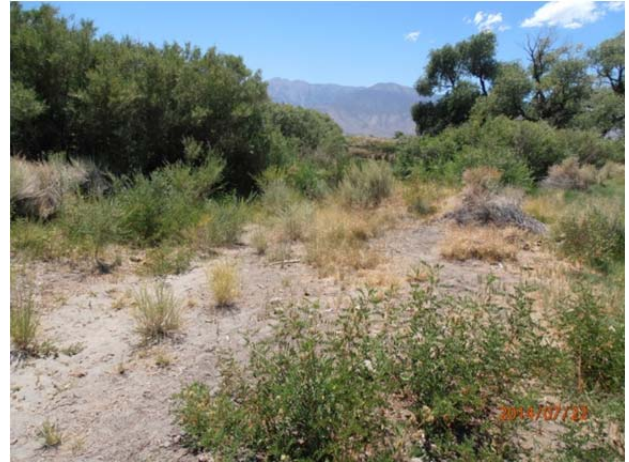
The photos below were taken inside the area that has been restricted from vehicular use following placement of controls. The photo on the right depicts vegetation recruitment that has established over vehicular tracks from the past four growing seasons. Alkali sacaton, Saltgrass, American licorice, Rubber rabbitbrush, and Torrey's saltbush continue to fill in gaps in the road. These species have significantly increased in cover since 2013. There are no signs of vandalism and the site has not been impacted any further by cattle or humans.
