This report includes Los Angeles Department of Water and Power's (LADWP) proposed Owens Valley operations plan for the first six months of the 2015-16 runoff year, an update on Owens Valley conditions, the current status of LADWP's environmental mitigation projects, and the status of other studies, projects, and activities.

In accordance with the 1997 MOU Section III.H, LADWP and Inyo County are required to prepare an annual report describing environmental conditions in the Owens Valley and the associated studies, projects, and activities conducted under the Water Agreement and the 1997 MOU. Sections 3 through 7 of this report are intended to fulfill that requirement.

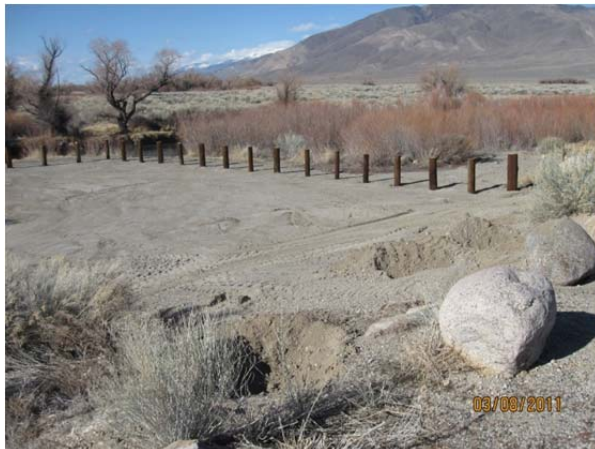
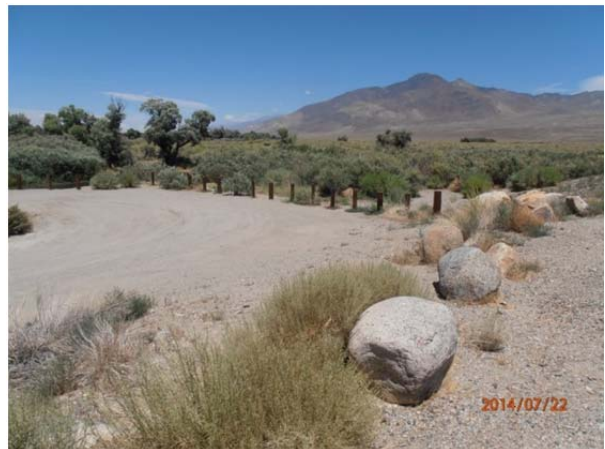
The photos below are taken from the designated parking area after vehicular controls were installed. The site has not been impacted any further by humans. Vegetation has established outside the parking area boundaries over the past four seasons post implementation of boulders and telephone poles.

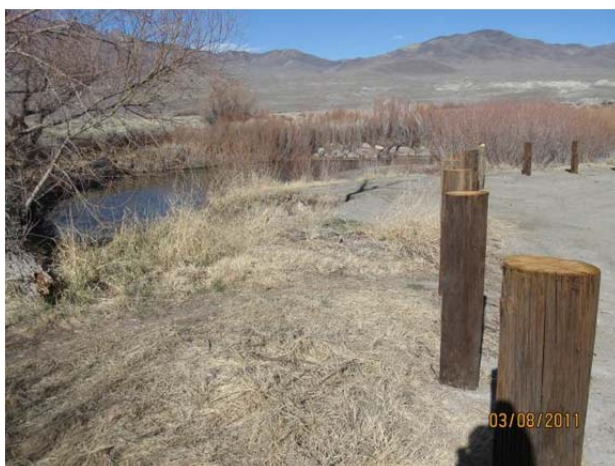
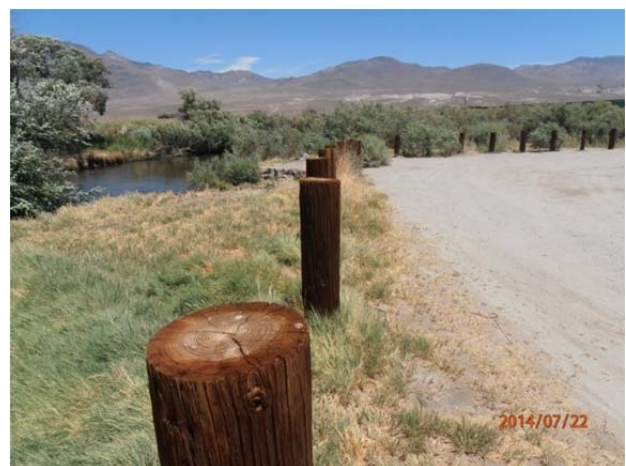
The photos below depict the Owens River bank after telephone poles were installed to restrict vehicular access to a designated parking area. The photo on the right depicts vegetation recruitment from the past four growing seasons. The site has not been impacted any further by humans and vehicular traffic. However, large amounts of trash were present along the northern bank. Saltgrass recruitment is healthy and vigorous along the wood posts.

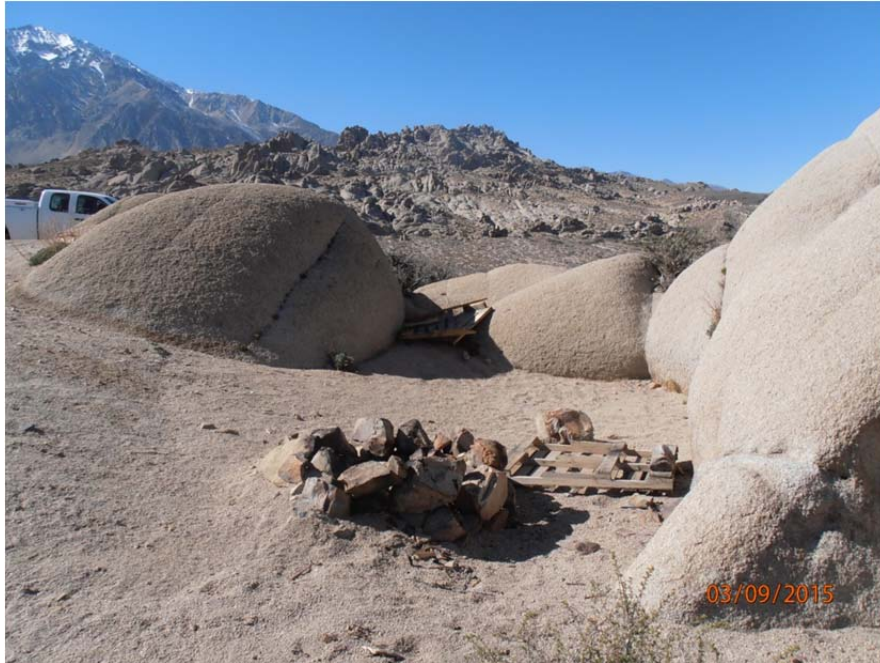
Example of a fire ring and palette just beyond a sign posted in the Buttermilk to remind users of fire restrictions, March 2015.
