Cabin Bar Ranch Water Bottling Facility Project

Vegetation Monitoring Report

May 2019

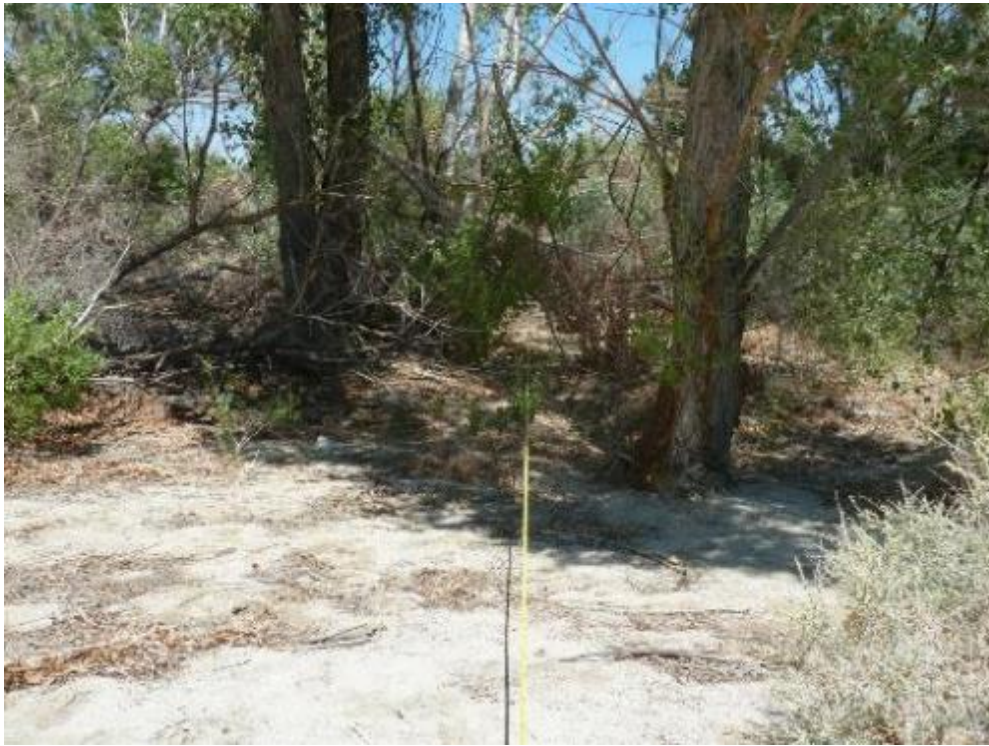
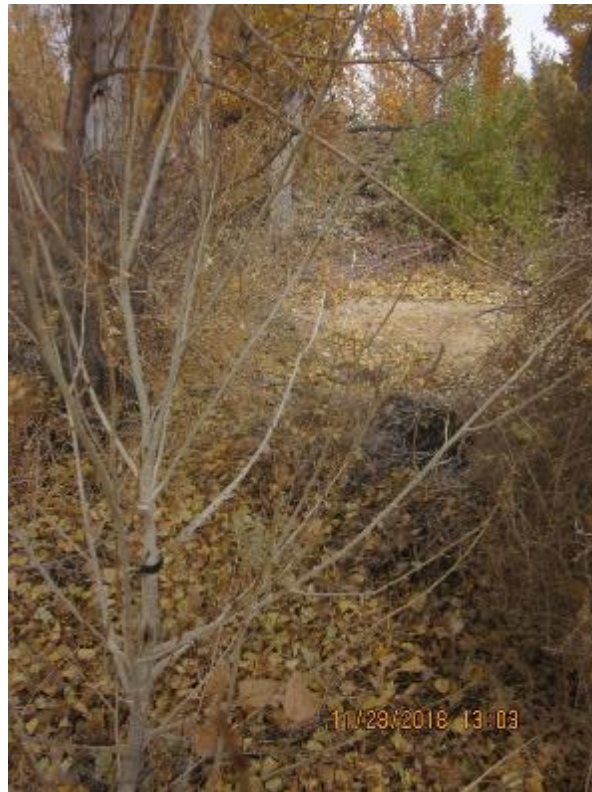
Transect 1 – Start – 2014 above-2018 below. For all photographs in this appendix, transect “Start” photographs are taken from the start of the transect viewing across the transect area. The “End” photographs are taken from the opposite end of the transect and view back into the transect area toward the “start” side.

Species	Percent cover		Difference 2018 minus 2014	Wetland Indicator Status
	2014	2018		
<i>Populus fremontii</i>	73	88	15	FACW
<i>Fraxinus velutina</i>	4	0	-4	FAC
<i>Salix laevigata</i>	1	19	18	FACW
<i>Artemesia ludoviciana</i>	0	0	0	FACU

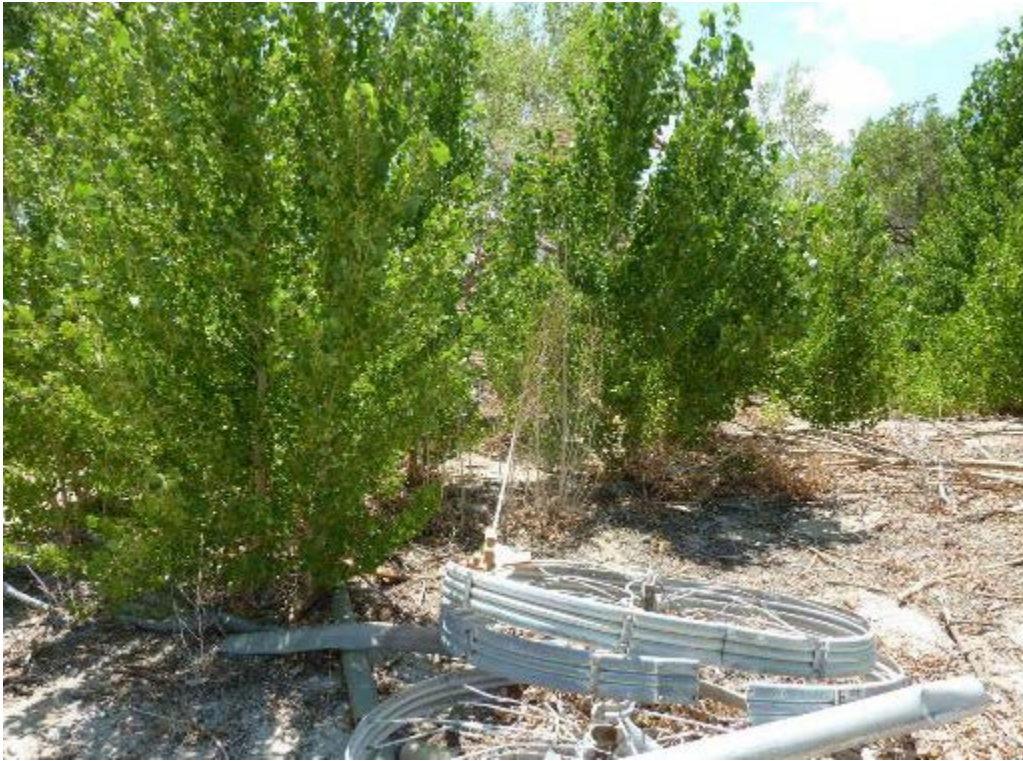
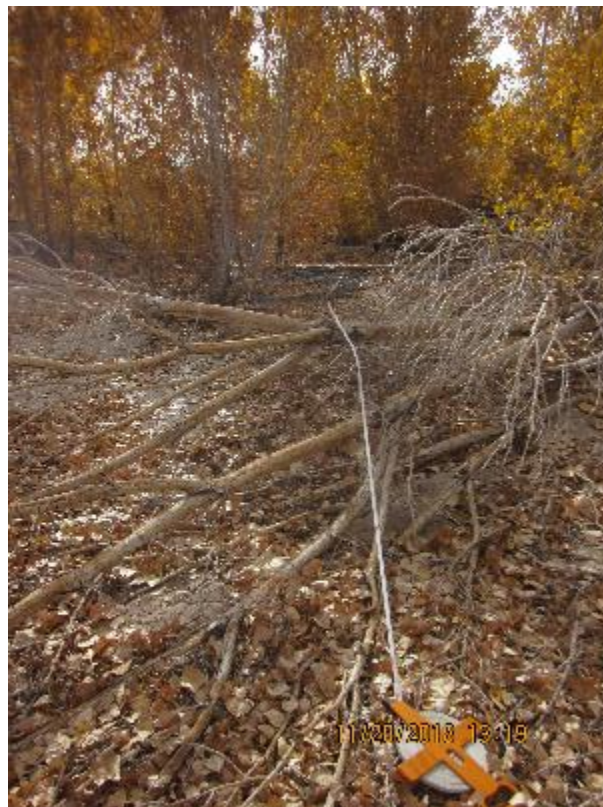
Transect 1 – End 2014 above-2018 below.

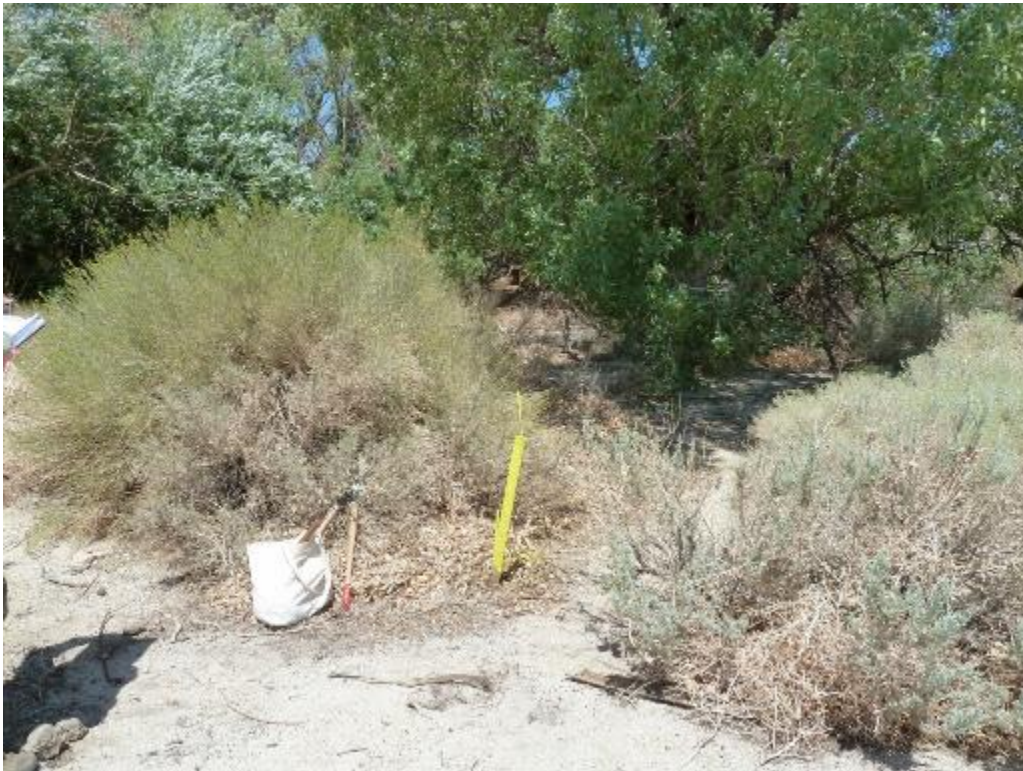
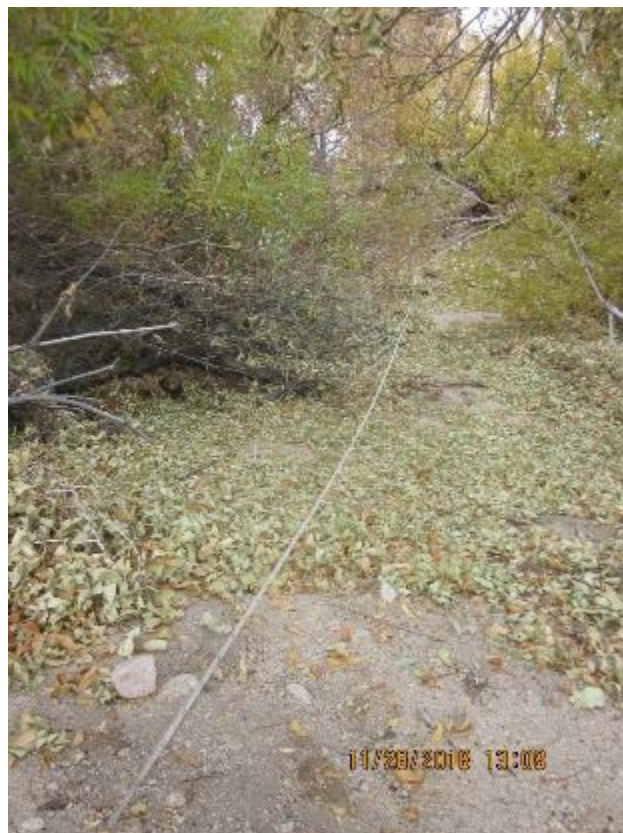
Transect 2 – Start. 2014 above-2018 below.

Species	Percent cover		Difference 2018 minus 2014	Wetland Indicator Status
	2014	2018		
<i>Fraxinus velutina</i>	67	60	-7	FACW
<i>Salix laevigata</i>	18	50	32	FACW
<i>Ericameria nauseosa</i>	13	0	-13	UPL

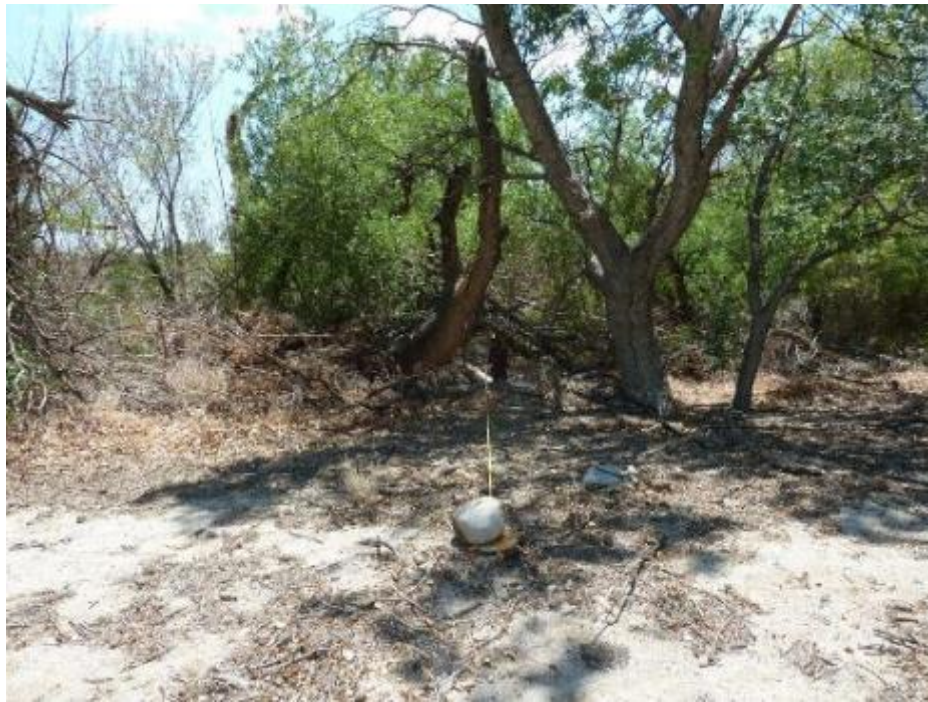
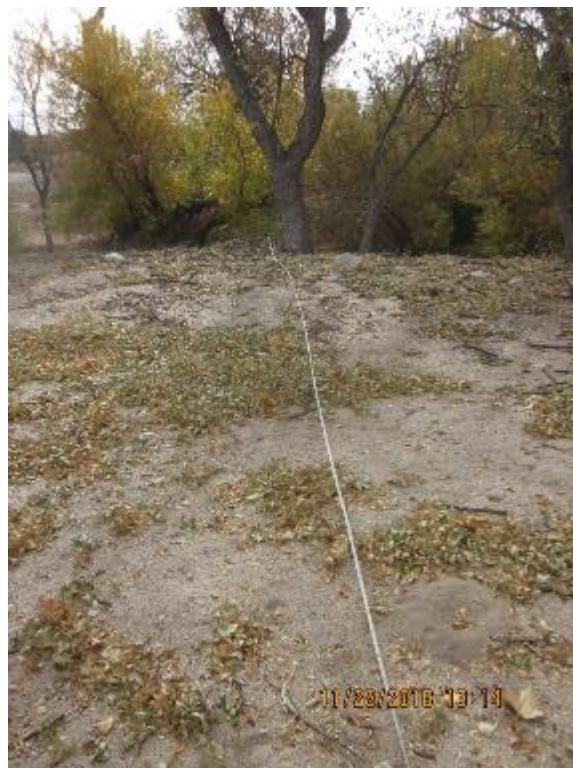
Transect 2 – End 2014 above-2018 below.

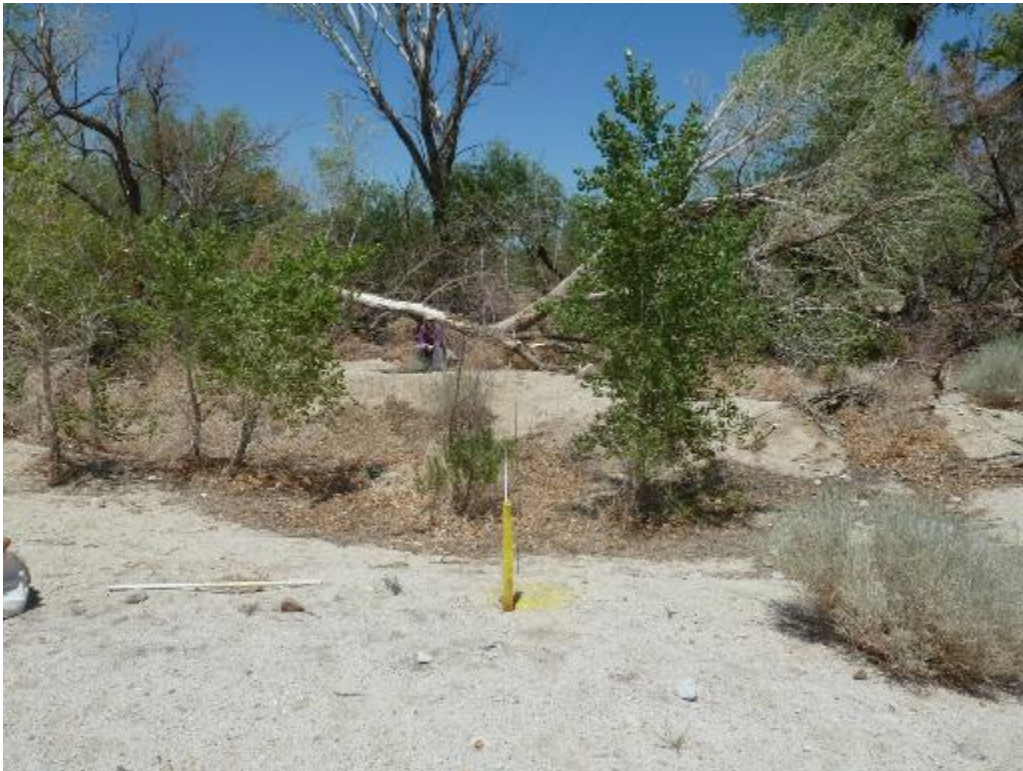
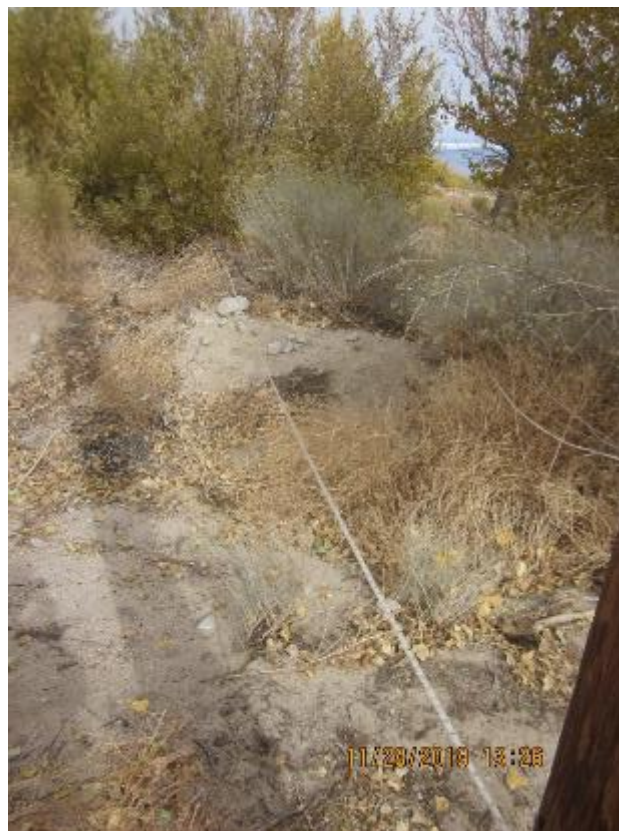
Transect 3 – Start 2014 above-2018 below.

Species	Percent cover		Difference 2018 minus 2014	Wetland Indicator Status
	2014	2018		
<i>Salix laevigata</i>	22	22	0	FACW
<i>Fraxinus velutina</i>	9	0	-9	FAC
<i>Populus fremontii</i>	0	27	27	FACW
<i>Ericameria nauseosa</i>	0	20	20	UPL
<i>Juncus balticus</i>	0	2	2	FACW
<i>Distichilis spicata</i>	0	2	2	FAC
<i>Thatch</i>	0	39	39

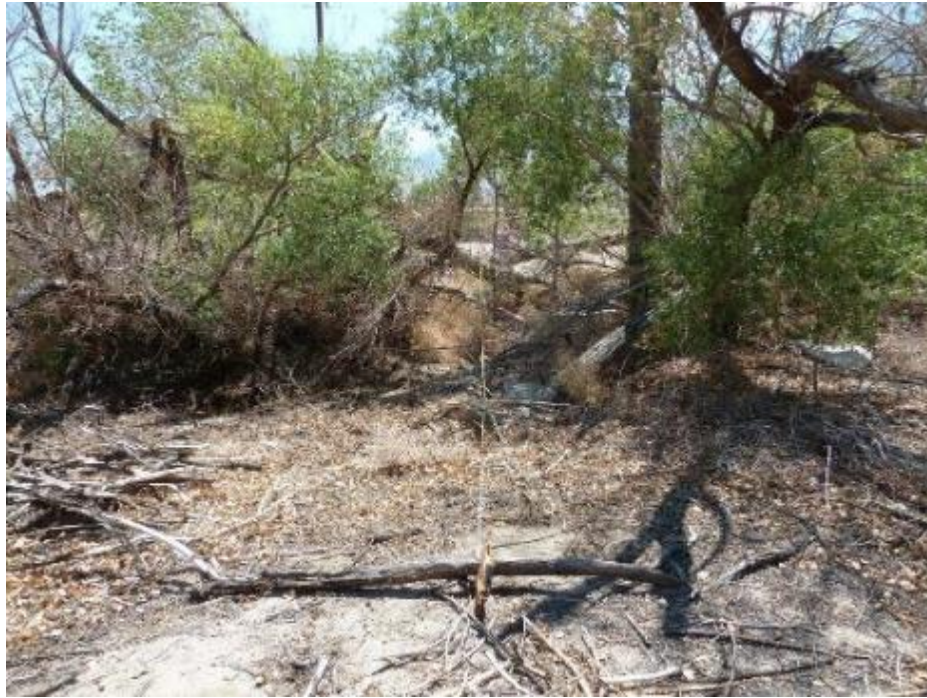
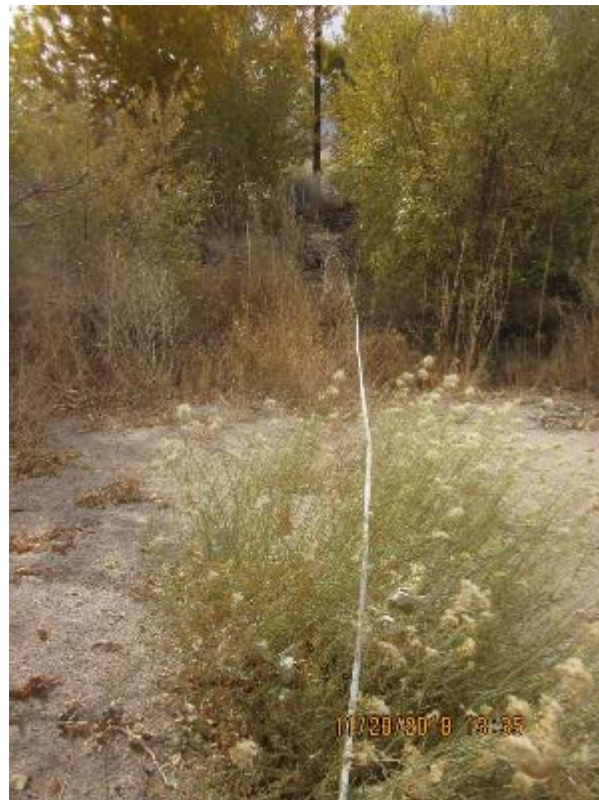
Transect 3 – End 2014 above-2018 below.

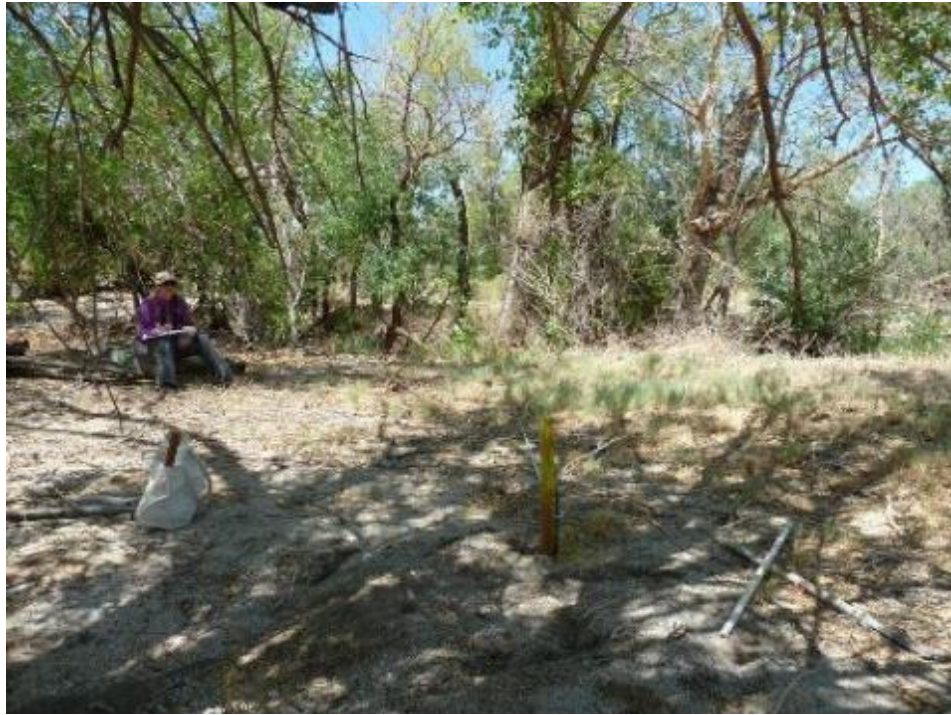
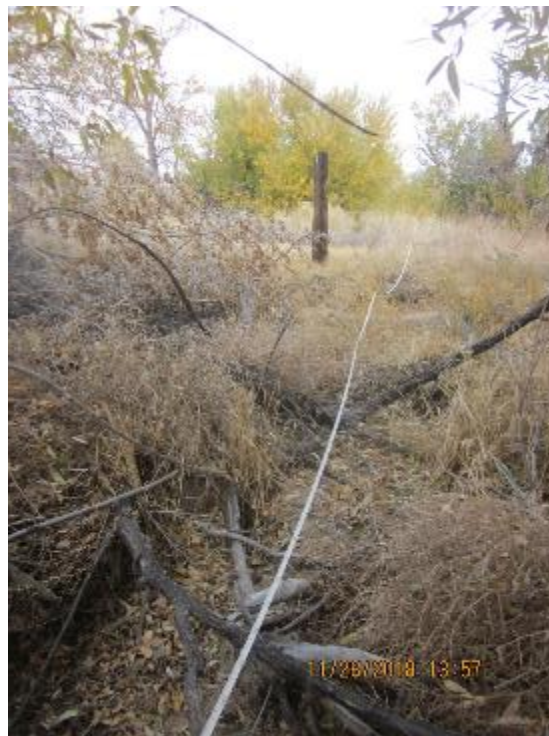
Transect 4 – Start 2014 above-2018 below.

Species	Percent cover		Difference 2018 minus 2014	Wetland Indicator Status
	2014	2018		
<i>Fraxinus velutina</i>	30	3	-27	FAC
<i>Populus fremontii</i>	15	0	-15	FACW
<i>Distichlis spicata</i>	14	28	14	FAC
<i>Ericameria nauseosa</i>	13	0	-13	UPL
<i>Salix laevigata</i>	12	17	5	FACW
<i>Leymus triticoides</i>	4	5	1	FAC

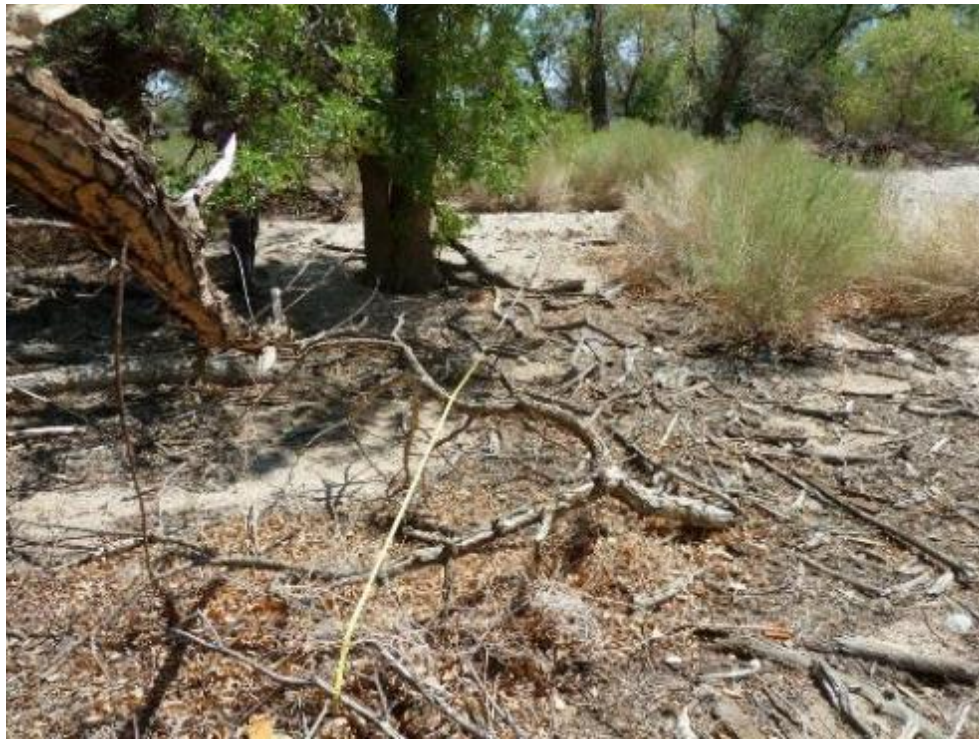
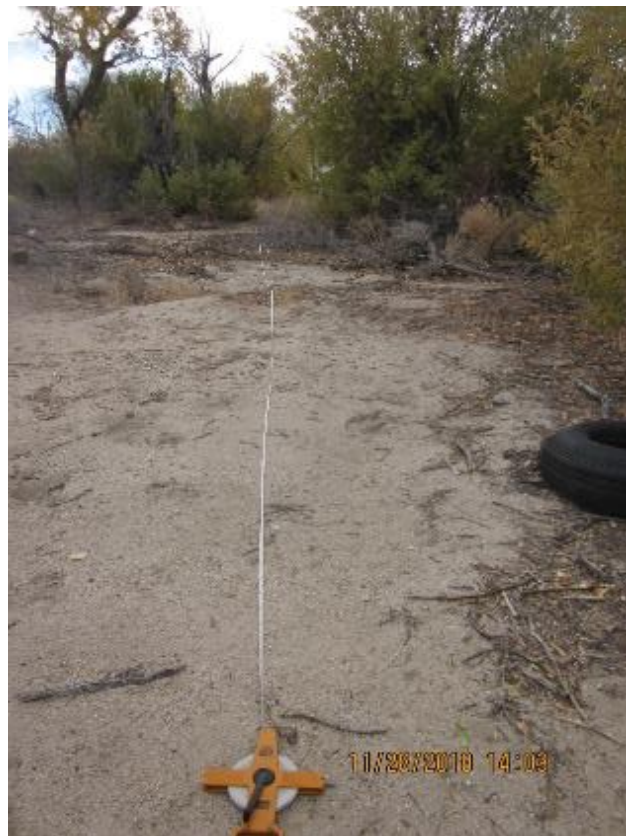
Transect 4 – End 2014 above-2018 below.

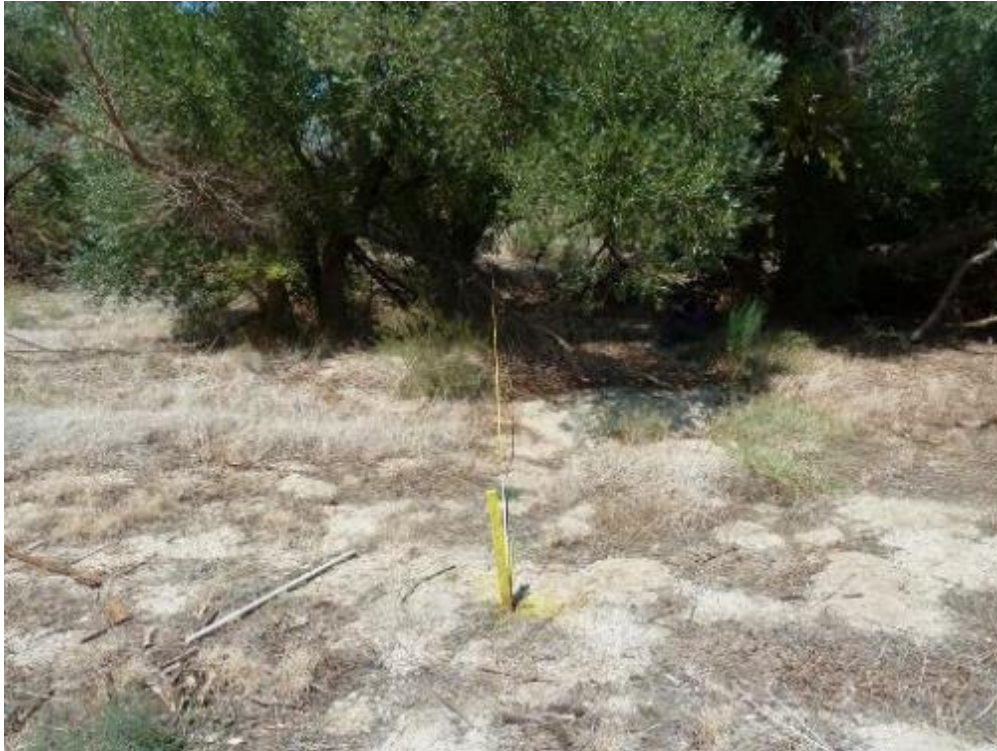
Transect 5 – Start 2014 above.

Species	Percent cover		Difference 2018 minus 2014	Wetland Indicator Status
	2014	2018		
<i>Salix laevigata</i>	53	11	-42	FACW
<i>Fraxinus velutina</i>	19	0	-19	FAC
<i>Ericameria nauseosa</i>	4	49	45	UPL
Thatch	0	44	44

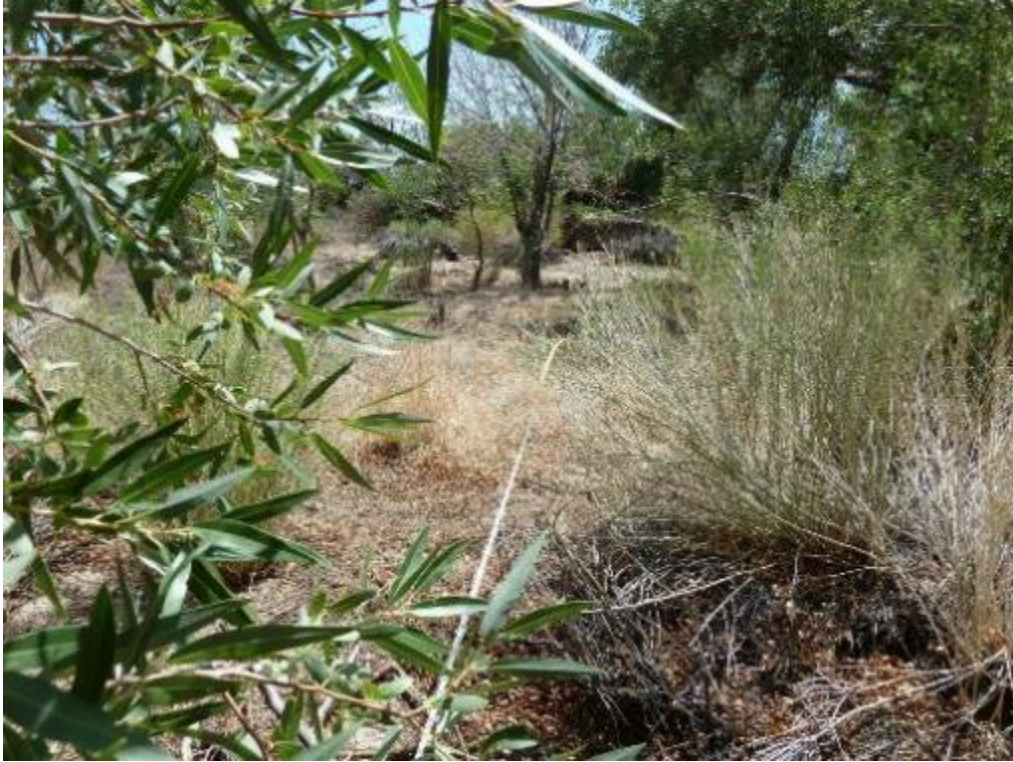
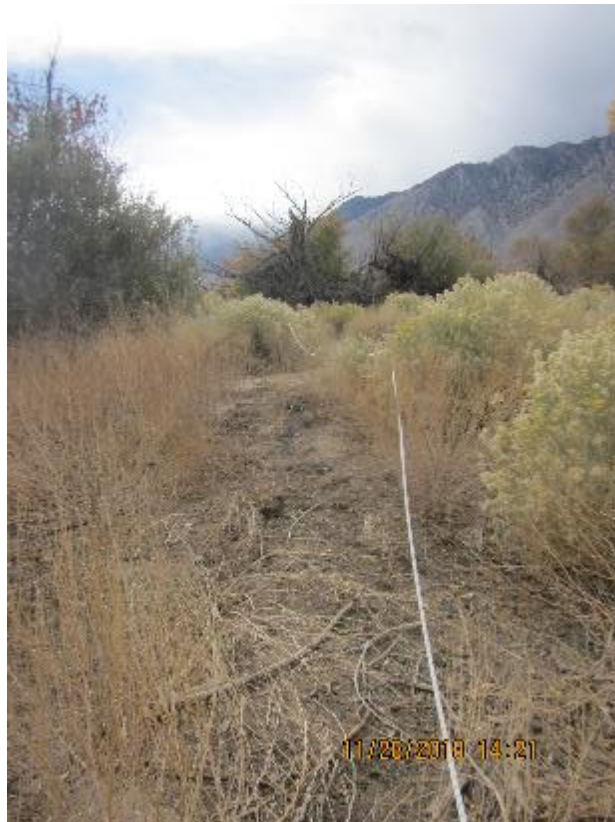
Transect 5 – End 2014 above-2018 below.

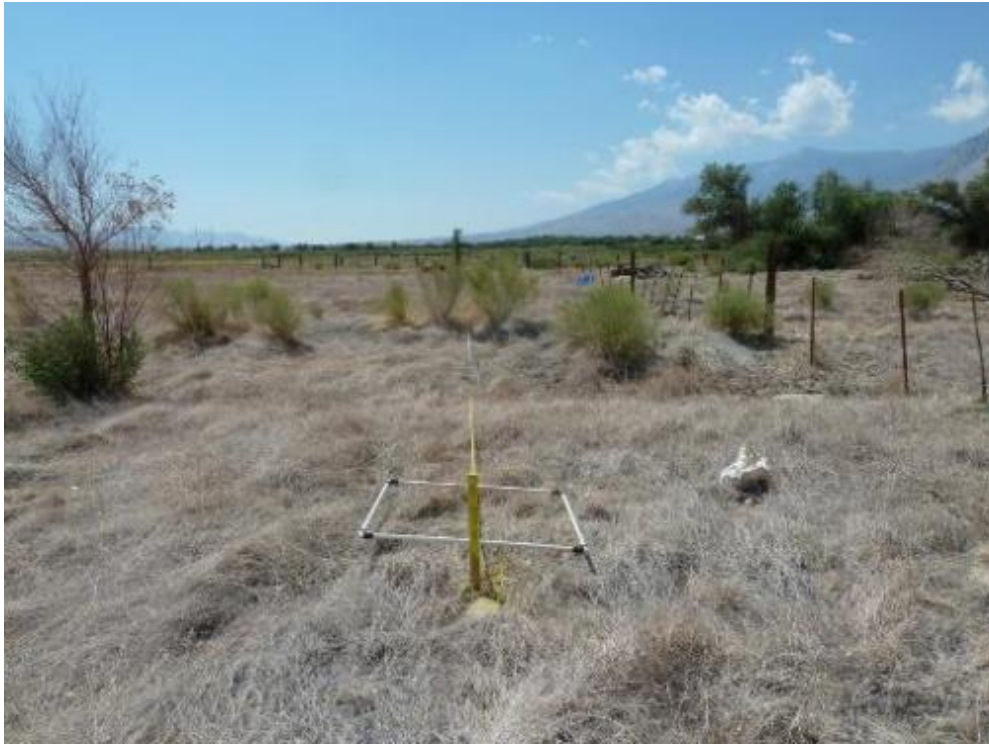
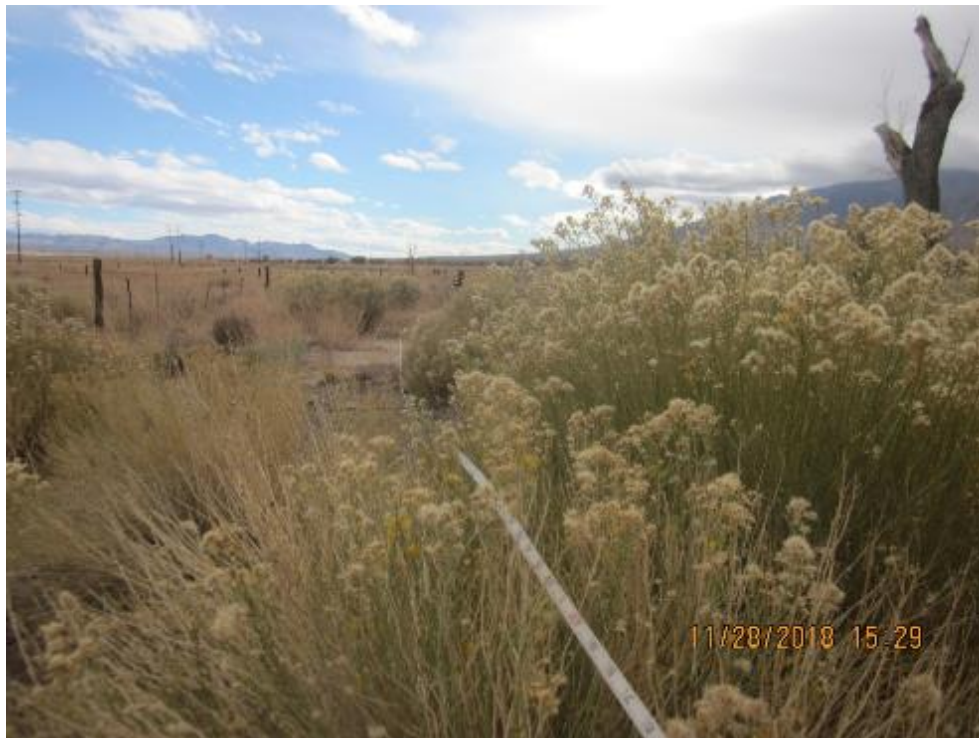
Transect 6 (and Transect E) – Start 2014 above-2018 below.

Species	Percent cover		Difference 2018 minus 2014	Wetland Indicator Status
	2014	2018		
Thatch	95	60	-35	
<i>Juncus balticus</i>	4	0	-4	FACW
<i>Ericameria nauseosa</i>	3	22	19	UPL
<i>Salsola tragus</i>	0	18	18	FACU

<i>Salsola tragus</i>	0	4	4	FACU
<i>Juncus balticus</i>	3	0	-3	FACW
Thatch	91	28	-63	
Sand/bare ground	0	39	39

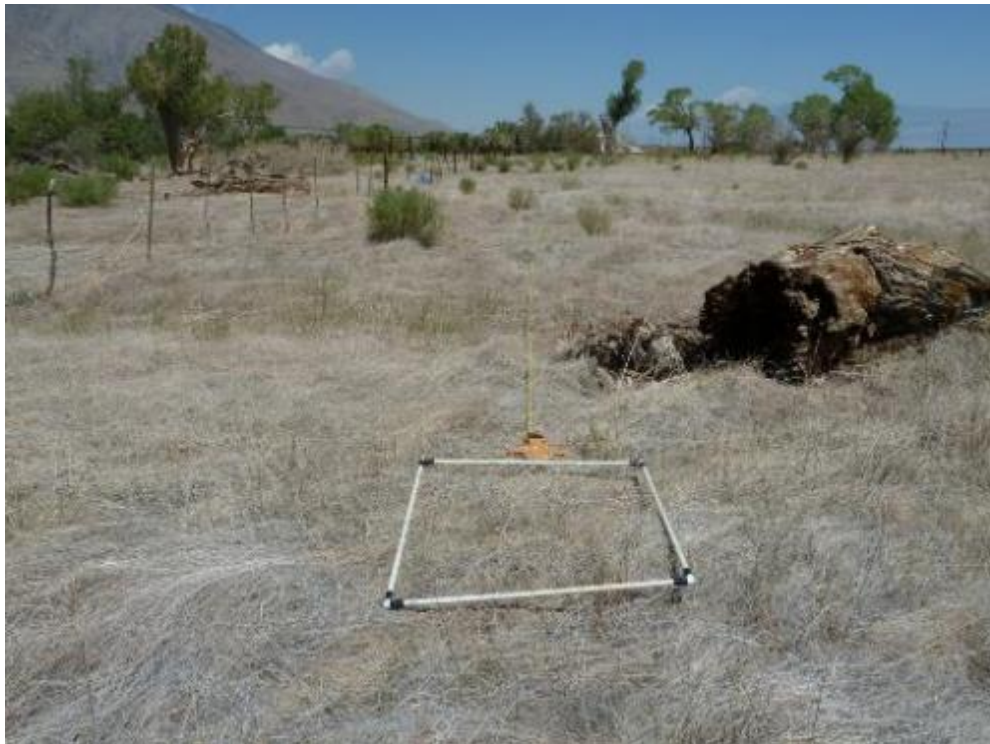
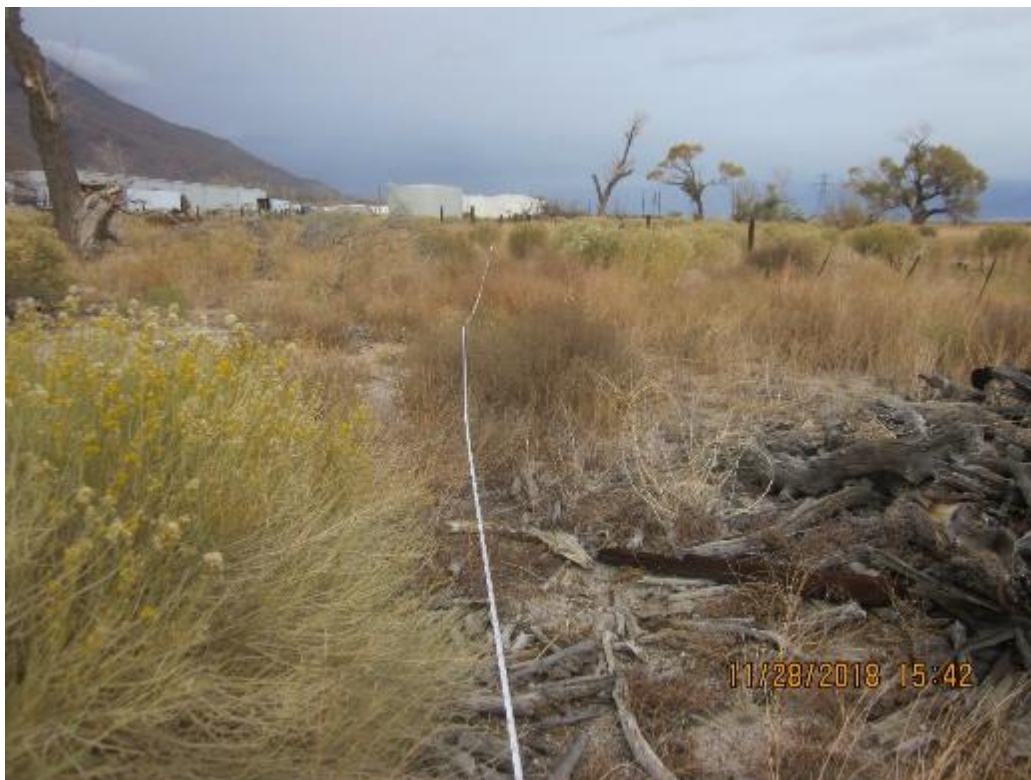
Transect 6 (and Transect E) – End 2014 above-2018 below

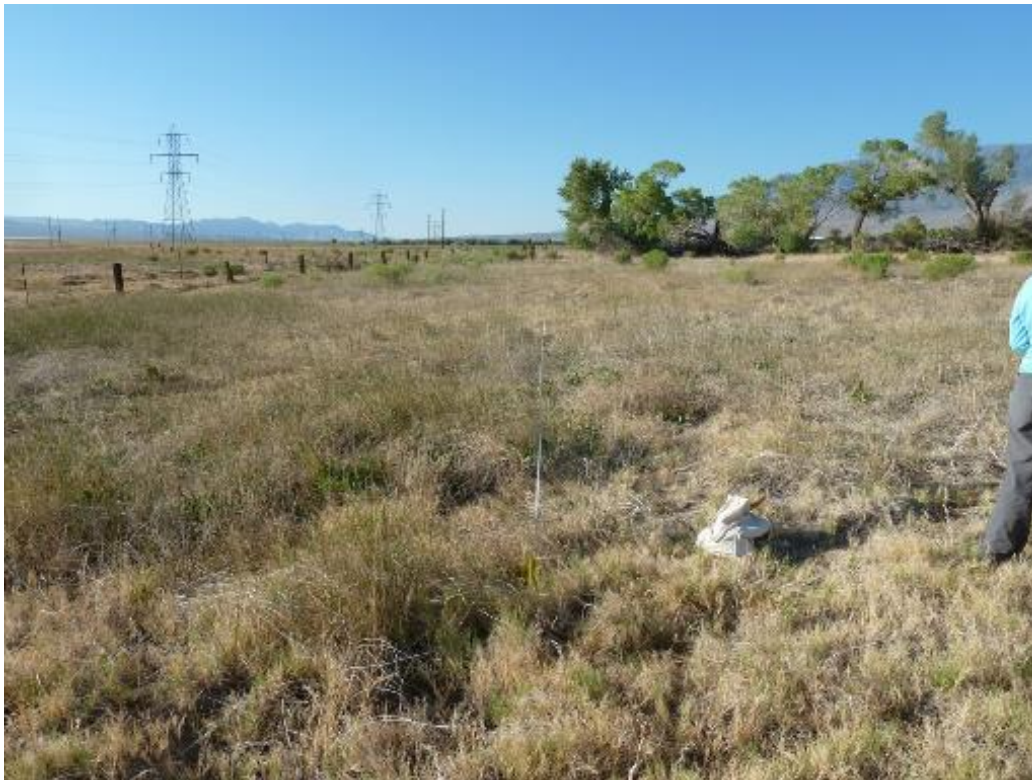
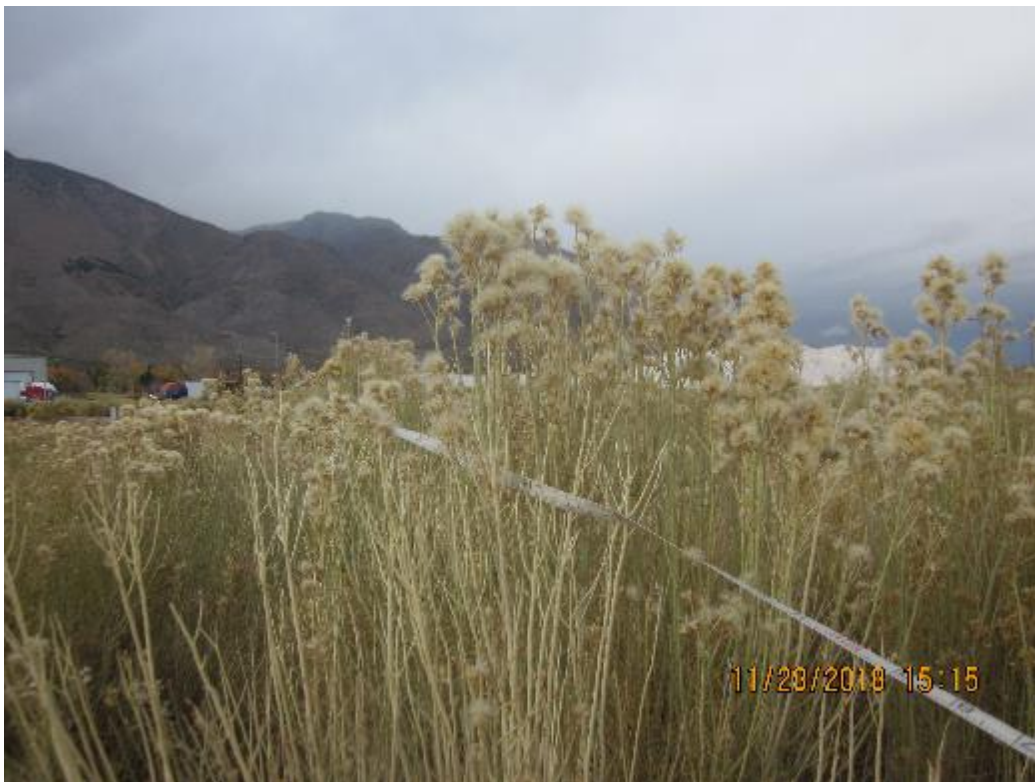
Transect 7 – Start 2014 above-2018 below.

Species	Percent cover		Difference 2018 minus 2014	Wetland Indicator Status
	2014	2018		
<i>Juncus balticus</i>	47	10	-37	FACW
Thatch	35	9	-26	
<i>Distichlis spicata</i>	19	63	44	FAC
<i>Anemopsis californica</i>	10	4	-6	OBL
<i>Ericameria nauseosa</i>	0	24	24	UPL

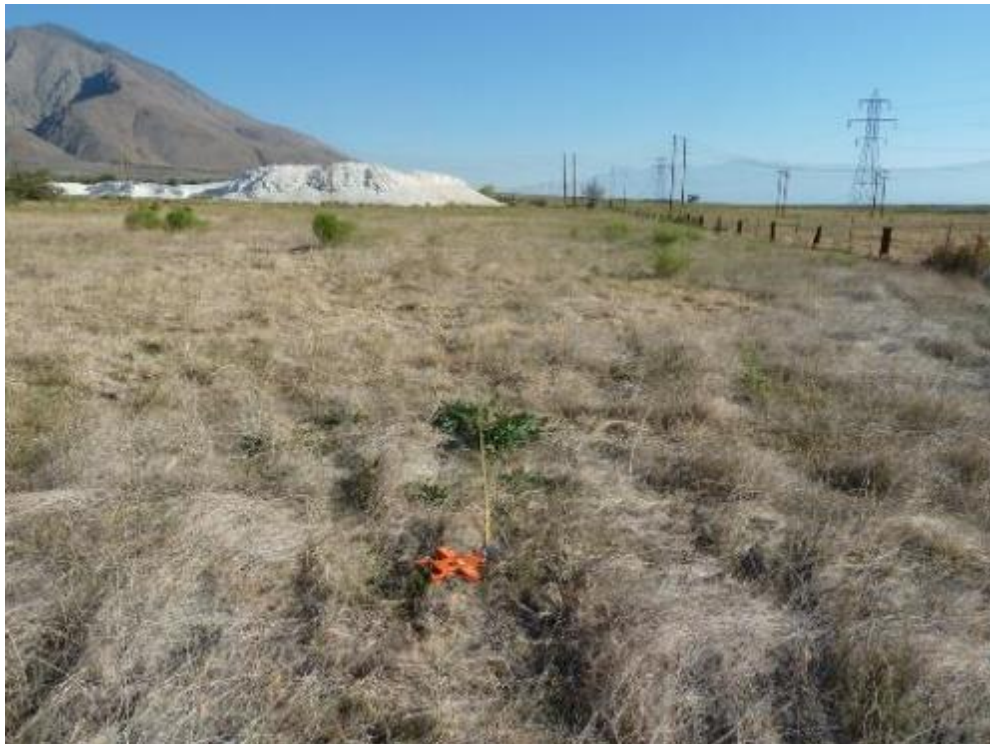
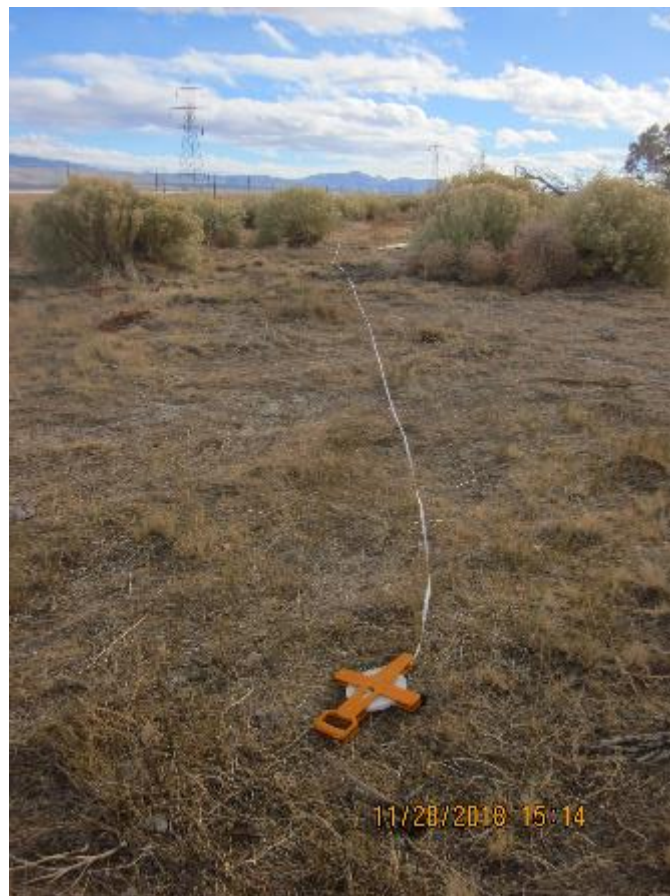
Transect 7 – End 2014 above-2018 below.

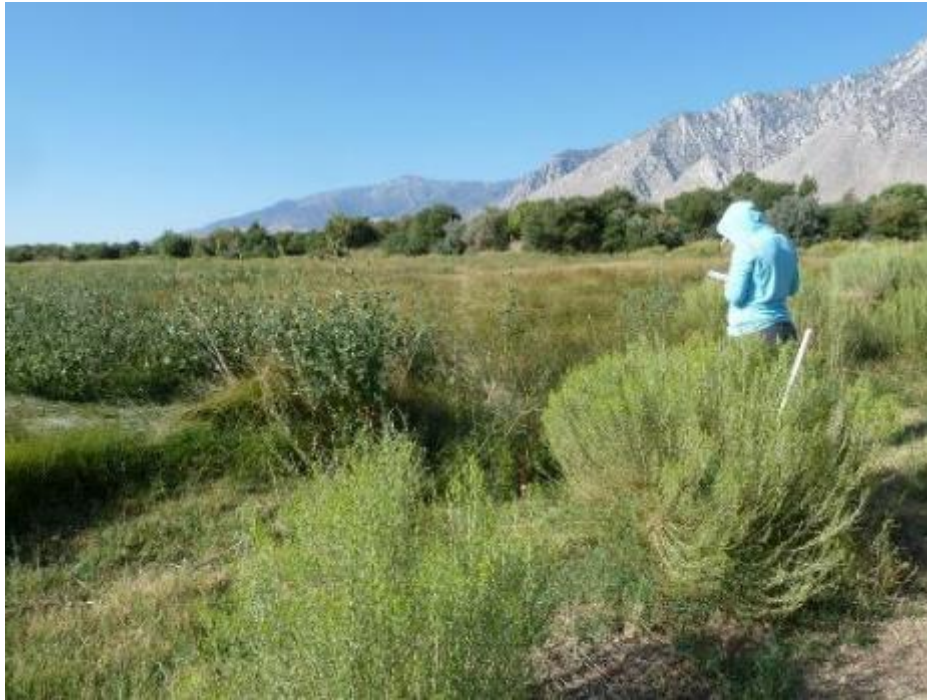
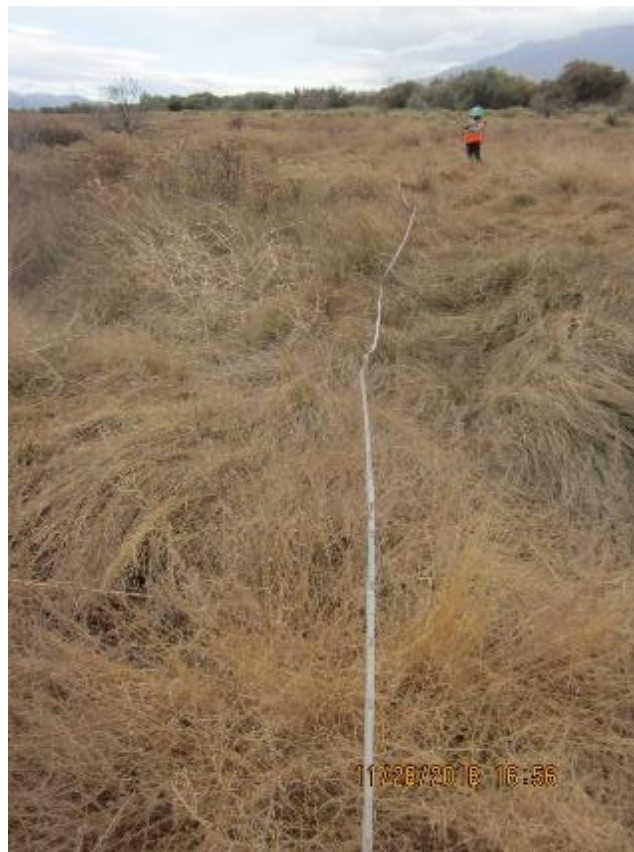
Transect 8 – Start 2014 above-2018 below.

Species	Percent cover		Difference 2018 minus 2014	Wetland Indicator Status
	2014	2018		
<i>Carex praegracilis</i>	58	68	10	FACW
Thatch	38	4	-34	
<i>Juncus balticus</i>	25	7	-18	FACW
<i>Carex nebrascensis</i>	11	52	41	OBL
<i>Distichlis spicata</i>	3	4	1	FAC
<i>Asclepias fascicularis</i>	3	6	3	FAC
<i>Lactuca serriola</i>	1	0	-1	FAC
<i>Ericameria nauseosa</i>	0	5	5	UPL

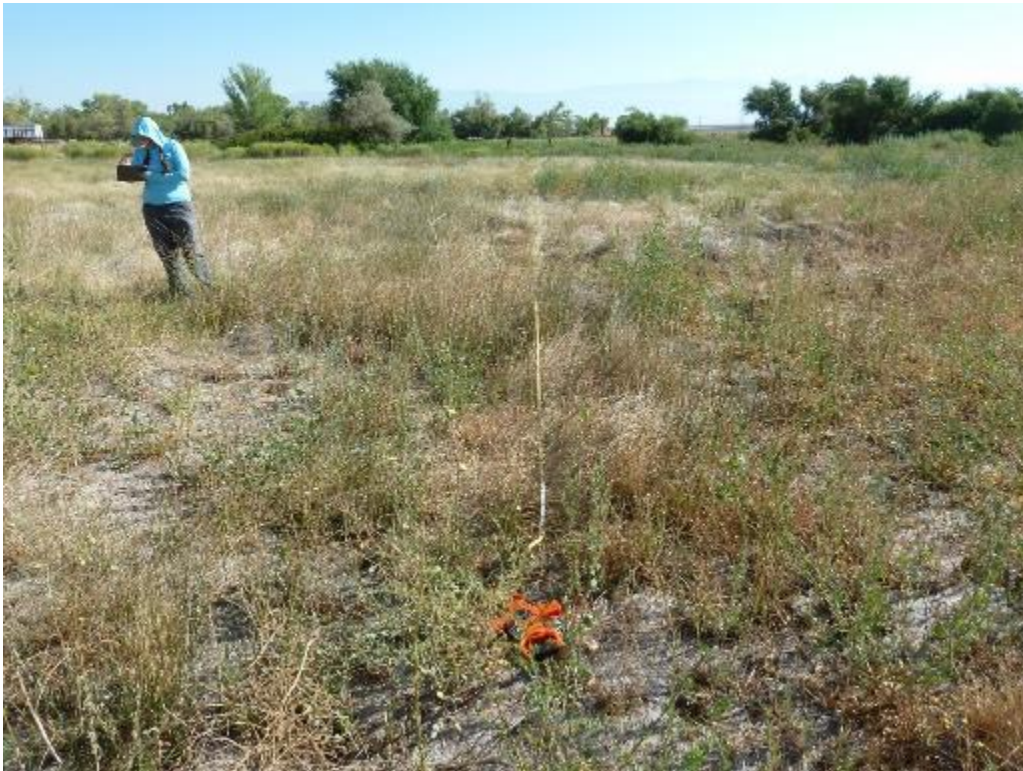
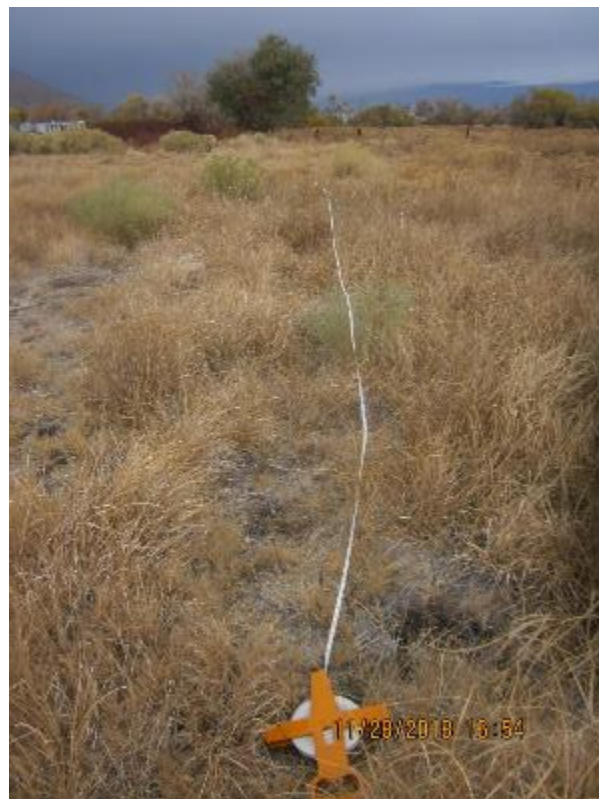
Transect 8 – End 2014 above-2018 below.

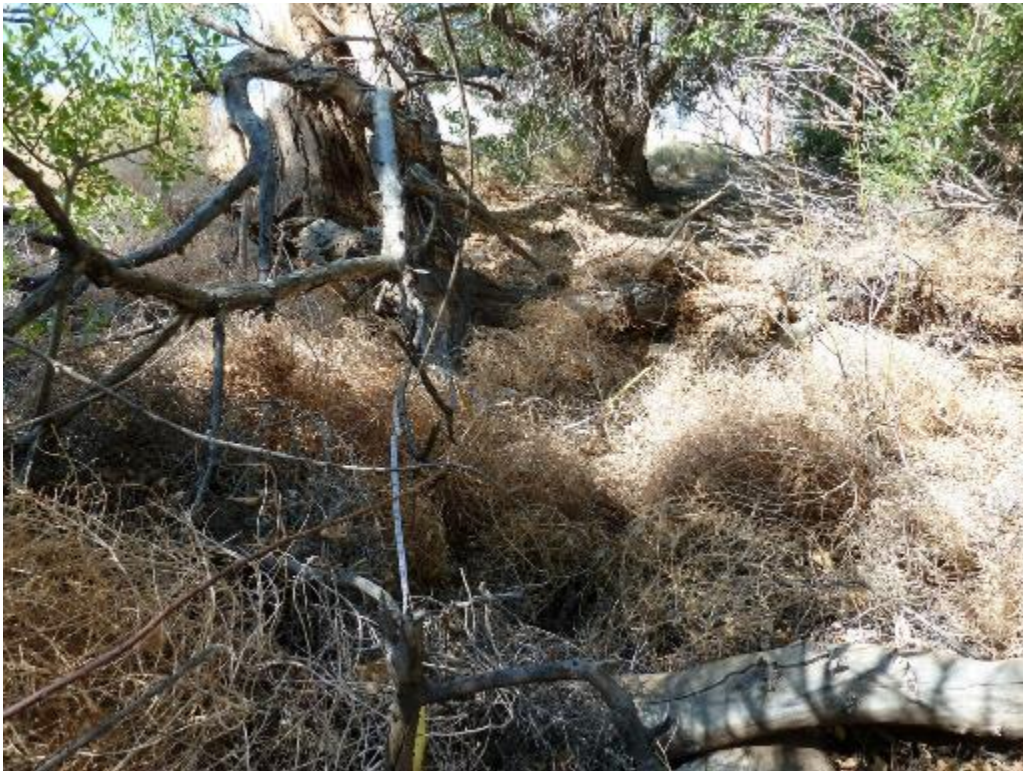
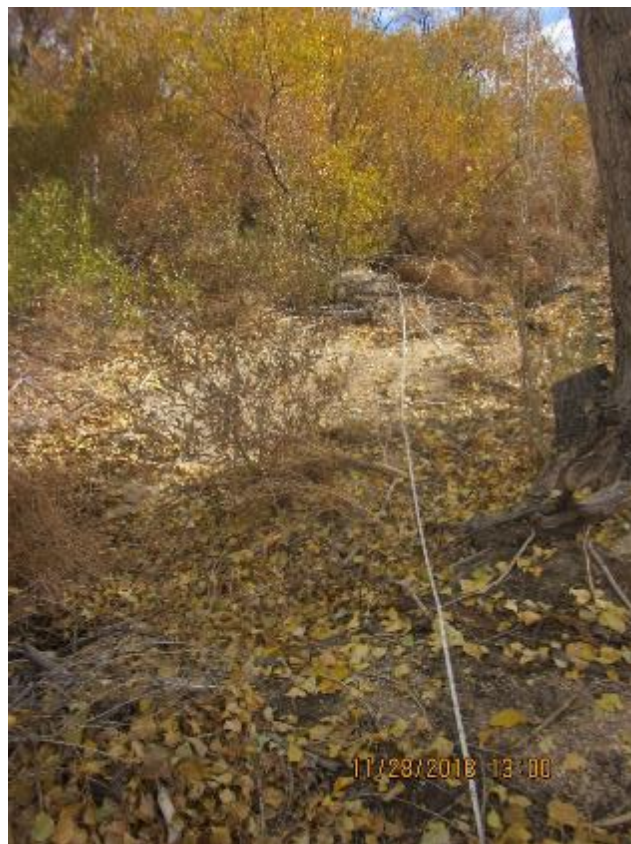
Greenline Transect South bank – representative photo along transect 2014 above-2018 below.

Species	Percent cover		Wetland Indicator Status
	2014	2018	
<i>Salix laevigata</i>	44	65	FACW
<i>Fraxinus velutina</i>	26	8	FAC
<i>Populus fremontii</i>	20	35	FACW
<i>Rosa woodsii</i>	2	5	FACU
