Cabin Bar Ranch Water Bottling Facility Project

Vegetation Monitoring Report

May 2019

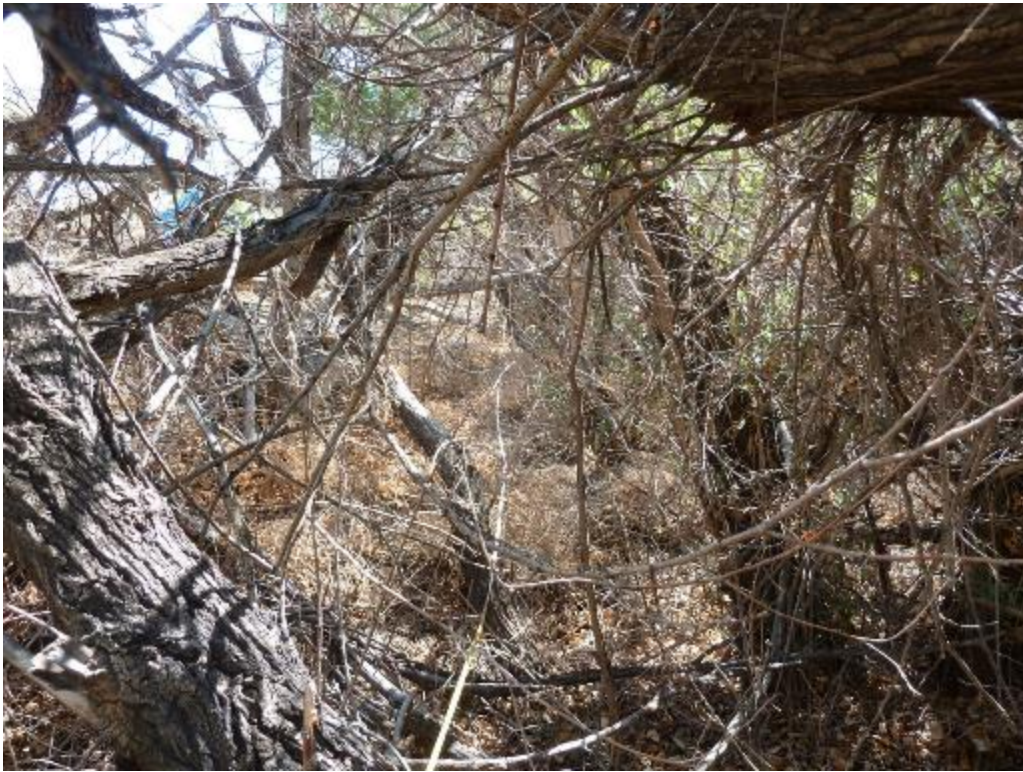
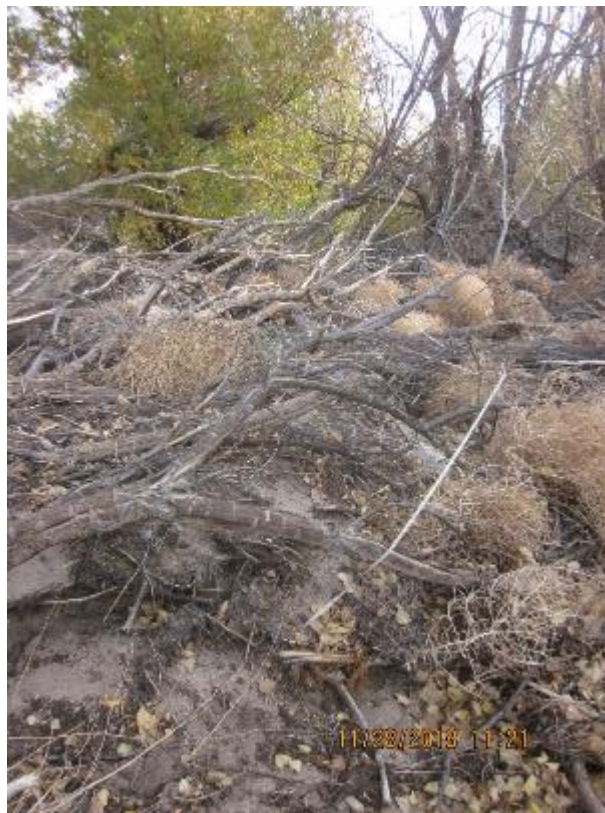
Greenline Transect North bank – representative photo along transect 2014 above-2018 below.

<i>Salix laevigata</i>	72	84	FACW
<i>Populus fremontii</i>	26	9	FACW
<i>Fraxinus velutina</i>	8	16	FAC

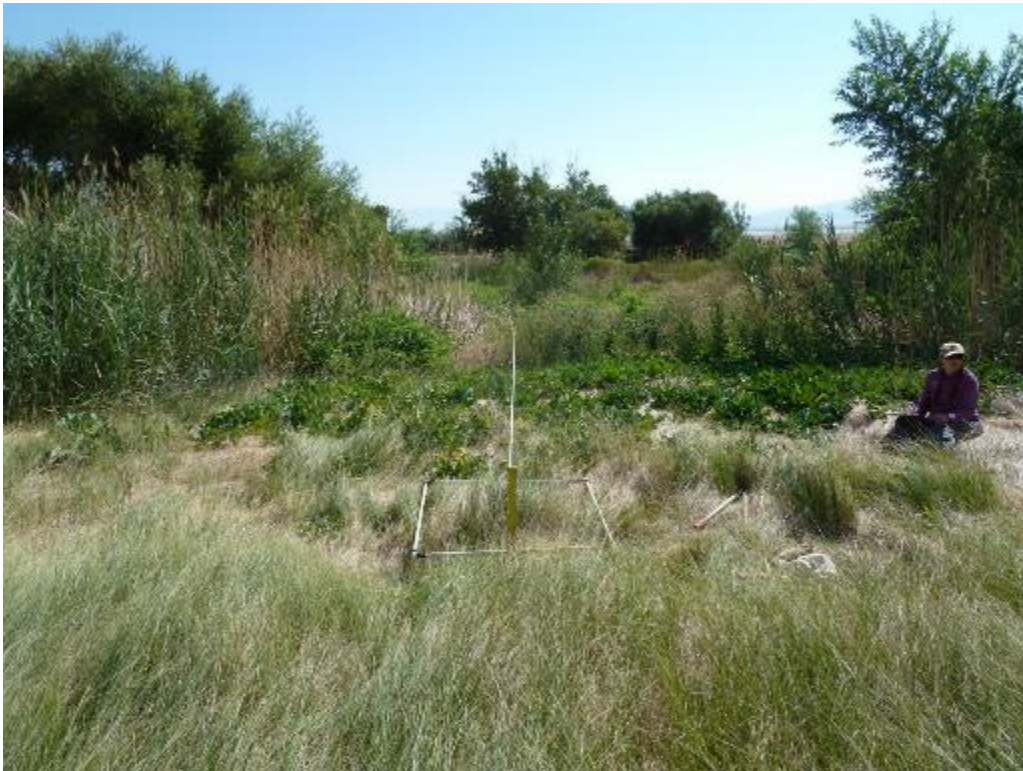
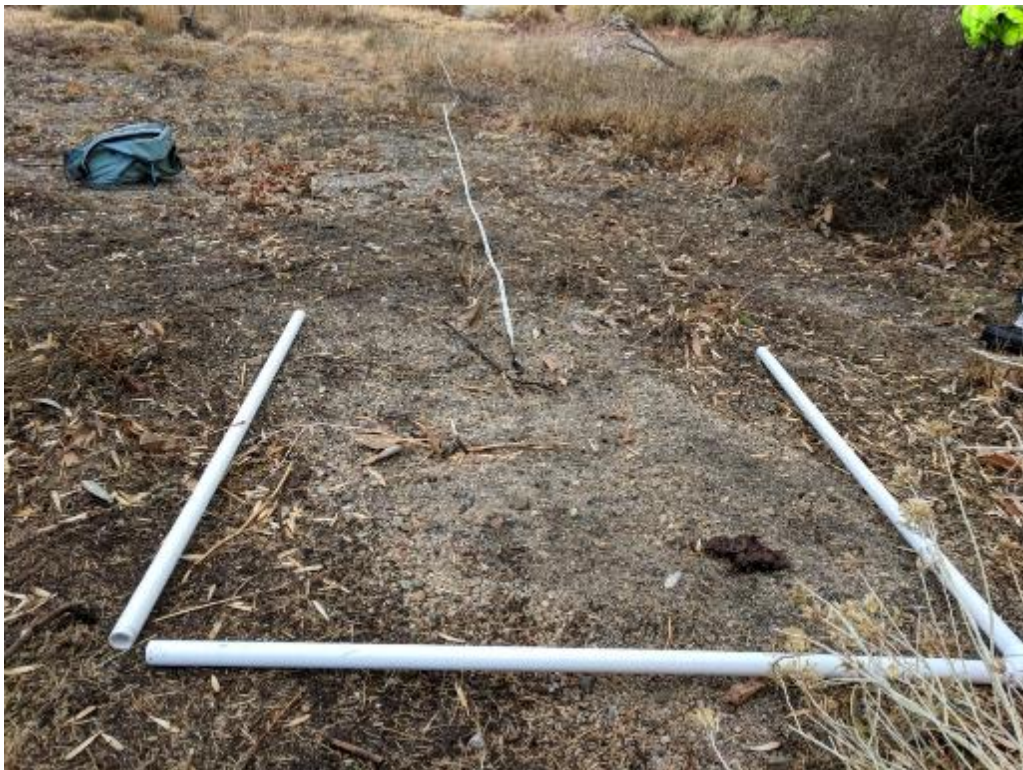
Transect A – Start 2014 above-2018 below.

<i>Carex praegracilis</i>	20	1	-19	FACW
<i>Chenopodium album</i>	0	9	9	FACW
<i>Elymus triticoides</i>	0	4	4	FAC
<i>Euthamia occidentalis</i>	1	10	9	FACW
<i>Juncus balticus</i>	4	2	-2	FACW
<i>Persicaria lapathifolia</i>	2	3	1	OBL
<i>Phragmites australis</i>	<1	0	<1	FACW
<i>Rosa woodsii</i>	0	<1	<1	FACU
<i>Salix laevigata</i>	0	4	4	FACW
<i>Salsola tragus</i>	0	6	6	FACU
<i>Schoenoplectus americanus</i>	34	0	-34	OBL
<i>Solanum americanum</i>	9	0	-9	FACU
<i>Thatch</i>	0	23	23	
<i>Sand</i>	0	11	11

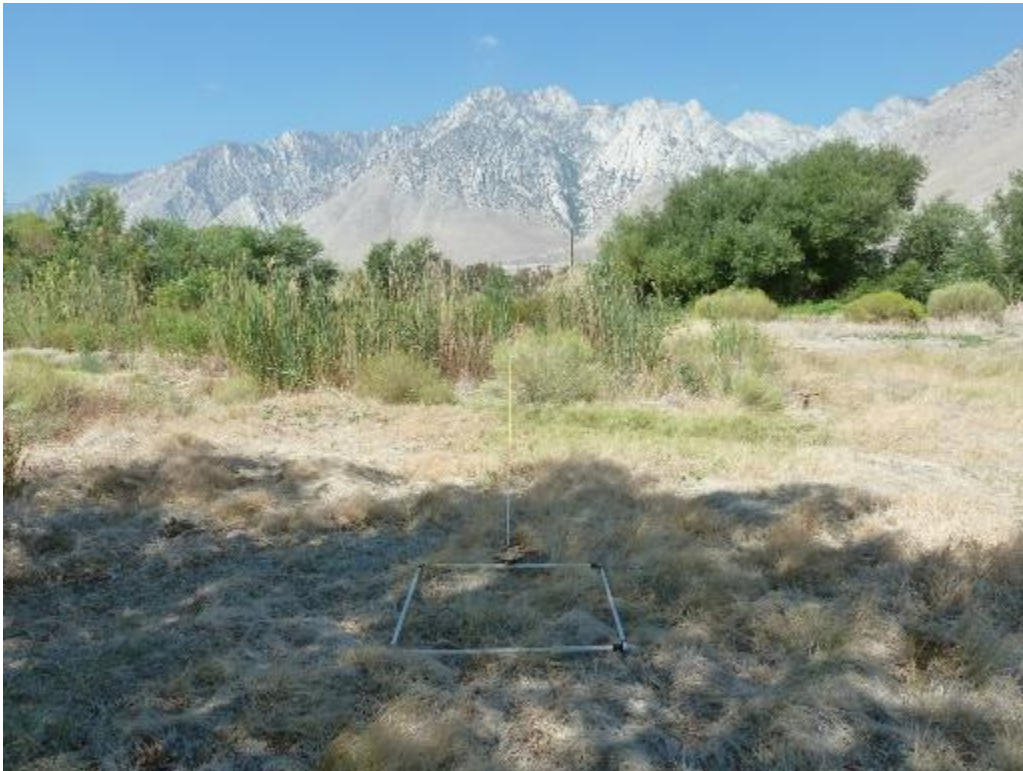
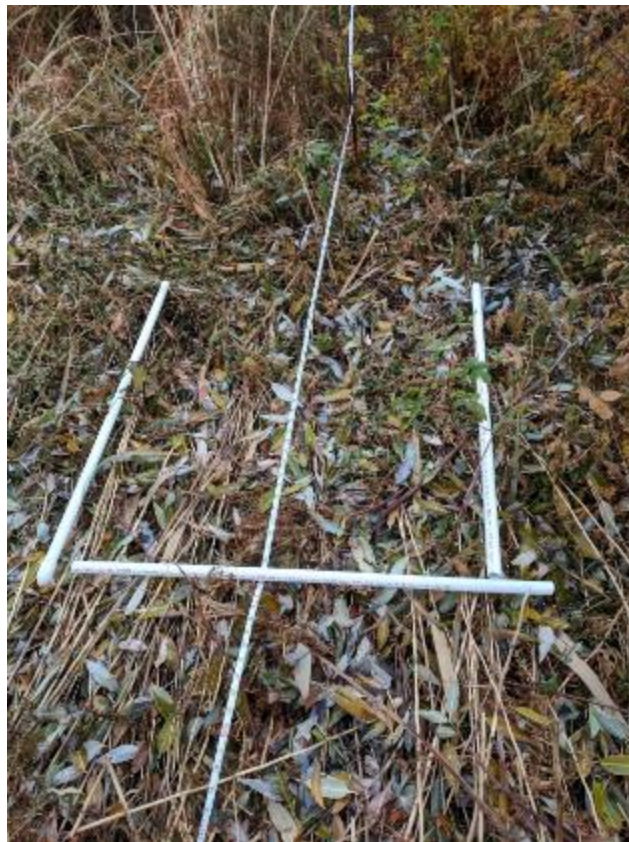
Transect A – End 2014 above-2018 below.

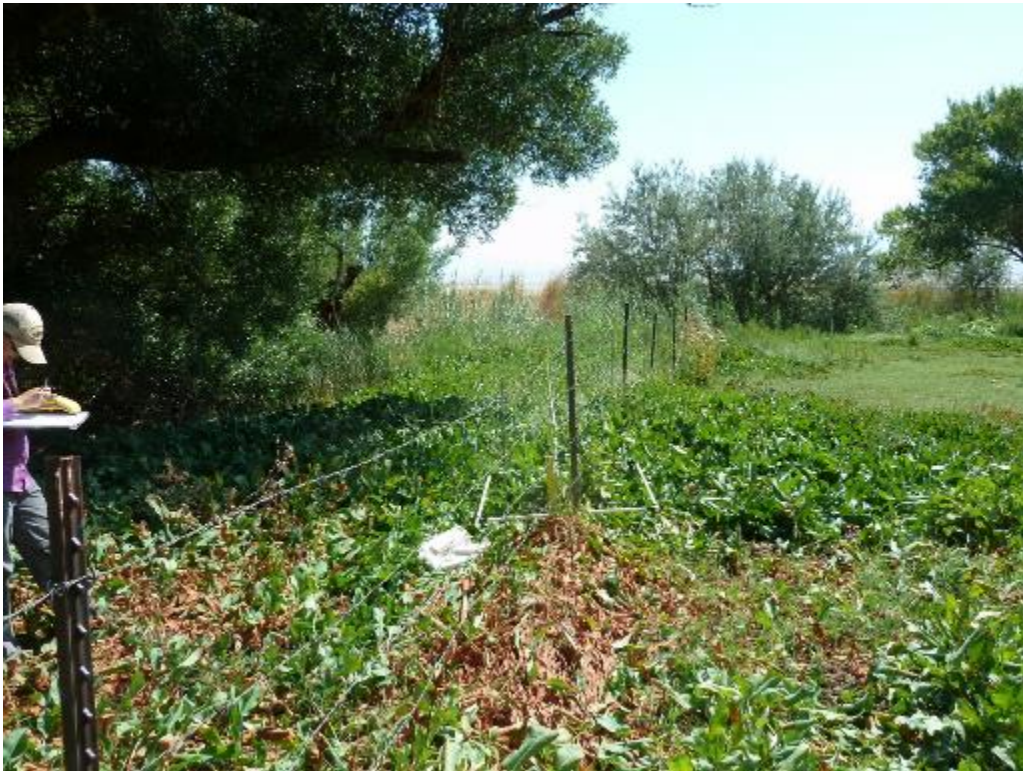
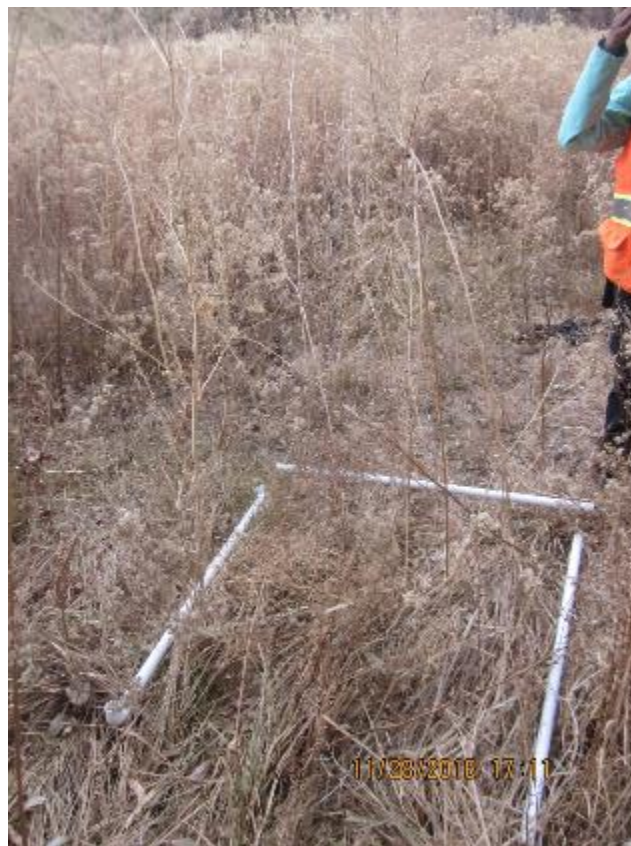
Transect B – Start 2014 above-2018 below.

Species	Percent cover		Difference 2018 minus 2014	Wetland Indicator Status
	2014	2018		
<i>Anemopsis californica</i>	0.1	0	-0	OBL
<i>Carex praegracilis</i>	5	26	21	FACW
<i>Cichorium intybus</i>	1	0	-1	FACU
<i>Elymus triticoides</i>	24	6	-18	FAC
<i>Euthamia occidentalis</i>	0	29	29	FACW
<i>Phragmites australis</i>	0	6	6	FACW
<i>Juncus balticus</i>	4	0	-4	FACW
<i>Lactuca serriola</i>	4	0	-4	FAC
<i>Lotus corniculatus</i>	0.1	0	-0	FAC
<i>Rosa woodsii</i>	16	0	-16	FACU
<i>Salix laevigata</i>	0	33	33	FACW
<i>Schoenoplectus americanus</i>	0	14	14	OBL
<i>thatch</i>	0	14	14	
<i>Bare ground</i>	0	0	0	
<i>water</i>	0	3	3

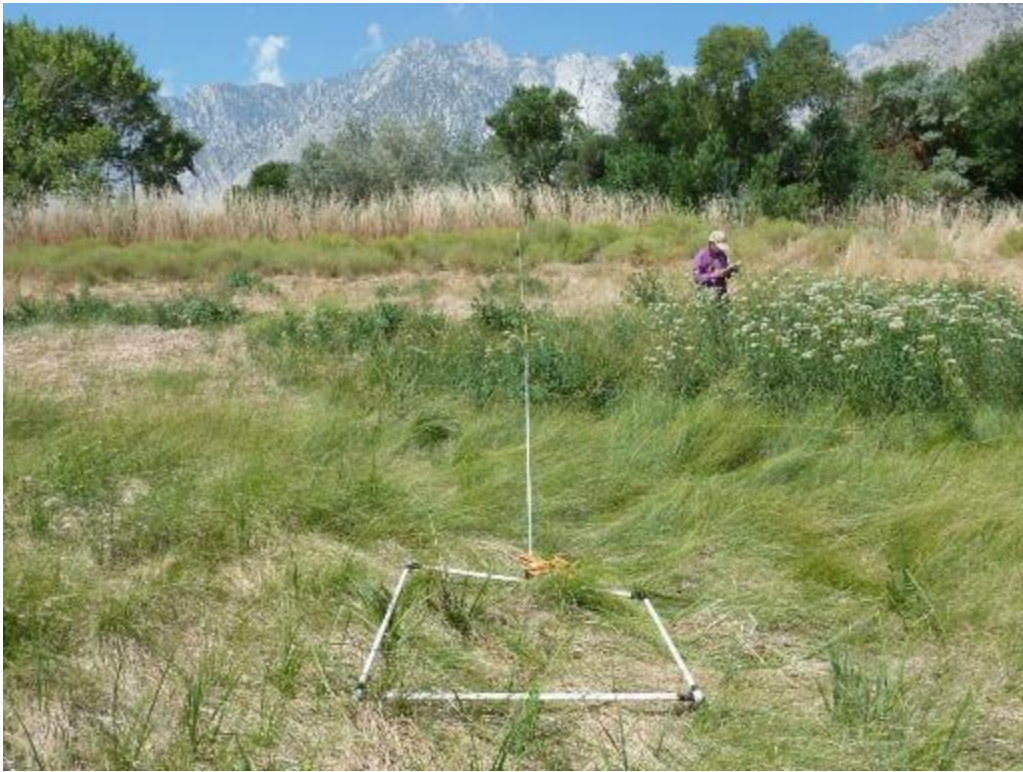
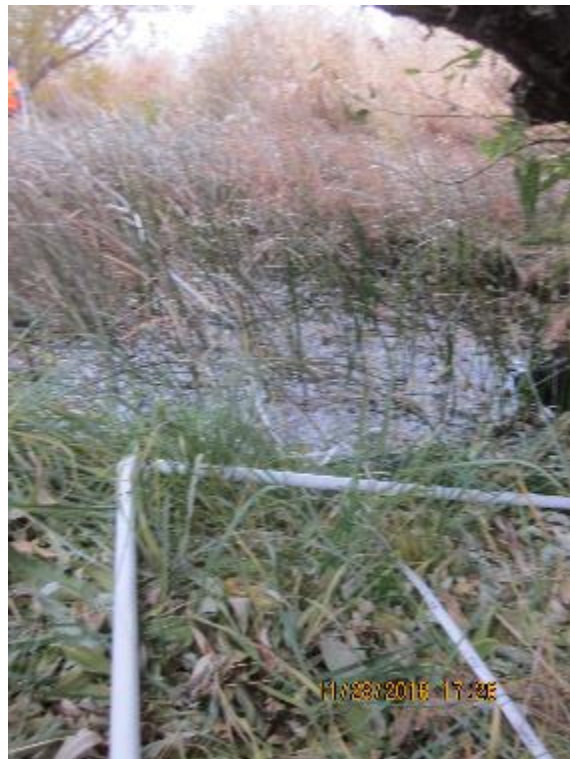
Transect B – End 2014 above-2018 below.

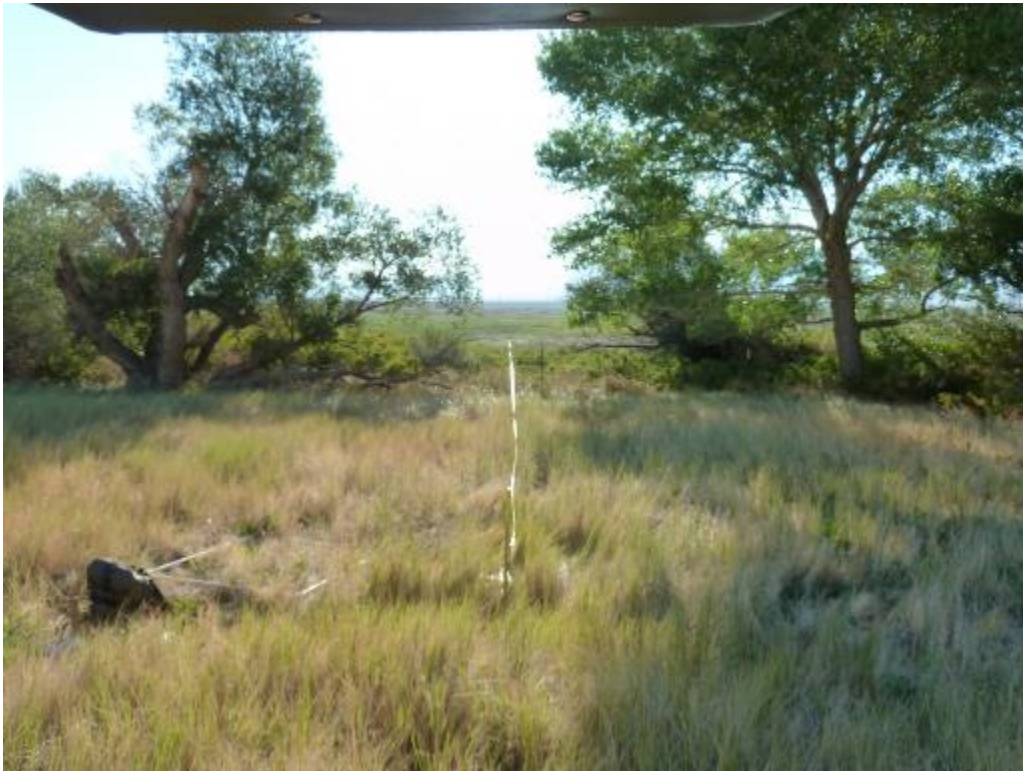
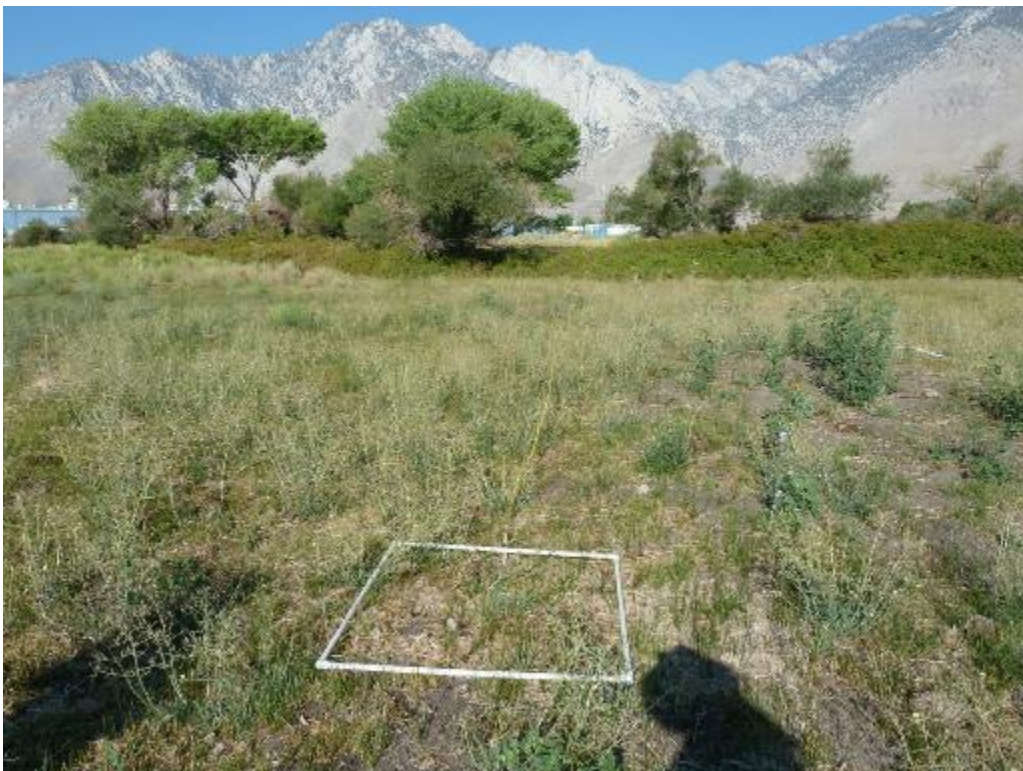
Transect C – Start 2014 above and End below (not surveyed in 2018).

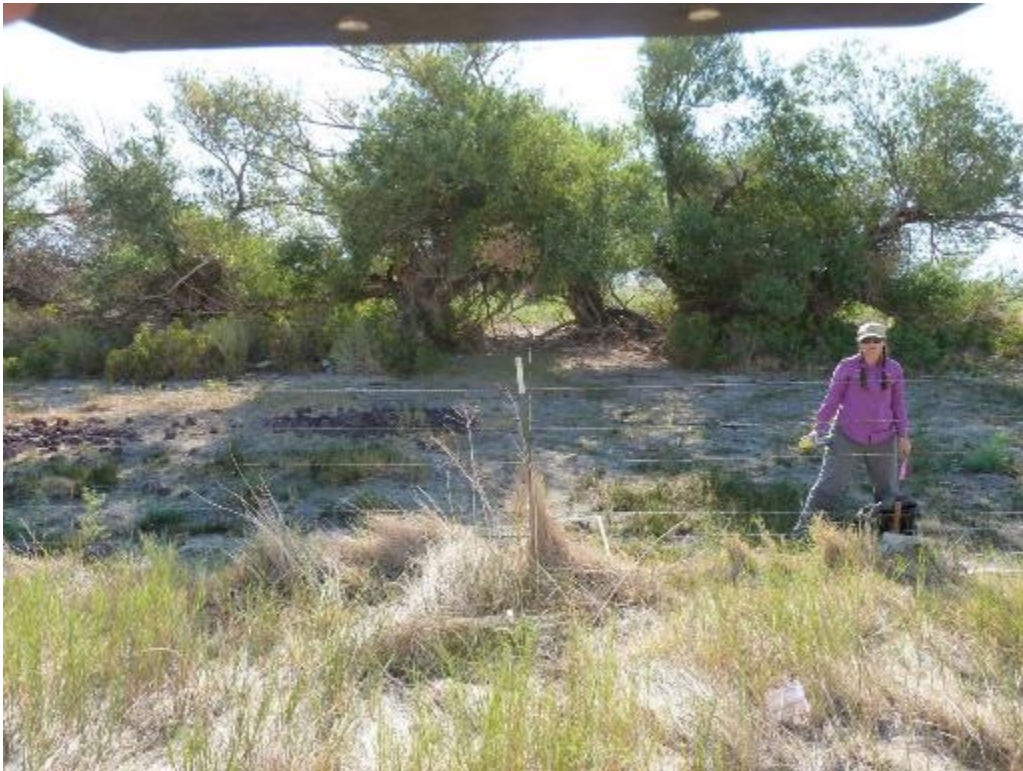
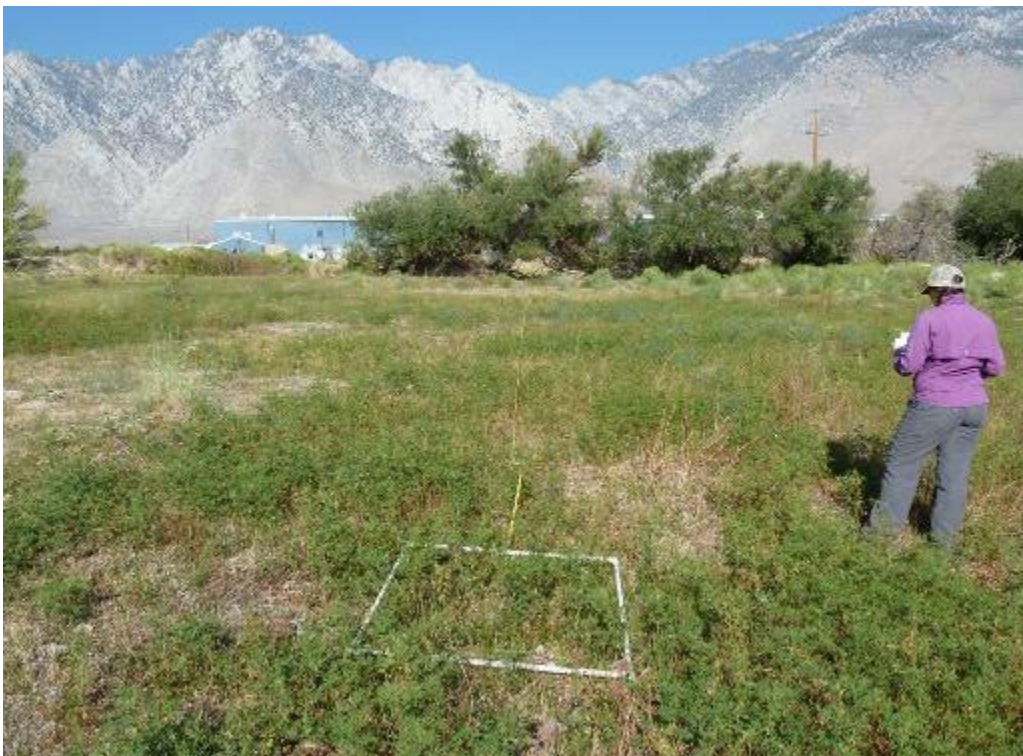
Transect D – Start 2014 above and End below (not surveyed in 2018).

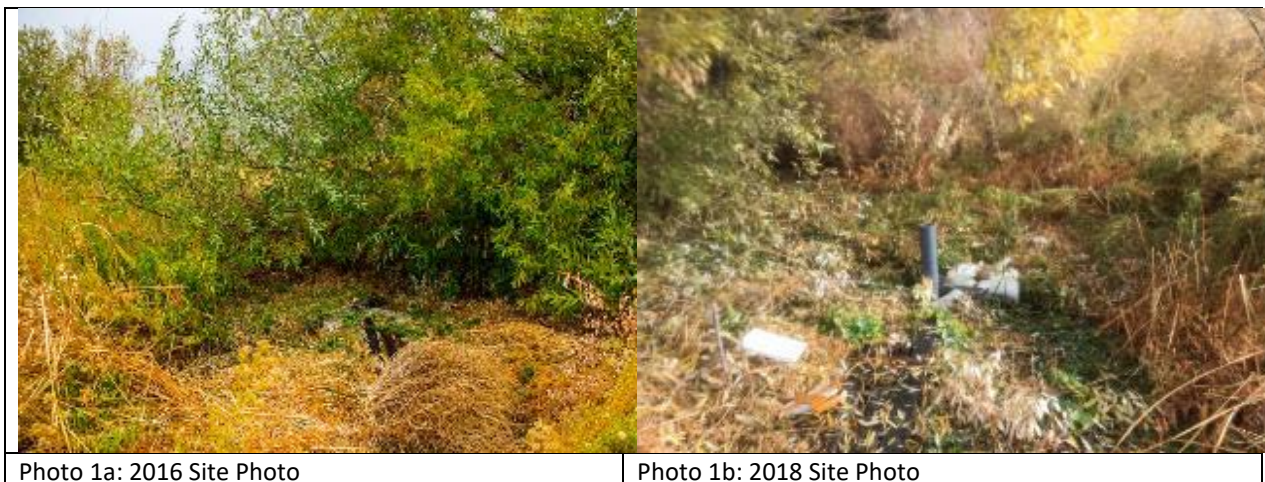
Photos 1a and 1b: CBS-9 – the spring water originates beneath the large red willow in the center of the photo. Water flows through a thirty cm wide hand-dug ditch for a distance of fifteen meters to the main collector ditch.

CBS-9 is the northernmost spring. The spring originates from the ground under a cover of red willow (*Salix laevigata*). The spring flume is located at the edge of the red willow thicket above the water (Photos 1a and 1b in Appendix A). From the flume the water flows through a small hand dug ditch 40 cm wide into the main collector ditch approximately 15 m east. Vegetation surrounding the hand dug ditch is dominated by herbaceous species such as American bulrush, water smartweed, water parsnip and cut-leaved speedwell. A full list of plant species around CBS-9 is presented in Table 1, with vegetative cover given for those species within a 28.3 m² circular plot around the spring flume.

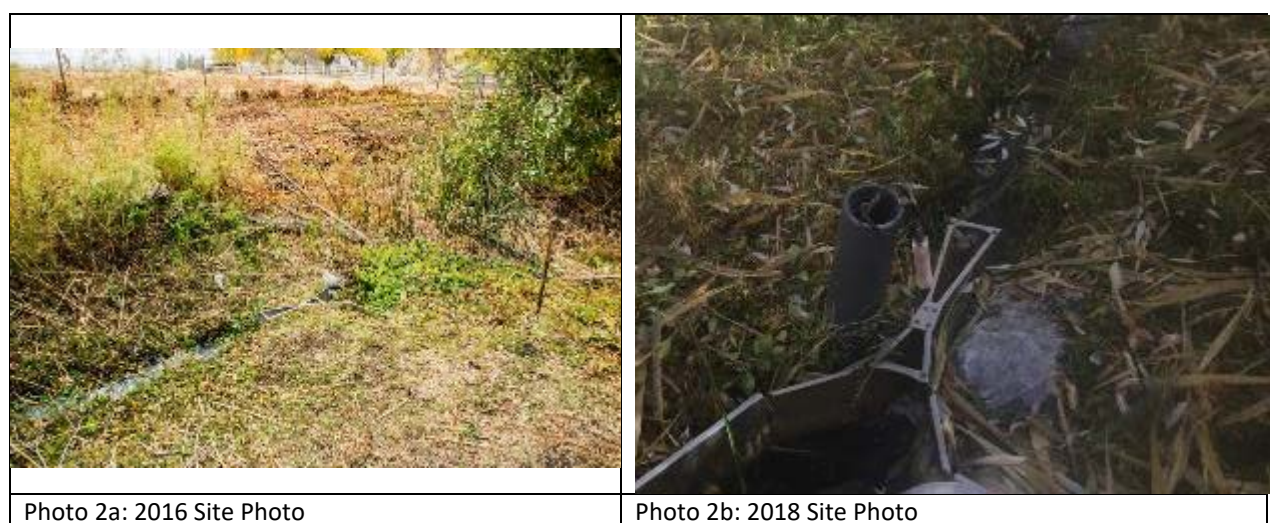
Photos 2a and 2b: CBS-6 - the spring daylights into a small pond (2.5 m in diameter, 5 square meters in area) at the base of a large red willow. The water then flows through the flume, then 11 meters along a small hand-dug feeder ditch to the main collector ditch.

The spring, CBS-6, originates in a sump pond that is located in the shade of a mature red willow (Photos 2a and 2b in Appendix A). The pond is approximately 2.5 meters in diameter and five square meters in area, and approximately 40 cm deep with a soft muddy bottom. The spring flume is directly adjacent to the pond. From the flume the water flows into the main collector ditch approximately 15 m to the east through a

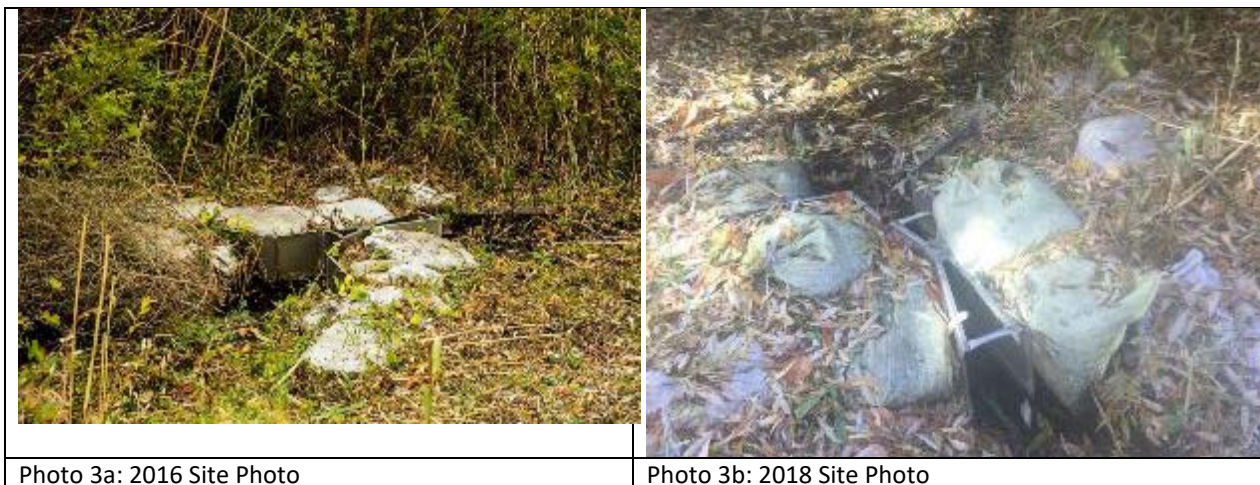
Photos 3a and 3b: CBS 2 – The spring originates underneath dense common reed just to the right of the flume (surrounded by cement bags).

The spring, CBS-2, originates under a dense stand of common reed. The spring flume is surrounded by cement bags and was installed in a clearing in the reed cover (Photos 3a and 3b in Appendix A). Vegetation surrounding the hand-dug ditch is dominated by herbaceous species including common reed, willow herb and water smartweed. A full list of plant species around CBS-2 is presented in Table 3, with vegetative cover given for those species within a 28.3 m² circular plot around the spring flume.

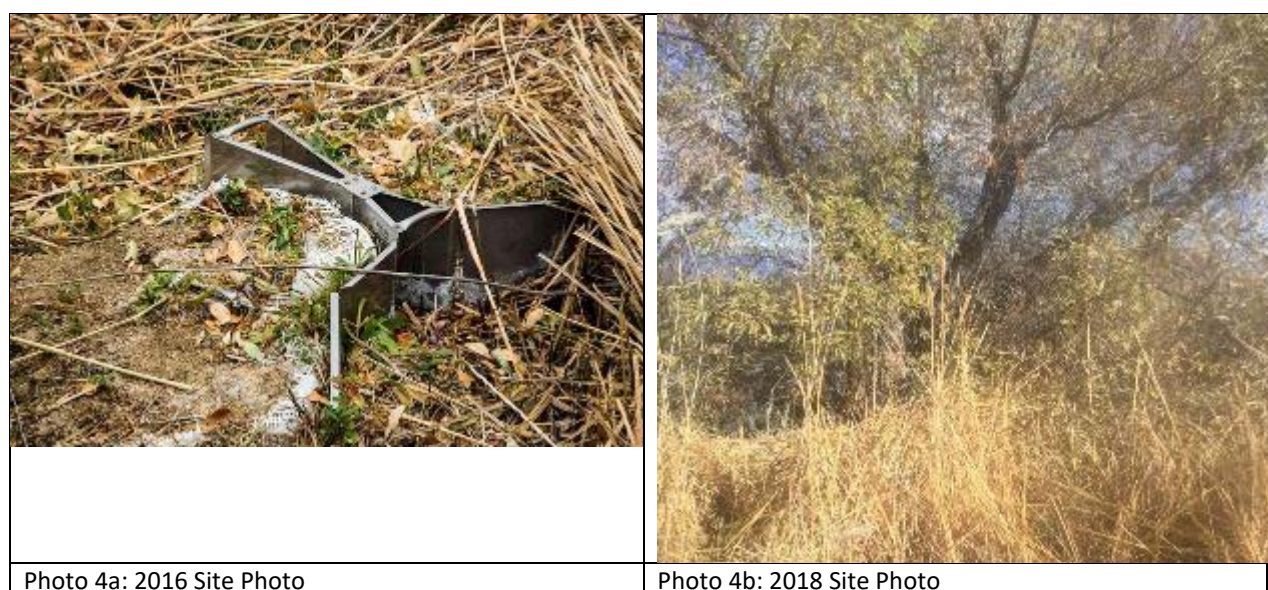
Photos 4a and 4b: CBS 4 - The spring originates in grazed American bulrush behind the flume (surrounded by degraded sand bags in the center of the photo). In Photo 4b, taken in 2018 the site was overgrown and the spring could not be located. A large area of the ground was saturated.

The spring, CBS-4, originates under a dense stand of American bulrush behind the spring flume. In 2016, the spring flume was surrounded by sand bags that have degraded and broken down. In 2018, the site was overgrown and the spring could not be located because the ground was saturated in the estimated vicinity of the spring (Photos 4a and 4b in Appendix A). Vegetation surrounding the spring showed signs of grazing and was dominated by herbaceous species such as American bulrush, common reed and willow herb. A full list of plant species around CBS-4 is presented in Table 4, with vegetative cover given for those species within a 28.3 m² circular plot around the spring flume.

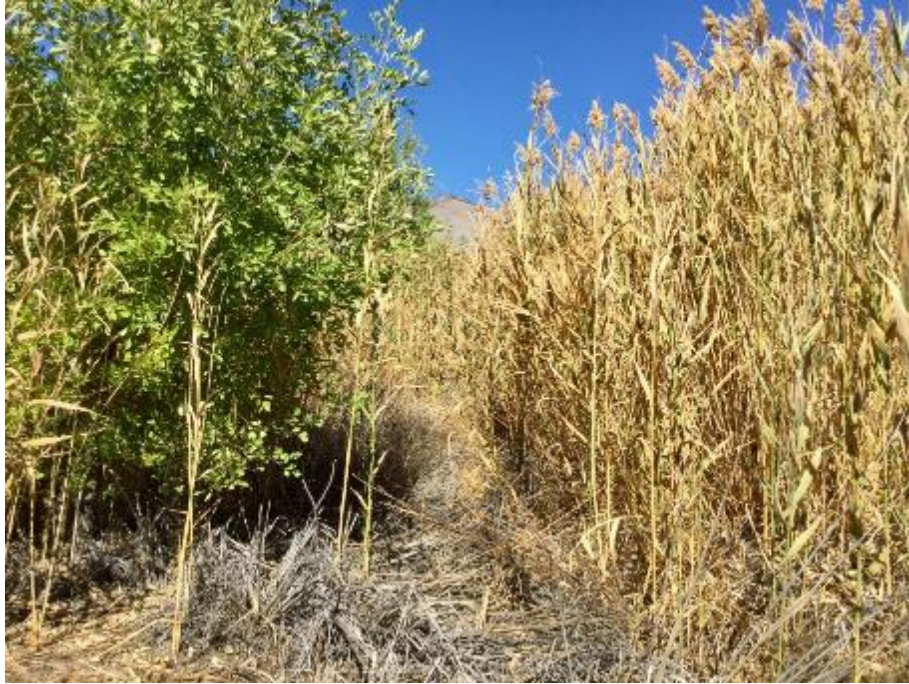
Photo 5: Main Collector Ditch –2014 The ditch runs in a northwesterly to southeasterly orientation to the east of the springs along the Spring Line Fault. The ditch averages 4 meters wide and has standing water along its length averaging 40 cm deep and dry at the northern end. Vegetation (predominantly common reed, bulrush, cattails, with scattered red willow and Russian olive) is growing into the water within the ditch and covering the water surface

The “Main Collector Ditch” runs in a northwesterly to southeasterly orientation to the east of the springs along the Spring Line Fault. When originally dug (perhaps in the 1980’s), the ditch was likely excavated to a width of approximately 2.5 meters wide and 2.5 meters deep. The exact current width of the ditch was difficult to measure as a result of the willow and reed vegetation that had grown over the banks and within the ditch. For most of the length of the ditch within the survey area, the ditch had standing water along its length averaging 30 to 60 cm deep and at the northern end was completely dry. Dense vegetation cover on the banks and tops of the ditch was dominated by common reed, American bulrush and cattails, with scattered red willow and Russian olive growing throughout the length of the ditch. The dense vegetation was growing into the ditch and formed a nearly continuous cover over the water surface in the ditch for most of its length. Photos 5 and 6 in Appendix A provides an illustration of a typical segment of the main collector ditch.

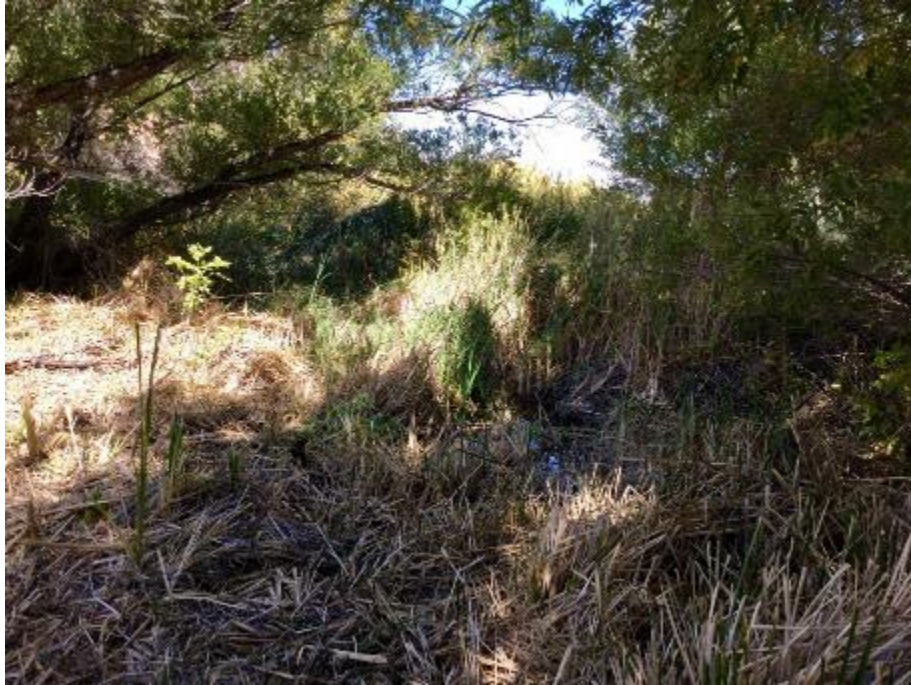
Photo 6: Main Collector Ditch –2014 Vegetation (predominantly common reed, bulrush and cattails with scattered red willow and Russian olive) is growing into the water within the ditch and covering the water surface
