Cabin Bar Ranch Water Bottling Facility Project 2020 Vegetation Monitoring Report

CG Roxane, LLC

Prepared by:
Kleinfelder/GANDA

May 2021

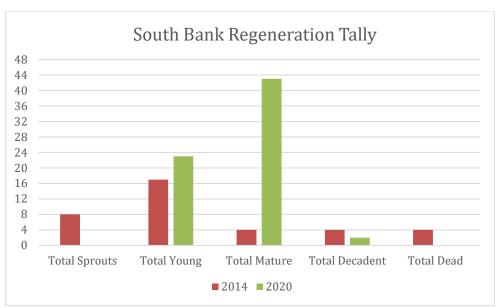
Figure 2: Regeneration Tally for the Greenline – South Bank

Species	Per	Wetland Indicator Status	
	2014	2020	Status
Salix laevigata	44	65	FACW
Fraxinus velutina	26	25	FAC
Populus fremontii	20	20	FACW
Rosa woodsii	2	13	FACU

Results of the greenline transects are provided below in the tables labeled "south bank" and "north bank." Results of the woody species regeneration tally are provided as charts illustrating the cumulative counts of individuals in each age class (Figures 2 and 3). Age class definitions follow those in Winward 2000 in which "sapling" is defined as one- to two-year-old tree, less than a quarter of its mature height; "young" is a three- to 10-year-old tree, a quarter to half its mature height; "mature" is a full height tree, with more than half the canopy alive; "decadent" is a mature tree with less than half the canopy alive; and "dead" is a tree with no canopy alive. A number of sapling-age individuals of ash and cottonwood were observed on the top of the banks outside of the greenline transect zone. Representative photographs of the greenline transects on both banks are provided in Appendix A.

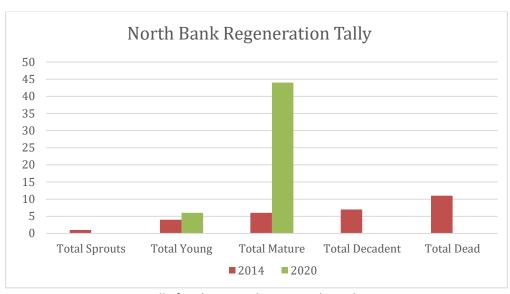
Figure 3: Regeneration Tally for the Greenline - North Bank

Species	Percent cover		Wetland Indicator
	2014	2020	Status
Salix laevigata	72	76	FACW
Populus fremontii	26	0	FACW
Fraxinus velutina	8	35	FAC

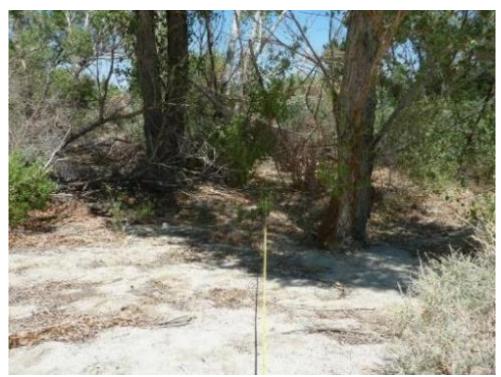
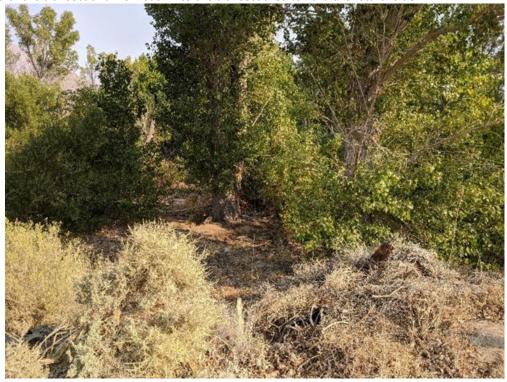
Transect 1 – Start – 2014 above-2020 below. For all photographs in this appendix, transect "Start" photographs are taken from the start of the transect viewing across the transect area. The "End" photographs are taken from the opposite end of the transect and view back into the transect area toward the "start" side.

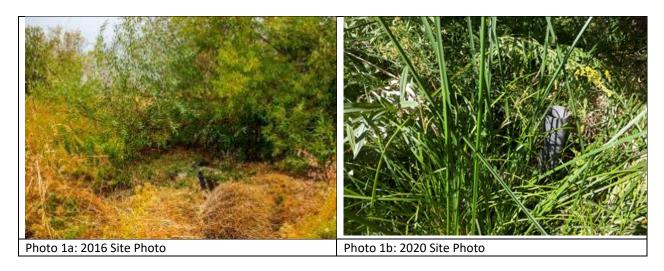
Photos 1a and 1b: CBS–9 – the spring water originates beneath the large red willow in the center of the photo. Water flows through a thirty cm wide hand-dug ditch for a distance of fifteen meters to the main collector ditch.

CBS-9 is the northernmost spring. The spring originates from the ground under a cover of red willow (*Salix laevigata*). The spring flume is located at the edge of the red willow thicket above the water (Photos 1a and 1b in Appendix A). From the flume the water flows through a small hand dug ditch 40 cm wide into the

main collector ditch approximately 15 m east. Vegetation surrounding the hand dug ditch is dominated by herbaceous species such as American bulrush, water smartweed, western goldentop and cattail. A full list of plant species around CBS-9 is presented in Table 1, with vegetative cover given for those species within a 28.3 m2 circular plot around the spring flume.

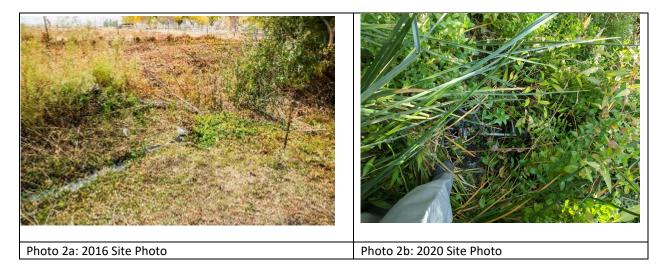
Photos 2a and 2b: CBS-6 - the spring daylights into a small pond (2.5 m in diameter, 5 square meters in area) at the base of a large red willow. The water then flows through the flume, then 11 meters along a small hand-dug feeder ditch to the main collector ditch.

The spring, CBS-6, originates in a sump pond that is located in the shade of a mature red willow (Photos 2a and 2b in Appendix A). The pond is approximately 2.5 meters in diameter and five square meters in area, and approximately 40 cm deep with a soft muddy bottom. The spring flume is directly adjacent to the pond. From the flume the water flows into the main collector ditch approximately 15 m to the east through a small hand dug ditch 30 cm wide. Vegetation surrounding the hand dug ditch is dominated by herbaceous species including field mint, common reed, yerba mansa, slender sedge and water smartweed. A full list of plant species around CBS-6 is presented in Table 2, with vegetative cover given for those species within a 28.3 m2 circular plot around the spring flume.

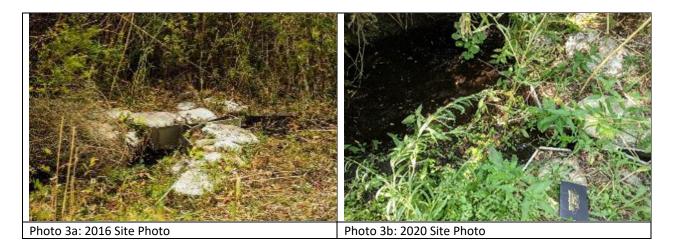
Photos 3a and 3b: CBS 2 – The spring originates underneath dense common reed just to the right of the flume (surrounded by cement bags).

The spring, CBS-2, originated under a dense stand of common reed as observed in 2016. In 2020, a more varied shrub and herbaceous cover surrounded the spring. The spring flume is surrounded by cement bags and was installed in a clearing in the reed cover (Photos 3a and 3b in Appendix A). Vegetation surrounding the hand-dug ditch is dominated by shrub and herbaceous species including wood rose, California golden rod and water smartweed. A full list of plant species around CBS-2 is presented in Table 3, with vegetative cover given for those species within a 28.3 m2 circular plot around the spring flume.

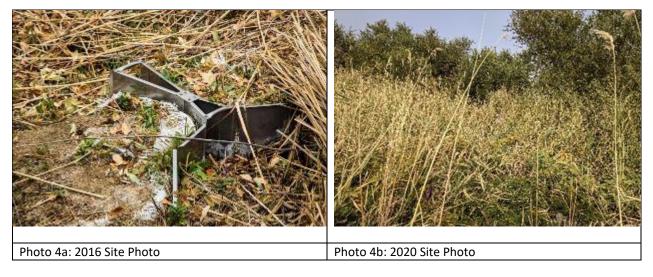
Photos 4a and 4b: CBS 4 - The spring originates in grazed American bulrush behind the flume (surrounded by degraded sand bags in the center of the 2014 photo). The spring was not located during 2020 site visit due to dense overgrowth of common reed.

The spring, CBS-4, originated under a dense stand of American bulrush as observed in 2016, and was surrounded by sandbags that had degraded and broken down. In 2020, the spring was not located due to dense growth of common reed approximately 12 feet tall. Vegetation surrounding the spring was dominated by herbaceous species mainly common reed, with some bullrush and western goldenrod. A full list of plant species around CBS-4 is presented in Table 4, with vegetative cover given for those species within a 28.3 m2 circular plot around the spring flume.

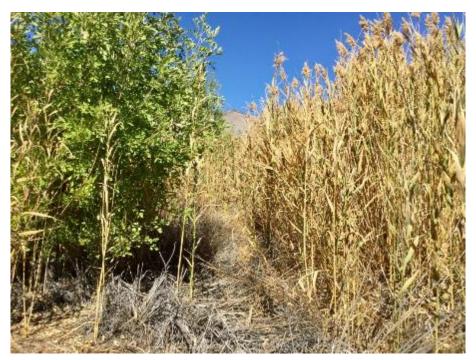
Photo 5: Main Collector Ditch –2014 The ditch runs in a northwesterly to southeasterly orientation to the east of the springs along the Spring Line Fault. The ditch averages 4 meters wide and has standing water along its length averaging 40 cm deep and dry at the northern end. Vegetation (predominantly common reed, bulrush, cattails, with scattered red willow and Russian olive) is growing into the water within the ditch and covering the water surface

The "Main Collector Ditch" runs in a northwesterly to southeasterly orientation to the east of the springs along the Spring Line Fault. When originally dug (perhaps in the 1980's), the ditch was likely excavated to a width of approximately 2.5 meters wide and 2.5 meters deep. The exact current width of the ditch was difficult to measure as a result of the willow and reed vegetation that had grown over the banks and within the ditch. For most of the length of the ditch within the survey area, the ditch had standing water along its length averaging 30 to 60 cm deep and at the northern end was completely dry. Dense vegetation cover on the banks and tops of the ditch was dominated by common reed, American bulrush and cattails, with scattered red willow and Russian olive growing throughout the length of the ditch. The dense vegetation was growing into the ditch and formed a nearly continuous cover over the water surface in the ditch for most of its length. Photos 5 and 6 in Appendix A provides an illustration of a typical segment of the main collector ditch.

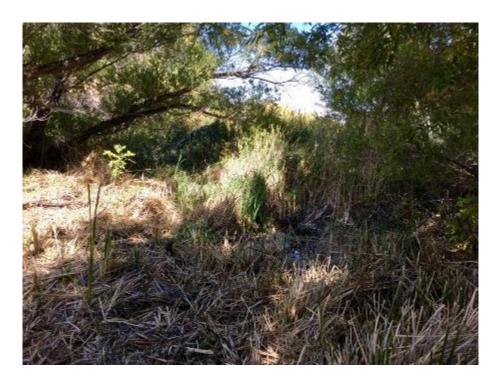
Photo 6: Main Collector Ditch –2014 Vegetation (predominantly common reed, bulrush and cattails with scattered red willow and Russian olive) is growing into the water within the ditch and covering the water surface
