# **Runoff Operations Update**

## **2022-23 Runoff Year**

**Los Angeles Department of Water and Power**

**Water Operations Division**

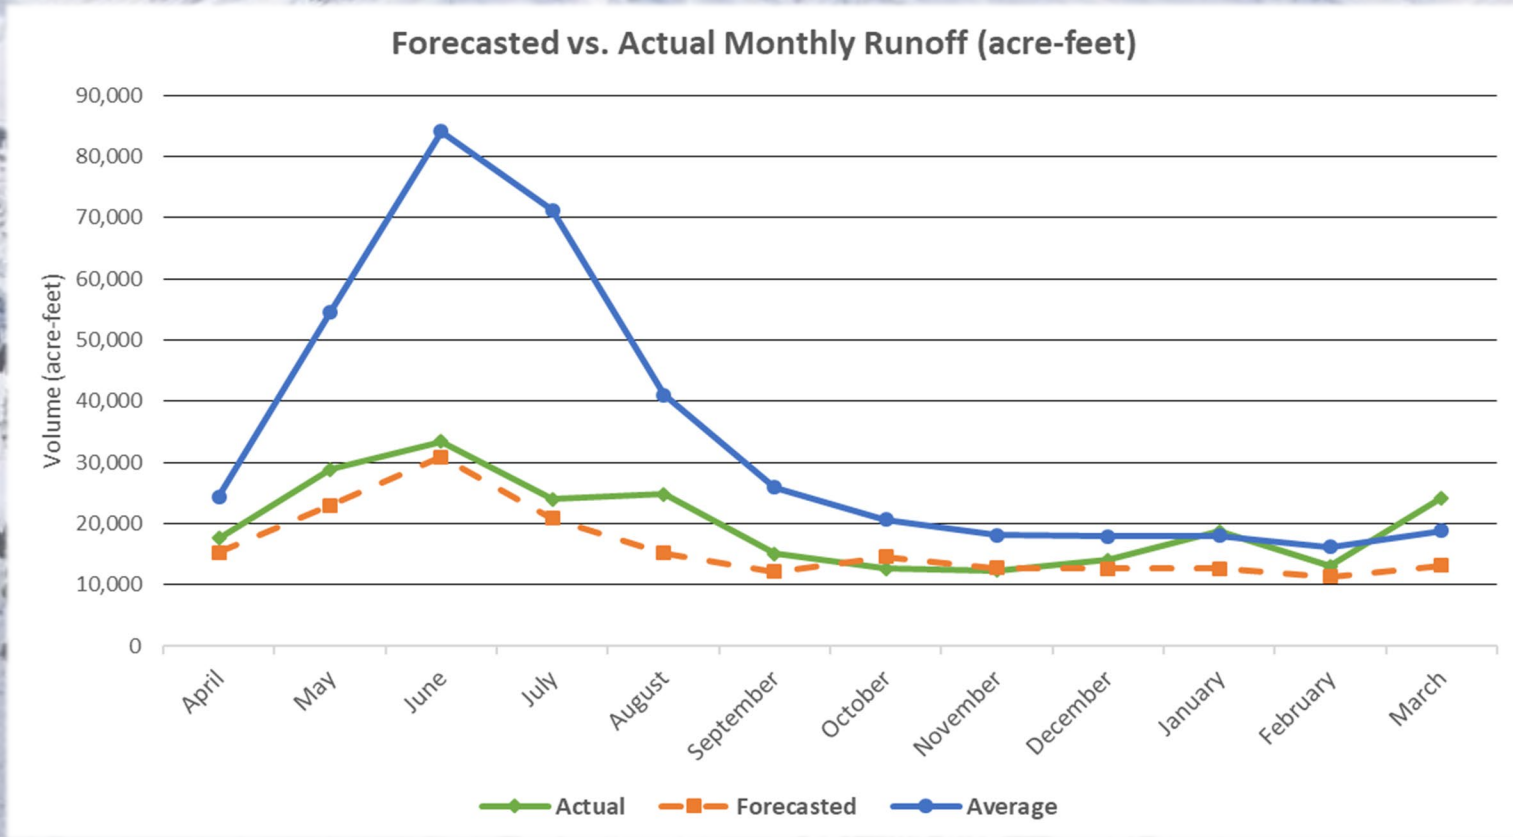
# 2022-23 Forecasted and Actual Runoff

**Forecasted Runoff: 47%**  
**Actual Runoff: 58%**

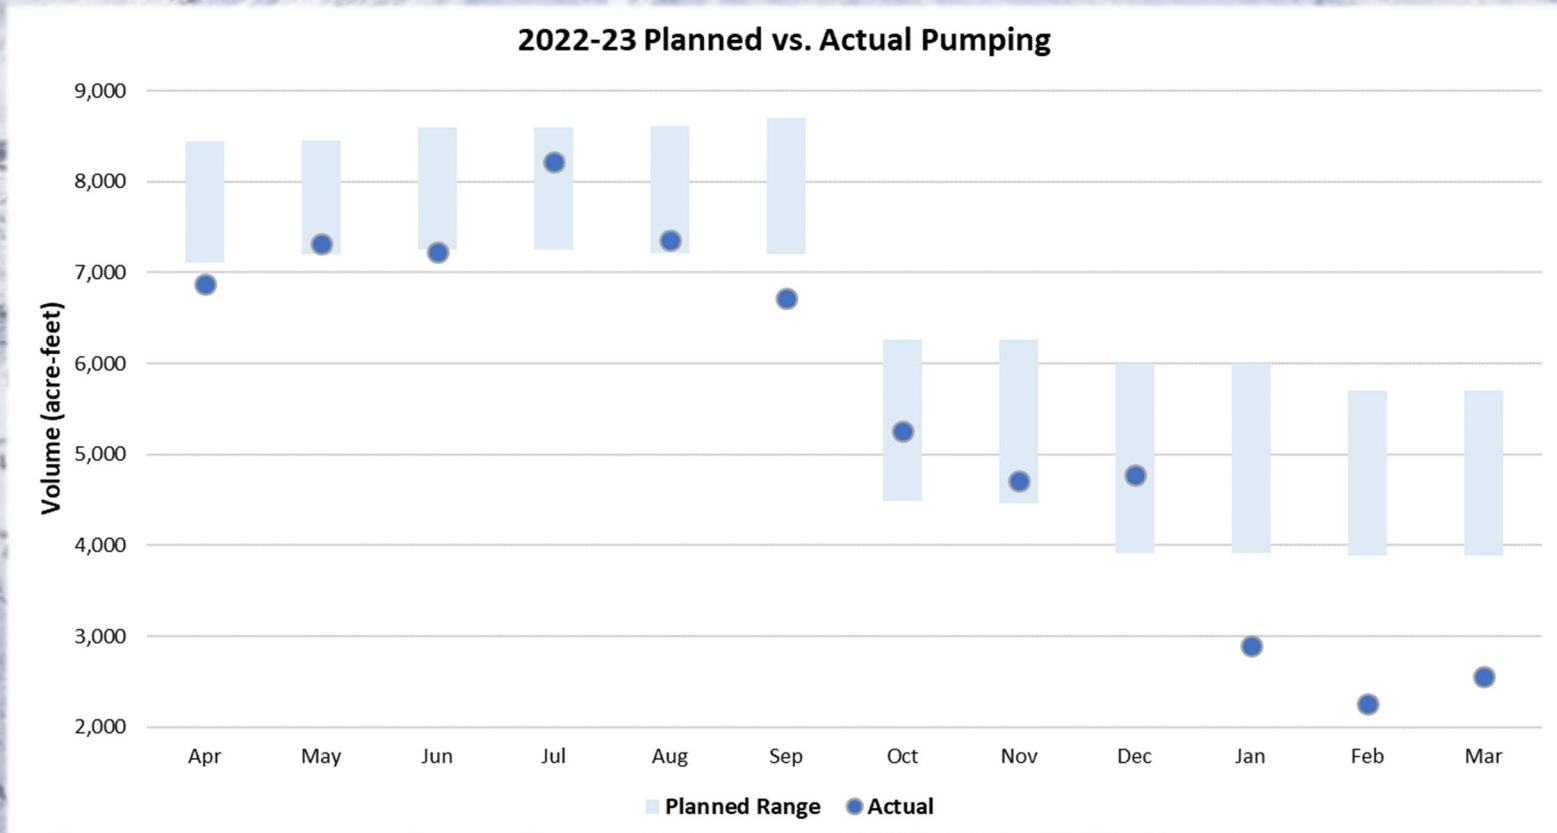
# 2022-23 Planned and Actual Pumping

**Planned Pumping: 67,800 af - 87,350 af**  
**Actual Pumping: 66,189 af**
