MITIGATION ANNUAL REPORT 2022-23

Inyo County Water Department (ICWD), Annual Report

Larry Freilich—Mitigation Projects Manager

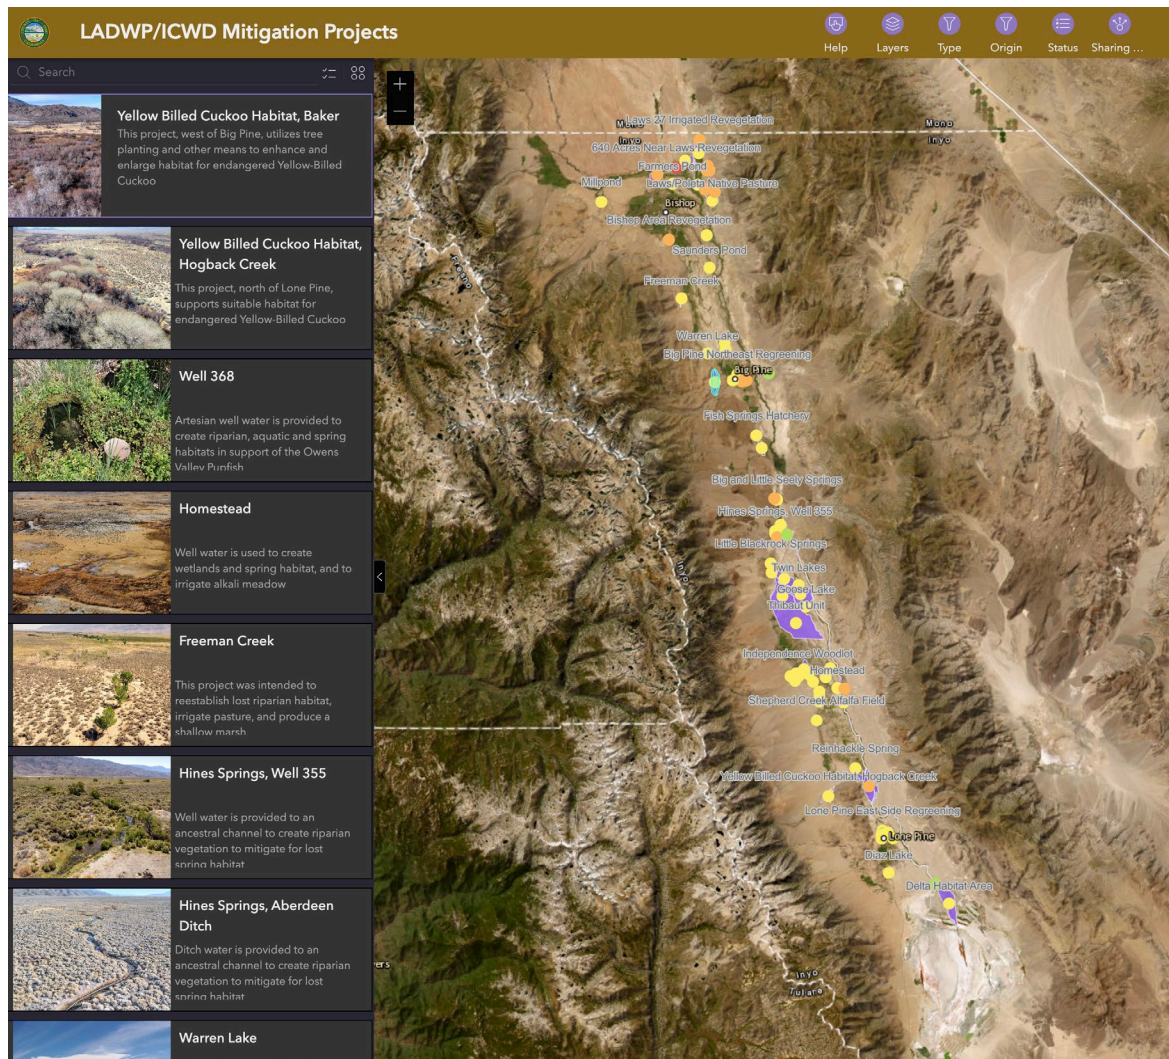
Figure 1. Mitigation Map representation.

In 2022, we introduced an online, interactive Mitigation Projects Map (Figure 1). This map, accessible on the Water Department's website, home page, under Quick Links, provides a comprehensive view of all mitigation project obligations in the Owens Valley related to the Long-Term Water Agreement, Stipulations and Orders, and subsequent mitigation initiatives. This graphic depiction of the projects complements the status table. The map is an excellent resource for various users: for newcomers, it offers a click-through introduction to the projects, and for those familiar with the projects, it serves as a valuable, up-to-date reference for research and monitoring. Users can explore the geographic distribution of projects, view project site photos, and use the search function to quickly find specific projects or project types. Filters enable users to locate projects based on goals, legal origin, status relative to goals, and water delivery.

By clicking on a project's centroid point on the map, users can access information about its origin, impact, and status, as well as a description. When available, water delivery details are also included. Furthermore, users can access an Additional Information library within the pop-up, containing photos and files related to the project, including origins, scientific studies, and modifications. These files can be downloaded for offline use.

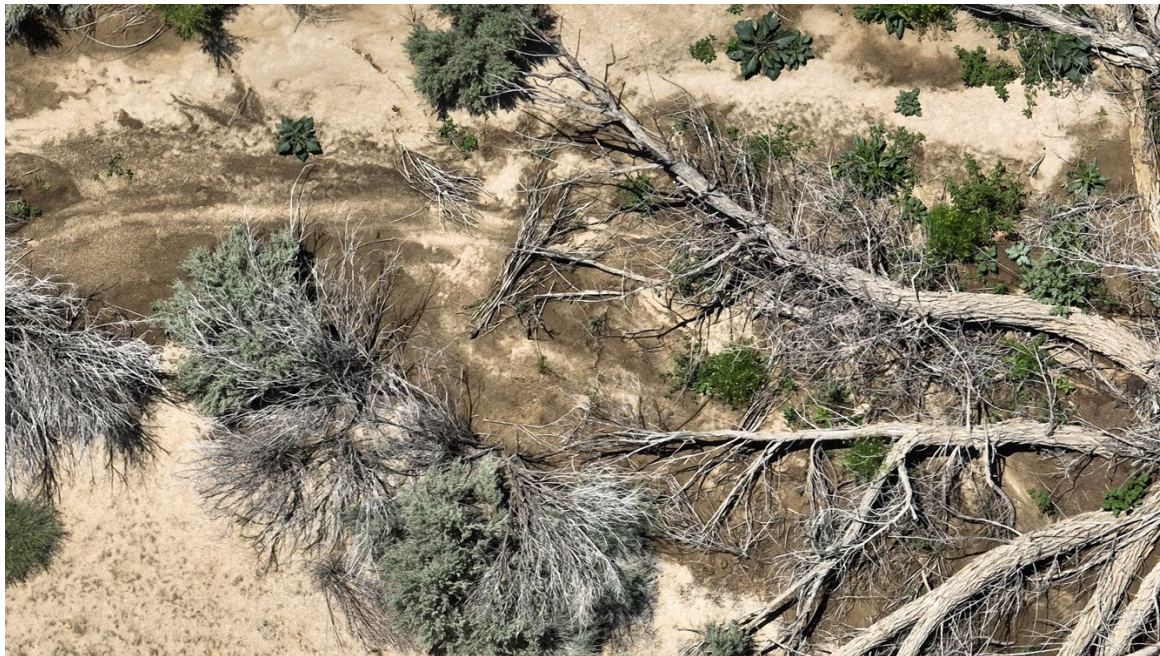
Approximately one-half mile south (upgradient) of where Freeman Creek crosses Keough Hot Springs Road, surface flow ceases, resulting in the recent decline and death of riparian vegetation, including large willow and cottonwood trees (beginning around 2020). Below this point, available groundwater is insufficient to sustain mature vegetation without project water augmentation. In the spring of 2022, sporadic new vegetation growth occurred along the creek margins, with some previously dormant (dead-appearing) trees showing growth.

Figure 2. Dead willow and stressed vegetation receiving some irrigation during the abnormally wet 2022-23 year (June 13, 2023).

The Water Department's scientists and staff have initiated an investigation into the factors that contribute to the observed fluctuations in the local hydrologic system. The following are being, or have been, considered as potential factors contributing to the observed changes in the Freeman Creek flow regime:

- Drought and wet hydrologic cycles
- Topographic gradient along the creek channel
- Surficial sedimentary lithology along the creek channel watercourse
- Owens Valley Fault Zone
- Anthropogenic creek flow diversion
- Pumping from nearby water wells

Our preliminary investigation has ruled out water diversions both upstream and in the vicinity of the point where flow reduction occurs at a diversion box. The Inyo County Sheriff's Department conducted a helicopter survey in the upper watershed to identify any potential water diversions and none were identified. At a historical diversion box, we traced and inspected a small-diameter irrigation line leading to the east, only to find it broken, abandoned, and unlikely to be contributing to the decrease in flow.

Water Department staff aims to conduct a comparison of vegetation conditions within drainages situated on the east side of the Coyote Warp. Specifically, they will qualitatively assess the vegetation in the lower stretches of Rawson Creek to the north and Shannon Canyon to the south, comparing vegetation conditions there with that of Freeman Creek.

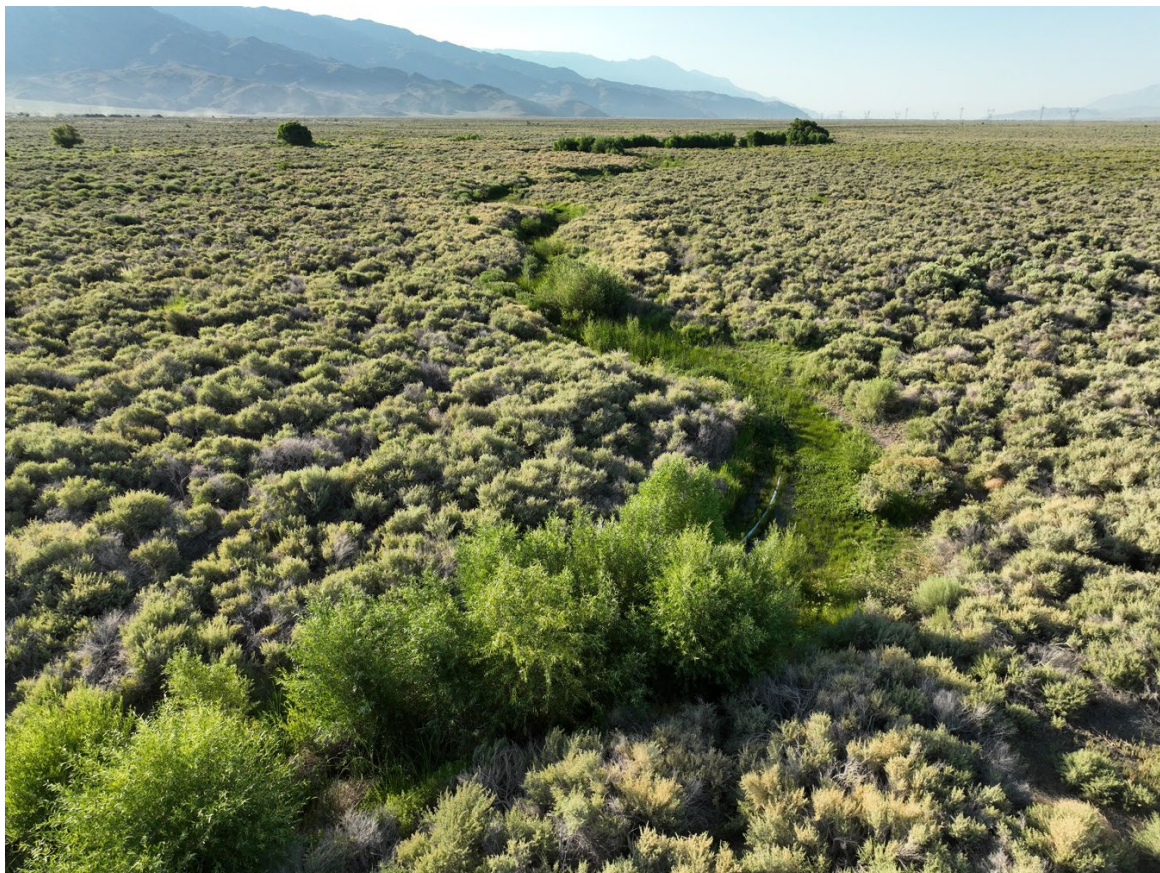
At the former Hines Spring site, ditch water and pumped water are delivered to two ancestral spring channels. Hines Spring W355 is supplied by its namesake groundwater well, located just north of the now-dry spring vent, while Hines Aberdeen is supplied from water diverted from the Aberdeen Ditch. Although these geographically neighboring channels share similar goals, they have distinct water supplies. Well 355 aims to potentially harbor native fish, which could be threatened by non-native fish entering the system from the ditch water. Both the W355 and Aberdeen Ditch projects have been slow to meet their riparian objectives, and as of last year, they did not seem to be meeting their project goals. However, there have been recent improvements, and the projects are now considered to be implemented and on-going (Figure 3).

In the 2021 Annual Report, the Well 355 project was called out for not achieving its goals of enhancing aquatic, riparian, and spring-type habitat. The report noted only marginal riparian development, with vegetation improvement extending only about 700 feet, out of approximately 2,300 feet of ancestral channel. Additionally, new woody riparian growth was lacking, and there was no planting of riparian trees and vegetation. Under the plan, “plantings of riparian trees and a selection of riparian herbaceous species will be conducted along the channel using utilizing seeds from nearby sources hand collected and distributed.” This had not occurred. The Hines Spring Aberdeen Ditch project faced similar issues, with limited riparian vegetation recruitment, indicating a need for supplemental plantings.

The 2021 Annual Report also mentioned that the wet 2016-2017 runoff year raised the groundwater table into the rooting zone, initiating new riparian development and helping recover riparian habitat that had declined a few years after project implementation. In response to another exceptionally wet runoff year in 2022-2023, both Hines Spring projects appear to have improved since last year's report, but additional studies are required to determine if the projects are meeting goals.

Figure 3. Hines Aberdeen Ditch, looking south, showing a flush of new vegetation in a rewatered ancestral spring channel (July 18, 2023)

Importantly, in 2023, the Water Department began to undertake systematic scientific studies of all of the 1600 acre-foot projects that have as goals the development of riparian and spring-type vegetation. Previously, these projects were assessed through pedestrian survey and through analysis of aerial and satellite imagery. The sustainability of this new riparian growth will be determined in the coming years, as ICWD continues to monitor these projects and provide reports if conditions change.

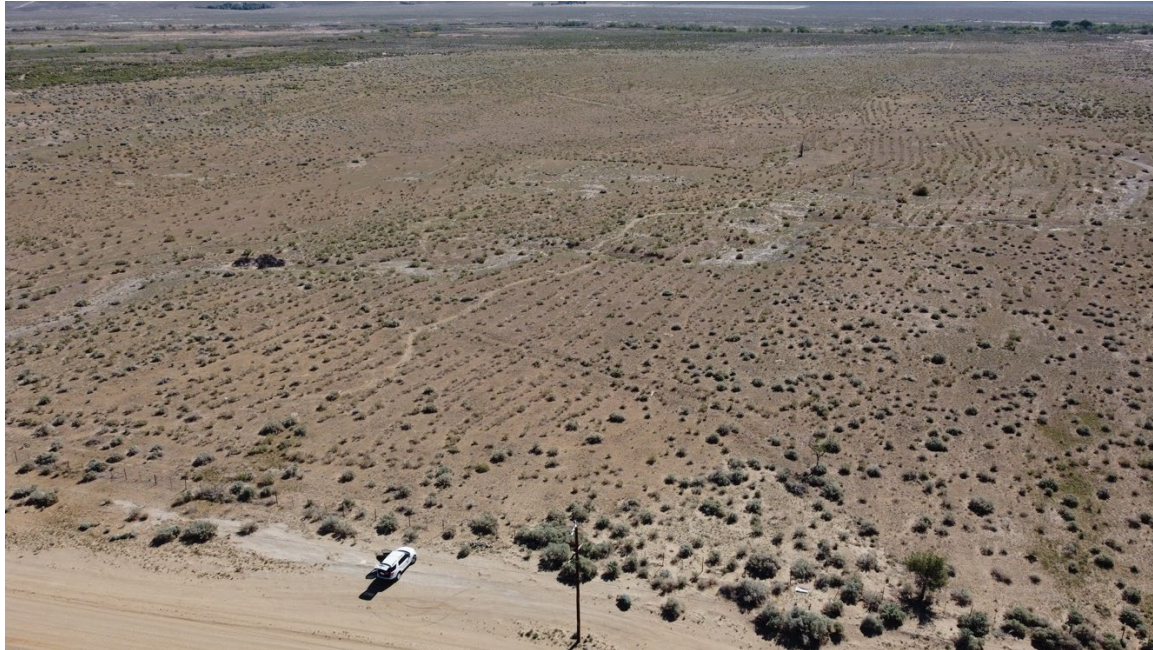
evaluate long-term sustainability. Various methodologies for conducting such analyses are presently being considered. In the final case, parcels that have been actively revegetated but are not meeting goals will be assessed using plot-based method that, once agreed upon, could be implemented in the next growing season (Figure 4).

Figure 4. Big Pine 160 revegetation project. An example of active and passive revegetation efforts (May 4, 2022)

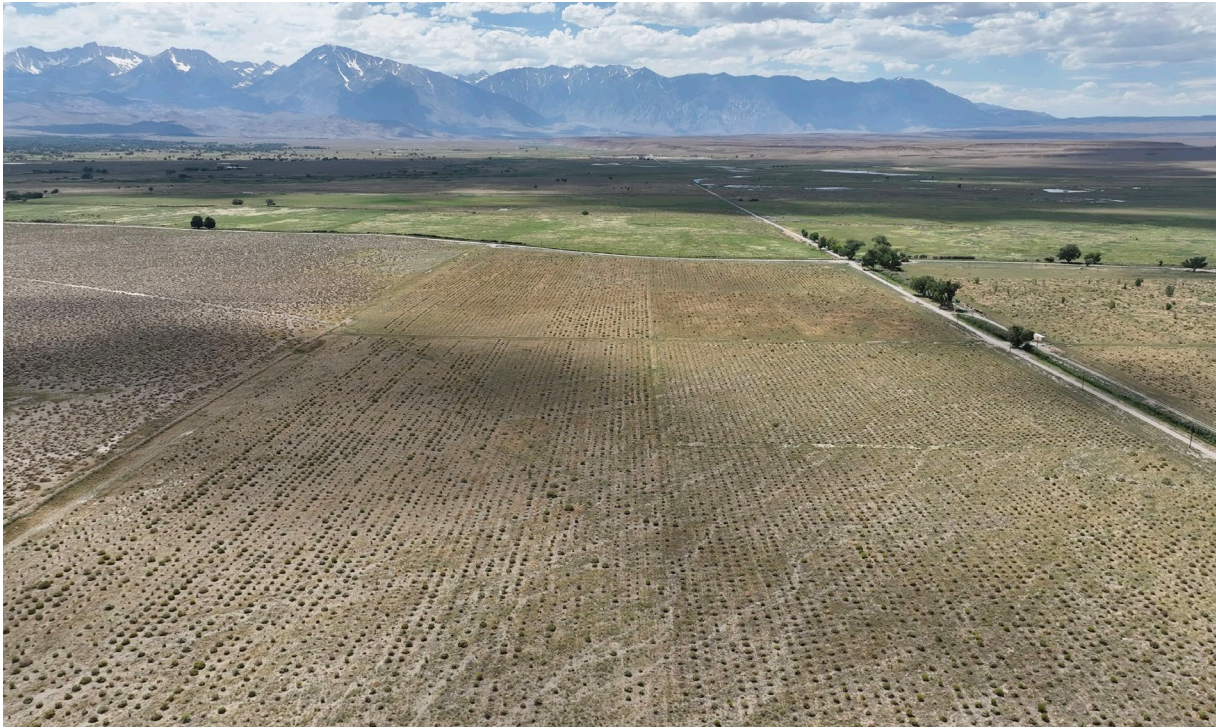
ICWD's letter to LADWP also addressed concerns about the Type E Transfer projects. LADWP's announcement of recent project monitoring and findings of goal attainment, and an intent to cease irrigation without County input was a surprise. ICWD believed irrigation cessation was years away and expected LADWP to provide notice and seek their input. The Water Department noted barren areas that had not been surveyed and the presence of plant species installed by DWP that are absent on adjacent lands and not in the 1999 Plan's Recommended Species List. ICWD also questioned whether recently fertilized and shallow-rooted plants left without water for two years would endure. Even if these plants endured due to precipitation, recent plantings might survive for two years but ultimately perish. To mitigate these concerns, ICWD suggested that irrigation should be provided for a minimum of at least one additional growing season in which precipitation is normal, or below normal. ICWD also pointed out that LADWP's planting of large patches of monotypic vegetation contradicted diversity goals crucial for the project success.

Figure 5. Laws Type E Transfer. Laws parcels 94 and 95 as an example of drip line irrigated revegetation (June 30, 2021)

In light of these concerns, ICWD will continue to closely monitor the revegetation projects and report any changes in conditions.
