Lower Owens River Project 2023 Annual Report

March 2024

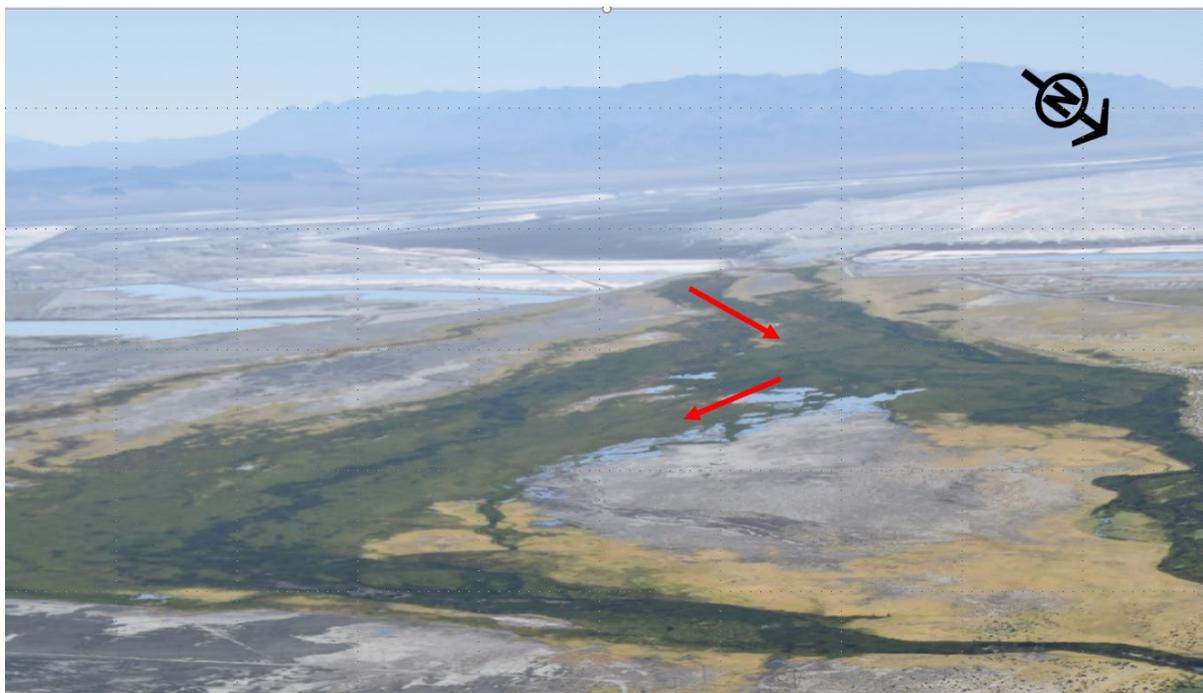
Figure 4-3. August 16, 2019, aerial image of DHA. Red arrows are reference locations.

To evaluate the effectiveness of the interim flow changes on emergent vegetation, aerial photos of vegetation conditions within the DHA, were qualitatively compared between pre-project and current conditions. Pre-project conditions (August 16, 2019) show extensive emergent vegetation throughout the DHA that is vigorous and actively growing (Figure 4-3). In contrast, conditions associated with Figure 4-4 (August 25, 2022), which was the third consecutive year of interim flows and represents a summer base flow of 4 cfs, show extensive areas of brown vegetation, particularly along the east and south side of the DHA - indicating hydrologic stress.

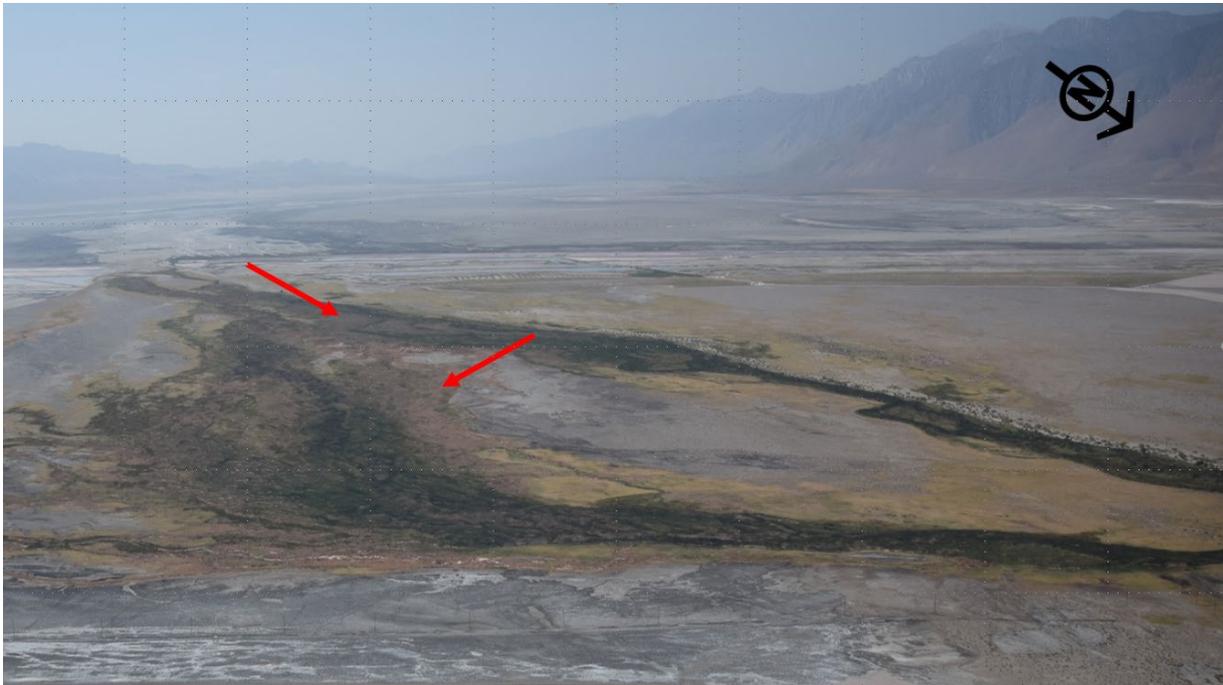
Figure 4-4. August 25, 2022, aerial image of DHA. Reference locations denoted by red arrows exhibit extensive die-back of emergent vegetation from hydrologic stress.

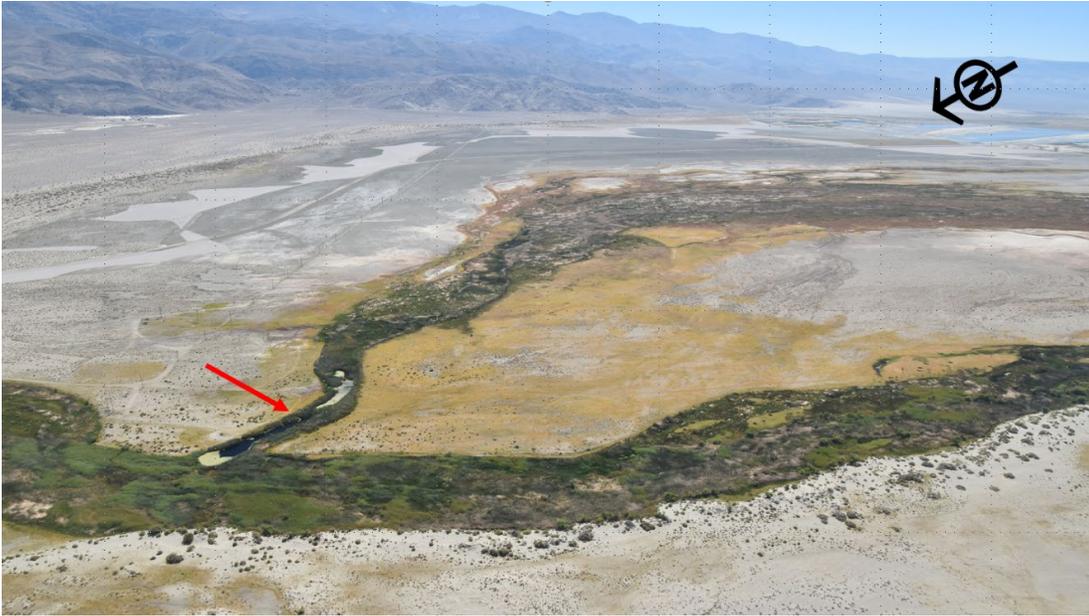
The location of permanent ponds 1 and 2 that were monitored during the 2022-23 RY are shown in Figure 4-5. Representative photos (Figure 4-6 and Figure 4-7.) from July 6, 2022, show that these ponds did remain flooded in the summer base-flow conditions, thus Criterion 2 was met.

Figure 4-6. July 6, 2022, aerial image of DHA. Red arrow denotes permanent pond 1 during reduced summer flows.

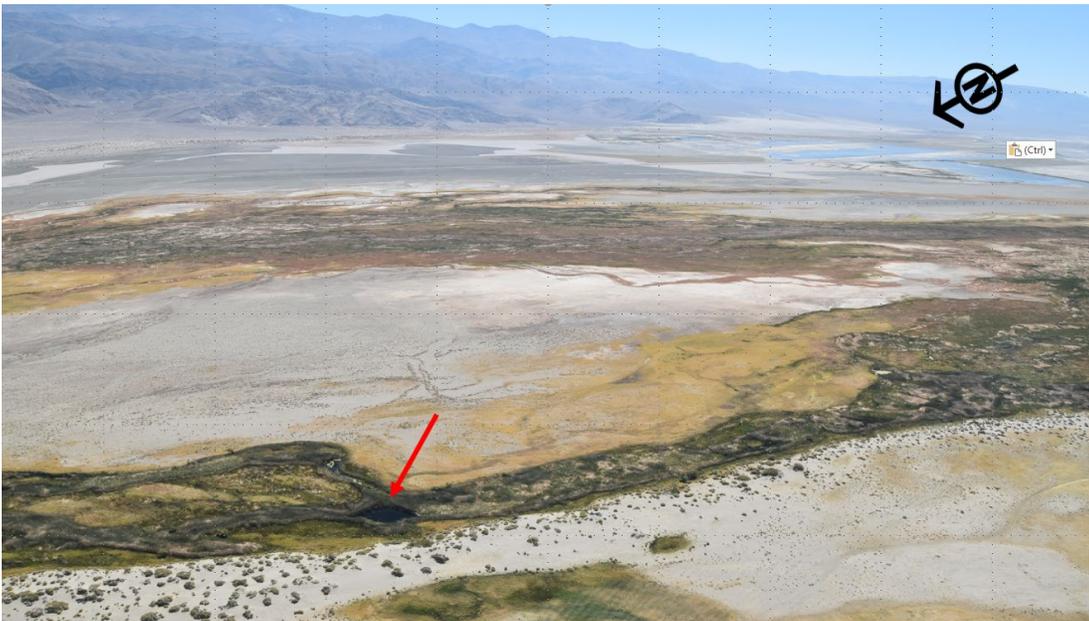
Figure 4-7. July 6, 2022, aerial image of DHA. Red arrow denotes permanent pond 2 during reduced summer flows.

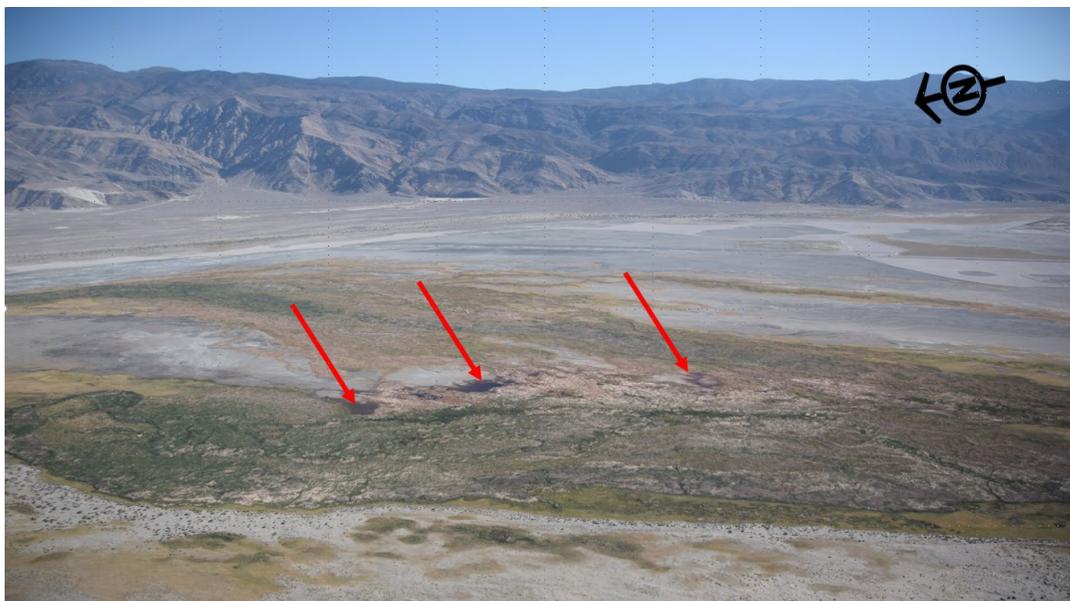
On September 1, 2022, the summer base flow of 4 cfs was increased to 11 cfs (Figure 4-1). The locations of seasonal ponds 4, 5, 9, and 15 are shown on Figure 4-5. Flooding of seasonal ponds 4, 5, and 9 were detected on September 6, 2022 (Figure 4-8). Because of the downstream lag time of the flows, seasonal pond 15 did not form until September 28, 2022 (Figure 4-9). Following the formation of these ponds, they were maintained throughout the remainder of 2022-23 RY and therefore Criterion 3 was met.

Figure 4-8. September 6, 2022, aerial Image of DHA. Red arrows denote seasonal ponds 4, 5, and 9 from left to right.

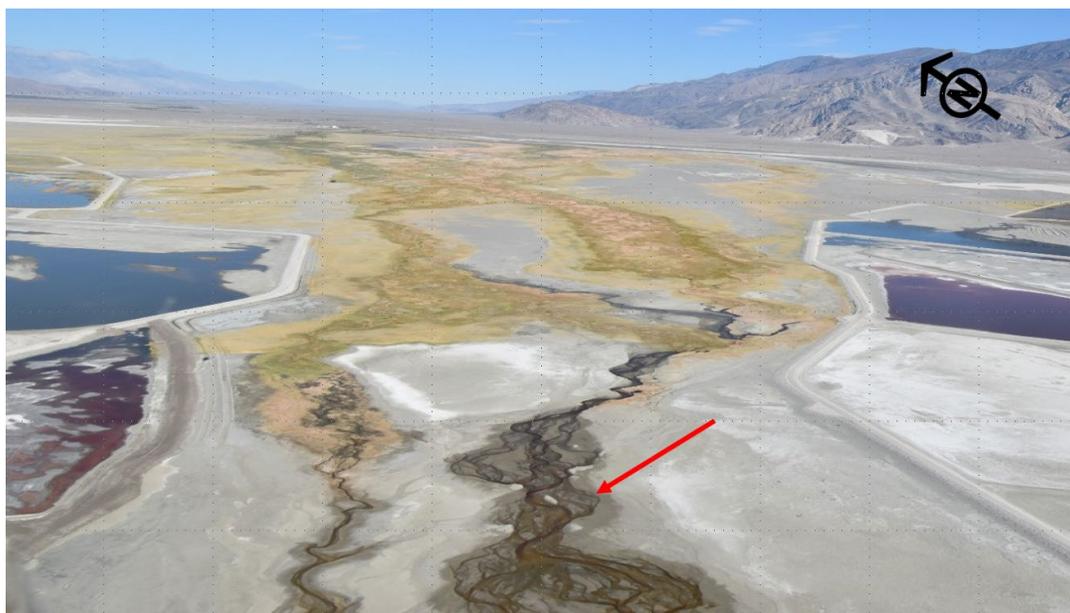
Figure 4-9. September 28, 2022, aerial Image of DHA. Red arrow denotes seasonal pond 15.

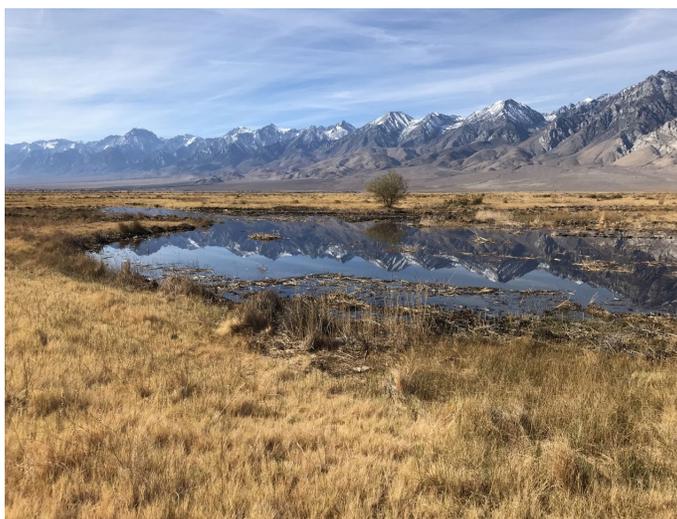
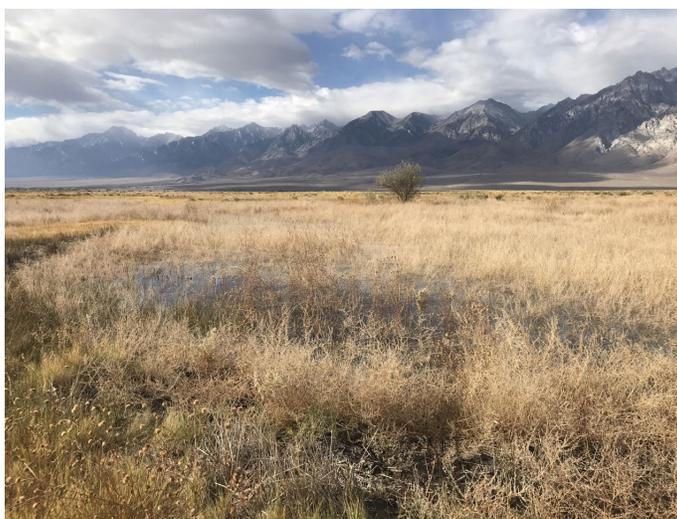
Subbasin WAG1, Photopoint WAG1_220

WAG1 borders the Blackrock Ditch, which supports a number of willows that attract a variety of songbirds. This subbasin is relatively small and only supports small areas of open water when flooded. There are three photopoints in this subbasin. In FC2, WAG1_220 was the one area that had open water visible at the photopoint; there was no open water observed at the other two photopoints due to vegetation growth. Even at WAG1_220, the density of *Bassia hyssopifolia* and *Helianthus annuus* was such that it obscured the view of the water. However, cover from these two species decreased from fall to spring, and more open water became visible over time (Figure 4-12, Figure 4-13) WAG1 had 1% of the HIS observations in the Waggoner Unit (Table 4-4).

Figure 4-12. WAG1_220 on November 2, 2021

Figure 4-13. WAG1_220 on November 1, 2022

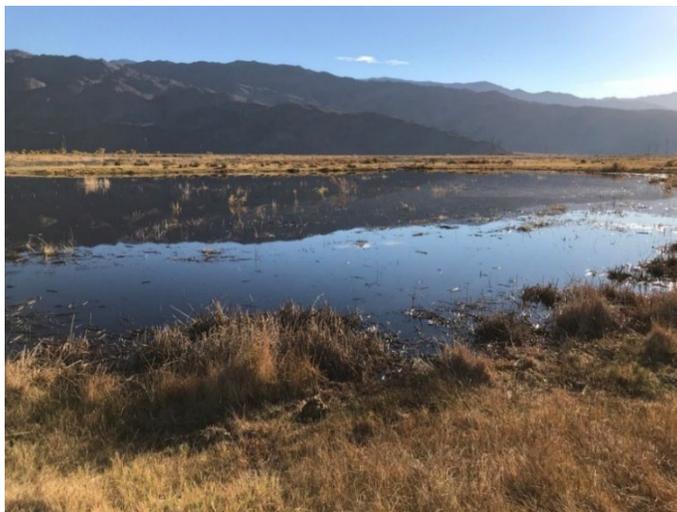
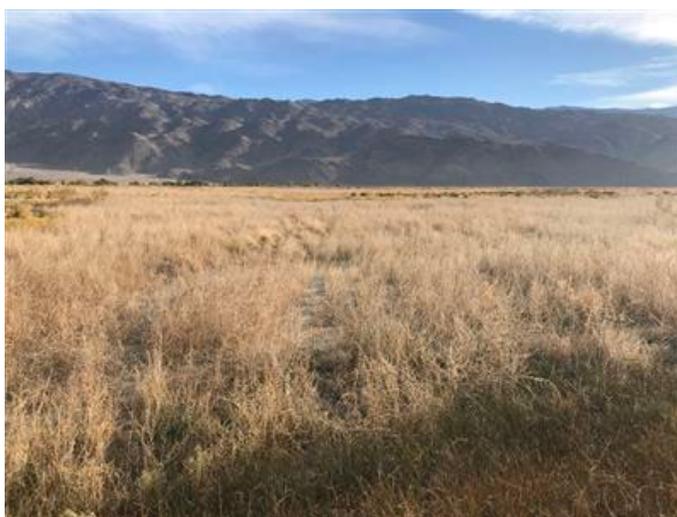
WAG2 is a large subbasin that has supported a central large, open water pond and some smaller side ponds connected by flooded channels. There are four photopoints in this subbasin. Between FC1 and FC2, there was an increase in *Bassia hyssopifolia* that obscured the water at WAG2_70 (Figure 4-14, Figure 4-15). The other three photopoints also had *Bassia hyssopifolia* and *Helianthus annuus*, though cover declined from fall to spring, maintaining open water at these locations (Figure 4-16, Figure 4-17). WAG2 had 21% of HIS observed in the Waggoner Unit (Table 4-4).

Figure 4-14. WAG2_70 on November 2, 2021

Figure 4-15. WAG2_70 on November 1, 2022

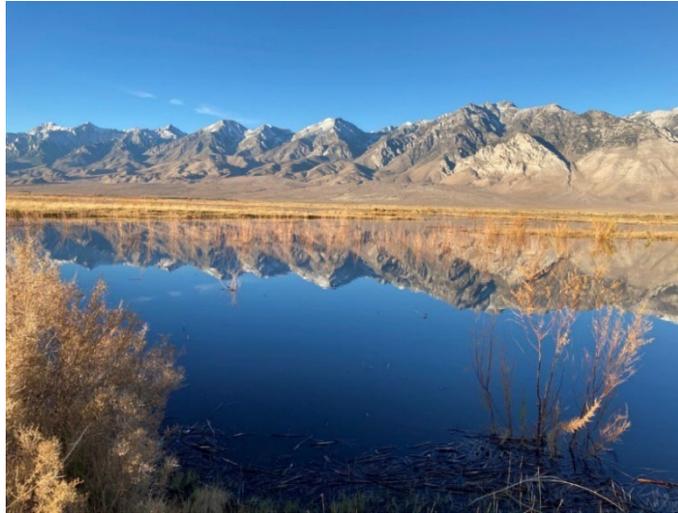
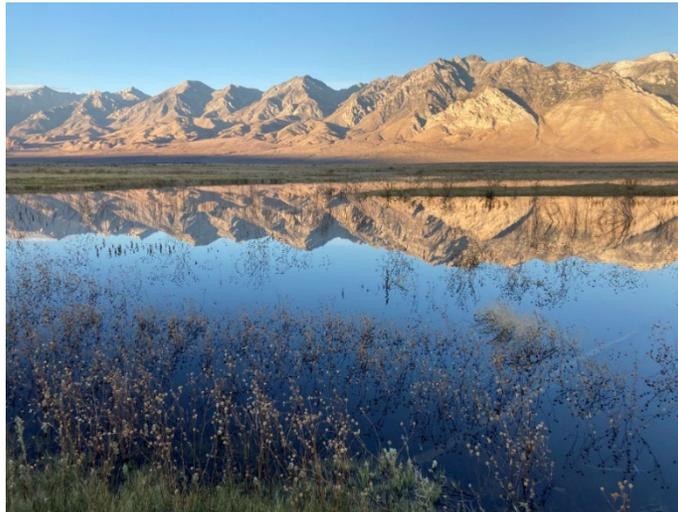
Figure 4-16. WAG2_240 on November 2, 2021

Figure 4-17. WAG2_240 on November 1, 2022

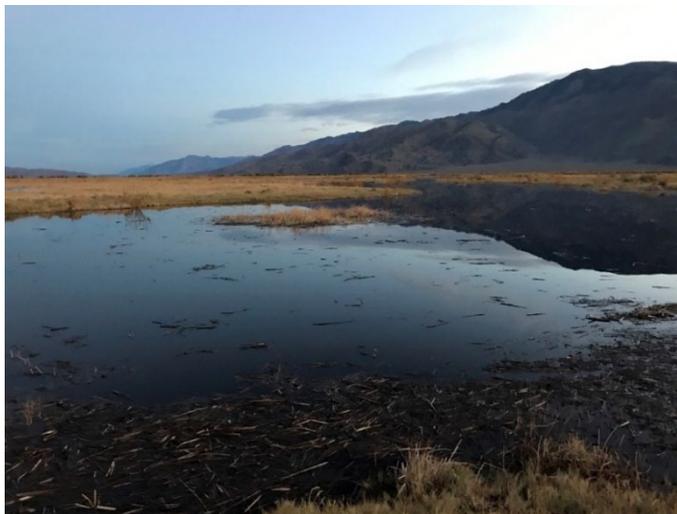
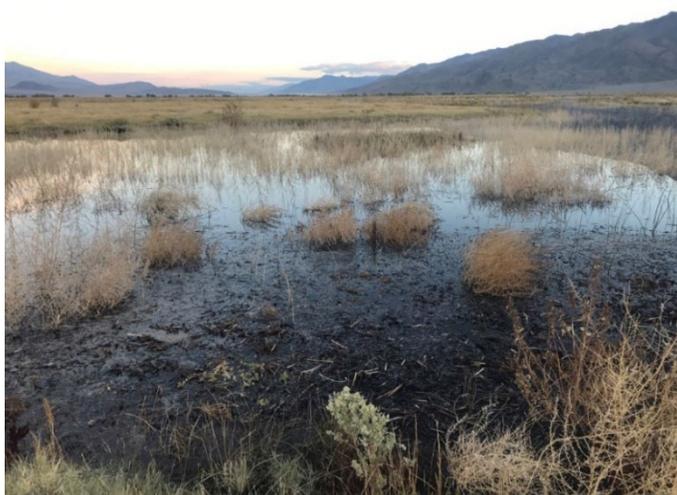
Subbasin WAG3, Photopoint WAG3_360

In WAG3, there is a complex series of small, shallow ponds and small “fingers” of flooding. There are four photopoints in this subbasin. During FC2, *Bassia hyssofolia* invaded the dry portion of the subbasin at WAG3_360, but it decreased over time as it filled with water (Figure 4-18, Figure 4-19). The other three photopoints showed increases in annual vegetation but retained open water. WAG3 had 14% of the HIS observations in the Waggoner Unit (Table 4-4).

Figure 4-18. WAG3_360 on November 2, 2021

Figure 4-19. WAG3_360 on November 1, 2022

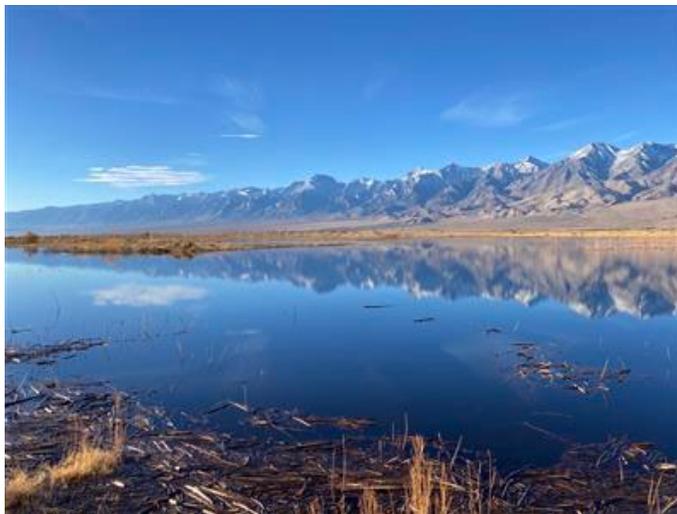
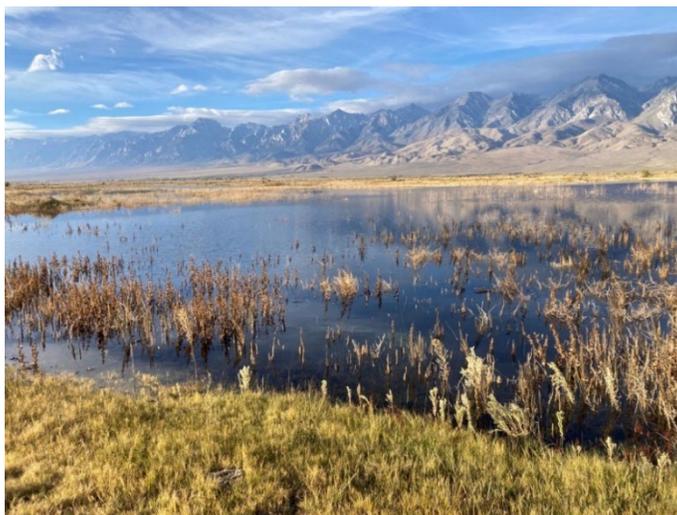
Subbasin WAG4, Photopoint WAG4_200

WAG4 is similar to WAG2 in that it supports a relatively large and deep open water pond. It had the most amount of flooded acreage at approximately 44 acres. Right after initial water releases this season, open water areas were limited and small, but by early November, open water was plentiful. The southern end of WAG4 is where waterfowl were observed (Figure 4-20, Figure 4-21). WAG4 had the highest percent of HIS observations (39%) in the Waggoner Unit (Table 4-4).

Figure 4-20. WAG4_200 on November 2, 2021

Figure 4-21. WAG4_200 on November 1, 2022

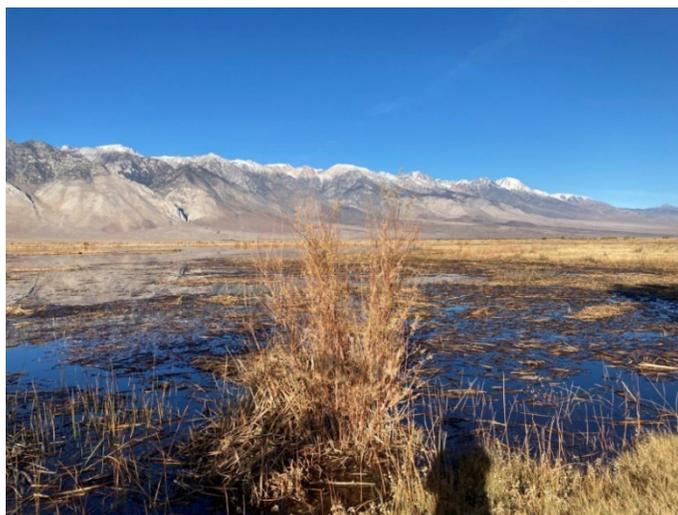
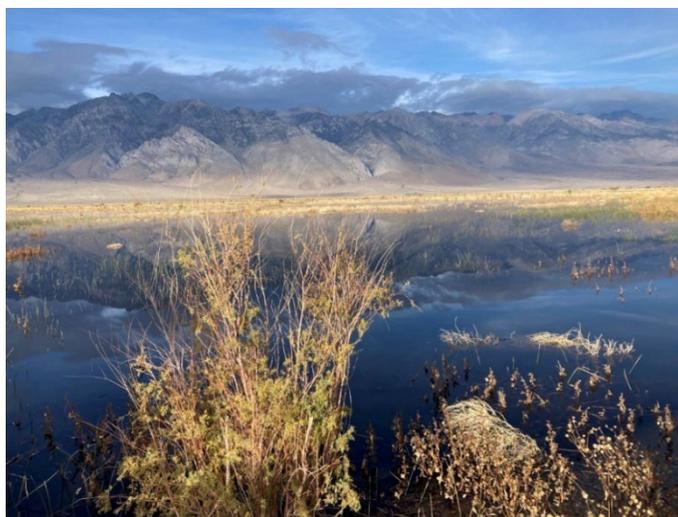
Subbasin WAG5, Photopoint WAG5_290

Much of WAG5 is shallow, but waterfowl were observed in slightly deeper areas. There are two photopoints in this subbasin. Between FC1 and FC2, both photopoints show that water remained relatively open in the subbasin (Figure 4-22, Figure 4-23). WAG5 had 19% of the HIS observations in the Waggoner Unit (Table 4-4).

Figure 4-22. WAG5_290 on November 2, 2021

Figure 4-23. WAG5_290 on November 1, 2022

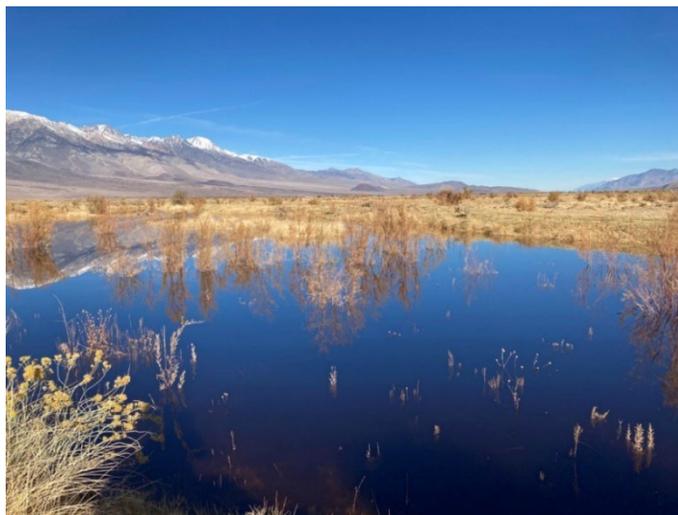
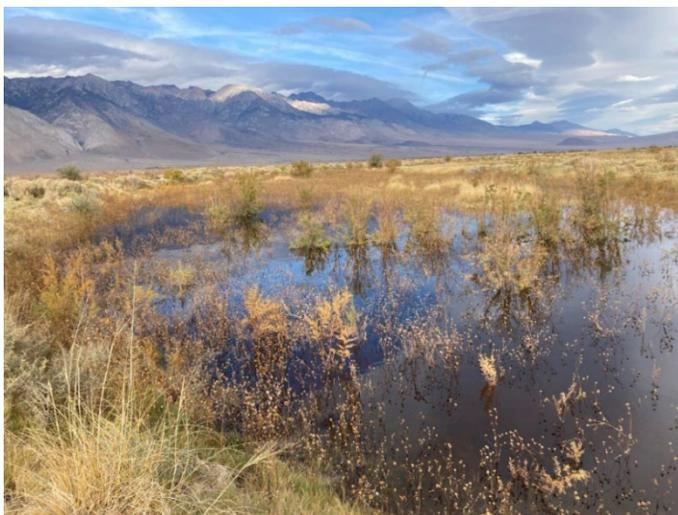
Subbasin WAG6, Photopoint WAG6_280

WAG6 is a very small subbasin at the south end of the Waggoner Unit, and it consists of small, narrow, and shallow ponds. There is only one photopoint in this subbasin. It had the least amount of flooded acreage at 7 acres. Since FC1, there has been some growth of *Helianthus annuus* along the edges of the subbasin, but it still remains relatively open

(Figure 4-24, Figure 4-25). WAG5 had 3% of the HIS observations in the Waggoner Unit (Table 4-4).

Figure 4-24. WAG6_280 on November 2, 2021

Figure 4-25. WAG6_280 on November 1, 2022

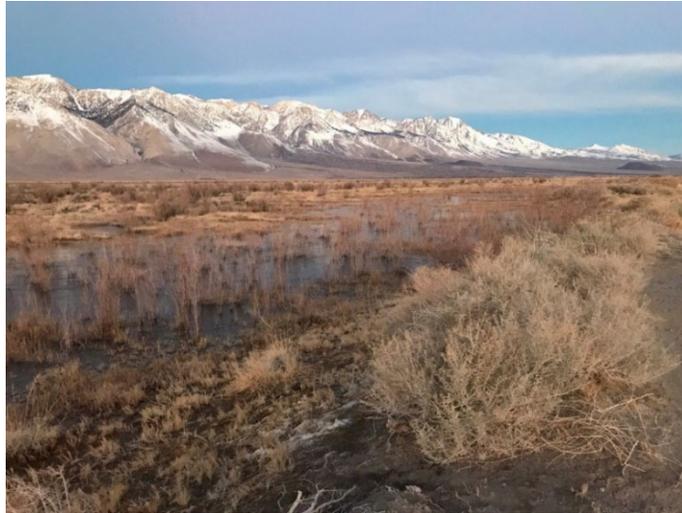
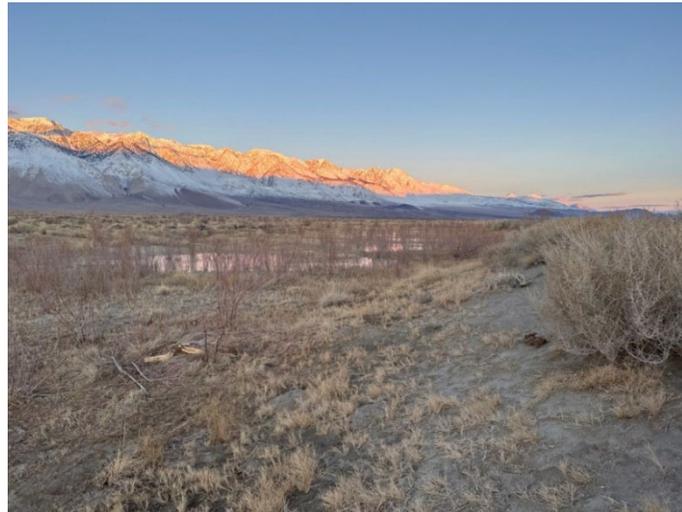
Subbasin WAG7, Photopoint WAG7_290

WAG7 is a small, intermittently-flooded area that is not being “actively” managed, but receives water from WAG4 when water levels are high, and some subsurface water from adjacent subbasins. There are two photopoints in this subbasin. WAG7 did not receive water until January 2022 during FC1 (Figure 4-26). During FC2 (2022-2023), water was in WAG7 by December 2022 (Figure 4-27). The habitat in this subbasin is limited, and only had 1% of the HIS observations in the Waggoner Unit (Table 4-4).

Figure 4-26. WAG7_290 on January 11, 2022

Figure 4-27. WAG7_290 on December 13, 2022

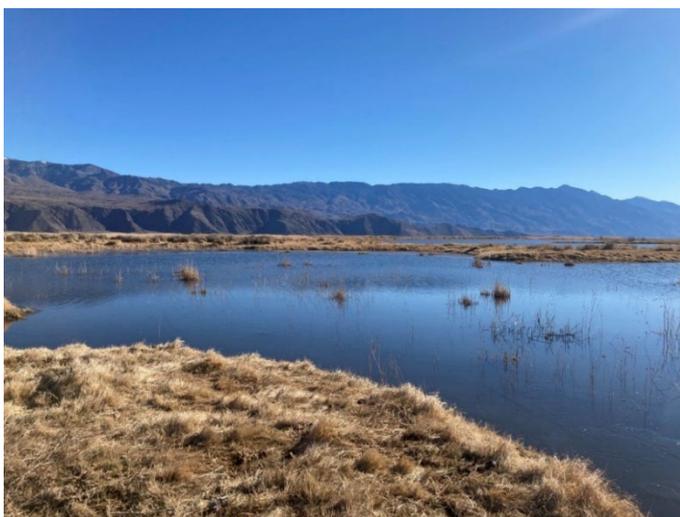
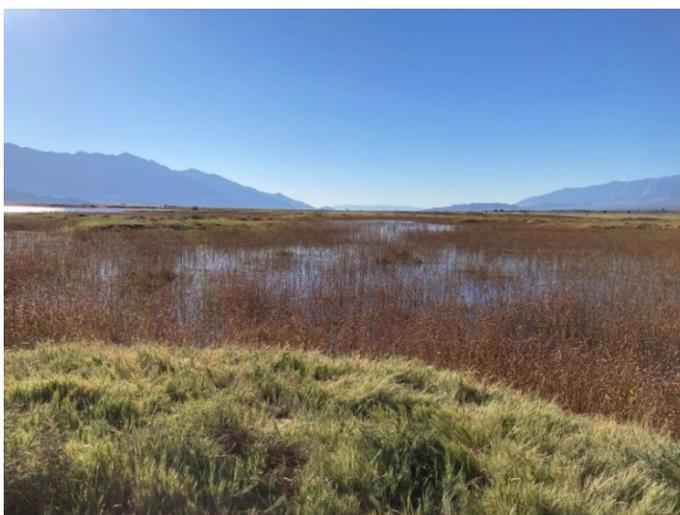
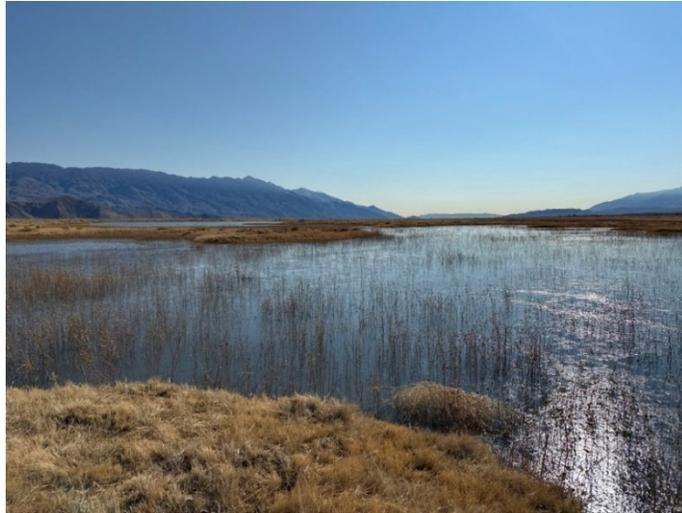
Subbasin TH5, Photopoint TH5_130

TH5 is a moderately-sized, open-water pond (Figure 4-29). There are two photopoints in this subbasin. In FC2, there was a large, dense stand of *Helianthus annuus* at both photopoints (Figure 4-29 and Figure 4-30); however, the density of this senesced vegetation declined over the monitoring period, resulting in more open water habitat (Figure 4-31). TH5 had 19% of the HIS observations in the Thibaut Unit (Table 4-4).

Figure 4-29. TH5_130 on December 17, 2021

Figure 4-30. TH5_130 on October 5, 2022

Figure 4-31. TH5_130 on December 14, 2022

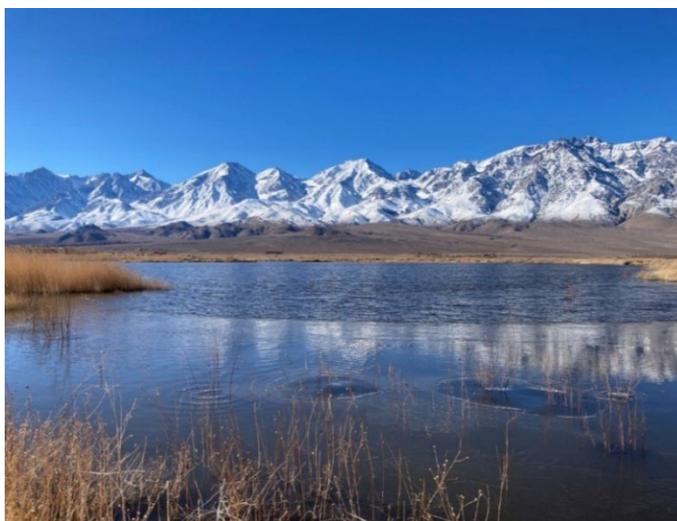
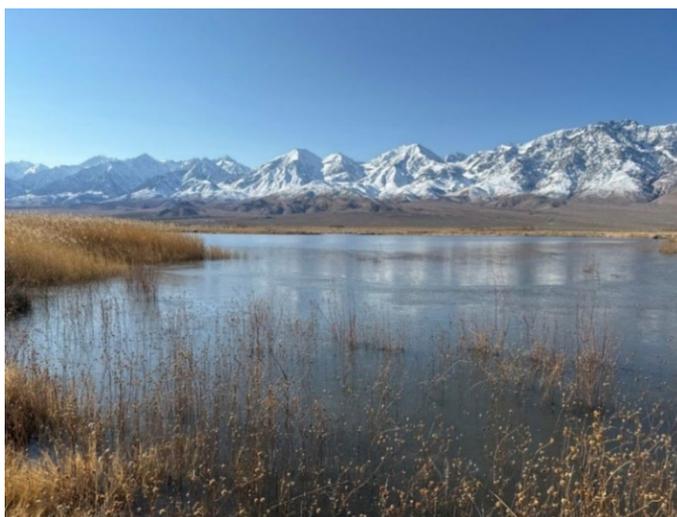
Subbasin TH6, Photopoint TH6_235

TH6 is a moderately-sized subbasin and likely supports the deepest pond in the BWMA. There are four photopoints in this subbasin. TH6 supports an island used by waterbirds for sleeping and loafing. At the north end of the pond are old tamarisk plants and stumps where waterfowl are often seen sleeping and loafing. There are some small, shallow ponds physically connected to the main pond as well. Photopoint TH6_235 is an example of how there has been some growth of annual vegetation between FC1 and FC2, but it still remains largely open (Figure 4-32, Figure 4-33). The other photopoints show a similar pattern, except for photopoint TH6_235. Here there has been an increase in open water as annual vegetation has broken down between FC1 and FC2. TH6 had the highest percentage (30%) of HIS observations in the Thibaut Unit (Table 4-4).

Figure 4-32. TH6_235 on December 17, 2021

Figure 4-33. TH6_235 on December 14, 2022

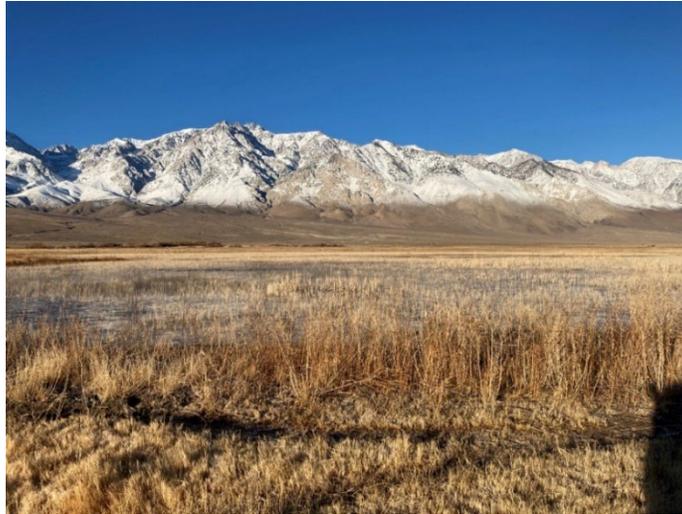
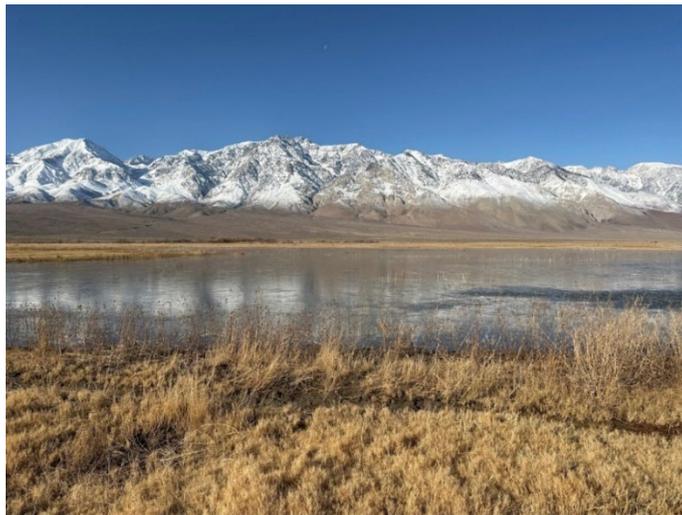
Subbasin TH7, Photopoint TH7_265

TH7 is part of the “Thibaut Pond” management area that has been seasonally flooded (October to March) since 2014. TH7 is a large, shallow pond that had the most flooded acreage at approximately 65 acres. There are three photopoints in TH7. The pond has supported large stands of *Helianthus annuus*, but is mostly surrounded by *Distichlis spicata* (Figure 4-34, Figure 4-35). TH7 had 18 % of the HIS observations in the Thibaut Unit (Table 4-4).

Figure 4-34. TH7_265 on December 17, 2021

Figure 4-35. TH7_265 on December 14, 2022

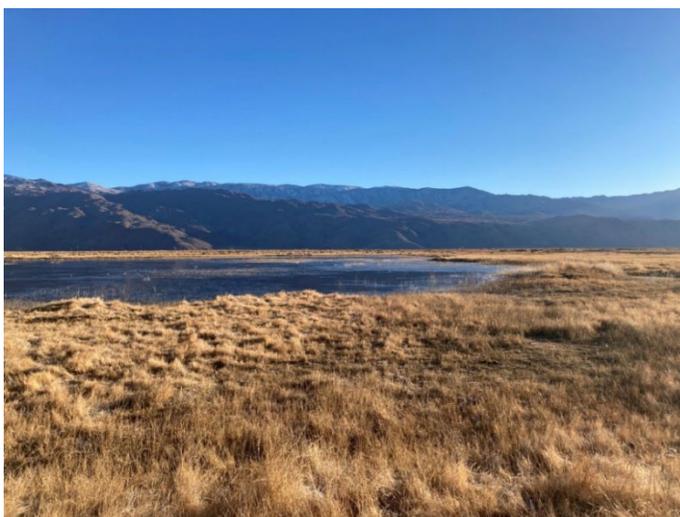
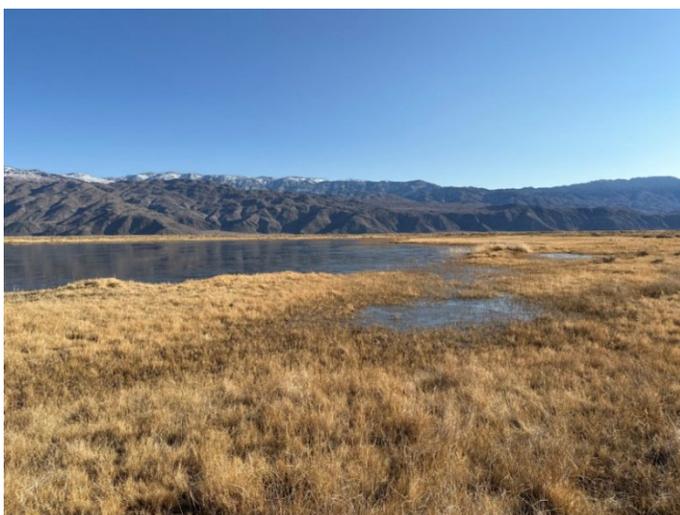
Subbasin TH8, Photopoint TH8_65

TH8 is also part of the “Thibaut Pond” management area that has been seasonally flooded (October to March) since 2014. TH8 includes two small and shallow ponds. There are two photopoints in this subbasin. There was no evidence of an increase in surrounding vegetation, and it remains largely dominated by *Distichlis spicata* (Figure 4-36, Figure 4-37). TH8 had a little over 1% of the HIS observations in the Thibaut Unit (Table 4-4).

Figure 4-36. TH8_65 on December 17, 2021

Figure 4-37. TH8_65 on December 14, 2022

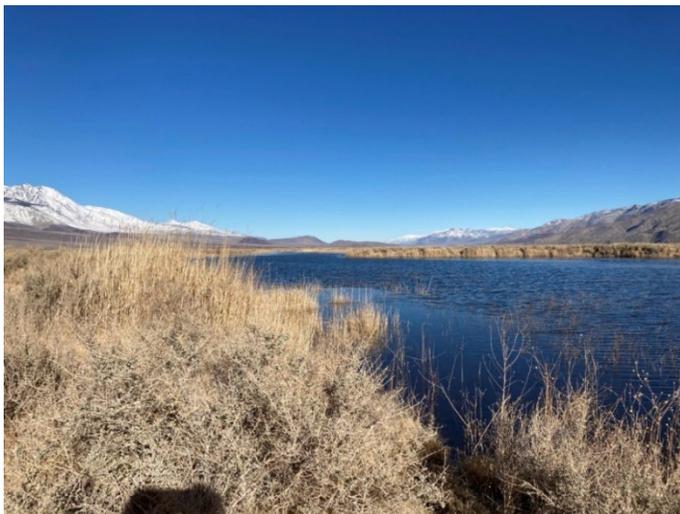
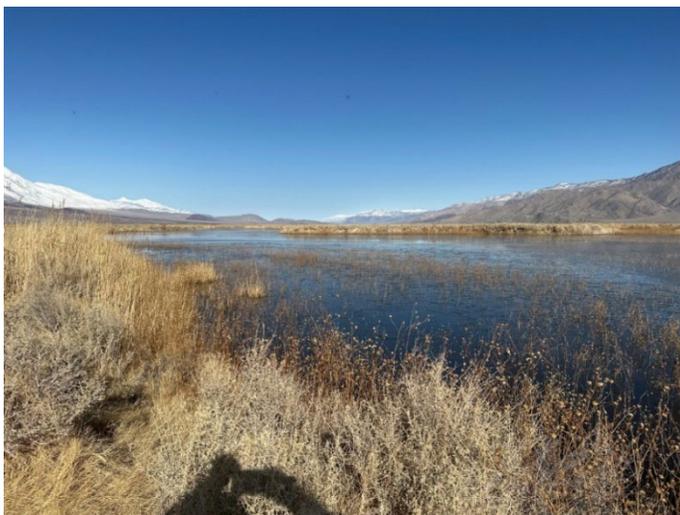
Subbasin TH10, Photopoint TH10_40

TH10 is a long, linear pond surrounded by dense saltbush scrub on the banks. It is one of the larger subbasins with the second highest amount of flooded acreage at approximately 35 acres. This subbasin has three photopoints. TH10 has also supported large stands of *Helianthus annuus*, which tended to decrease throughout the flooding cycle (Figure 4-38, Figure 4-39). TH10 had 13% of the HIS observations in the Thibaut Unit (Table 4-4).

Figure 4-38. TH10_40 on December 17, 2021

Figure 4-39. TH10_40 on December 14, 2022

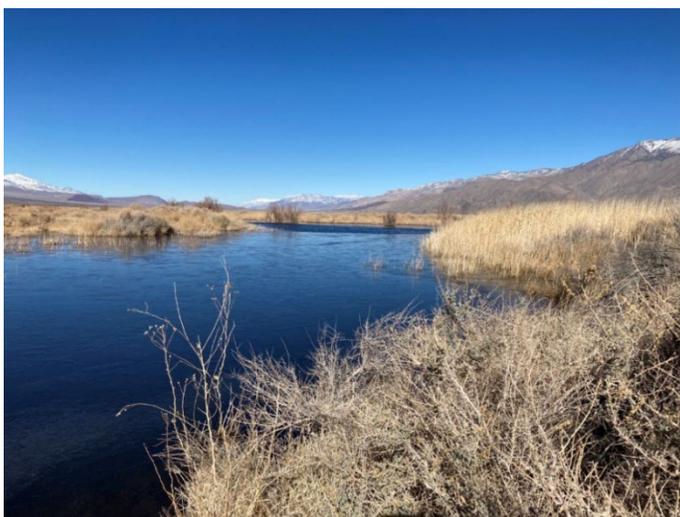
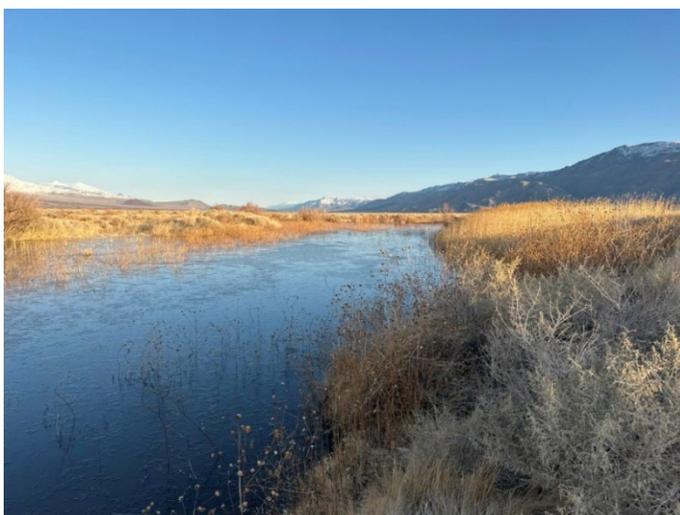
Subbasin TH11, Photopoint TH11_0

TH11 consists of small, narrow ponds surrounded by dense saltbush scrub on the banks. It is one of the smaller subbasins at approximately 15 flooded acres. It has only one photopoint. This subbasin, like others, supported *Helianthus annuus* along its banks (Figure 4-40, Figure 4-41). TH11 had 6% of the HIS observations seen in the Thibaut Unit (Table 4-4).

Figure 4-40. TH11_0 on December 17, 2021

Figure 4-41. TH11_0 on December 14, 2022

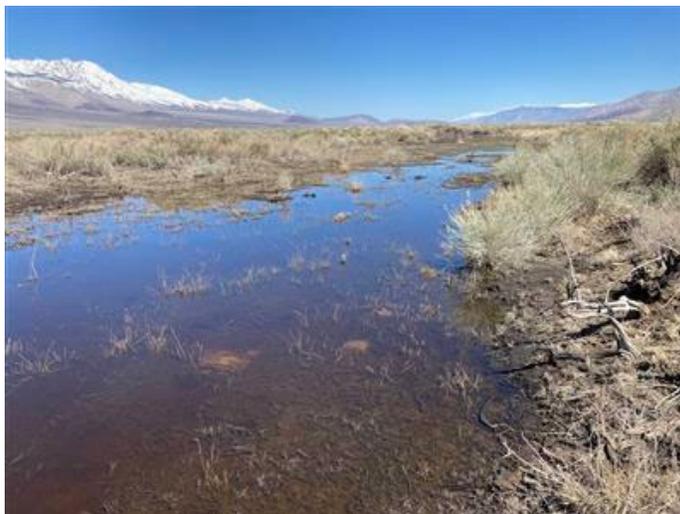
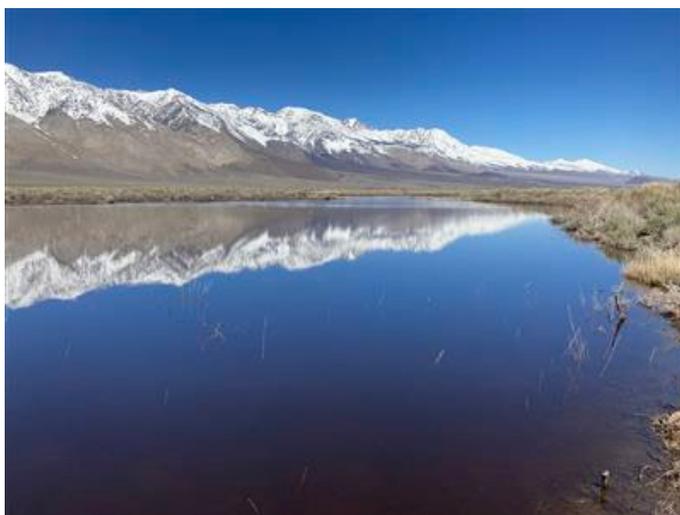
Subbasin SW1, Photopoints SW1_330 (North and South)

SW1 was not monitored in FC1, but was in FC2. SW1 had no water in it at the time the flooded extent was mapped. SW1 is relatively wide and shallow. There are three photopoints in this subbasin. By March 2023, water had filled SW1, but because the BWMA was flooded and could not be surveyed on foot, the most recent photo was from April 2023. Water had mostly filled the subbasin by photopoints SW1_330 (north and south) (Figure 4-42, Figure 4-43). Only 2 HIS species and 14 HIS individuals were observed in SW1 (Table 4-4).

Figure 4-42. SW1_330 (north) on April 10, 2023

Figure 4-43. SW1_330 (south) on April 10, 2023

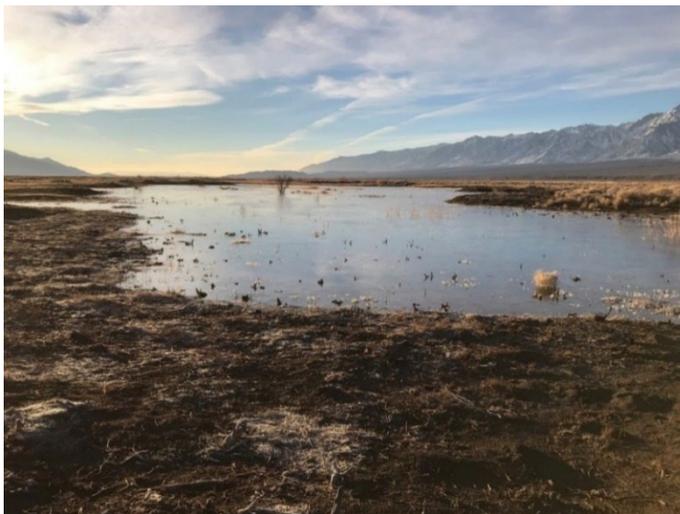
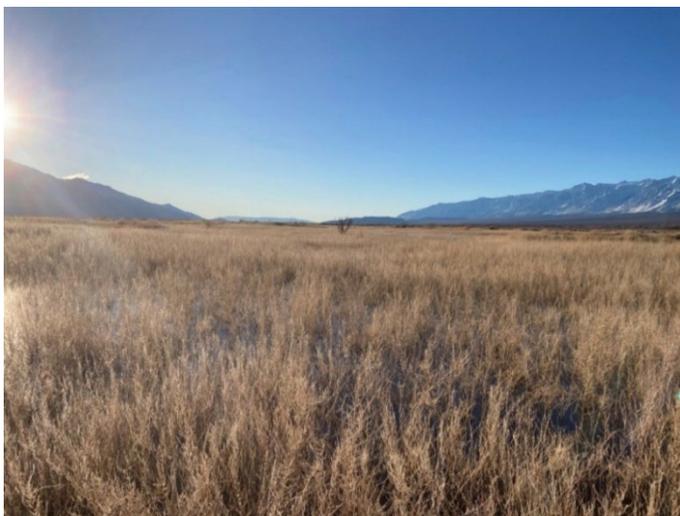
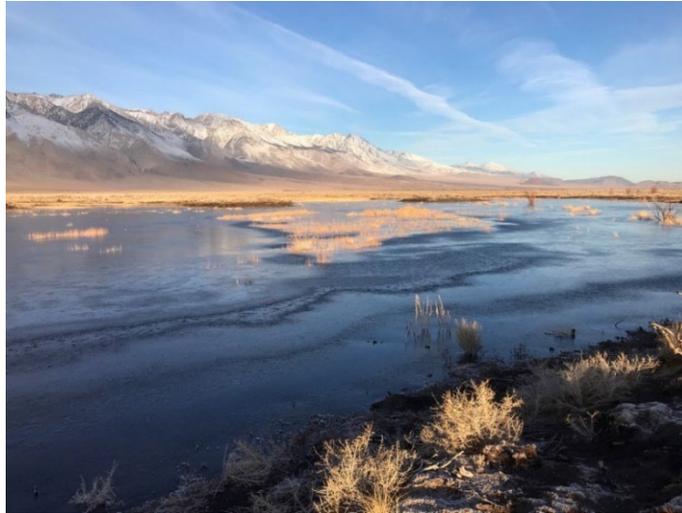
Subbasin SW2, Photopoints SW2_150 and SW2_320

SW2 is a large subbasin that includes a large, moderately deep pond and a second small, shallow pond to the north. The large, main pond was densely covered with *Bassia hyssopifolia* prior to flooding. There are seven photopoints in this subbasin. In FC2, *Bassia hyssopifolia* was once again abundant in SW2, and had colonized the smaller pond to the north, but as seen in other subbasins, this vegetation declined over the flooding cycle (Figure 4-44, Figure 4-45,

Figure 4-46, Figure 4-47). The total average flooded acreage for SW2 was approximately 46 acres. SW2 had 12% of the HIS observations in the Thibaut Unit (Table 4-4).

Figure 4-44. SW2_150 on December 20, 2021

Figure 4-45. SW2_150 on December 1, 2022

Figure 4-46. SW2_320 on December 20, 2021

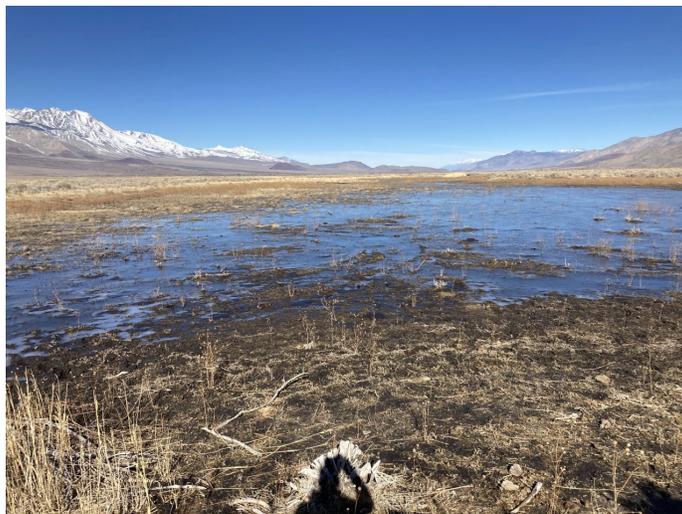
Figure 4-49. W9_335 on January 11, 2022

W9 is a relatively shallow subbasin with three photopoints. Since W9 was intermittently flooded in 2021 (FC1), the earliest photo was from January 2022. Photopoint W9_335 overlooks a large pond that, in November 2022 (FC2), had dense cover of *Helianthus annuus* (Figure 4-49, Figure 4-50). Photopoint W9_340 is located at the very southern end of the subunit and overlooks a small, narrow pond. This photopoint also shows *Helianthus annuus* colonizing this area (Figure 4-51, Figure 4-52). This subbasin supported 9% of the HIS observations in the Winterton Subunit (Table 4-4).

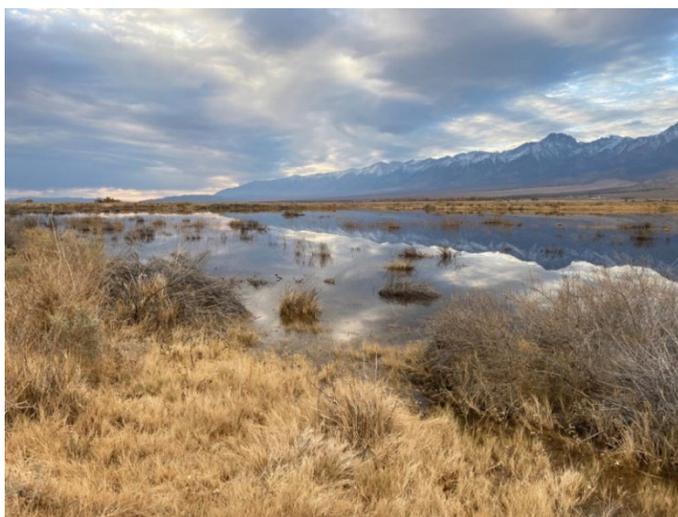
Figure 4-53. W11_170 on November 1, 2021

W11 supported a moderately-sized open water pond, with approximately 21 flooded acres. There are two photopoints in this subbasin. The basin is highly vegetated with saltgrass (*Distichlis spicata*). Between FC1 and FC2, this subbasin has supported stands of *Helianthus annuus* (Figure 4-53, Figure 4-54). This subbasin had 12% of the HIS observations in this subunit (Table 4-4).

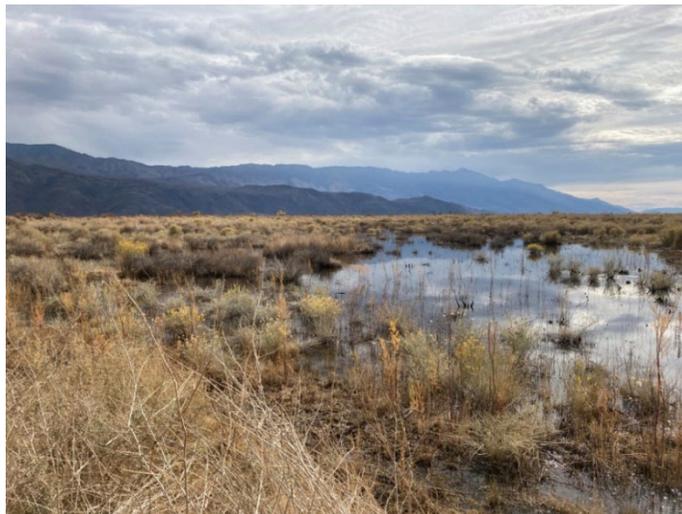
Figure 4-55. W12_110 on November 1, 2021

W12 is a small, shallow shrubby subbasin with little open water area (Figure 4-55, Figure 4-56). It is intermittently flooded. There are two photopoints in this subbasin. At the time of the flooded extent mapping in FC2, there was no water in W12. This subbasin had only one HIS observation in this subunit (Table 4-4).

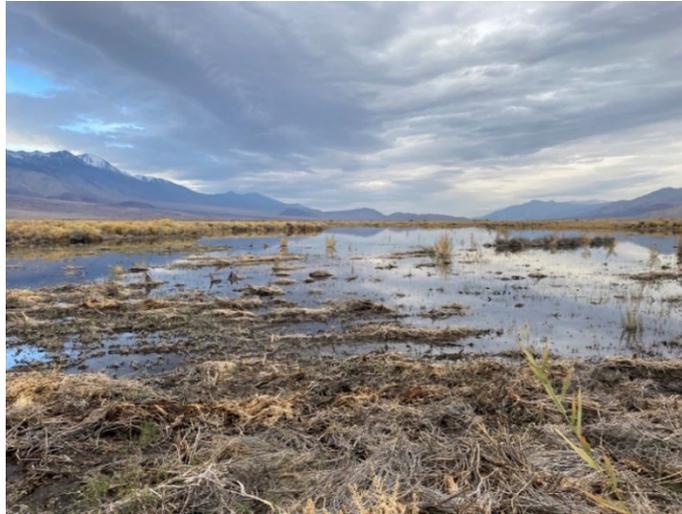
Figure 4-57. W13_340 on November 1, 2021

W13 is dominated by dense stands of saltbrush (*Atriplex* sp.) and rabbitbrush (*Ericameria nauseosa*). There are four photopoints in this subbasin. In FC1, it supported the largest open water area in East Winterton and supported the most HIS. In FC2, *Bassia hyssopifolia* was observed around the photopoints (Figure 4-57, Figure 4-58), and it was moderately-sized with approximately 29 flooded acres. It also had the highest percentage of HIS observations in this subunit at 49% (Table 4-4).

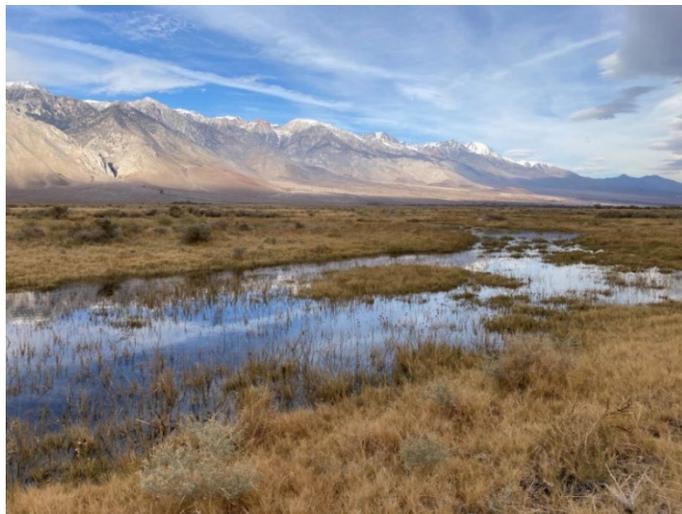
Figure 4-59. W14_300 on November 1, 2021

W14 contained a mix of small, shallow, grassy ponds and shrubby areas. In FC2, it was approximately 13 flooded acres. There are two photopoints in this subbasin. There was no single pond of any significant size, but instead, the habitat was relatively braided and broken up. This subbasin supported stands of *Helianthus annuus* in some areas (Figure 4-59, Figure 4-60). This subbasin supported the second highest percentage of HIS observations in this subunit at 30% (Table 4-4).
