Lower Owens River Project 2023 Annual Report

March 2024

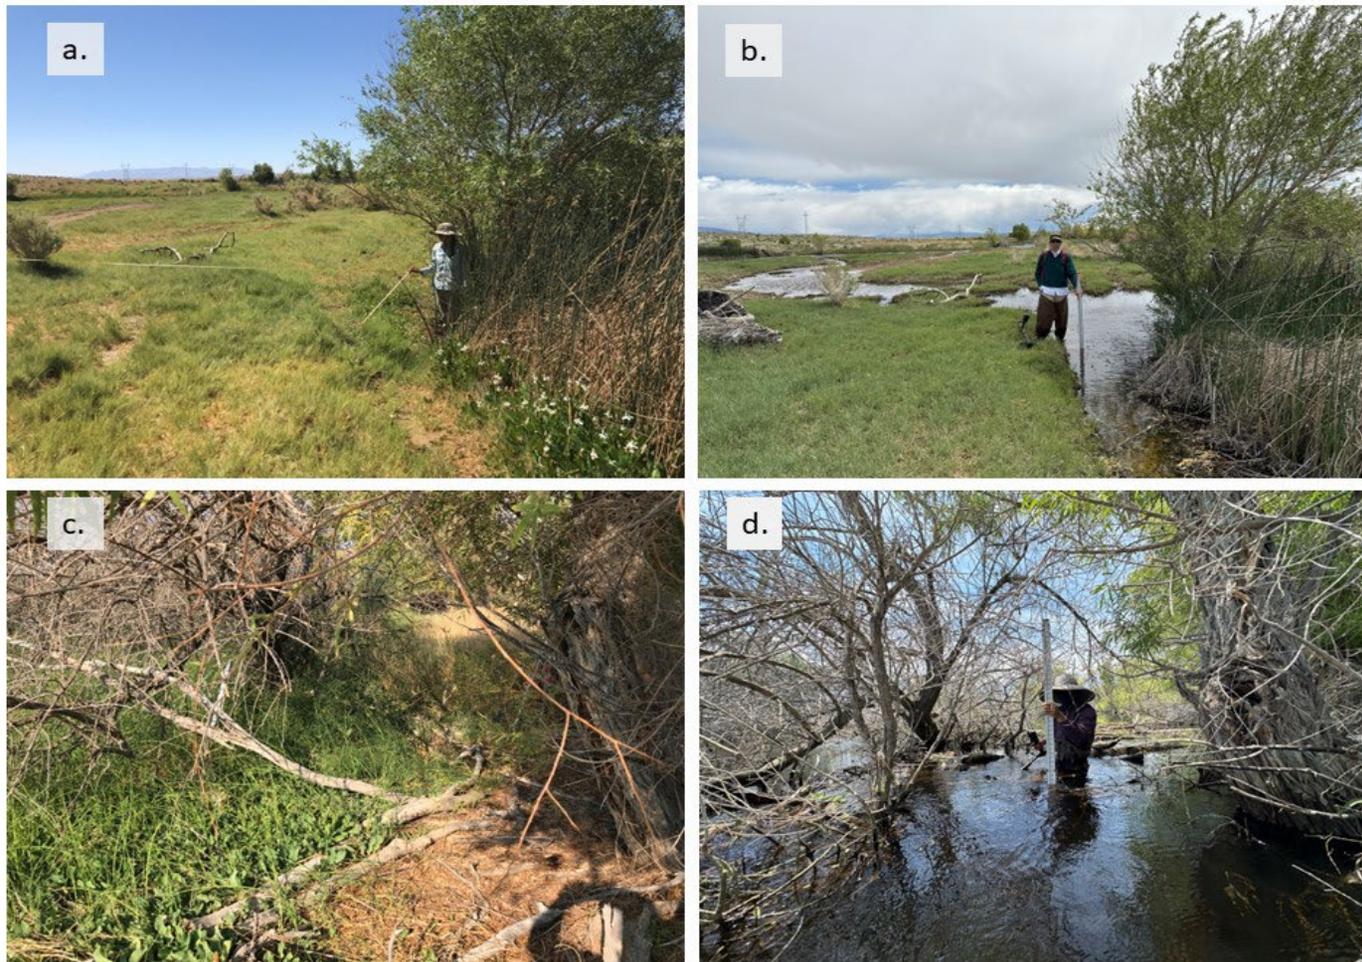
Figure 4-70. Normal and high-flow comparisons on the LOR Project. Images a) and c) depict two riparian transect bank-full locations under normal summer flows (50-90 cfs) during 2022 in a and 2021 in c, while b) and d) show the same locations during approximately 200 and 579 cfs; inundated under 0.4 and 4.4 ft of water, respectively, in June 2023.

This project was not completed in summer 2023 due to high flows preventing access (Figure 4-70). Data will be analyzed when the field component of the project is complete, and a more comprehensive analysis will be presented in the 2024 or 2025 LORP Annual Report.

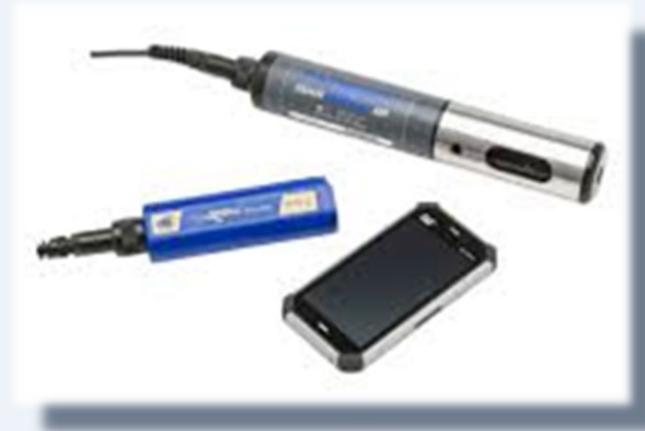
2023 Water Quality Stations

Parameters:

- Dissolved Oxygen (DO), mg/L
- Temperature (Temp), °F
- Specific Conductivity (Sp Cond), $\mu\text{S}/\text{cm}$
- pH

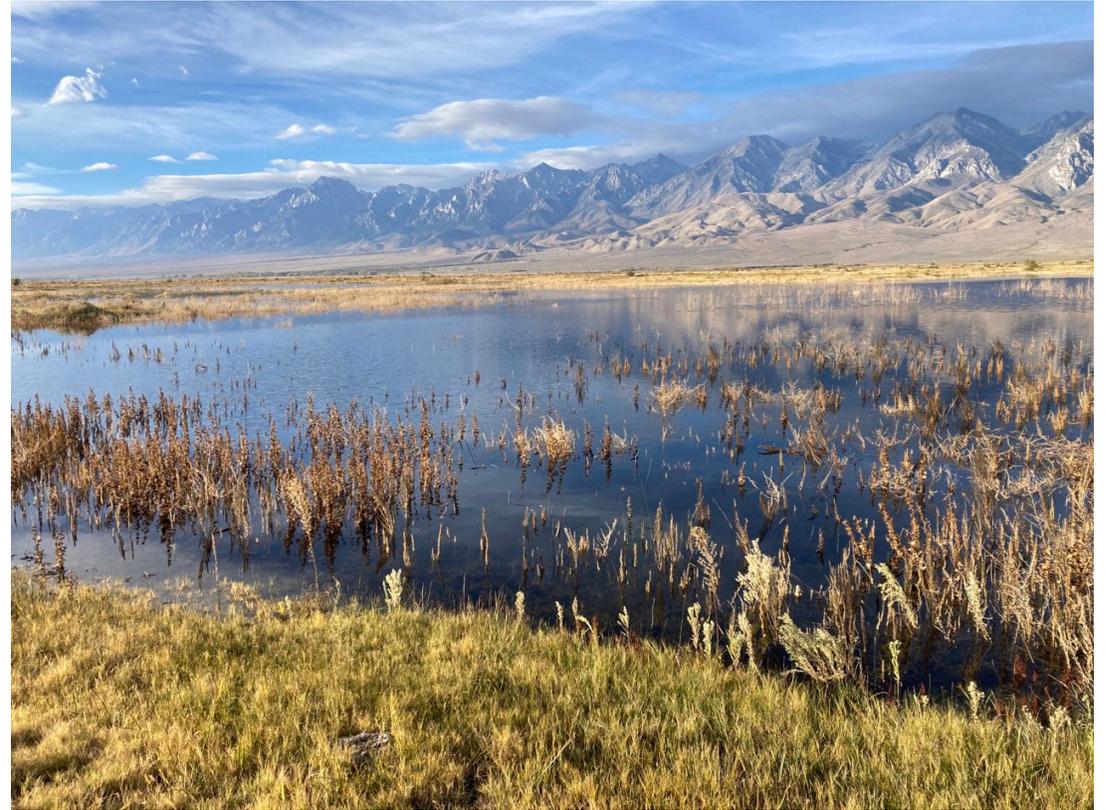
Percentage of HIS by Subbasin

- Individual subbasins varied in their attractiveness to birds
- Thibaut supported 59%
 - Subbasin TH6 had the highest
- Waggoner supported 28%
 - Subbasin WAG4 had the highest
- South Winterton (8%) & East Winterton (4%) were the lowest

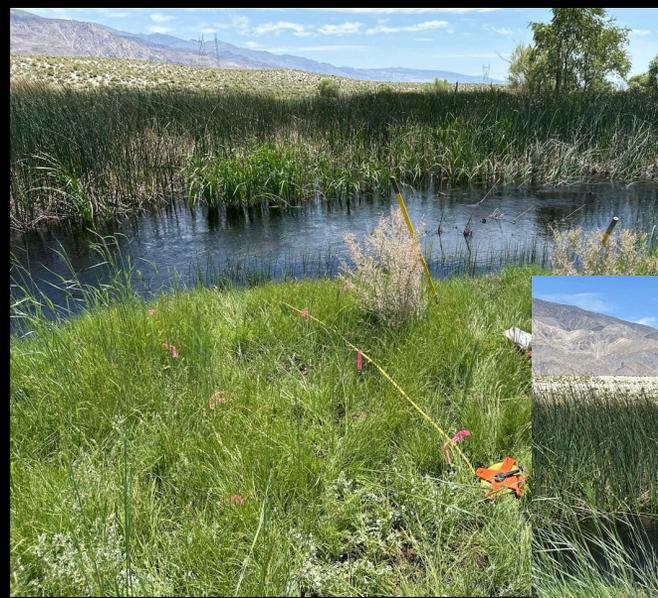
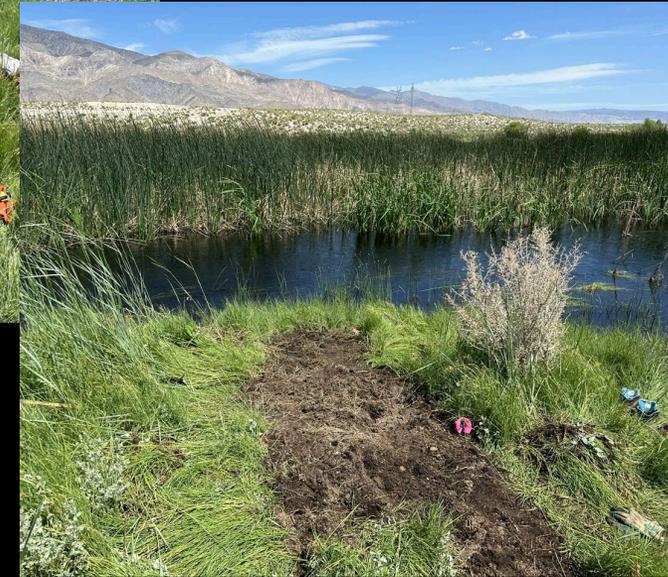
- Plant removals at 5 sites
- Reaches 5 & 6: lowest recruitment
 - Reach 5: 3 sites
 - Reach 6: 2 sites
- Recruitment at 3 of 5 sites (possibly 4... but a hurricane)
- 10 recruits total

Site	Reach	Date	# Salix sp.
1	5	8/17/2023	0
2	5	8/17/2023	6
3	5	8/17/2023	1
4	6	8/17/2023	3
5	6	not visited in August

At the five removal locations, a total of 10 *Salix sp.* seedlings were detected, with 7 found on Reach 5, and 3 on Reach 6 (Table 4-7). On LORP Reach 5, recruitment occurred at two removal sites; a greater number of locations than most years post project inception (with primarily no recruitment) and twice the number of sites as two of the three years with recruitment (Table 4-7) as assessed by the RAS. Previously, the greatest recruitment recorded on reaches 5 and 6 was in the first three years of the project when there was little plant competition on formerly dry banks and low elevation floodplain surfaces (2007-2009). On reach 6, three individuals were recorded at one of two removal sites, just less than the mean number of recruitment locations (1.5) since the beginning of the project (Table 4-7).
