# **Lower Owens River Project**

## **2008 Annual Monitoring Draft Report**

**Prepared by: Los Angeles Department of Water and Power,  
Inyo County Water Department,  
and  
Ecosystem Sciences, Inc.**

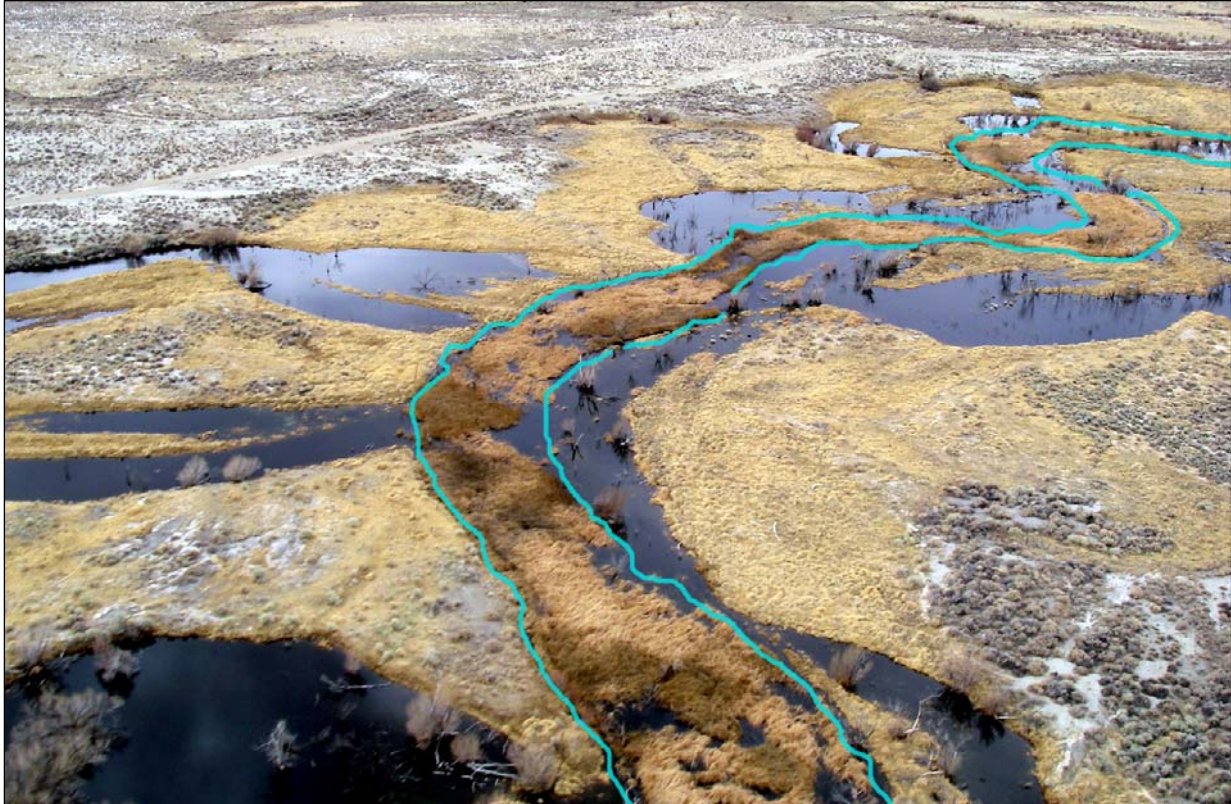
**Seasonal Habitat Flow Figure 2. Oblique Aerial Photo of Seasonal Habitat Flooding in the LORP.**

Pictured is a flooded reach of the river at approximately 175 cfs. The green-blue line in the photo represents the confined river channel and wetted edge under baseflow conditions. This reach of the river was significantly inundated with flooding during the high flows.

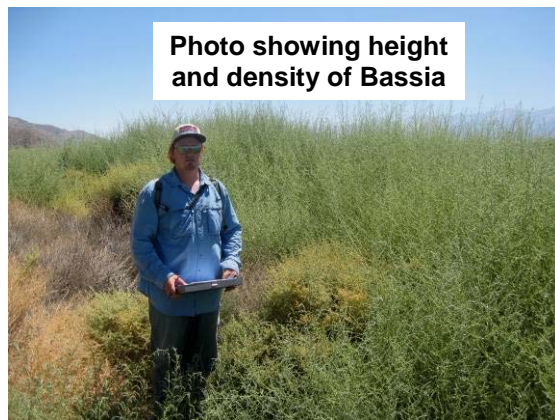
The exotic plants noted by observers were bull thistle (*Cirsium vulgare*) and fivehook bassia (*Bassia hyssopifolia*). Bull thistle was noted in the wetland areas of Winterton and Waggoner and along the river downstream of Billy Lake return and near Hidden Lakes. Bassia, although a widespread and common weed, was notable this year because of the tall, largely impenetrable stands that formed along the Owens River in the former dry reach. Observers noted 4-6 foot tall dense stands of bassia covering the floodplain on both the east and west sides of the river from Blackrock Ditch (river mile 5.0) downstream to the east-west fence line just north of Two Culverts (river mile 15.6) (see photos below). Tumbleweed (*Salsola tragus*) was mixed in with the bassia in many areas. RAS Figure 2 shows the approximate extent of the dense bassia stands and the locations of bull thistle. The bassia prevented access to the river banks in many areas in this reach. Bull thistle has an overall rating of “Moderate” in the California Invasive Plant Inventory (Cal-IPC 2006). Bassia has an overall rating of “Limited” under Cal-IPC. Neither species is currently classified as a noxious weed in California.

**Photo showing height and density of Bassia**

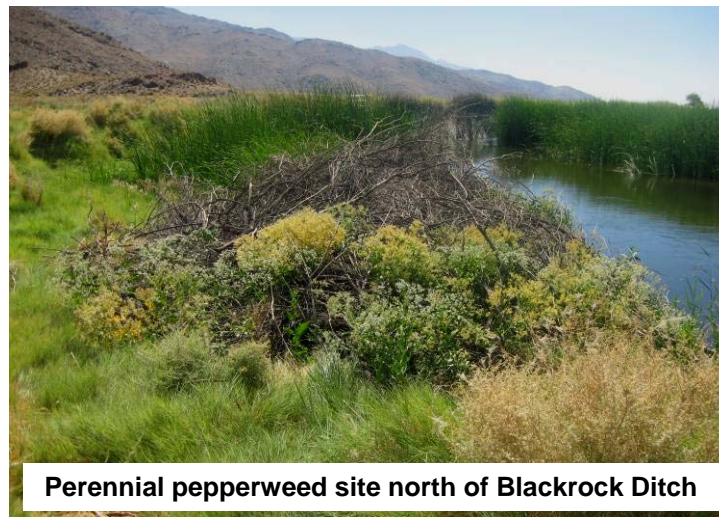
Perennial pepperweed (*Lepidium latifolium*) was documented in four different areas - two of which had not been previously documented. RAS Figure 3 shows the four general areas where perennial pepperweed was found are Drew Slough and three floodplain areas east of the river – 1) approximately 0.5 miles north of Blackrock Ditch, 2) 0.5 miles south of Manzanar Reward Road, and 3) 2 miles south of Manzanar Reward Road. The Drew Slough site and the sites 0.5 miles south of Manzanar Reward Road had not been previously documented or treated. The perennial pepperweed found in the Winterton Unit last year was not able to be relocated. Noxious Weed Documentation and Reporting Forms were filled out for each site and sent or hand-delivered to the Inyo/Mono County Agricultural Commissioners Office in Bishop. Further details of prior treatment of the sites or treatment since discovery can be found in the 2008 LORP Weed Report.

**Perennial pepperweed site north of Blackrock Ditch**

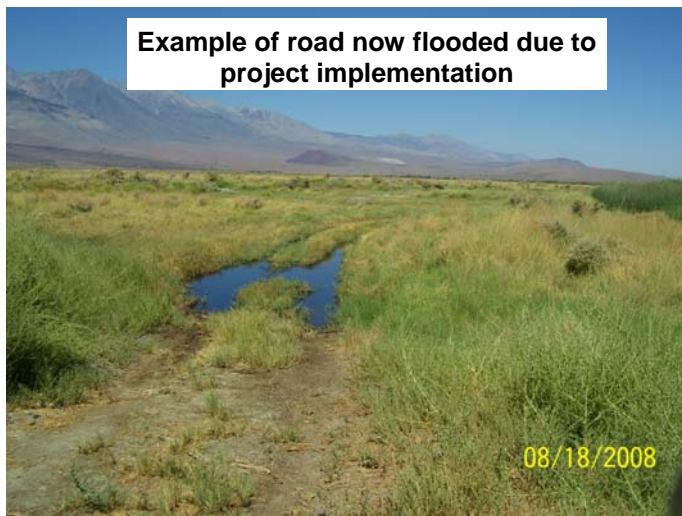
**Example of road now flooded due to project implementation**

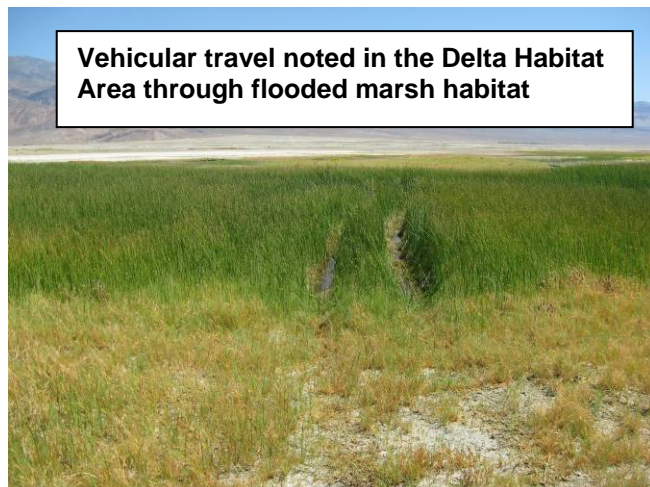
Roads were also noted in the BWMA and River Lakes and Ponds. In the BWMA, a few existing roads in the Thibaut and Winterton Units were also now flooded. At the south end of the Delta Habitat Area (DHA), ATV tracks were noted through wetland vegetation and across flooded playa (see photo below). The ATV tracks have been present at the south end of the DHA for some time, as workers on the lakebed have used ATVs to access monitoring sites. One observer noted vegetation impacts from travel through flooded marsh habitat, while a second observer noted that tracks through the area appeared more extensive and widespread than in previous years (i.e. not confined to previously-used travel routes).

**Vehicular travel noted in the Delta Habitat Area through flooded marsh habitat**
