**COUNTY OF INYO
WATER DEPARTMENT**

December 26, 2013

SUBJECT: Groundwater Conditions in West Bishop

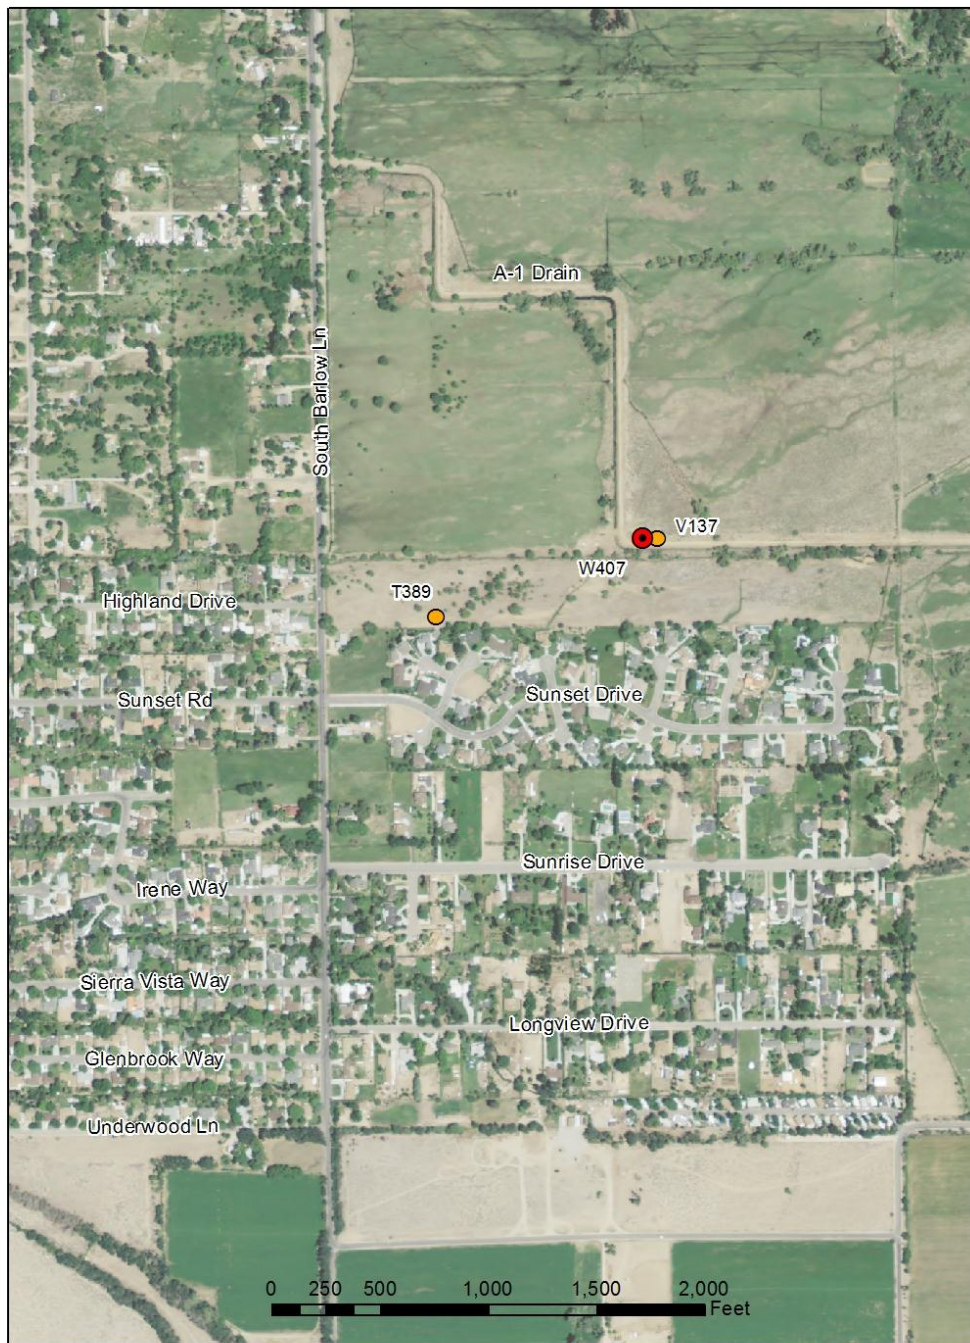
Well W407 is a LADWP production well located north of Sunset Drive and east of Barlow Lane and is within a few thousand feet of Highland Drive (Figure 1). W407 pumps into A-1 Drain and typically runs from April through September (approximately 180 days) to supply irrigation and stock water to LADWP leases and use permit holders in the south Bishop area. W407 was installed in February 1998 and an aquifer test was done in February 1998. W407 replaced W137, which was installed in 1931. The capacity of W407 is about 2.8 cubic feet per second (cfs), and the amount of water pumped annually from W407 has generally been higher than pumpage from V137 (Figure 2). During years of high runoff, less water is pumped due to the availability of surface water to supply uses on the Bishop Cone (e.g., Figure 2; 1983, 1986, 2005, and 2006). After W407 was installed, V137 was converted to a monitoring well.

Figure 1. Highland Drive/Well W407 area.
