# Surface Flow- Transducer RV 112- Davis Ranch South Flow

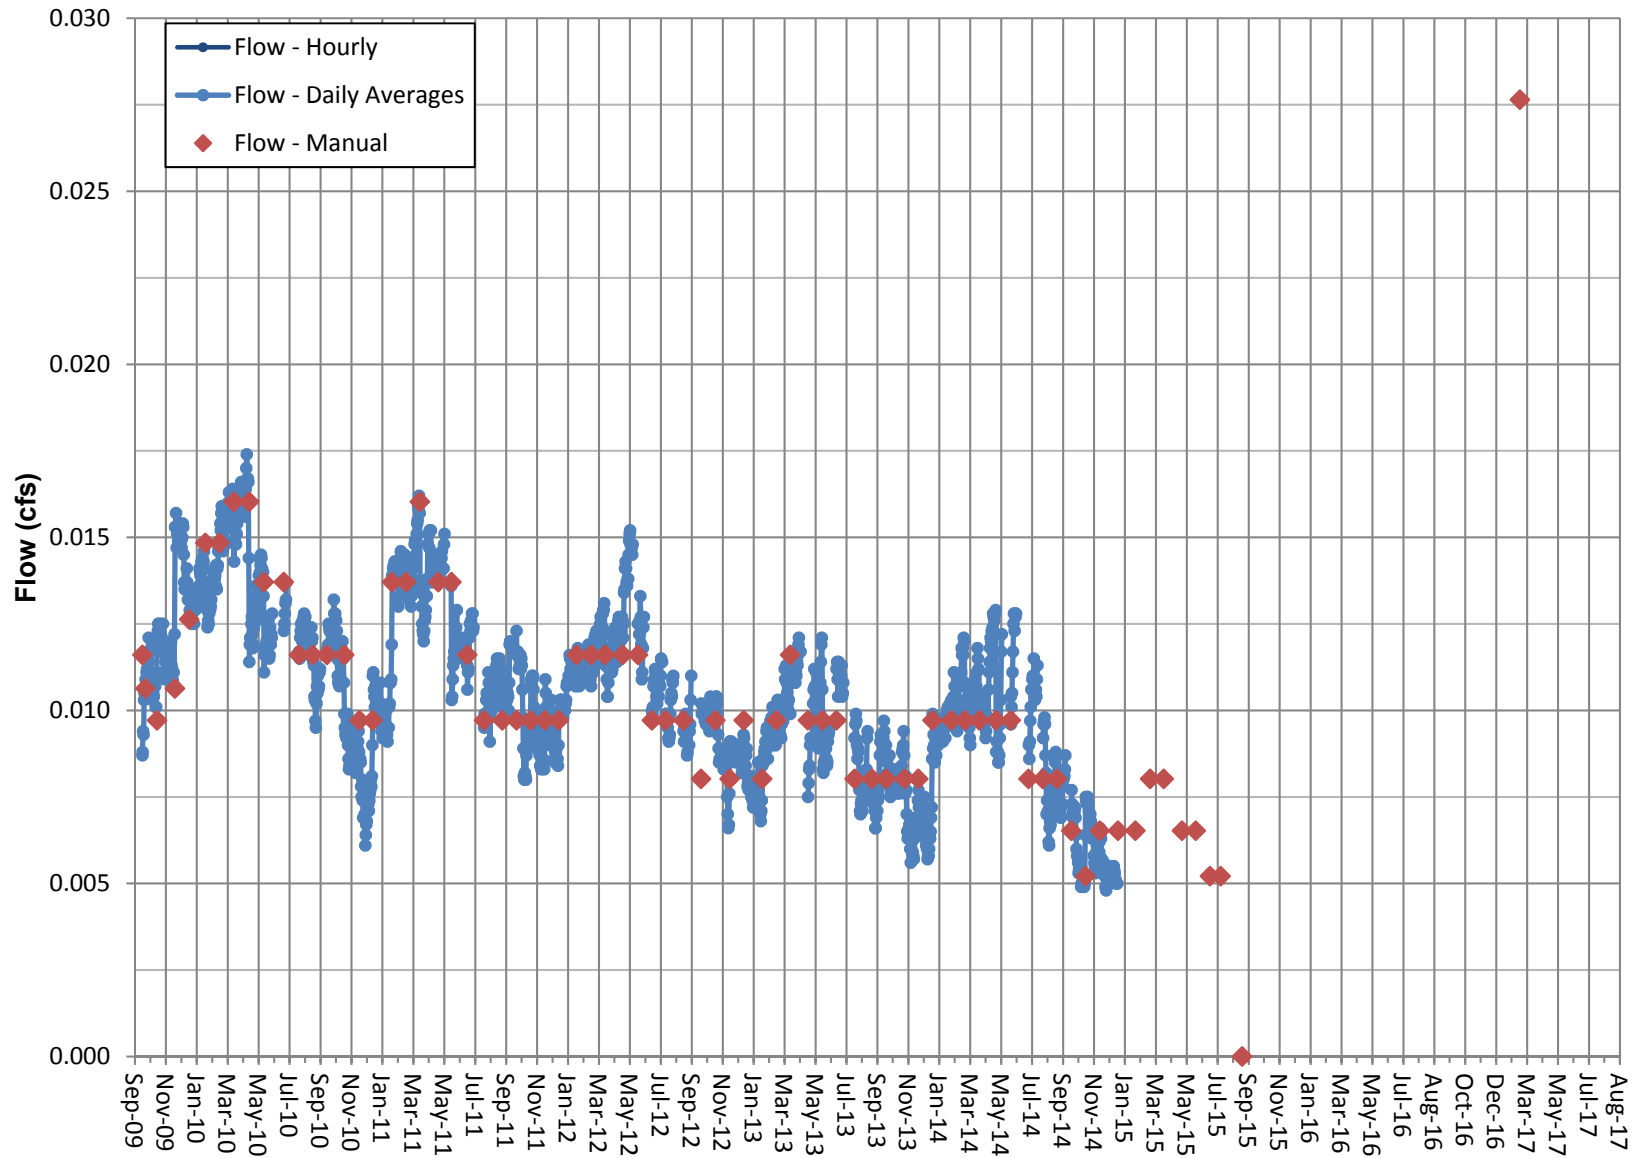
Note: Transducer removed in 2015, water supply pump was installed in DR South Well in July 2015.  
Pumped water can now bypass flume, flow not monitored as of Sept. 2015.

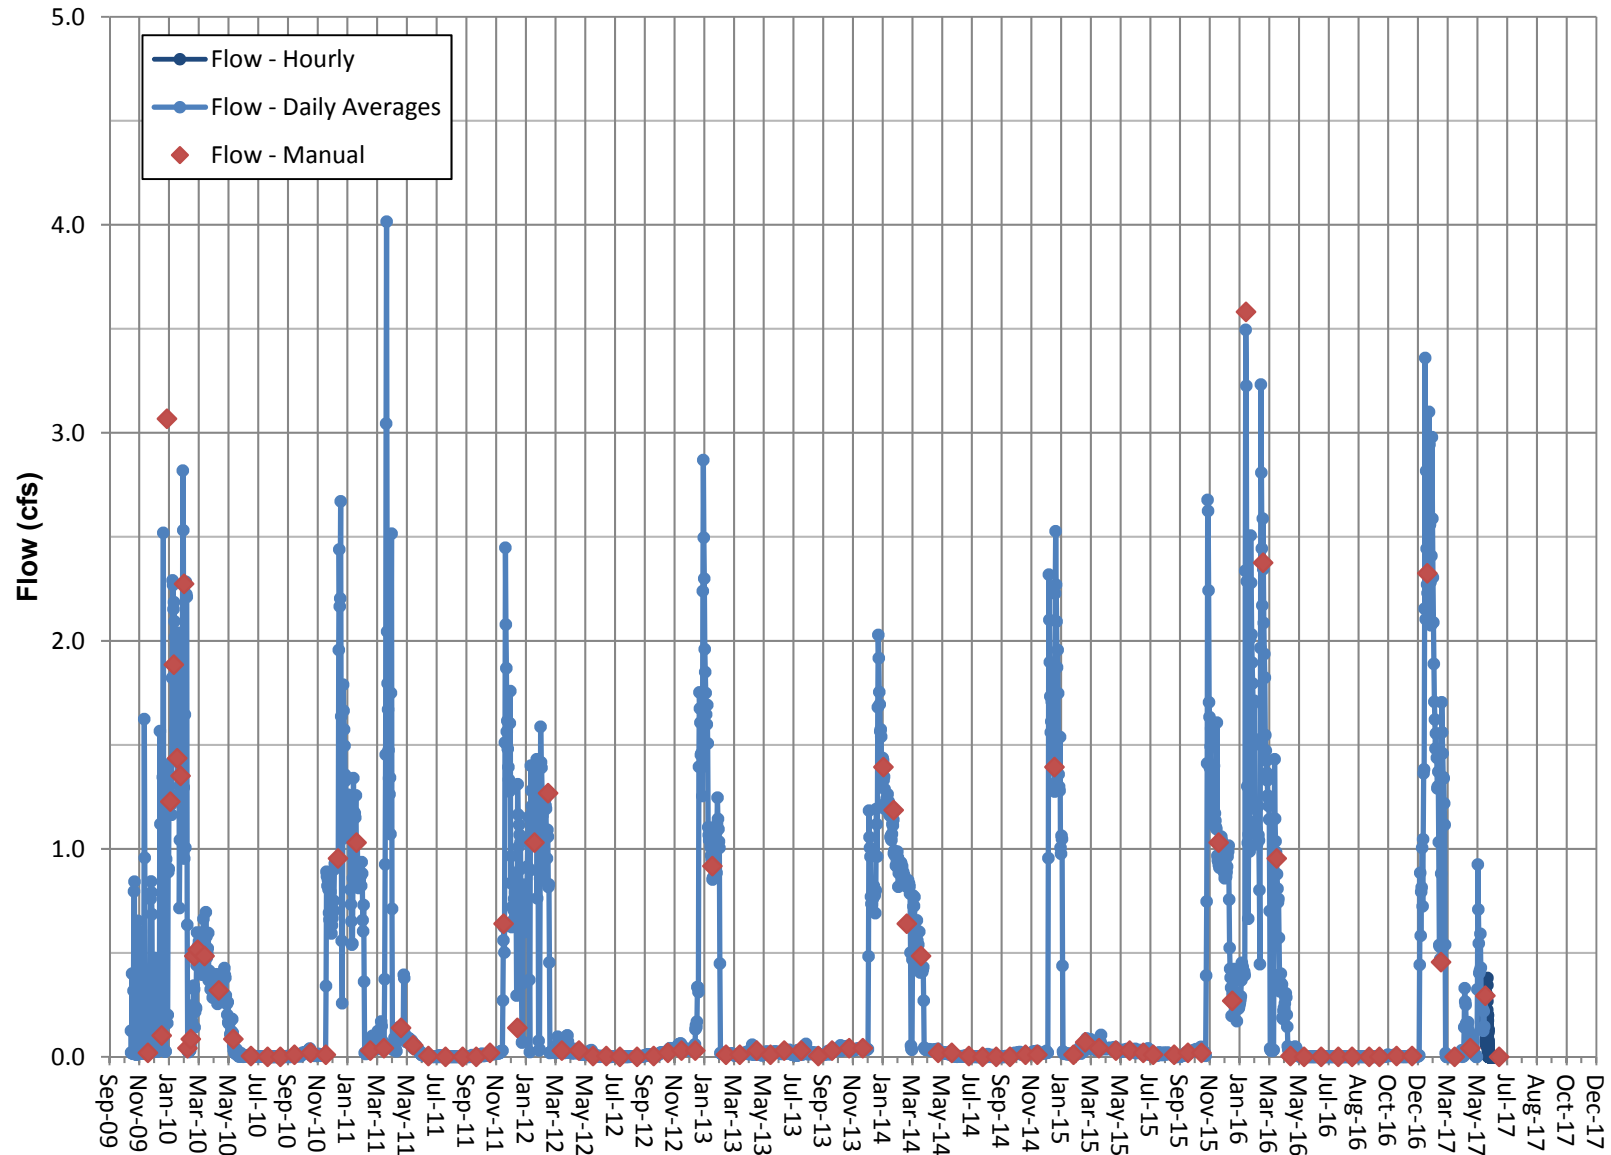
## Surface Flow- Transducer RV 230- Little Lake Outflow

Note: Flows through Little Lake Outflow are influenced by natural and water management processes at Little Lake Ranch. Coso Operating Co. initiated Hay Ranch Project pumping on 12/25/09.

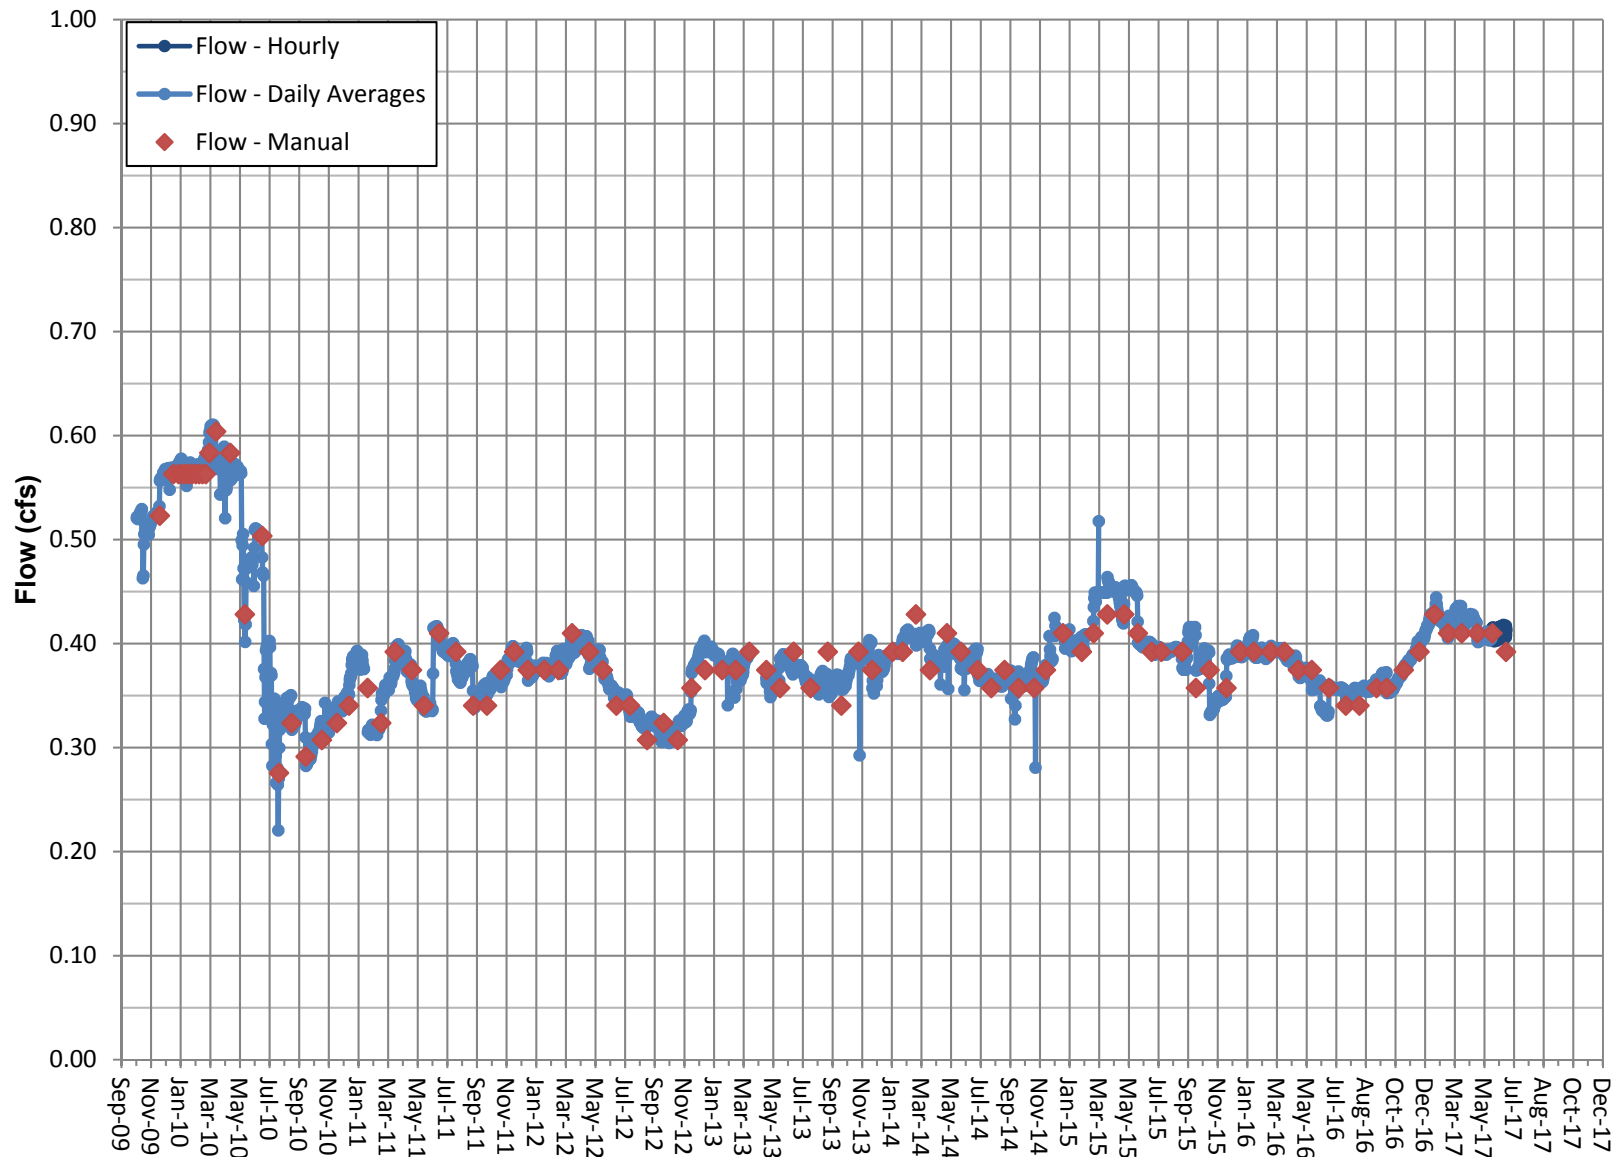
# Surface Flow- Transducer RV 240- Coso Springs

Note: Coso Springs is an artesian spring.

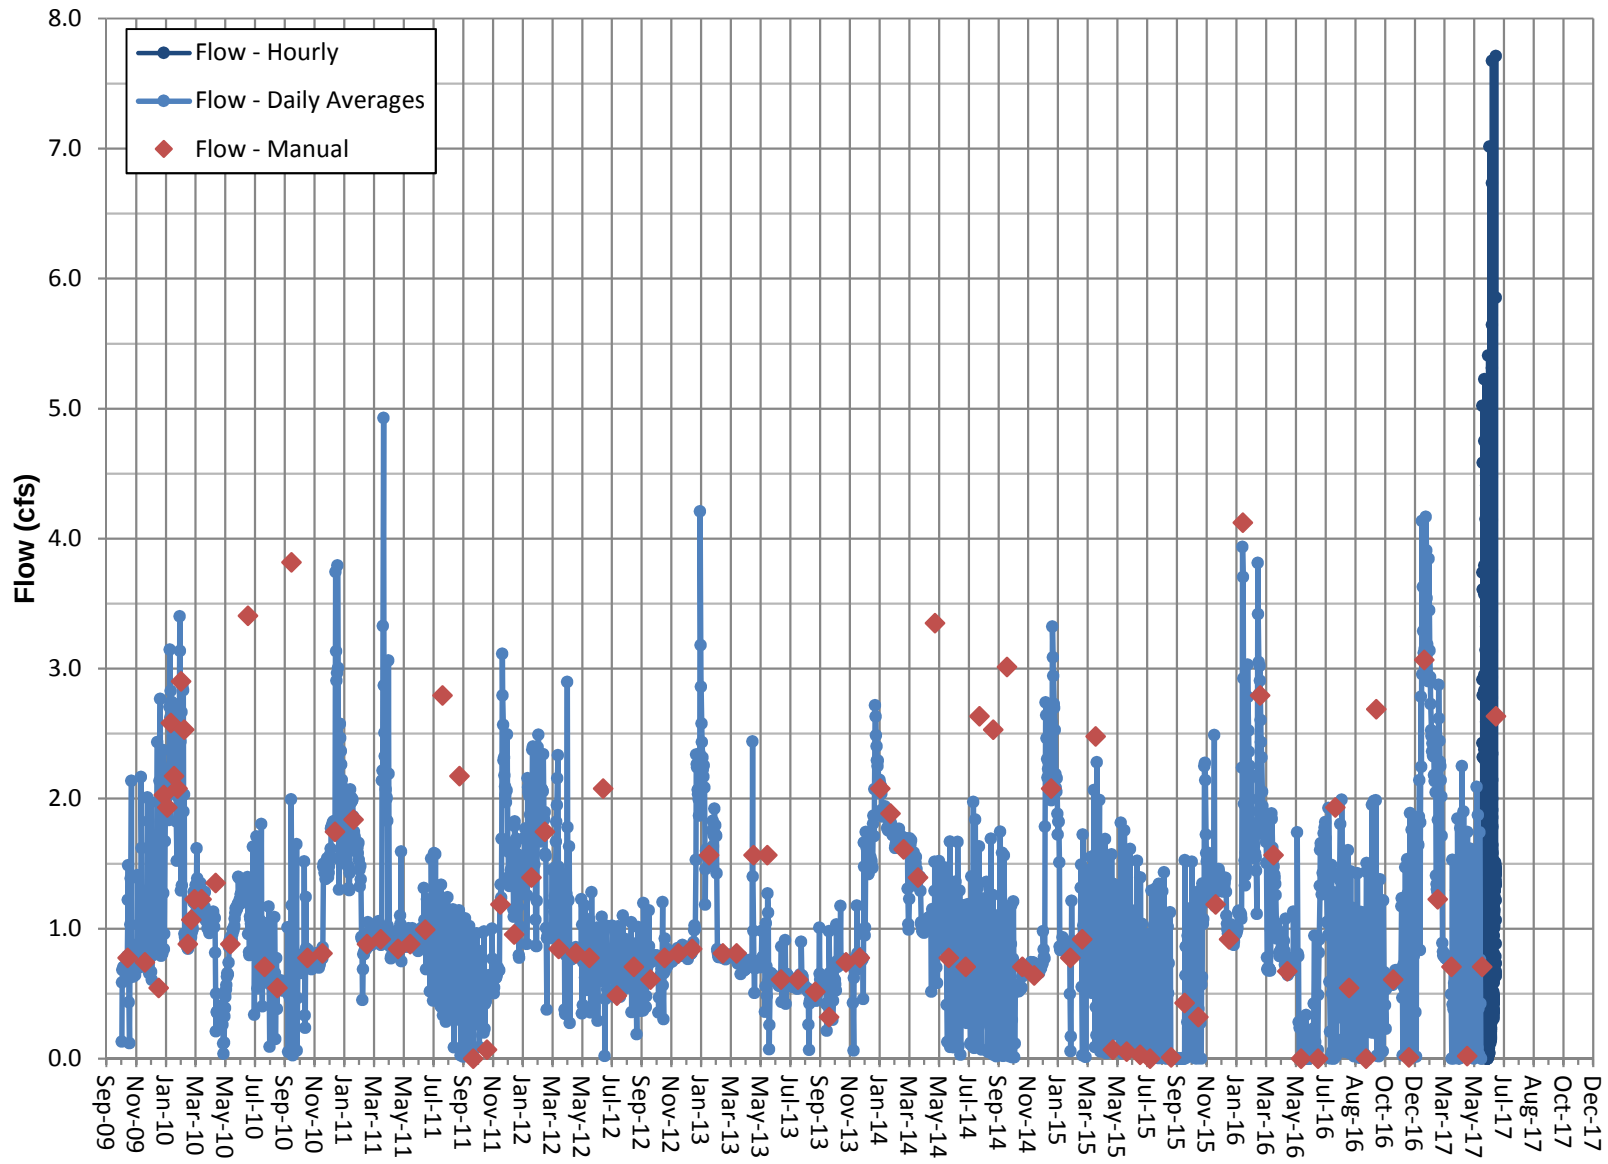
# Surface Flow- Transducer RV 245- North Culvert

Note: Flows through North Culvert are influenced by natural and water management processes at Little Lake Ranch. Coso Operating Co. initiated Hay Ranch Project pumping on 12/25/09.
