**HAY RANCH PROJECT CONDITIONAL USE PERMIT  
HYDROLOGIC MONITORING REPORT**

**SECOND QUARTER 2018  
INYO COUNTY, CALIFORNIA**

**RE: Hay Ranch Project Conditional Use Permit  
Hydrologic Monitoring Report, Second Quarter 2018  
Inyo County, California**

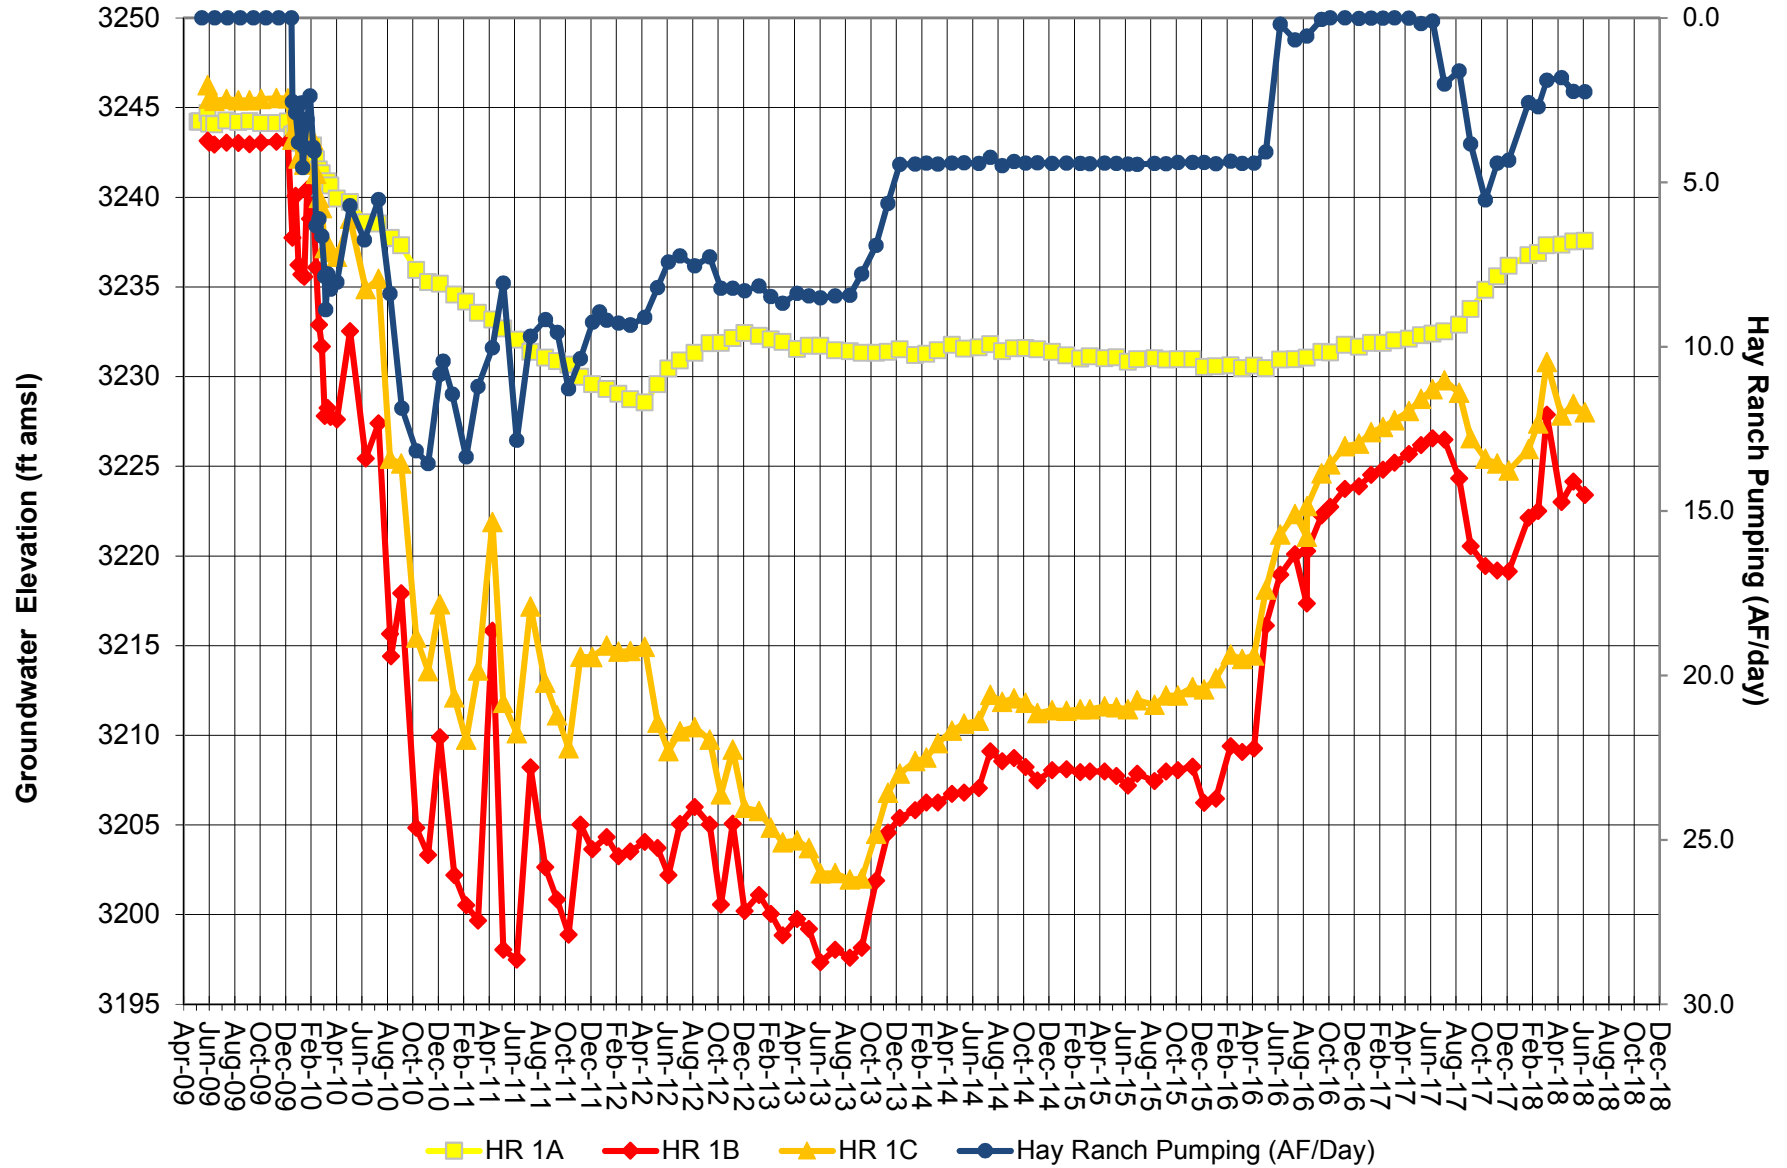
Note: GWE data based on manual DTW measurements. Hay Ranch pumping is average acre feet per day.  
 Screened intervals: HR 1A 170-260 feet; HR 1B 490-540 feet; HR 1C 340-405 feet.  
 Coso Operating initiated Hay Ranch Project pumping on 12/25/09.

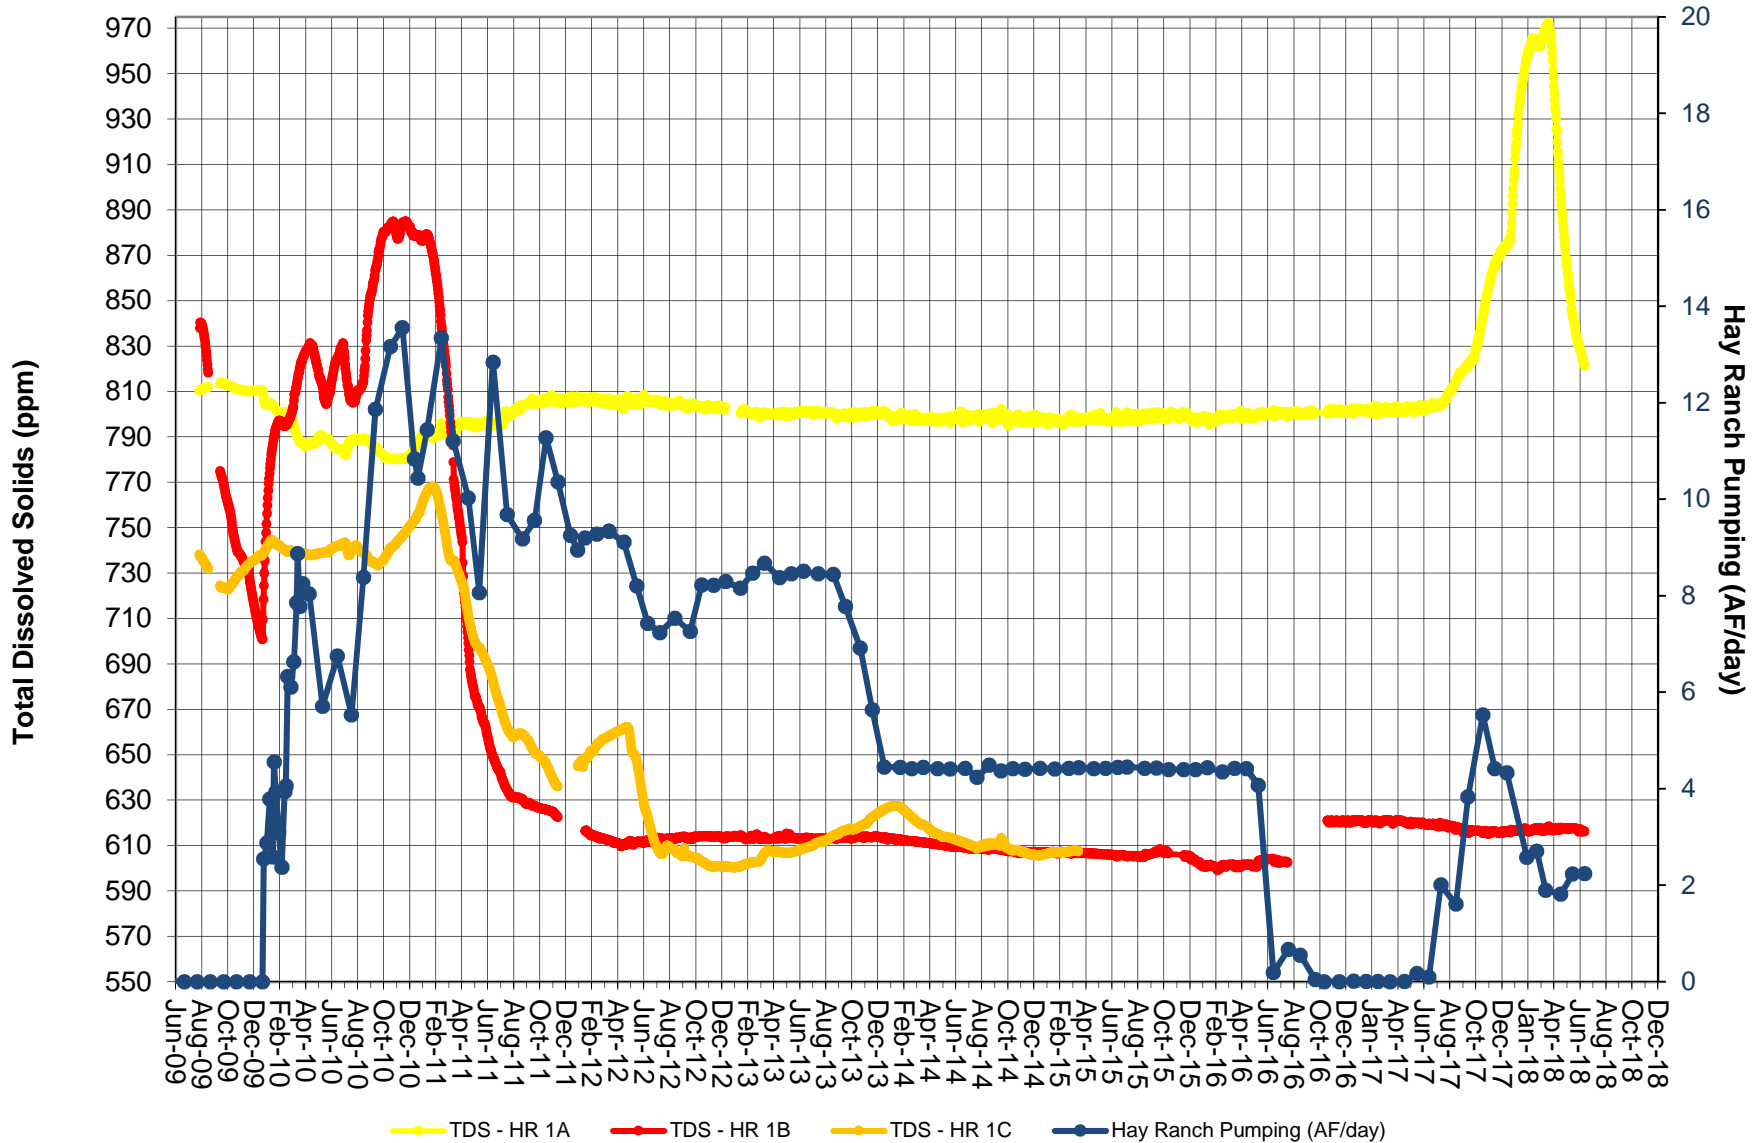
Note:  
 Screened intervals: HR 1A 170-260 feet; HR 1B 490-540 feet; HR 1C 340-405 feet.  
 HR 1A, 1B and 1C data gaps due to transducer malfunction or adjustment.  
 PT removed from HR1C in March 2015.

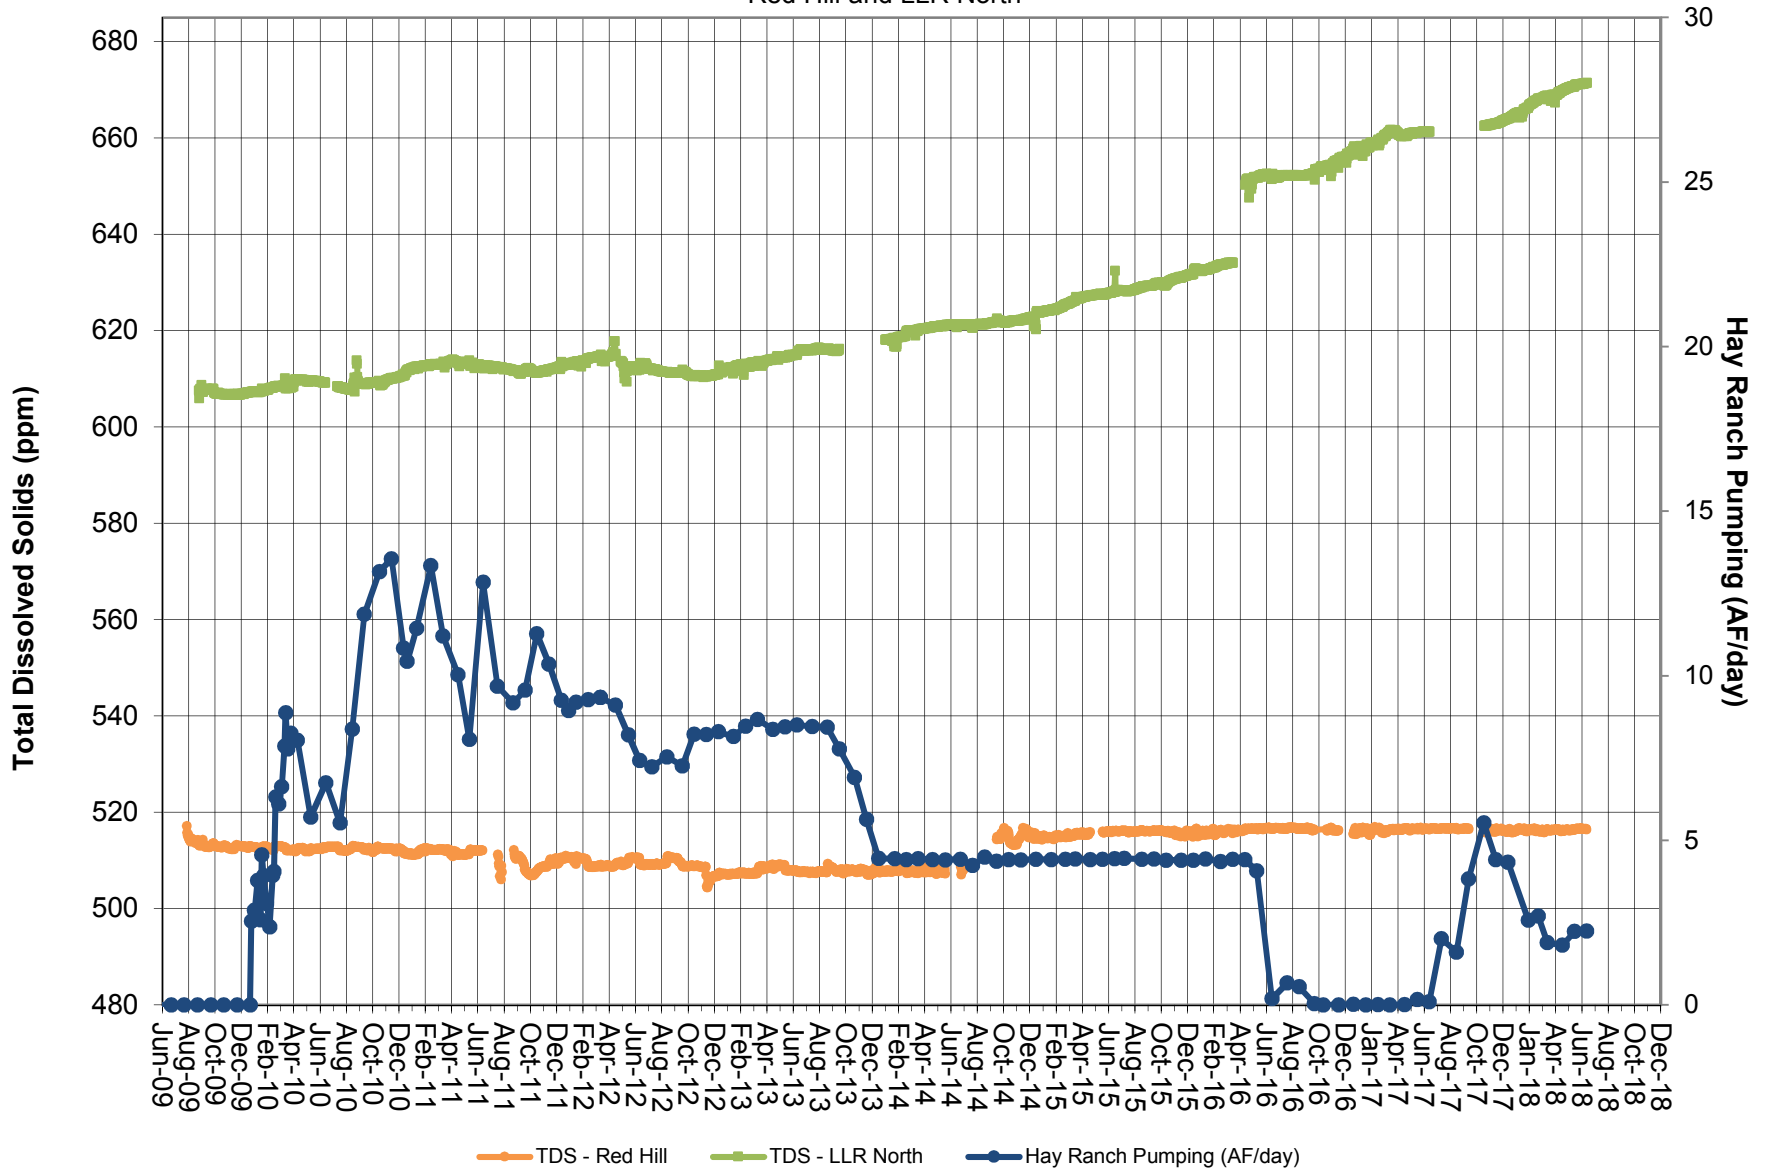
Note: TDS data from in-well transducers. Hay Ranch pumping is average acre feet per day.  
 Coso Operating initiated Hay Ranch Project pumping on 12/25/09.  
 Red Hill and LLR North data gaps due to transducer malfunction.
