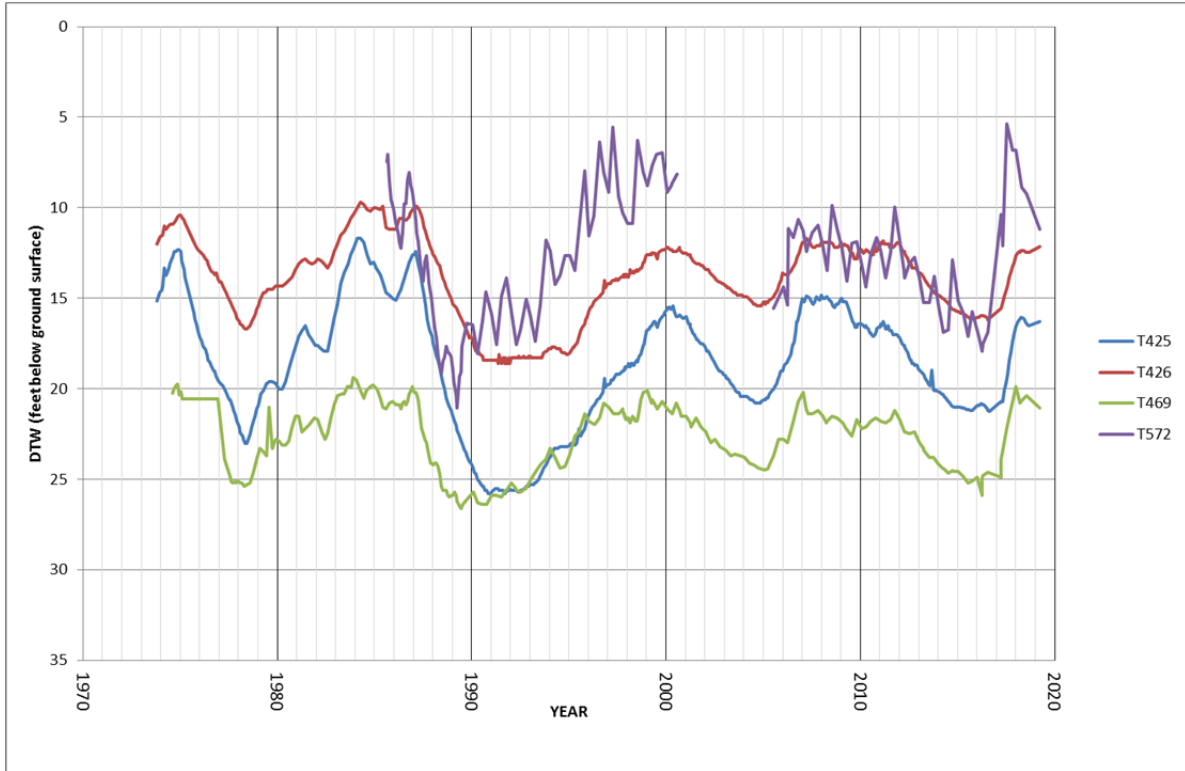
Figure 3.15. Hydrographs of indicator wells in the Big Pine wellfield. Periods of missing data for T572 occurred when the well was plugged and in need of repair.

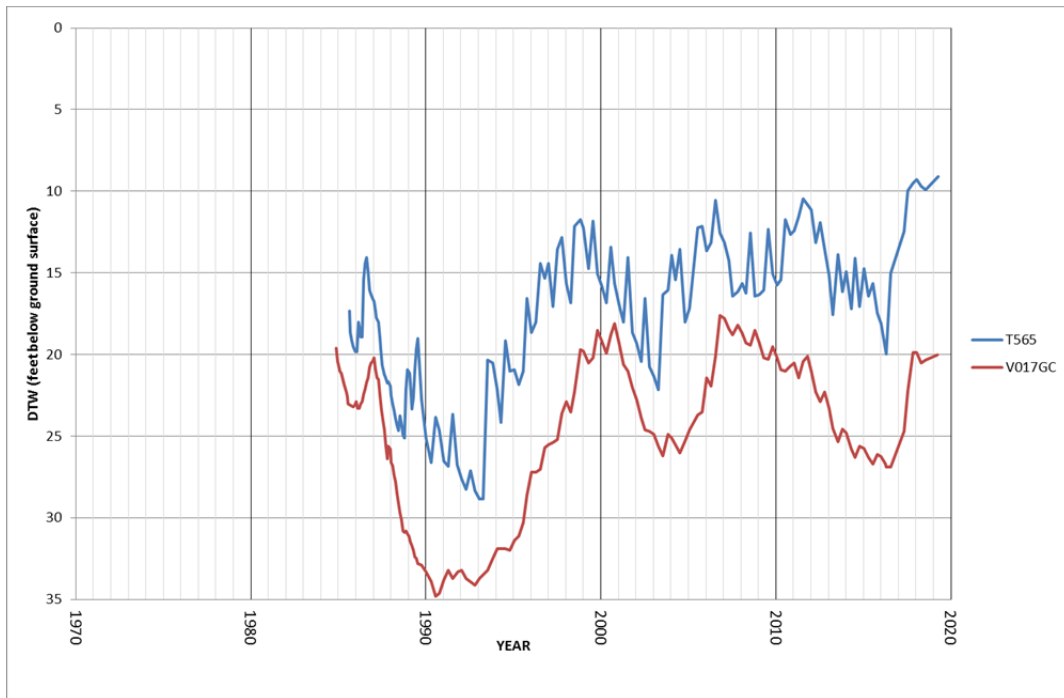
Figure 3.16. Hydrographs of monitoring wells in the southern Big Pine wellfield near pumping wells W218 and W219.
