RE: SUMMARY OF HYDROLOGIC MONITORING ACTIVITIES, FEBRUARY 2022

Rose Valley, Inyo County, California Hay Ranch Project Conditional Use Permit #2007-03

This letter summarizes hydrologic monitoring activities conducted in February 2022 by TEAM Environmental (TEAM), related to the Hay Ranch Water Extraction Project and CUP #2007-03.

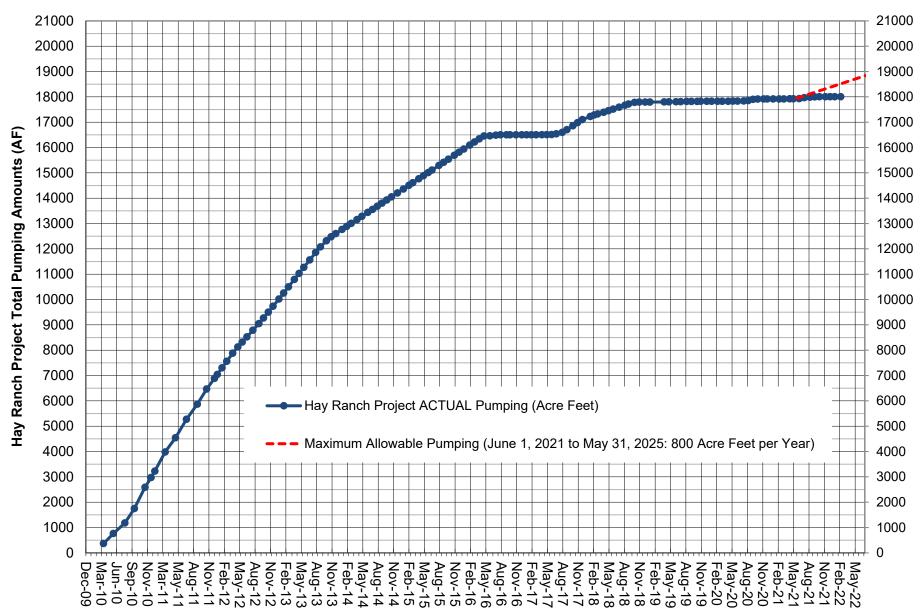
FIGURE 1 ACTUAL AND MAXIMUM ALLOWABLE PUMPING AMOUNTS (TOTALS) FOR HAY RANCH PROJECT

Figure 1 presents the combined amount of groundwater pumped from the Hay Ranch North and South wells, in acre-feet, from December 25, 2009 through January 12, 2022 compared to the current maximum allowable pumping amount. The total amount of groundwater extracted from the Hay Ranch property from December 25, 2009 to February 16, 2022 (Hay Ranch CUP project total) is approximately 18,006 AF.

Coso Operating Company has pumped less than the maximum allowable amounts throughout the project.
