# HAY RANCH PROJECT CONDITIONAL USE PERMIT HYDROLOGIC MONITORING AND REPORTING FIRST QUARTER 2013 INYO COUNTY, CALIFORNIA

RE: Hay Ranch Project Conditional Use Permit Hydrologic Monitoring and Reporting First Quarter Report 2013 Inyo County, California

TEAM Engineering & Management, Inc. (TEAM), is pleased to present the results of hydrologic monitoring activities in Rose Valley relating to the Hay Ranch Project Conditional Use Permit (#2007-003) conducted from January through March 2013.

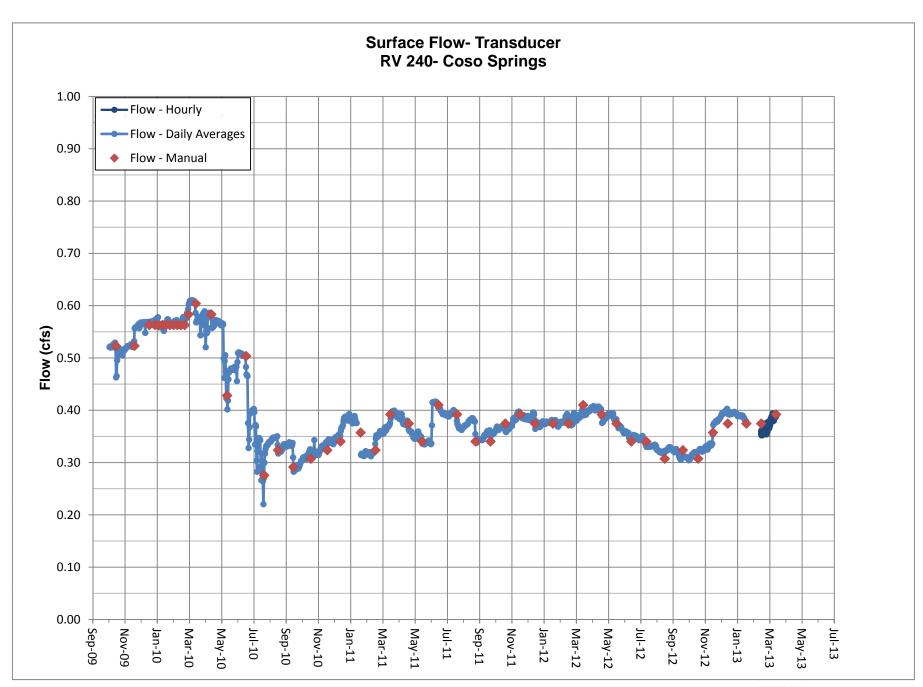
Note: Coso Springs is an artesian spring.
