**HAY RANCH PROJECT CONDITIONAL USE PERMIT  
HYDROLOGIC MONITORING AND REPORTING  
SECOND QUARTER 2014  
INYO COUNTY, CALIFORNIA**

**RE: Hay Ranch Project Conditional Use Permit  
Hydrologic Monitoring and Reporting  
Second Quarter Report 2014  
Inyo County, California**

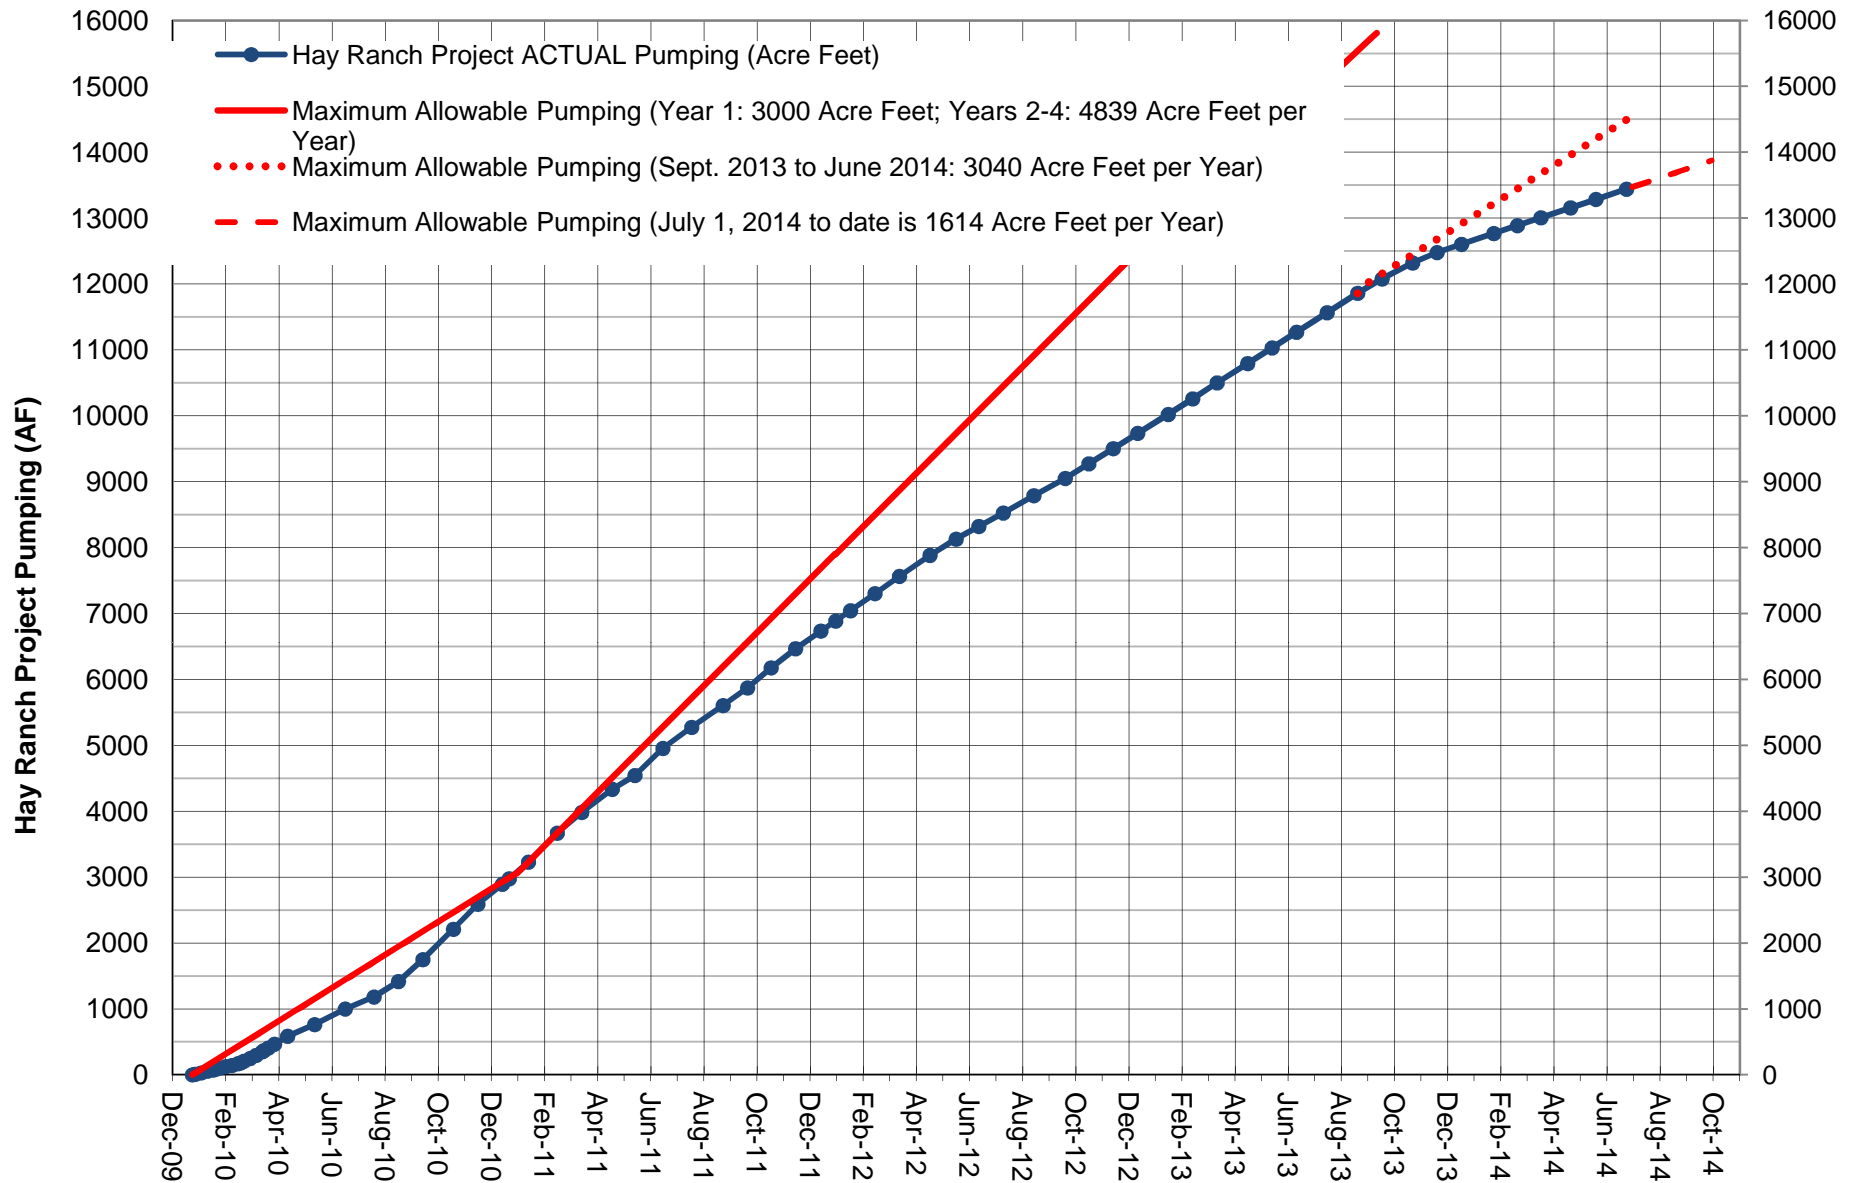
**FIGURE 17**  
ACTUAL AND MAXIMUM ALLOWABLE PUMPING FOR HAY RANCH PROJECT

Note: Coso Operating Co. initiated Hay Ranch Project pumping on 12/25/09.
