**HAY RANCH PROJECT CONDITIONAL USE PERMIT  
HYDROLOGIC MONITORING AND REPORTING  
THIRD QUARTER 2013  
INYO COUNTY, CALIFORNIA**

**RE: Hay Ranch Project Conditional Use Permit  
Hydrologic Monitoring and Reporting  
Third Quarter Report 2013  
Inyo County, California**

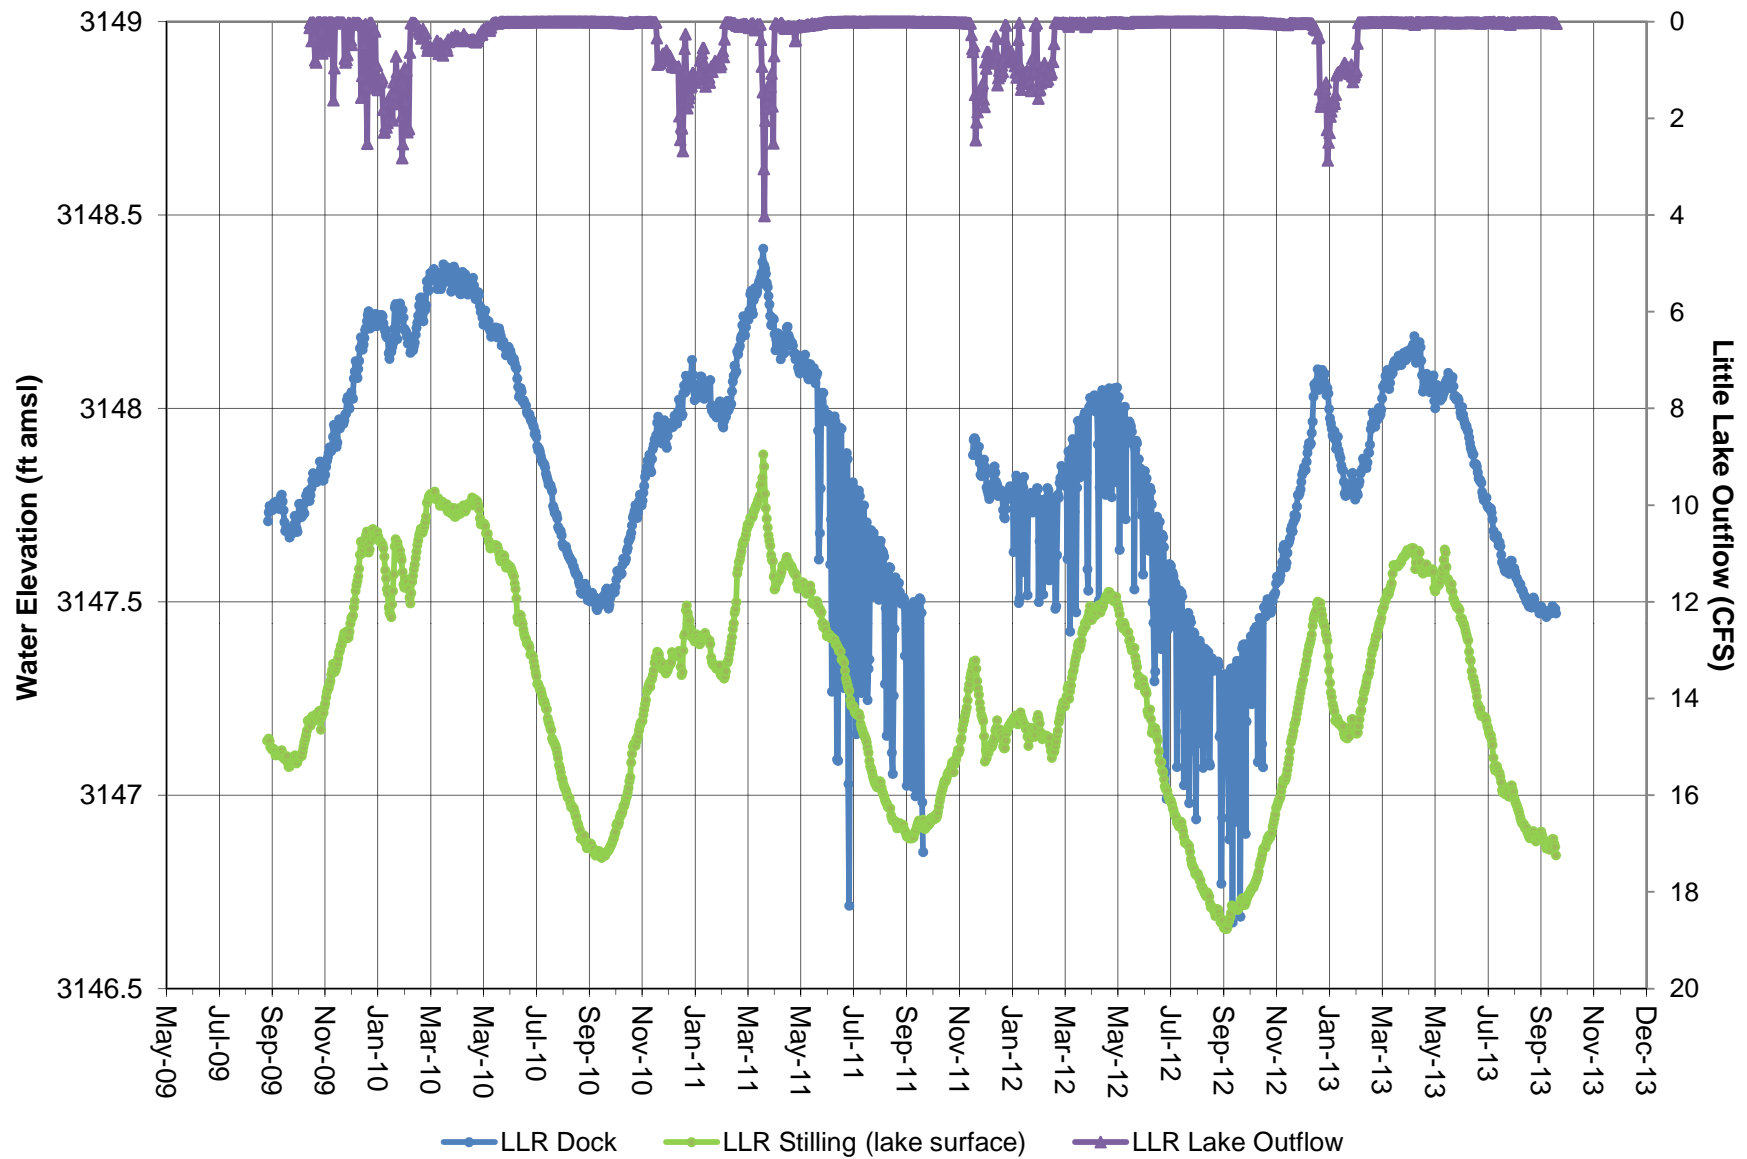
Note: Little Lake Outflow in cubic feet per second. Fall 2011 data gap in Dock well due to pressure transducer malfunction. LLR staff conducted water management at Dock Well (intermittent pumping) from 2011 to date.
