**HAY RANCH PROJECT CONDITIONAL USE PERMIT
HYDROLOGIC MONITORING AND REPORTING
FOURTH QUARTER 2013
INYO COUNTY, CALIFORNIA**

**RE: Hay Ranch Project Conditional Use Permit
Hydrologic Monitoring and Reporting
Fourth Quarter Report 2013
Inyo County, California**

TEAM Engineering & Management, Inc. (TEAM), is pleased to present the results of hydrologic monitoring activities in Rose Valley relating to the Hay Ranch Project Conditional Use Permit (#2007-003) conducted from October through December 2013.

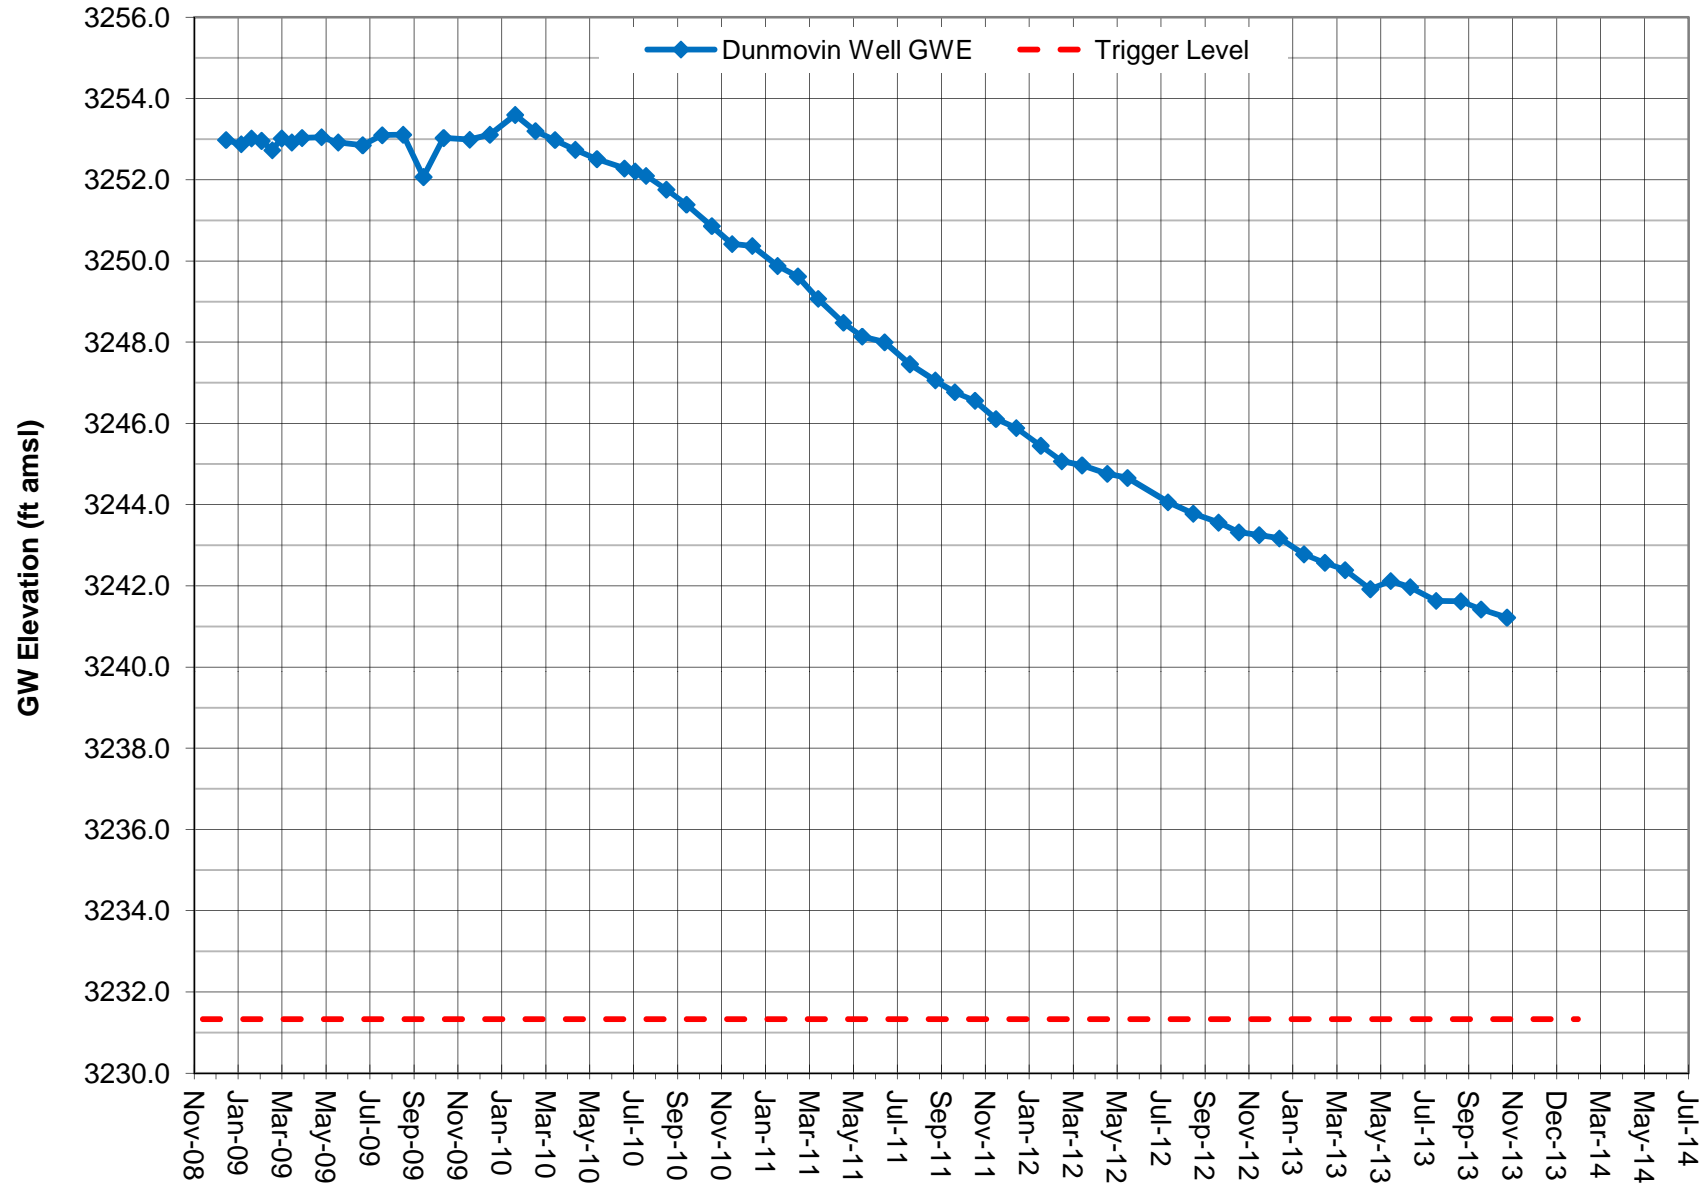
Note: Groundwater elevation data based on manual depth-to-water measurements. Lines between data points are approximations.
 Dunmovin Well is an active domestic supply well.
 Coso Operating Co. initiated Hay Ranch Project pumping on 12/25/09.

In October, a new groundwater pump was installed at a greater depth in the Dunmovin Well. The existing pump failed in mid October due to mechanical issues likely related to old age or corrosion. COC paid for this pump replacement.
