RE: Summary of Hydrologic Monitoring Activities November 2014

Rose Valley, Inyo County, California Hay Ranch Project Conditional Use Permit #2007-03

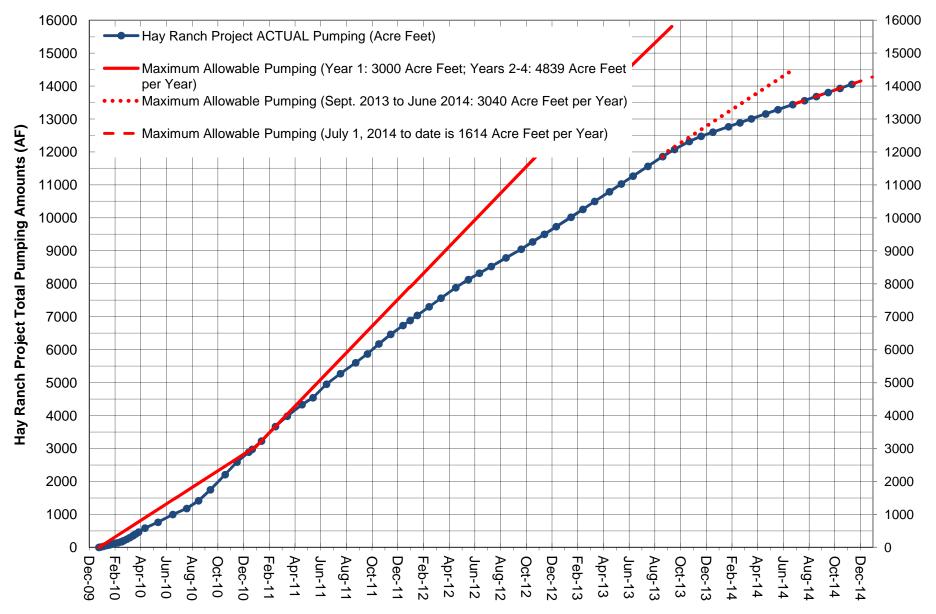
FIGURE 1
ACTUAL AND MAXIMUM ALLOWABLE PUMPING AMOUNTS (TOTALS) FOR HAY RANCH PROJECT

Figure 1 presents the combined amount of groundwater pumped from the Hay Ranch North and South wells, in acre feet, from December 25, 2009 through November 12, 2014 compared to the maximum

allowable pumping amount. The total amount of groundwater extracted from the Hay Ranch property from December 25, 2009 to November 12, 2014 (Hay Ranch CUP project total) is approximately 14053 AF. The maximum pumping rate was approximately 3,000 acre-feet per year (AFY) for December 25, 2009 through December 31, 2010; was 4,839 AFY from January 1, 2011 through August 30, 2013; was 3,040 AFY from September 2013 through June, 2014; and is 1,614 AFY from July 1, 2014 to date. Coso Operating Company has been and currently is pumping less than the maximum allowable amount of groundwater from the Hay Ranch Wells.
