# HAY RANCH PROJECT CONDITIONAL USE PERMIT HYDROLOGIC MONITORING REPORT

THIRD QUARTER 2017  
INYO COUNTY, CALIFORNIA

TEAM Engineering & Management, Inc. (TEAM), is pleased to present the results of hydrologic monitoring activities, relating to the Hay Ranch Project Conditional Use Permit (#2007-003), conducted in Rose Valley from July to September 2017.

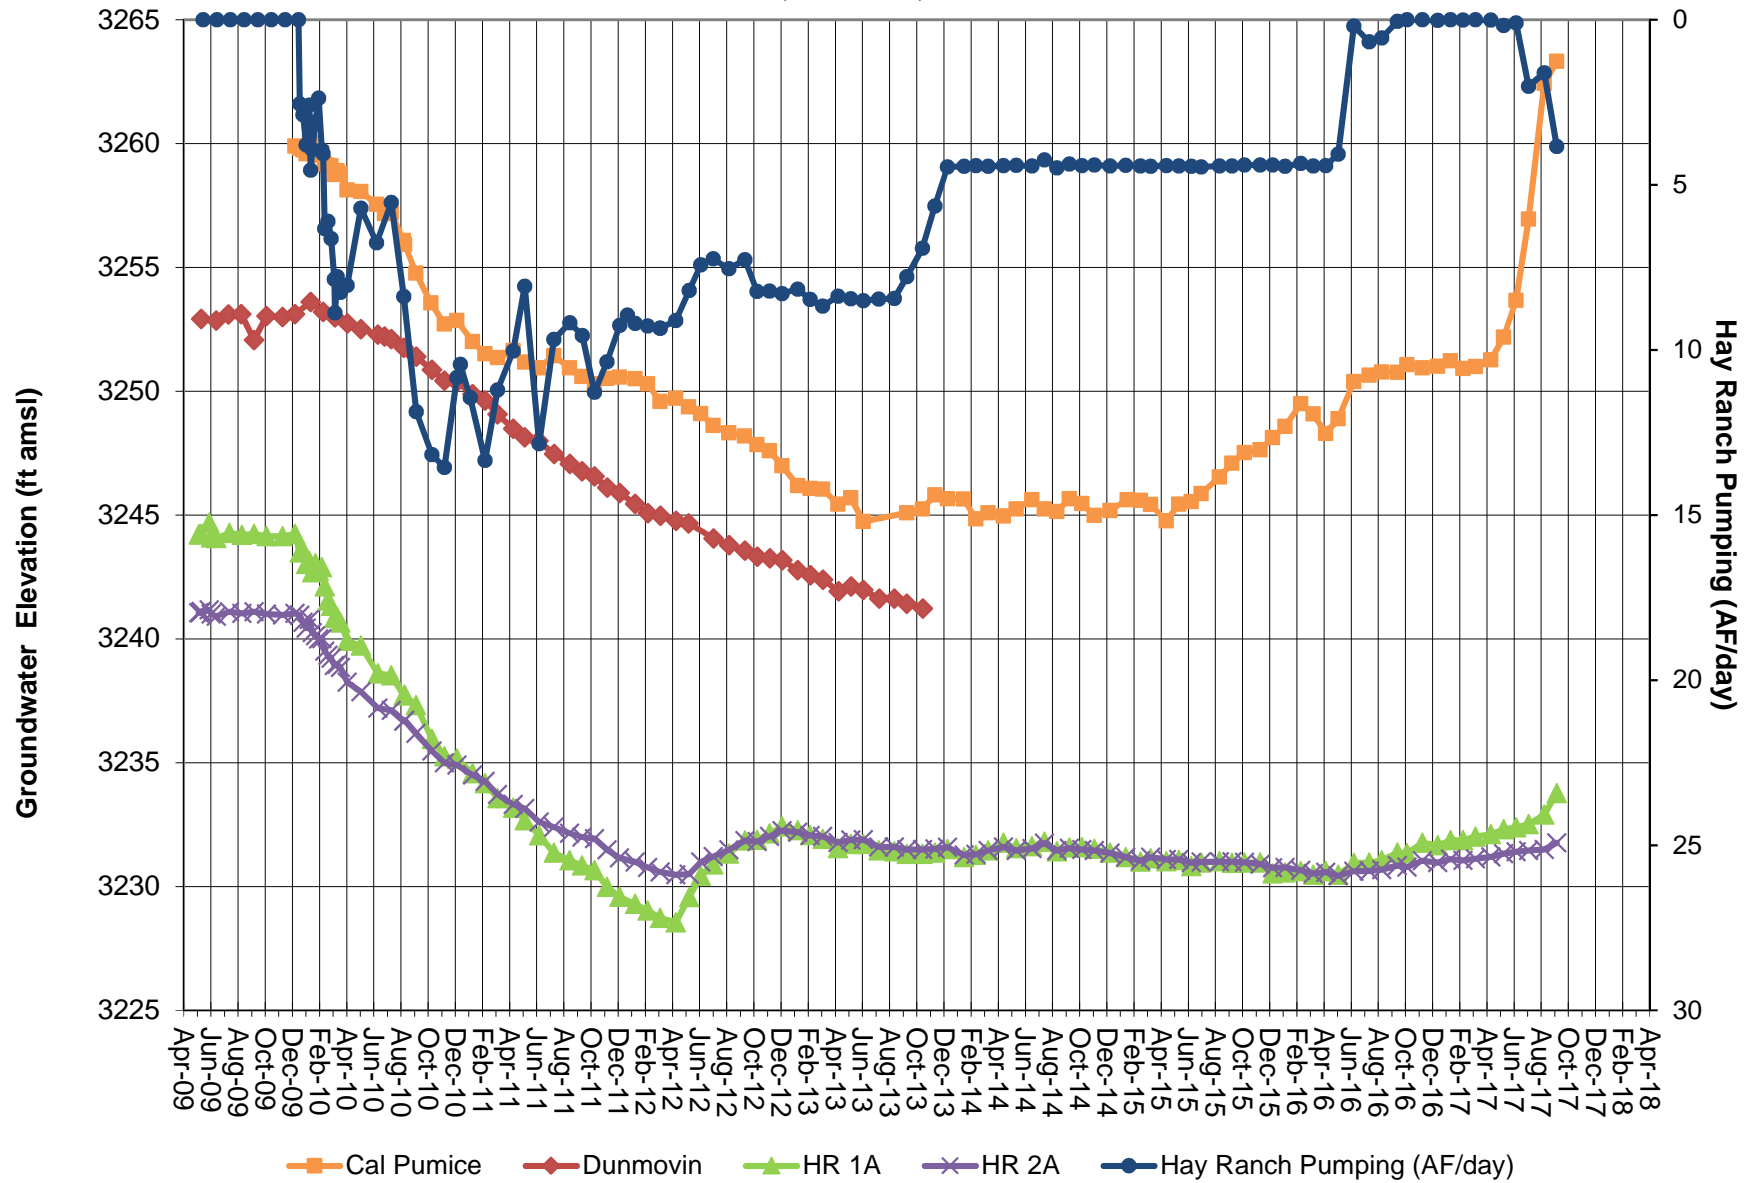
Note: Groundwater elevation data based on manual depth-to-water measurements.  
 Hay Ranch pumping is average acre feet per day.  
 Coso Operating initiated Hay Ranch Project pumping on 12/25/09.

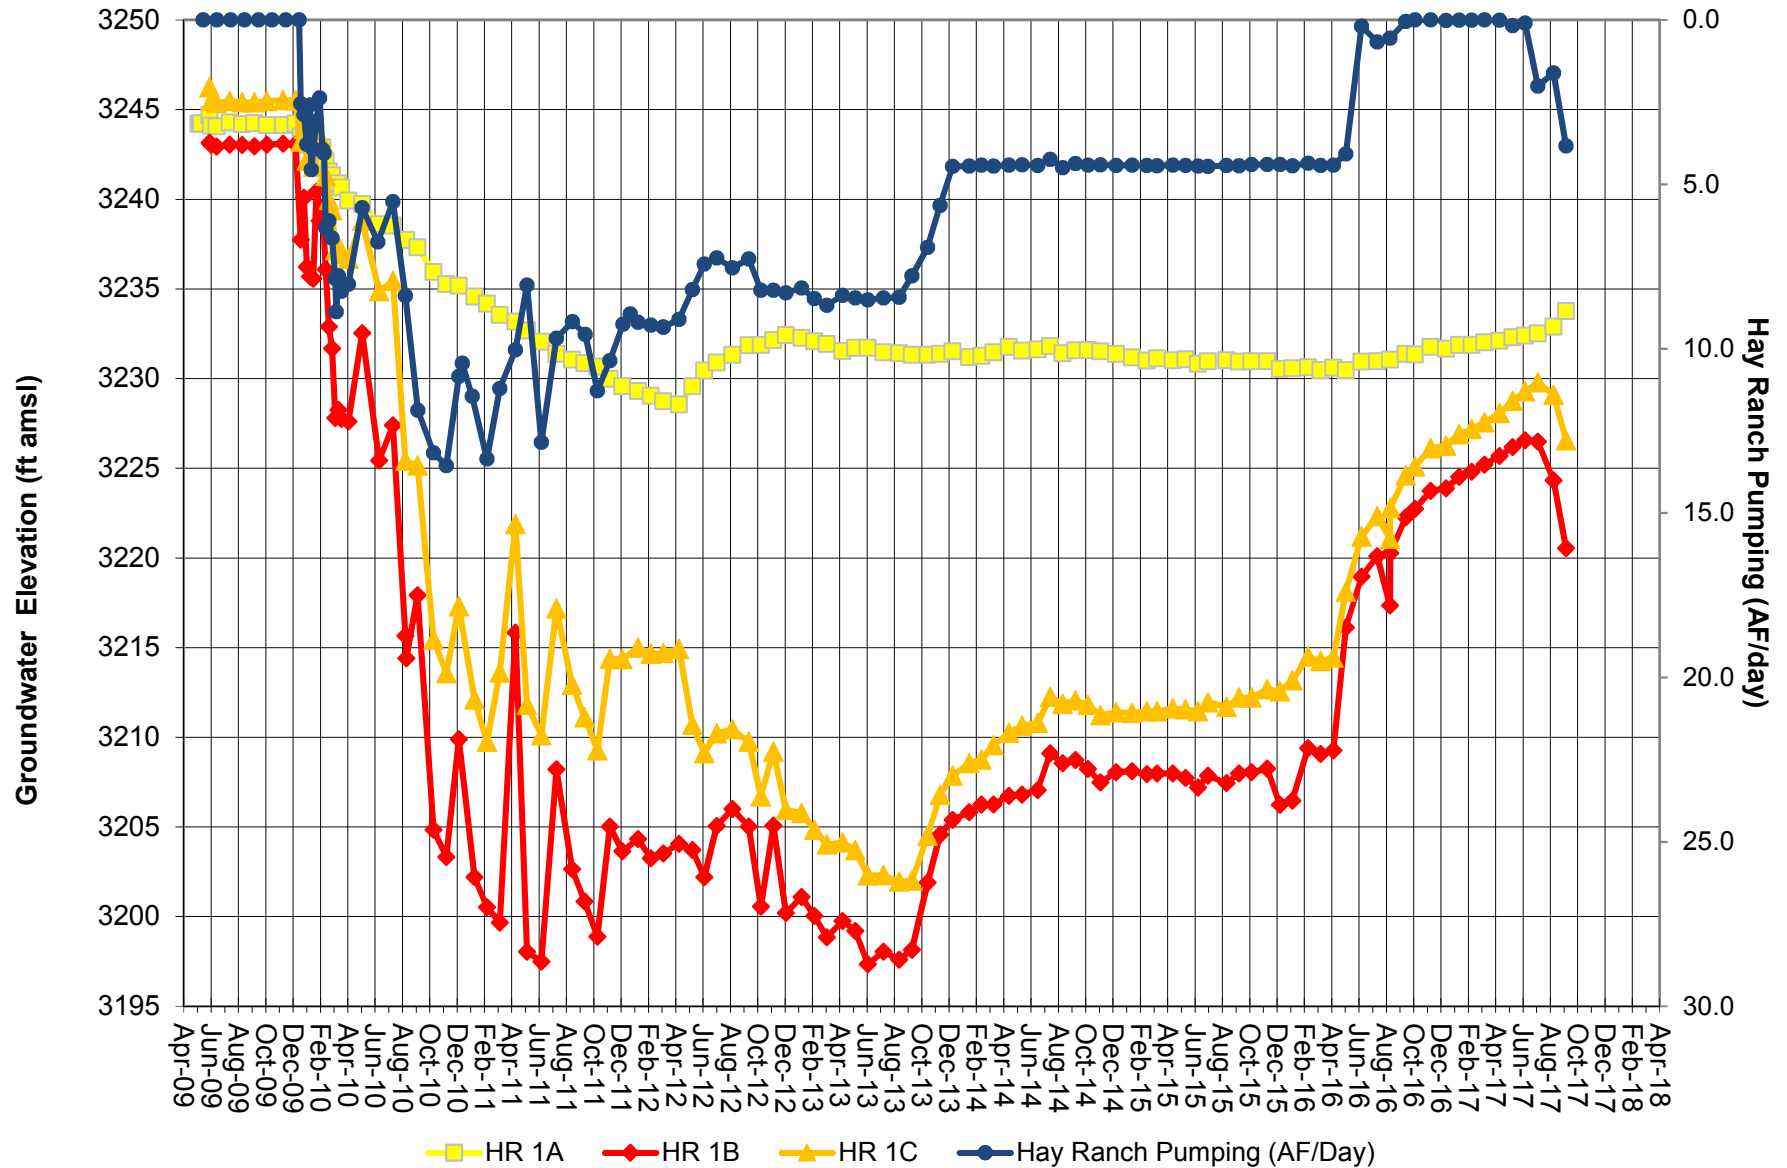
Note: GWE data based on manual DTW measurements. Hay Ranch pumping is average acre feet per day.  
Screened intervals: HR 1A 170-260 feet; HR 1B 490-540 feet; HR 1C 340-405 feet.  
Coso Operating initiated Hay Ranch Project pumping on 12/25/09.

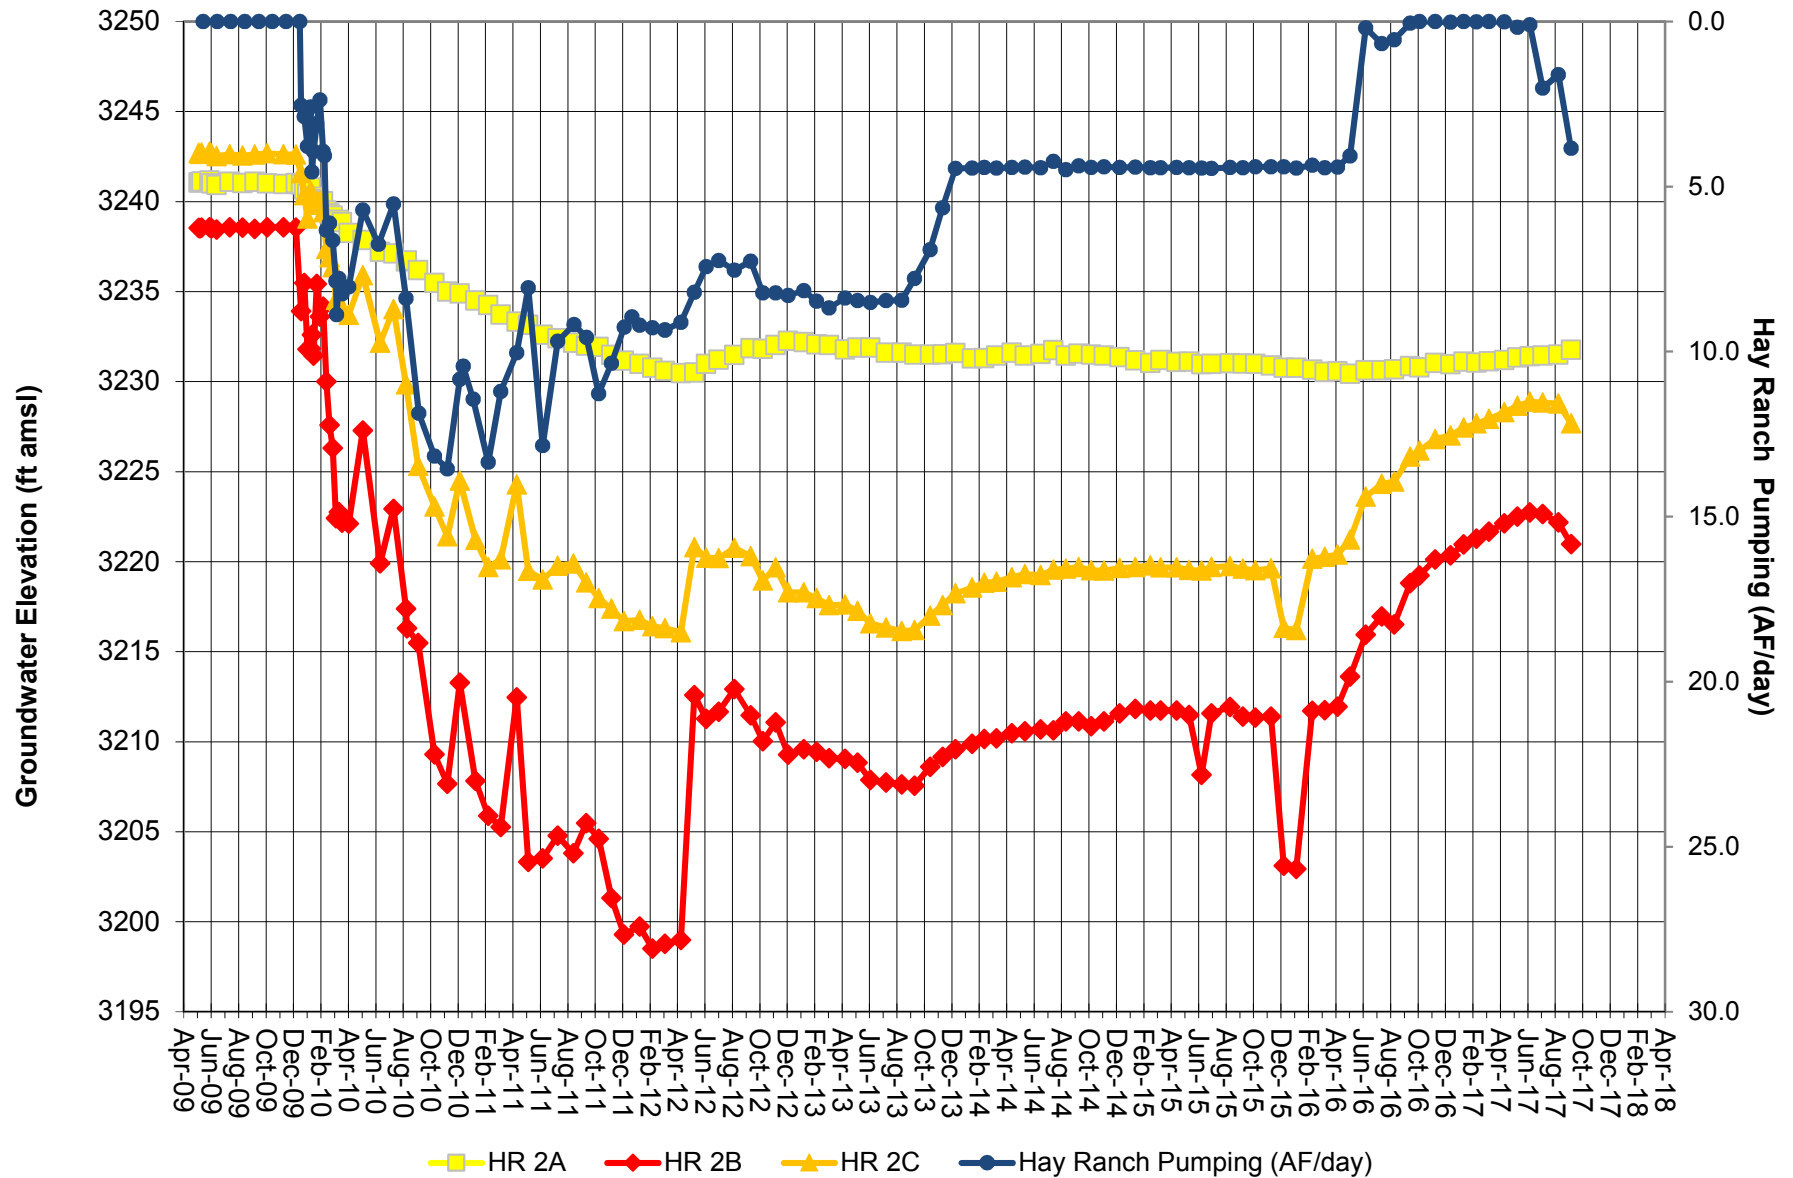
Note: GWE data based on manual DTW measurements. Hay Ranch pumping is average acre feet per day.  
Screened intervals: HR 2A 180-300 feet; HR 2B 519-584 feet; HR 2C 370-420 feet.  
Coso Operating initiated Hay Ranch Project pumping on 12/25/09.

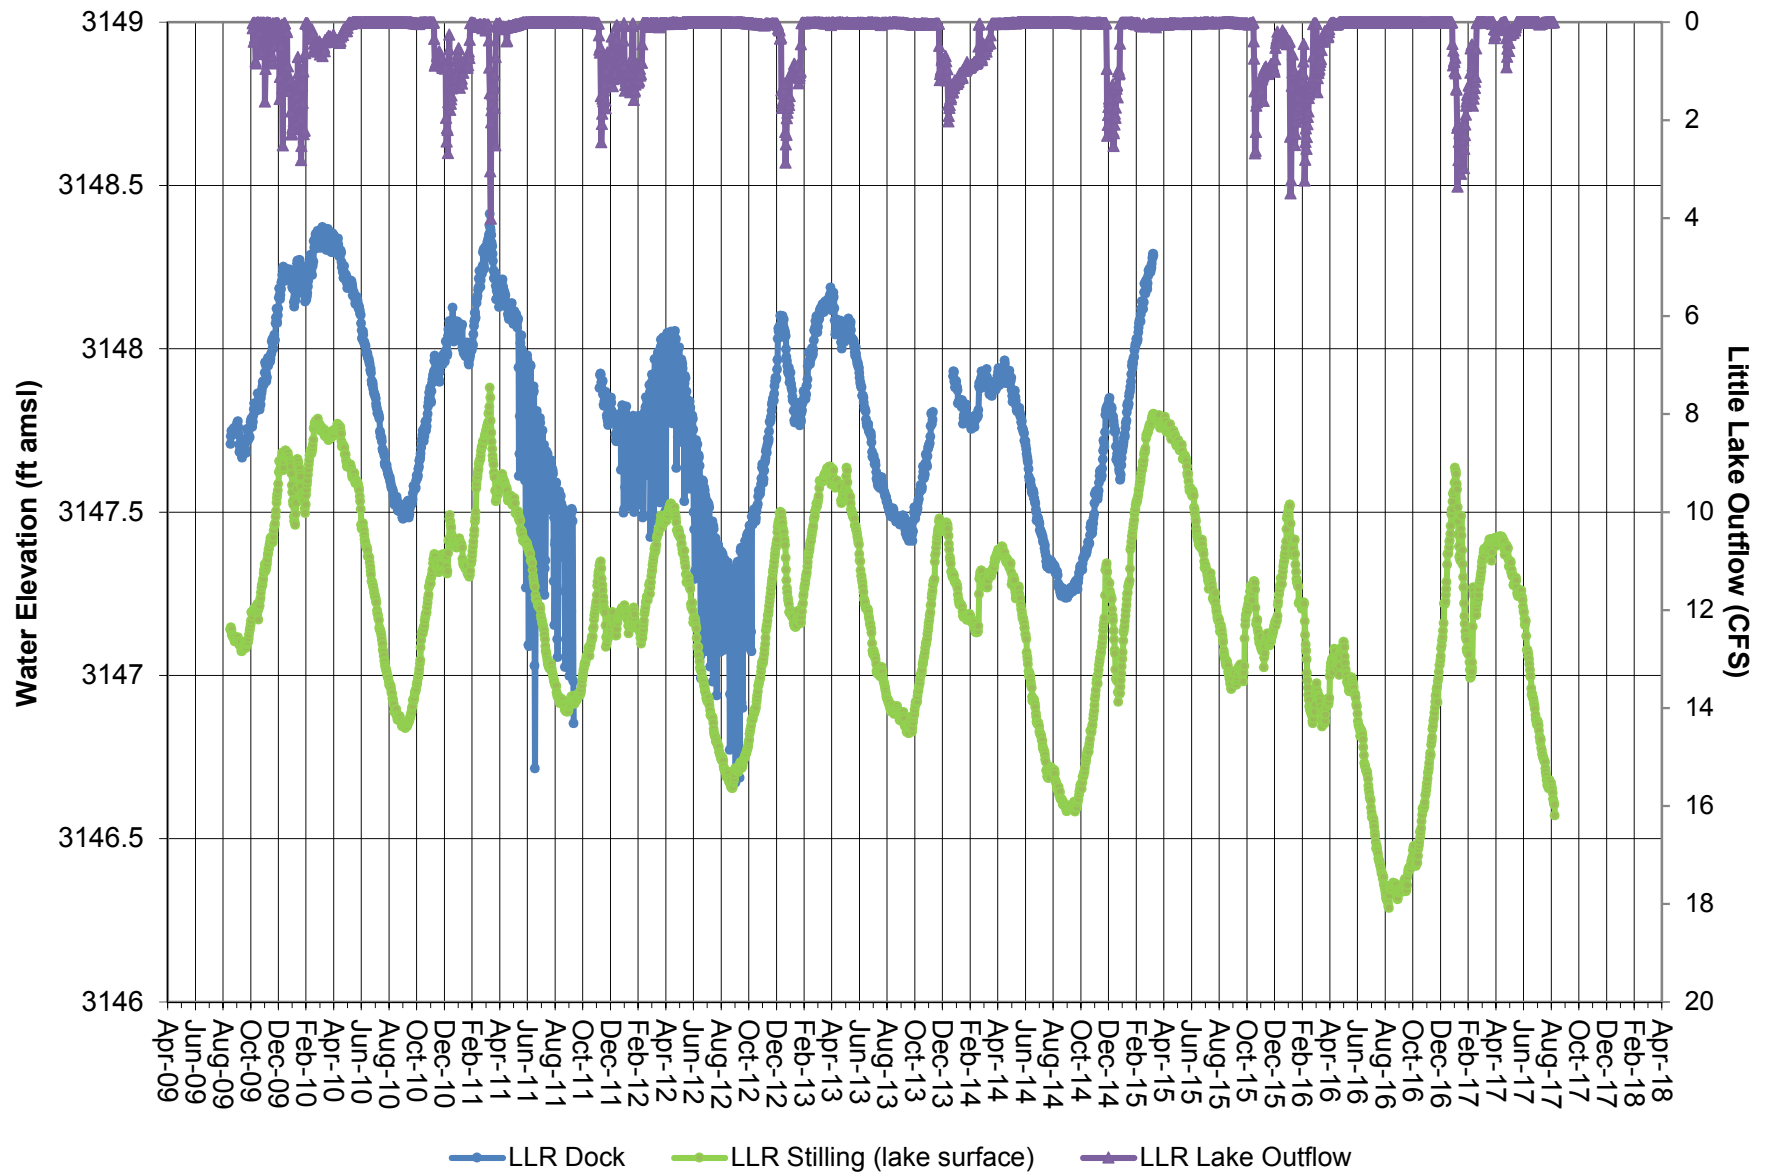
Note: Little Lake Outflow in cubic feet per second.  
 LLR staff conducted water intermittent pumping from 2011-2012.  
 Pressure Transducer removed from Dock Well in March 2015.

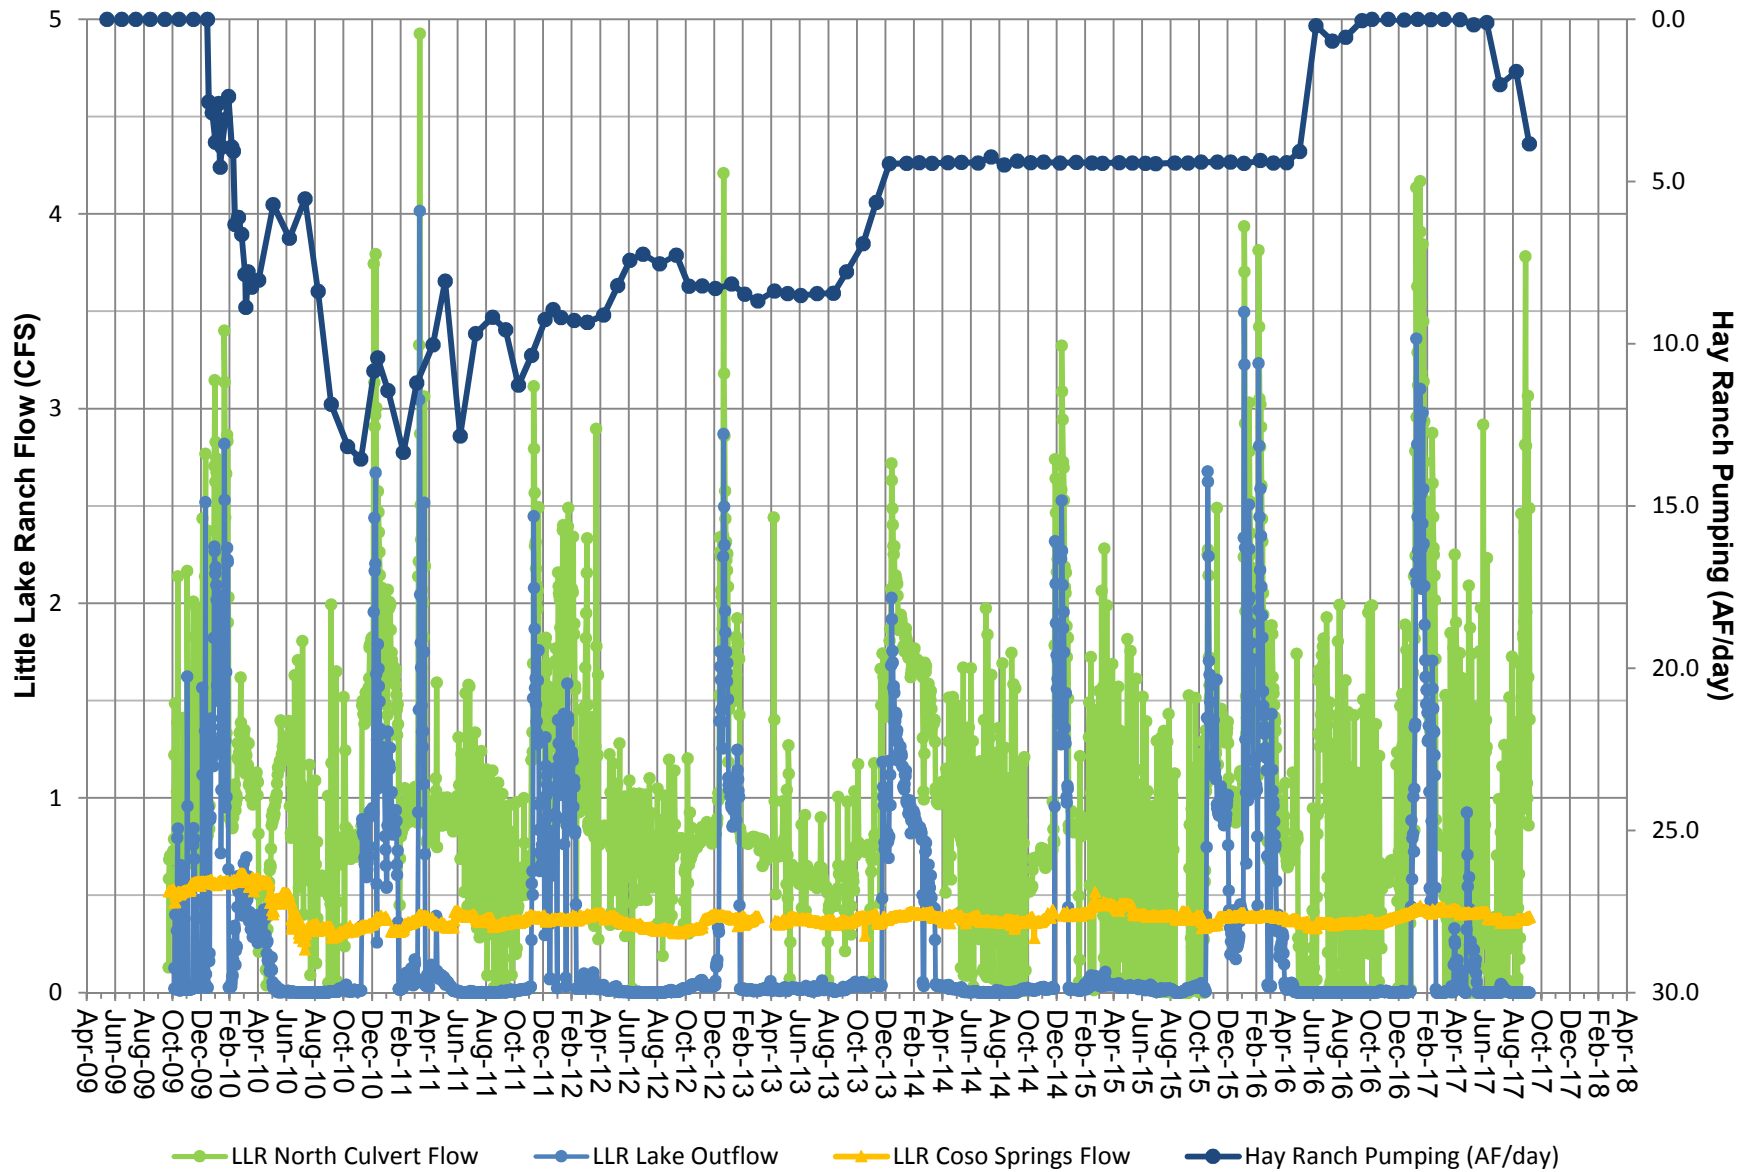
Note: Little Lake Ranch Flows are cubic feet per second.  
 Hay Ranch pumping is average acre feet per day.

A hydrograph which compares surface water flows in the Little Lake Ranch area to Hay Ranch Project pumping rates over time is also included in this report as Figure 13. Surface water flows from Lake Outflow, Coso Springs Flow and North Culvert Flow are listed on the left axis, in cubic feet per second. Hay Ranch Project average daily pumping amounts, in acre-feet per day, are listed on the right axis in inverse order. As noted in Section 3.3, surface flow captured by the North Culvert Flow flume represents an accumulation of surface flows from Little Lake, Coso Springs and the Siphon Well flow.

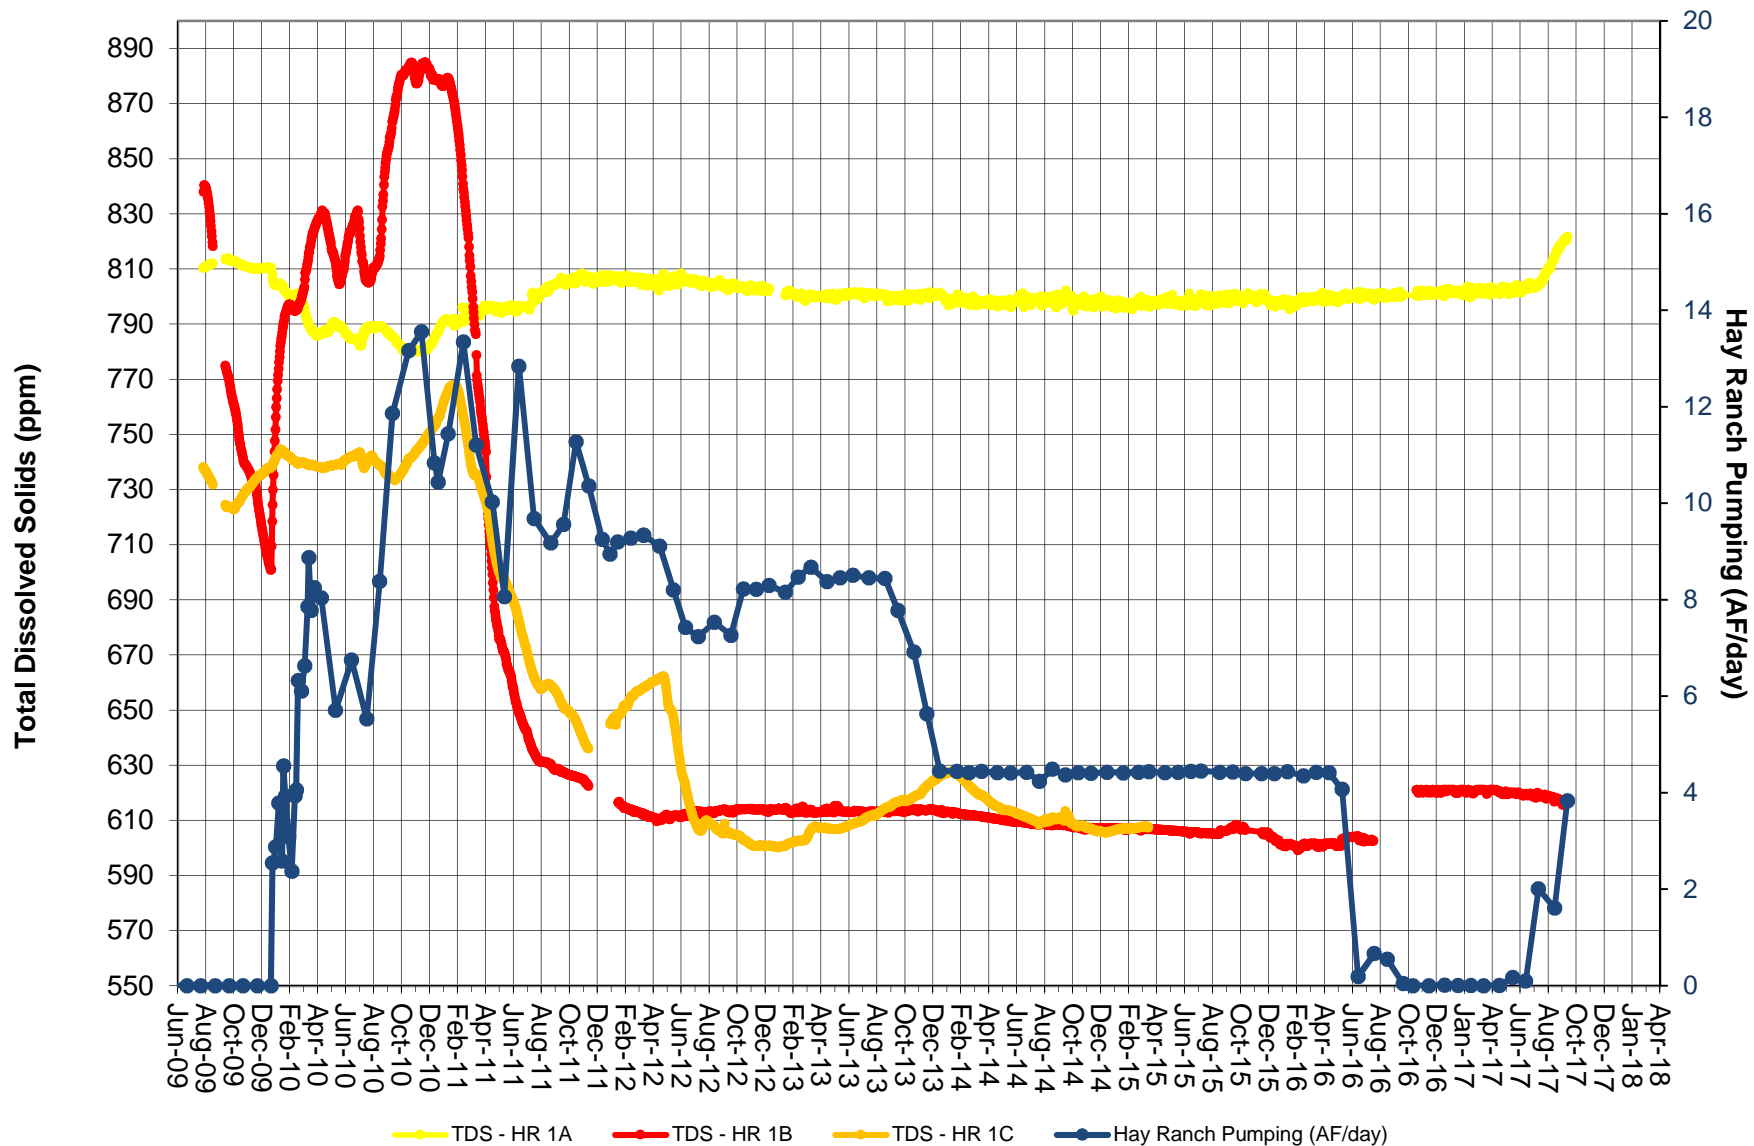
Note:  
Screened intervals: HR 1A 170-260 feet; HR 1B 490-540 feet; HR 1C 340-405 feet.  
HR 1A, 1B and 1C data gaps due to transducer malfunction or adjustment.  
PT removed from HR1C in March 2015.

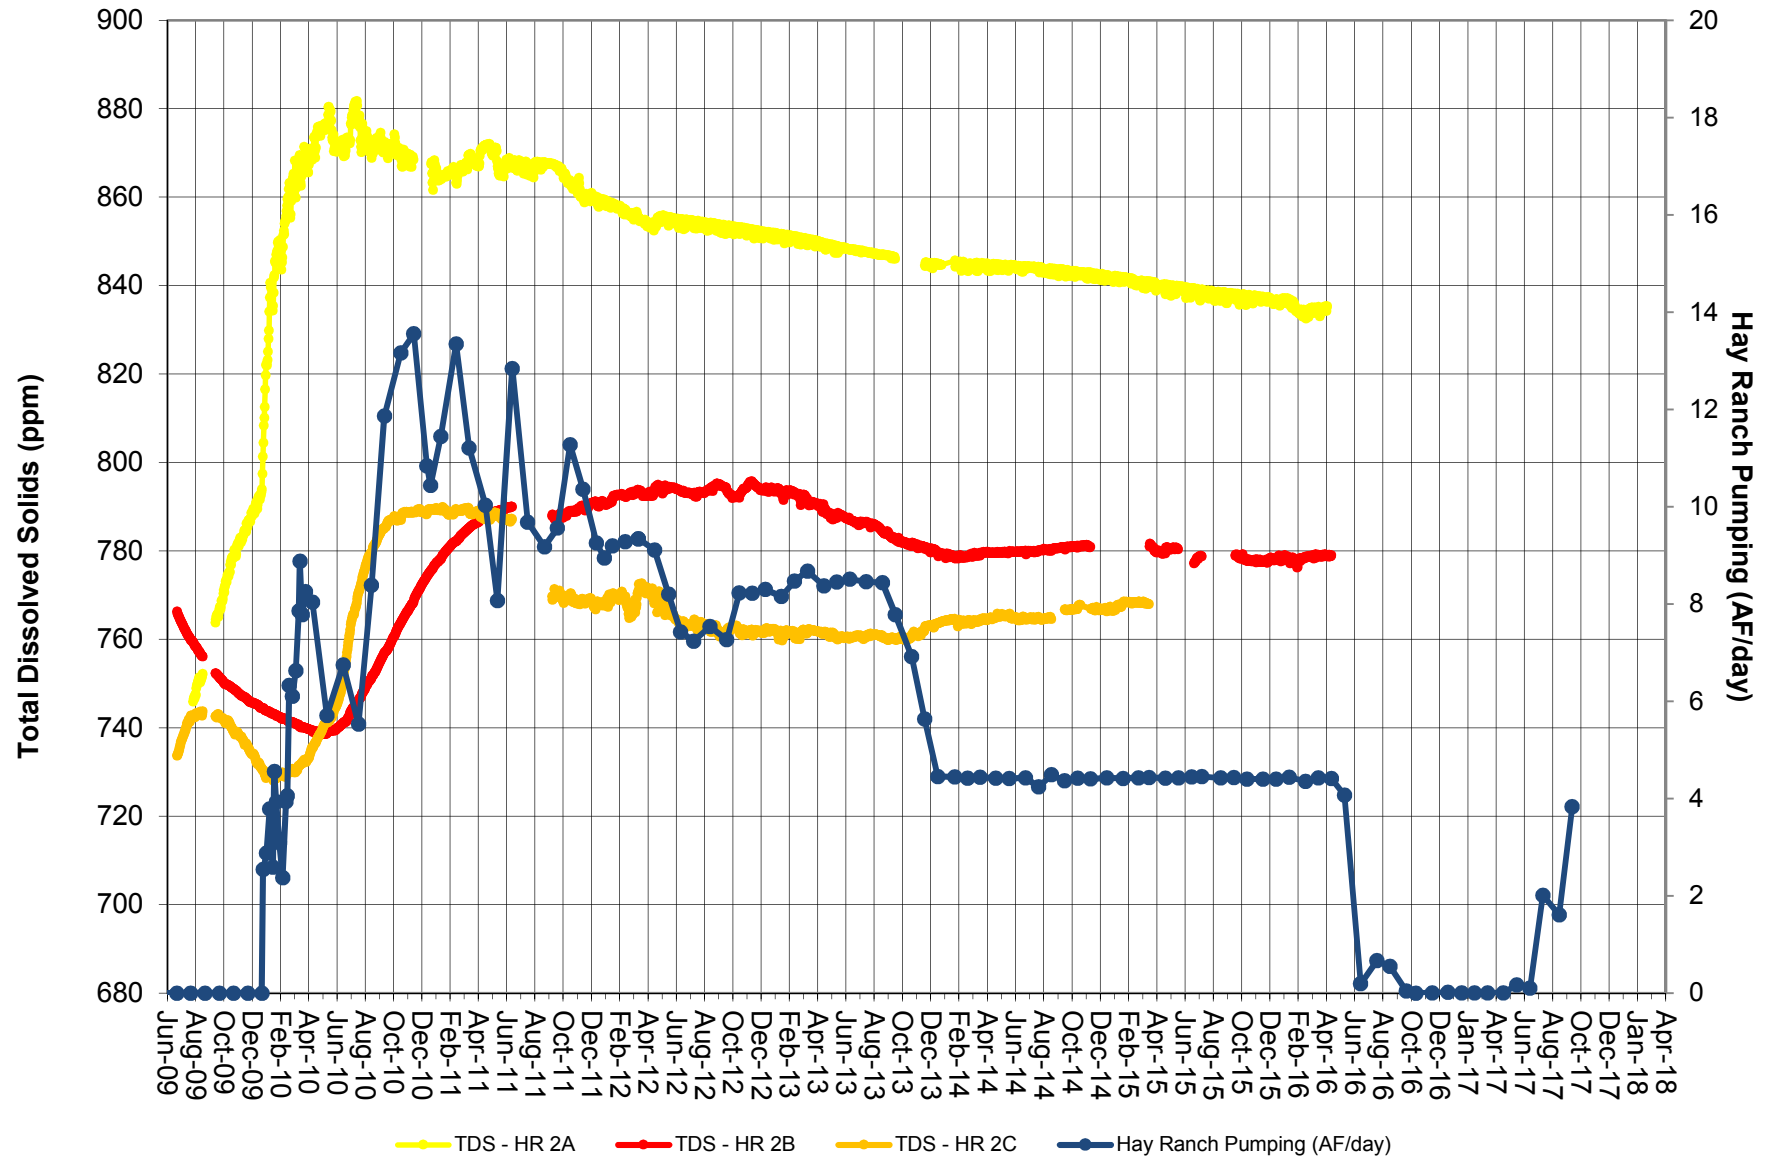
Note: Screened intervals: HR 2A 180-300 feet; HR 2B 519-584 feet; HR 2C 370-420 feet.  
HR 2A, and 2B no longer record TDS as of April 2016.  
PT removed from HR2C in March 2015.

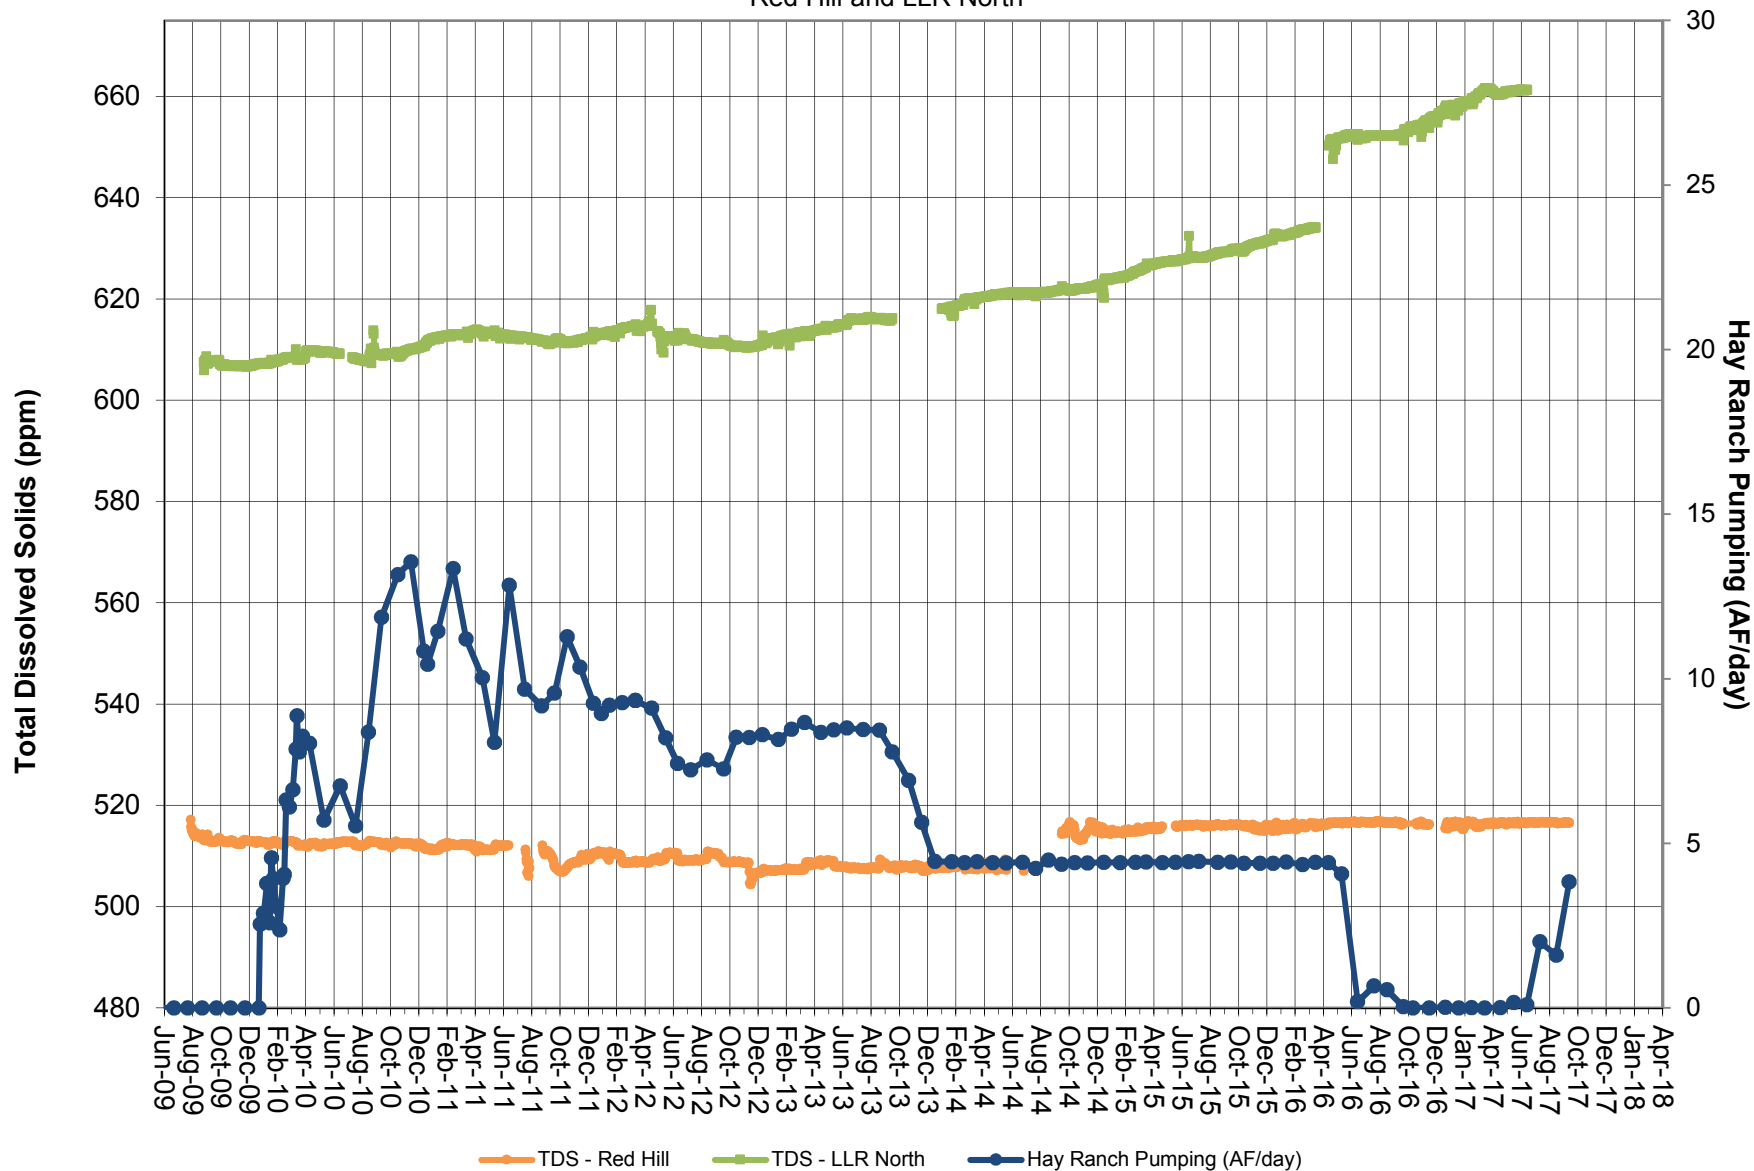
Note: TDS data from in-well transducers. Hay Ranch pumping is average acre feet per day.  
Coso Operating initiated Hay Ranch Project pumping on 12/25/09.  
Red Hill and LLR North data gaps due to transducer malfunction.

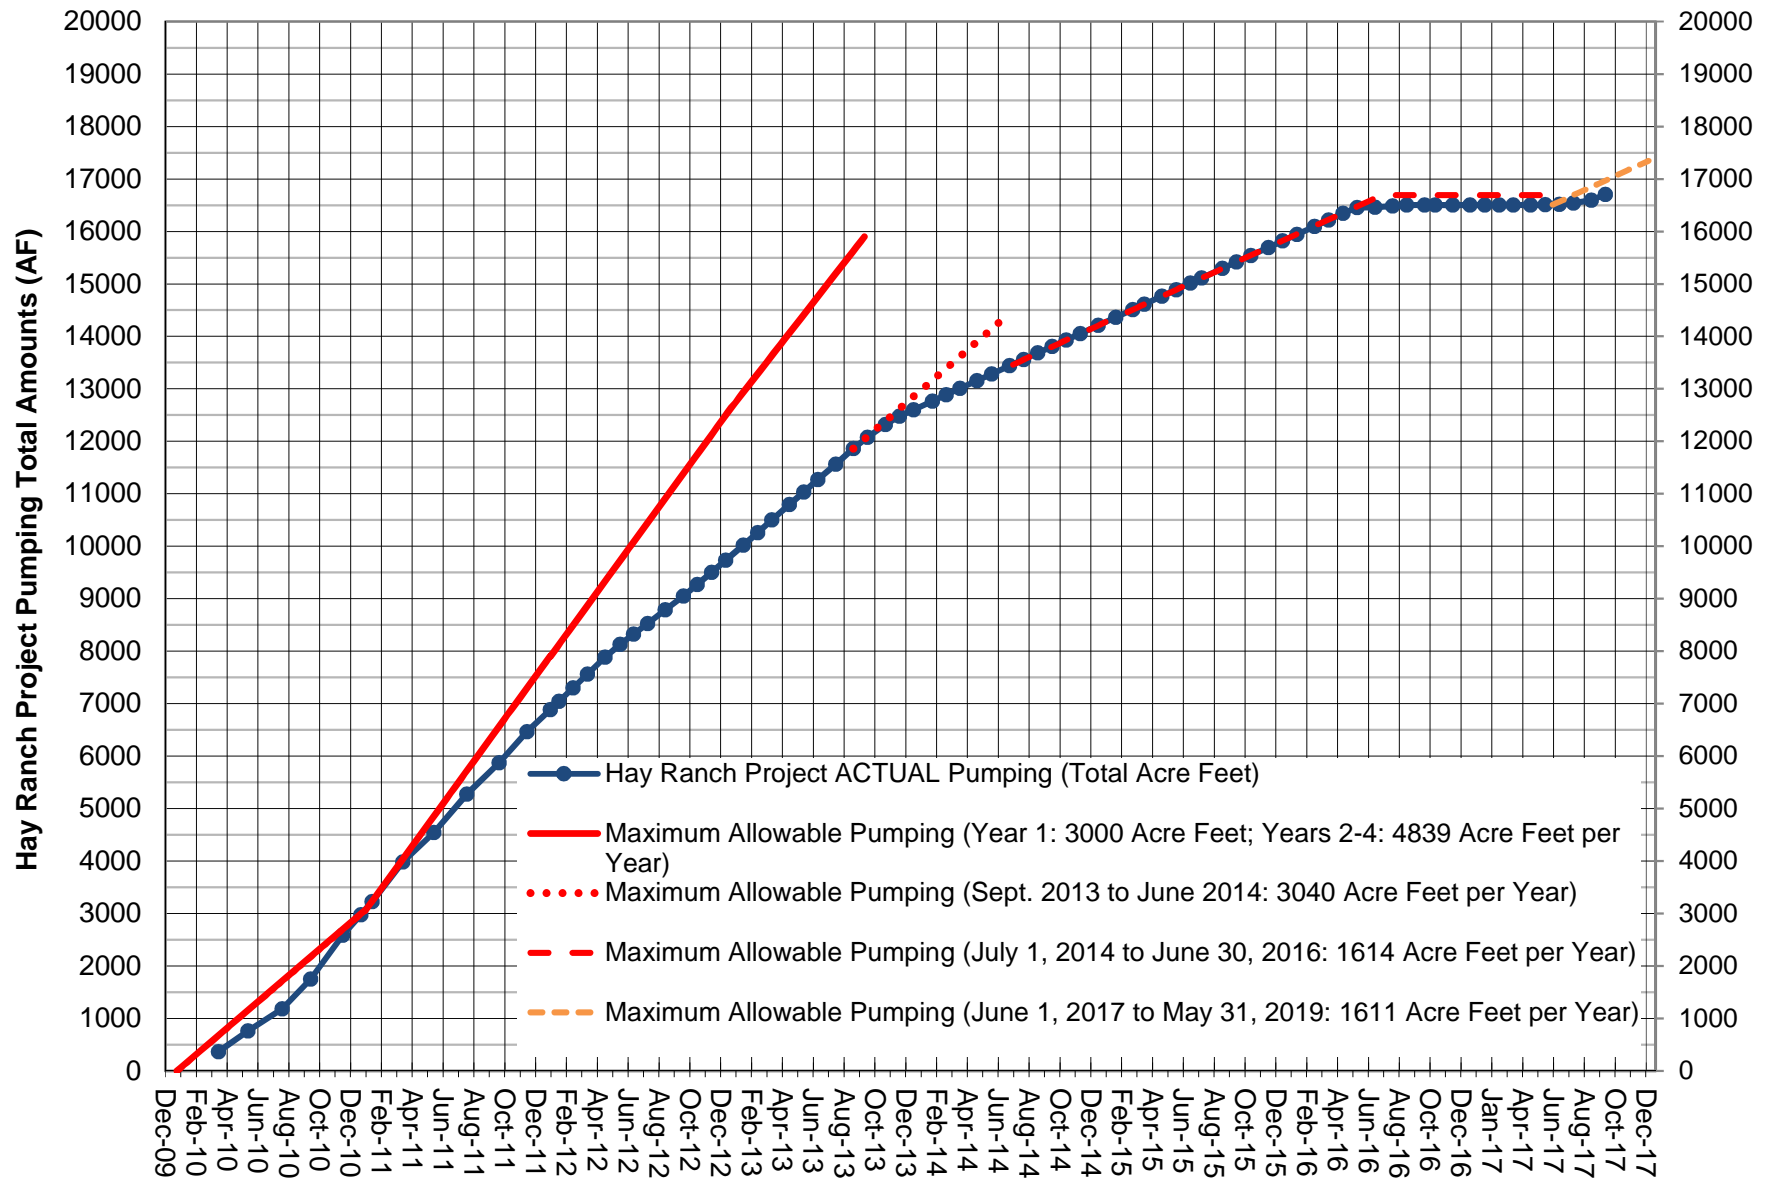
Note: Project pumping initiated 12/25/09. Maximum Allowable pumping rate was 3000 AF/yr for 12/09 to 12/10, 4839 AF/yr for 1/11-8/13, 3040 AF/yr for 9/13 to 6/14, 1614 AF/yr from 7/14 to 6/16 and 1611 AFY for 6/17 to 5/19.

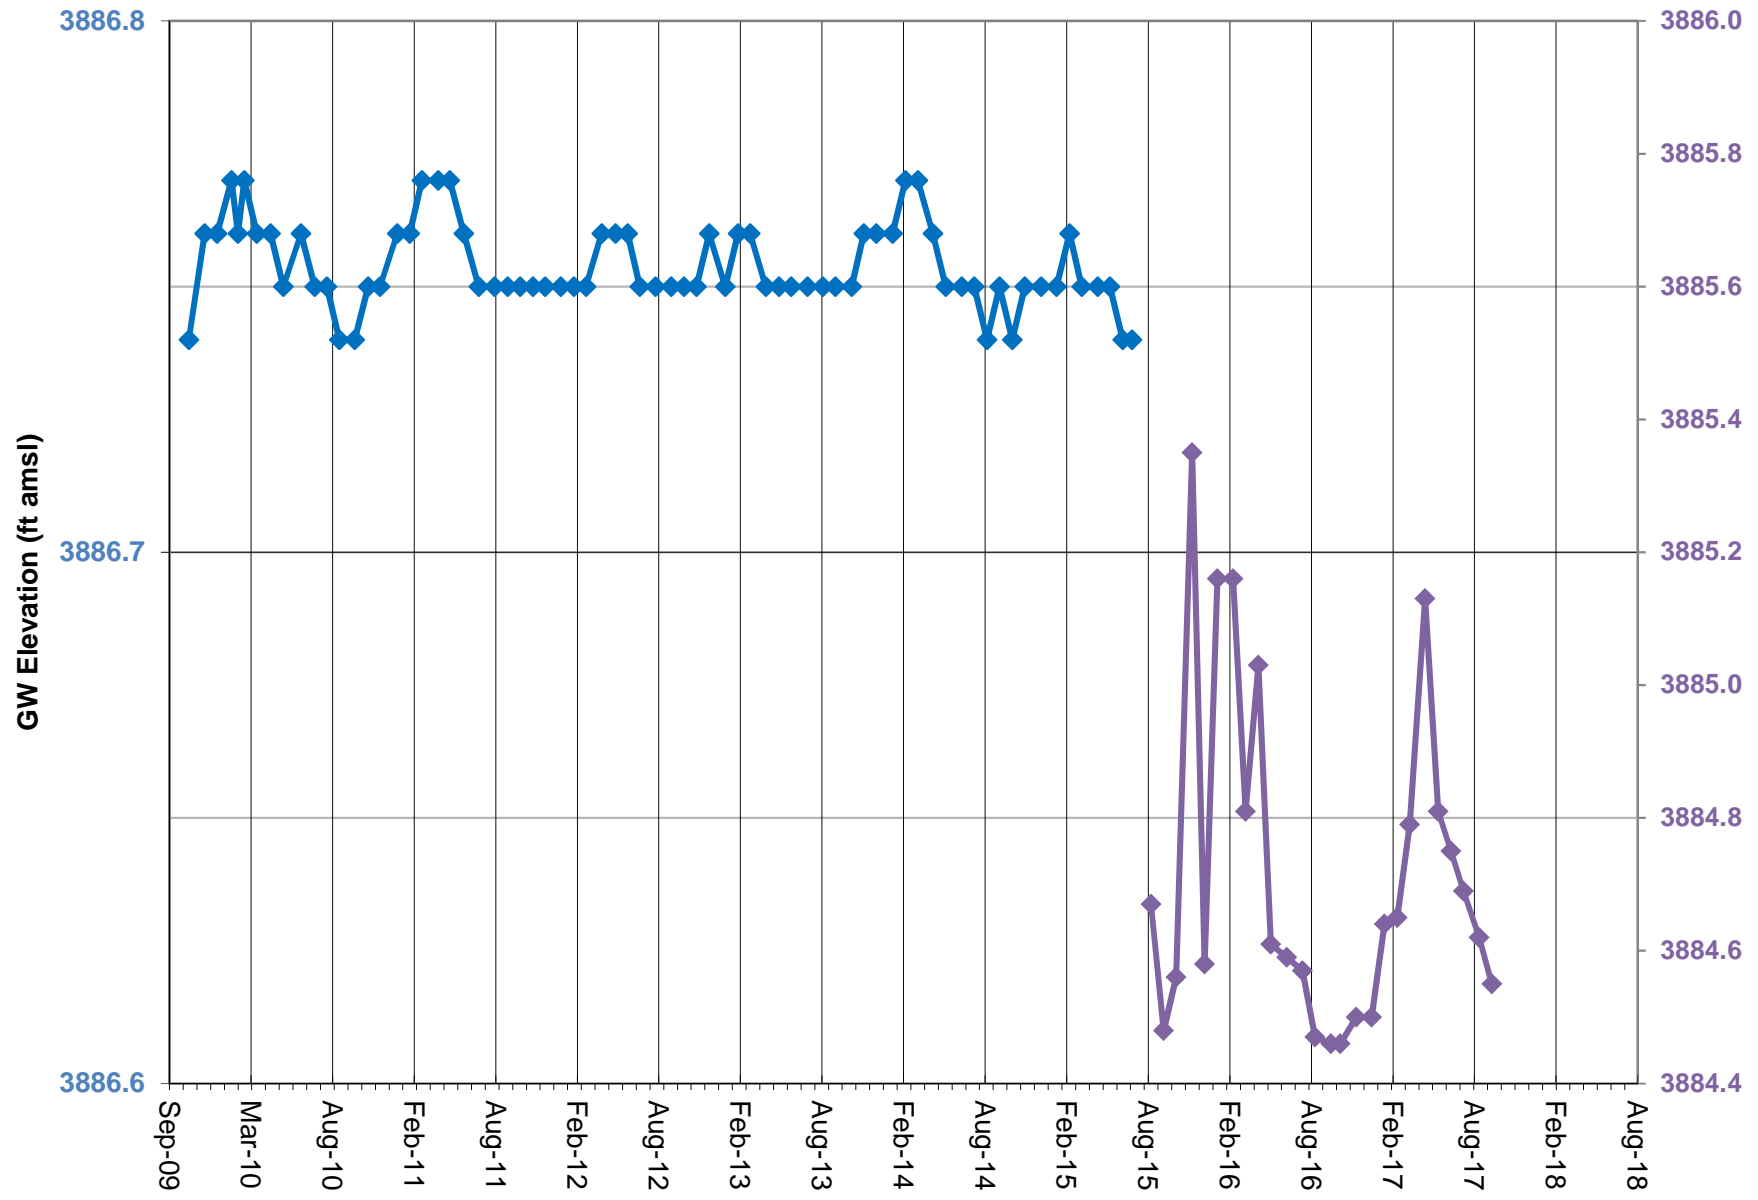
Note: Groundwater elevation data based on manual depth-to-water measurements.  
 Water-supply pump installed in DR South in July 2015.  
 Note secondary axis for GWEs post-pump installation.
