# HAY RANCH PROJECT CONDITIONAL USE PERMIT HYDROLOGIC MONITORING REPORT

THIRD QUARTER 2017  
INYO COUNTY, CALIFORNIA

TEAM Engineering & Management, Inc. (TEAM), is pleased to present the results of hydrologic monitoring activities, relating to the Hay Ranch Project Conditional Use Permit (#2007-003), conducted in Rose Valley from July to September 2017.

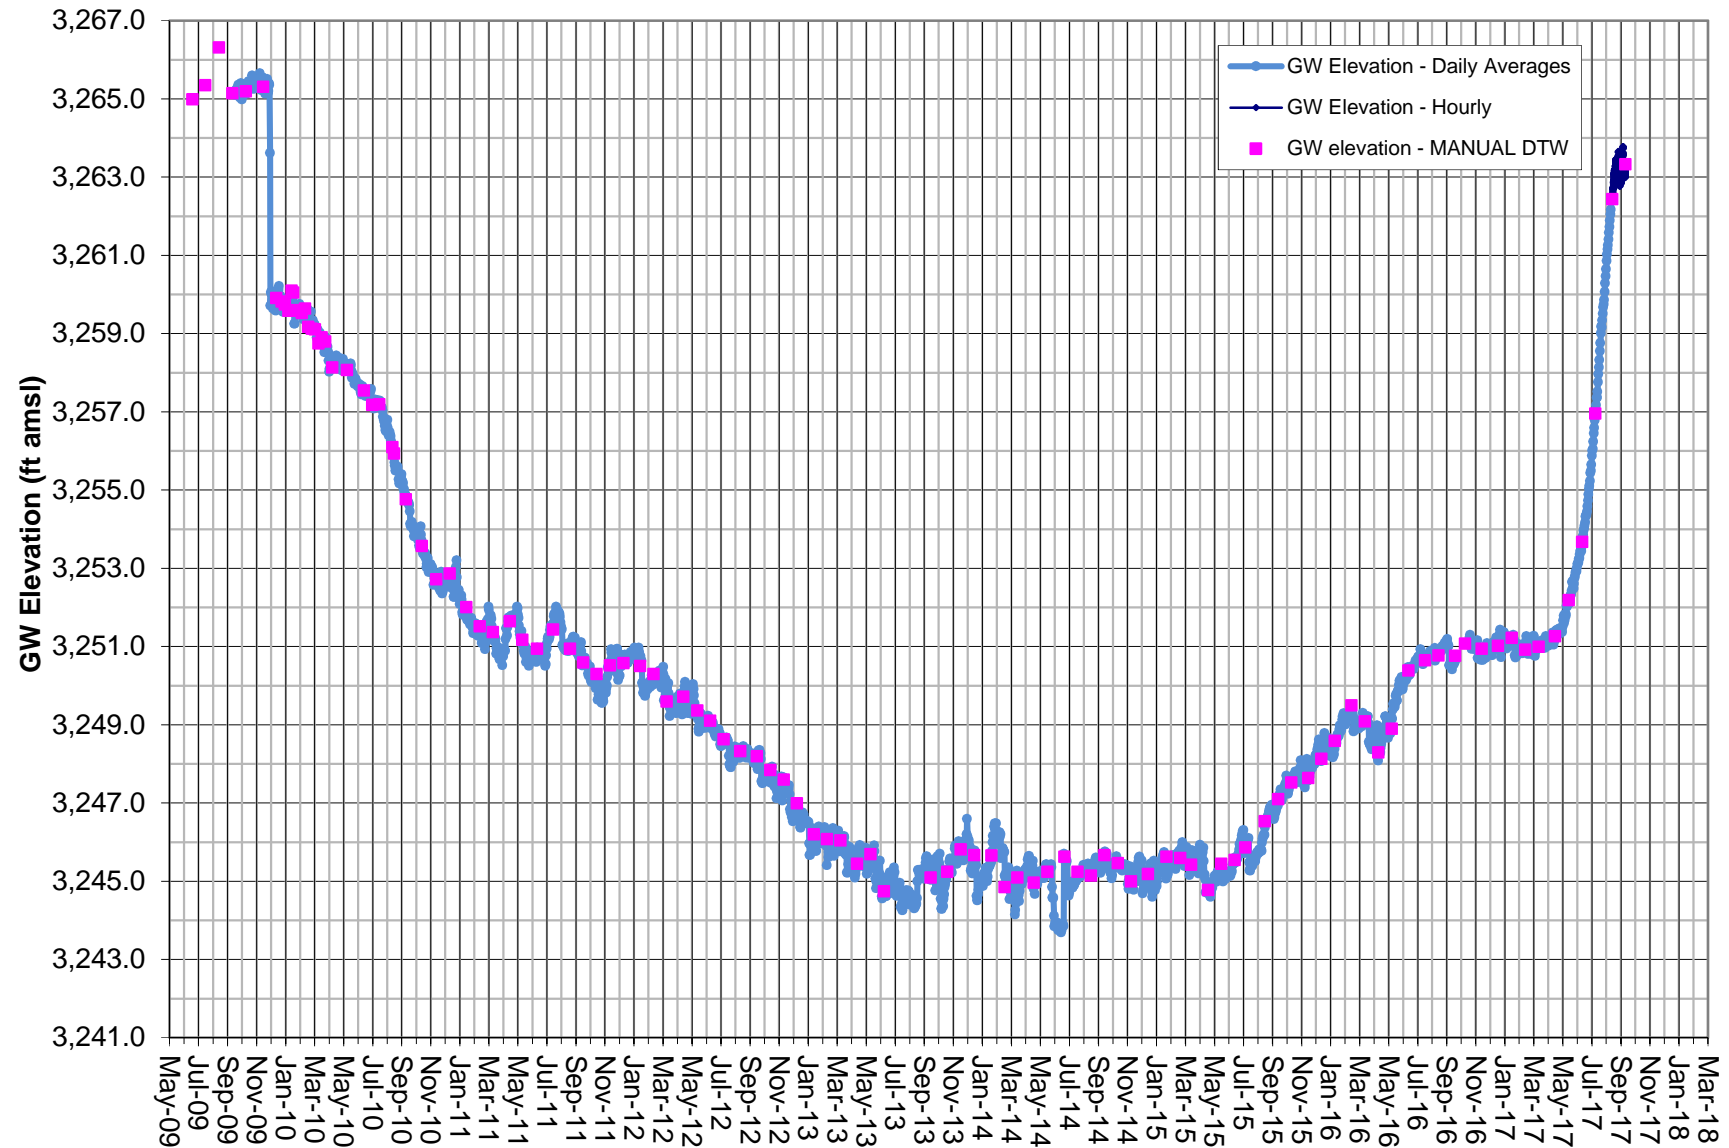
Note: Transducer data adjusted by BaroTroll and correlated to Manual DTW.  
 The 12/3/09 GWE decrease was confirmed by in-well PT and manual DTW.  
 Coso Operating Co. initiated Hay Ranch Project pumping on 12/25/09.

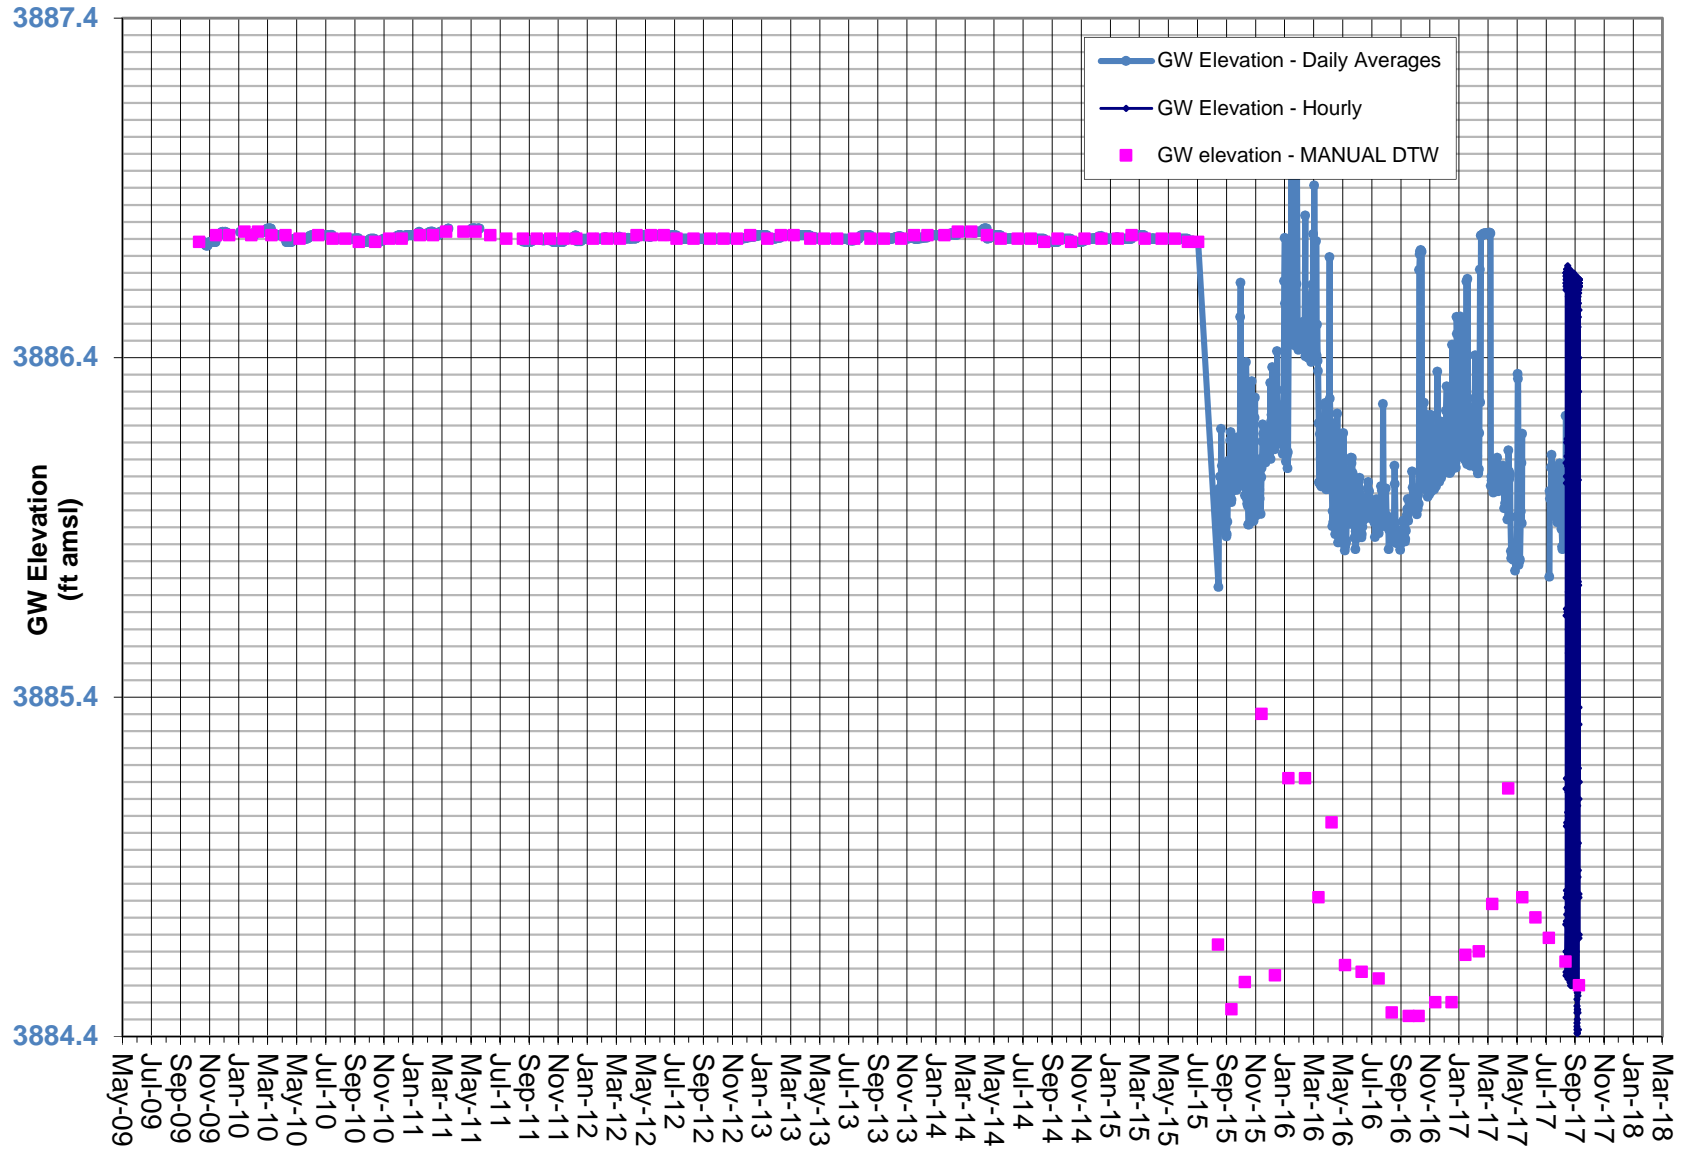
Note: Vented transducer data correlated to Manual DTW measurements.  
Solar water supply pump installed in DR South in July 2015, which affects the accuracy of DTW correlation.

The transducer in the Davis Ranch South Well (RV-111) was inoperable on June 14, 2017 and was removed. On July 12, 2017 the transducer which was installed in the CJ Ranch Well (RV-90) was removed and installed in RV-111. There were no other significant operational issues observed during the reporting period.

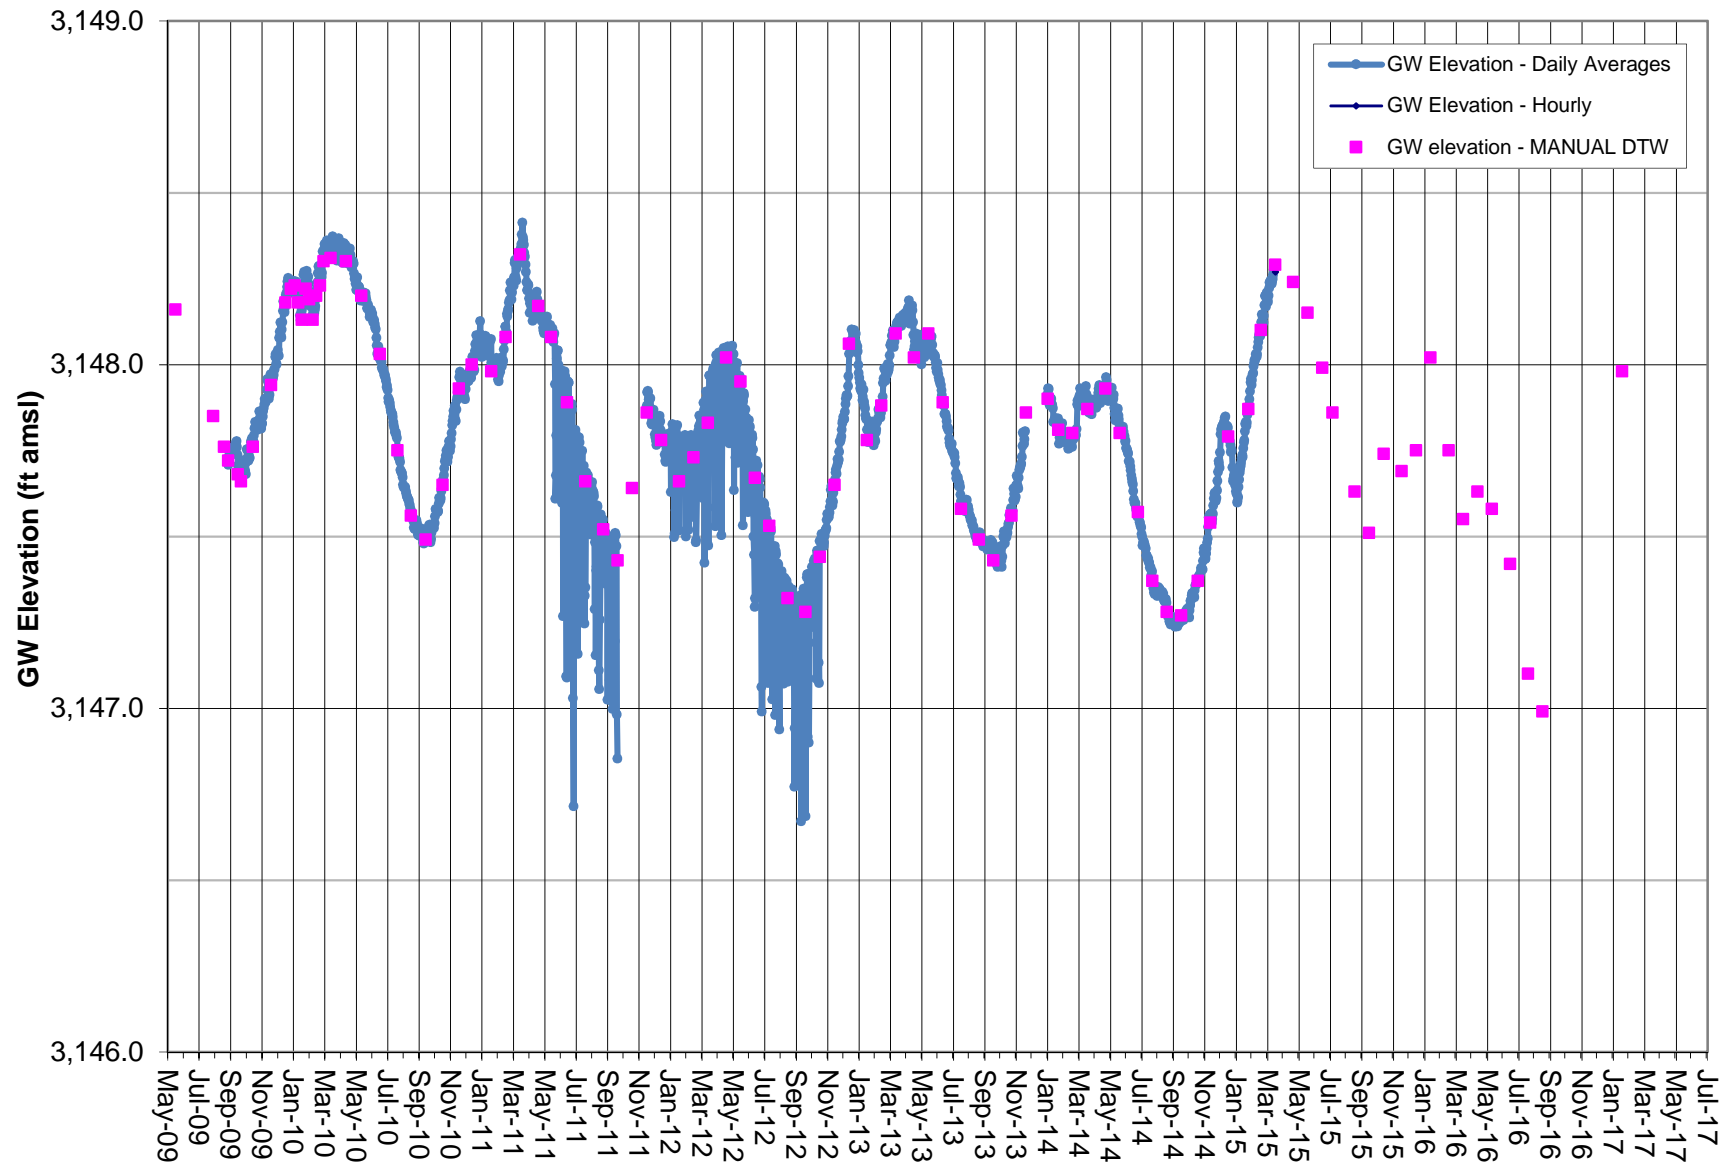
Note: Temporary GWE drops from May 2011 to October 2012 caused by active water management (pumping) of well by LLR staff.  
Pressure Transducer removed in 2015 as approved by ICWD.

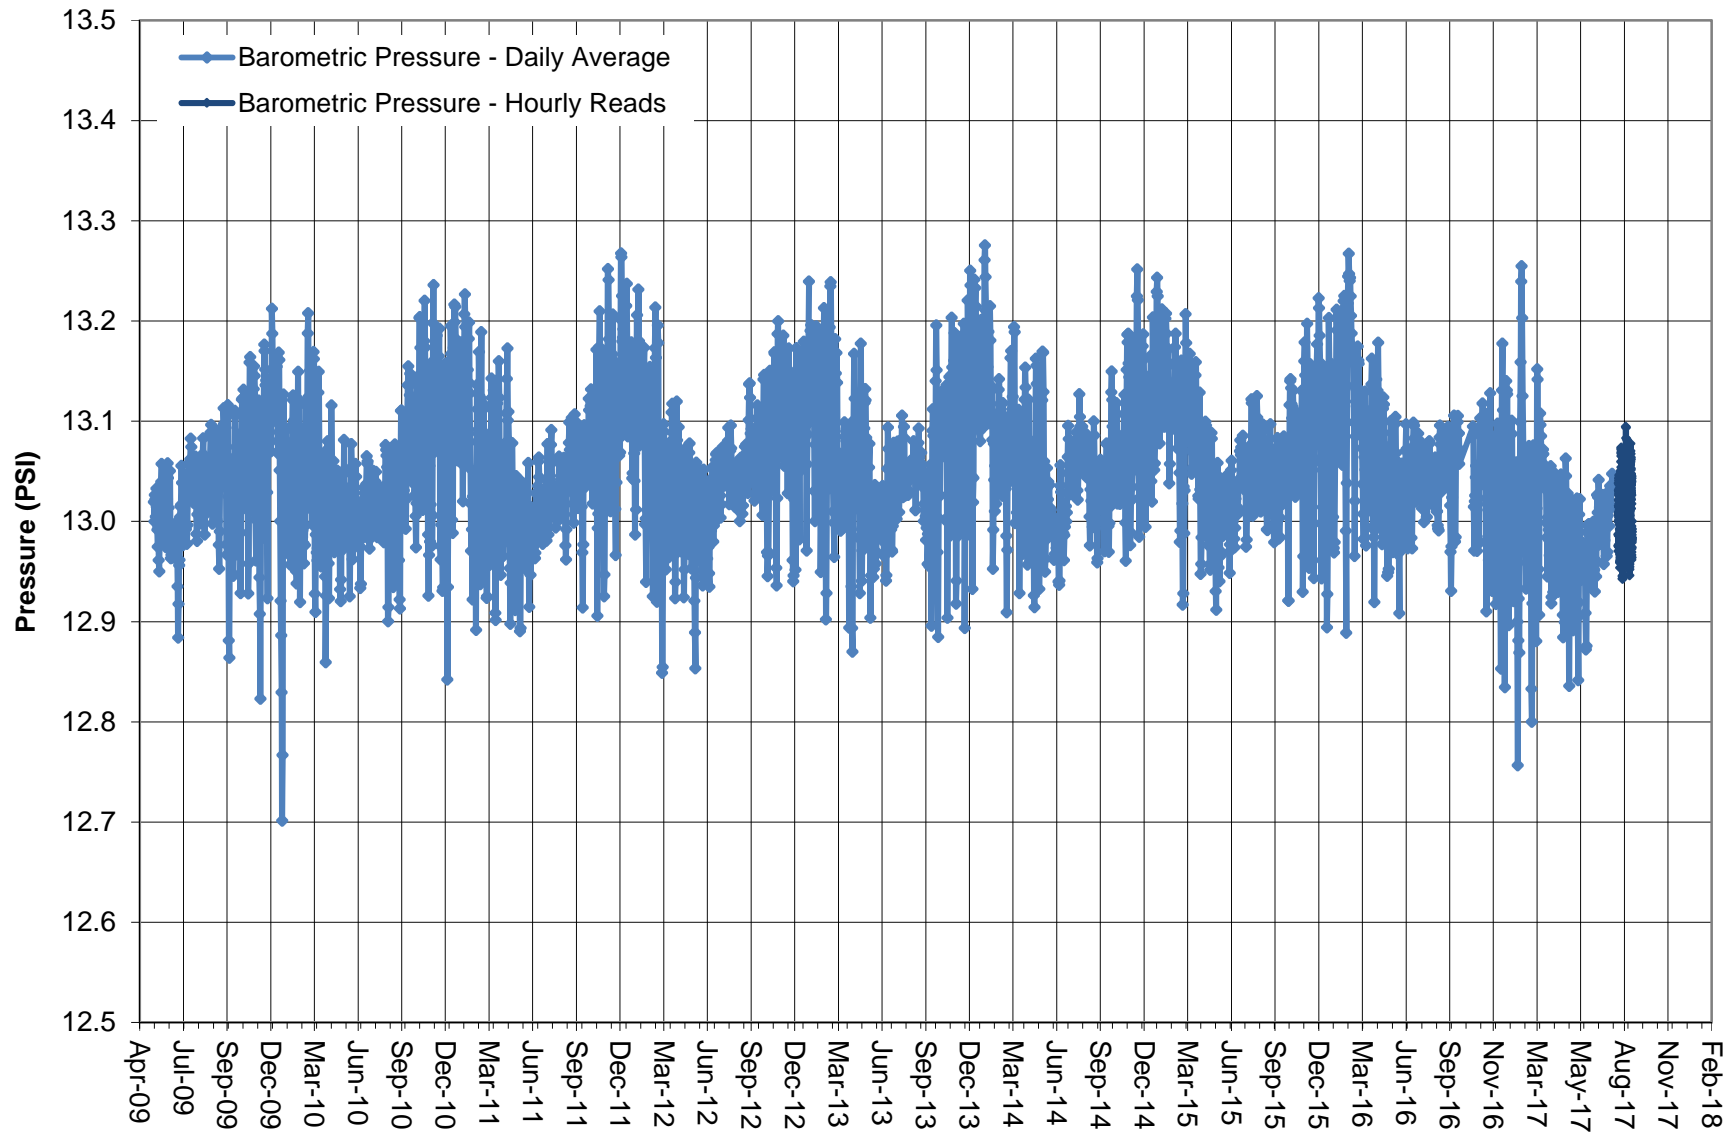
Note: BaroTroll located in well casing of well HR-2B.  
Used to adjust pressure readings in non-vented transducers.  
BaroTroll stopped working and was replaced 10/19/2016.
