HAY RANCH PROJECT CONDITIONAL USE PERMIT HYDROLOGIC MONITORING REPORT

FOURTH QUARTER 2017
INYO COUNTY, CALIFORNIA

JANUARY 26, 2018

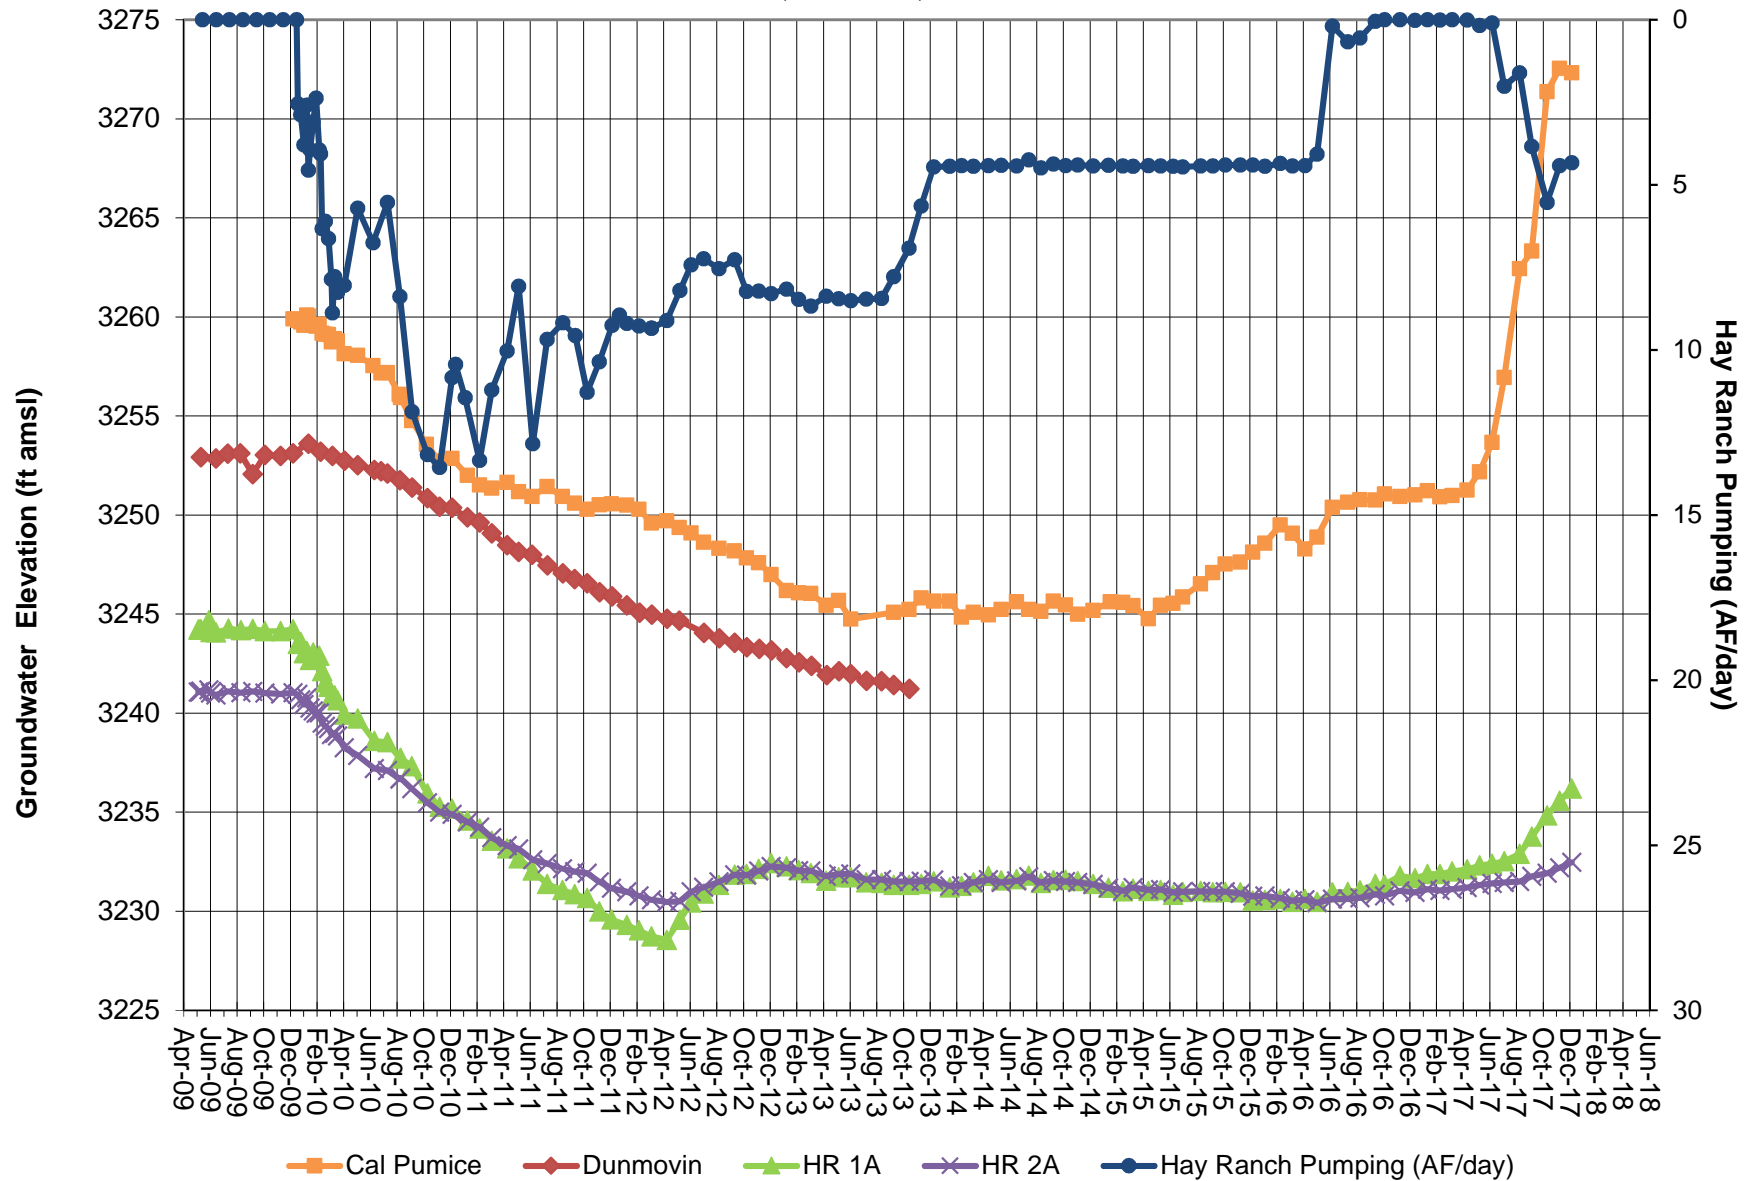
FIGURE 3
GROUNDWATER ELEVATION and HAY RANCH PUMPING
 Cal Pumice, Dunmovin, HR 1A and HR 2A

Note: Groundwater elevation data based on manual depth-to-water measurements.
 Hay Ranch pumping is average acre feet per day.
 Coso Operating initiated Hay Ranch Project pumping on 12/25/09.

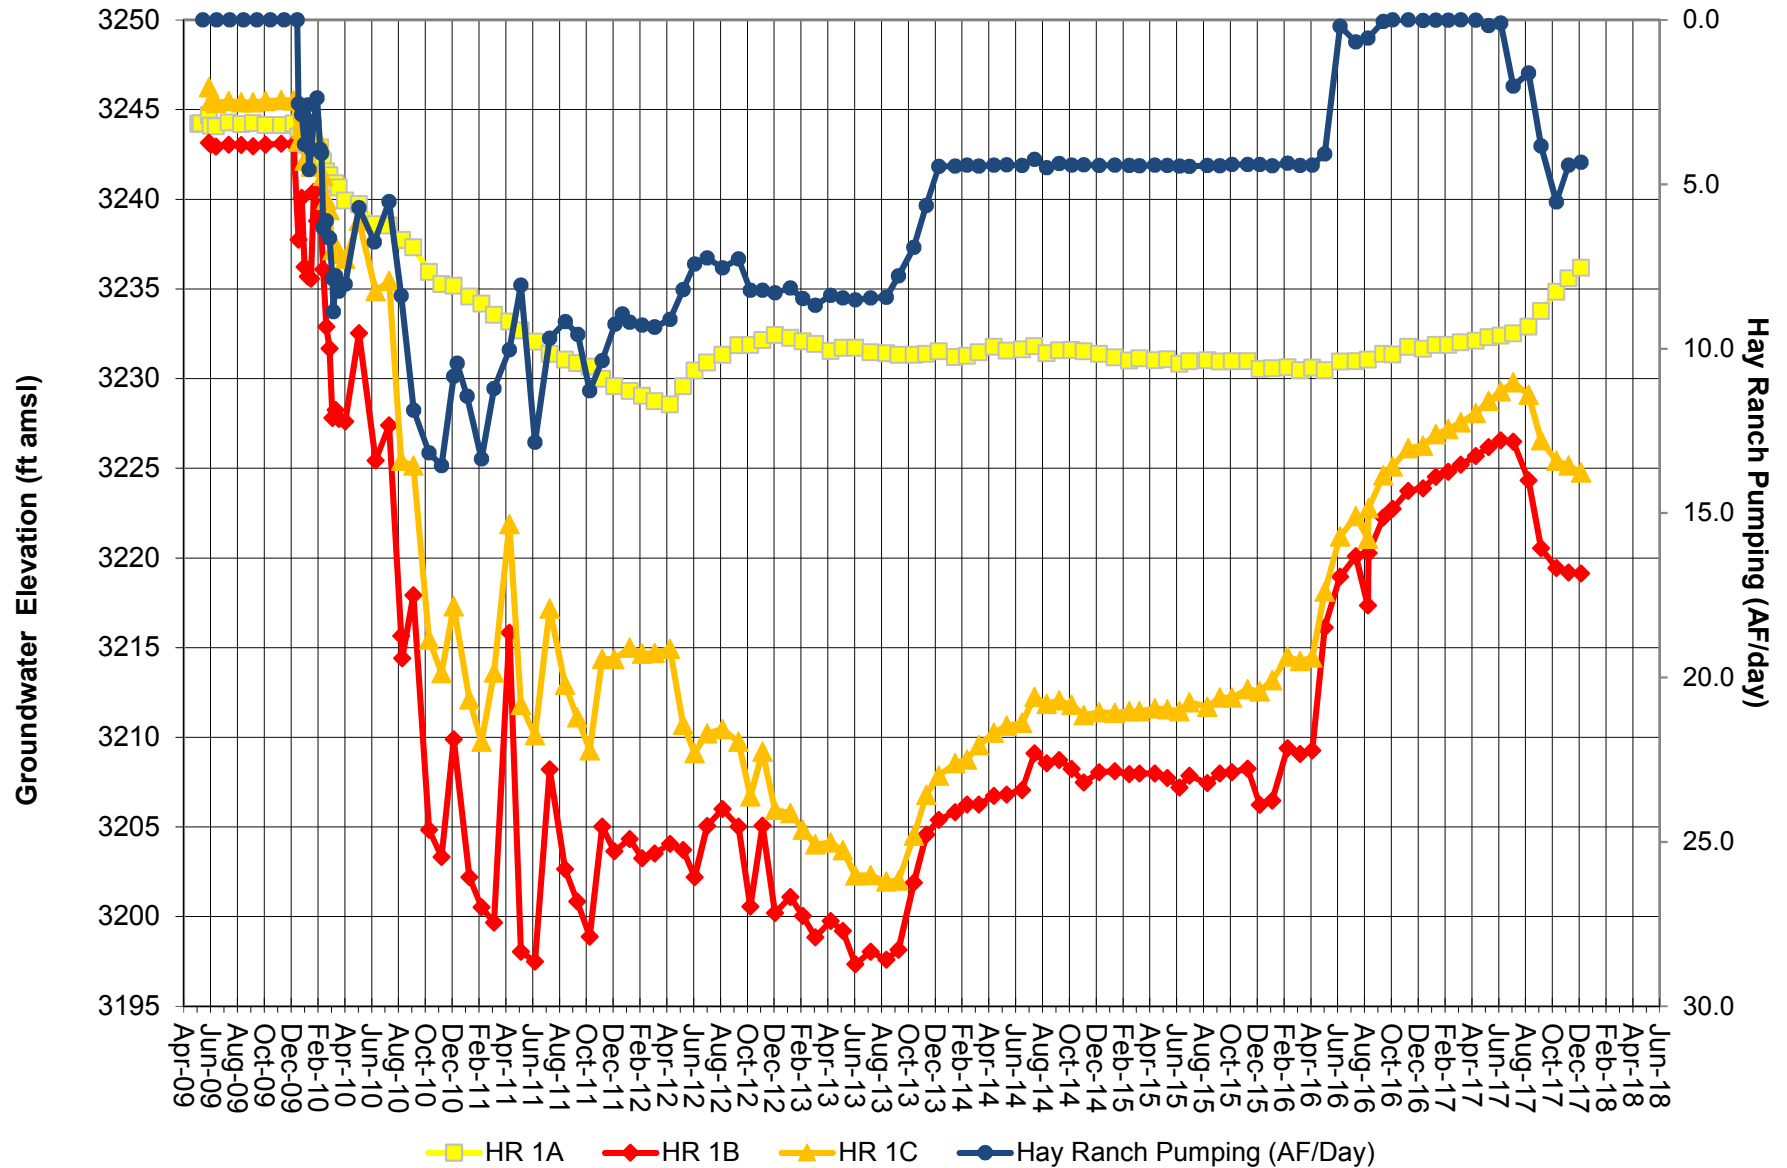
FIGURE 4
GROUNDWATER ELEVATION and HAY RANCH PUMPING
HR 1A, HR 1B and HR 1C

Note: GWE data based on manual DTW measurements. Hay Ranch pumping is average acre feet per day.
Screened intervals: HR 1A 170-260 feet; HR 1B 490-540 feet; HR 1C 340-405 feet.
Coso Operating initiated Hay Ranch Project pumping on 12/25/09.

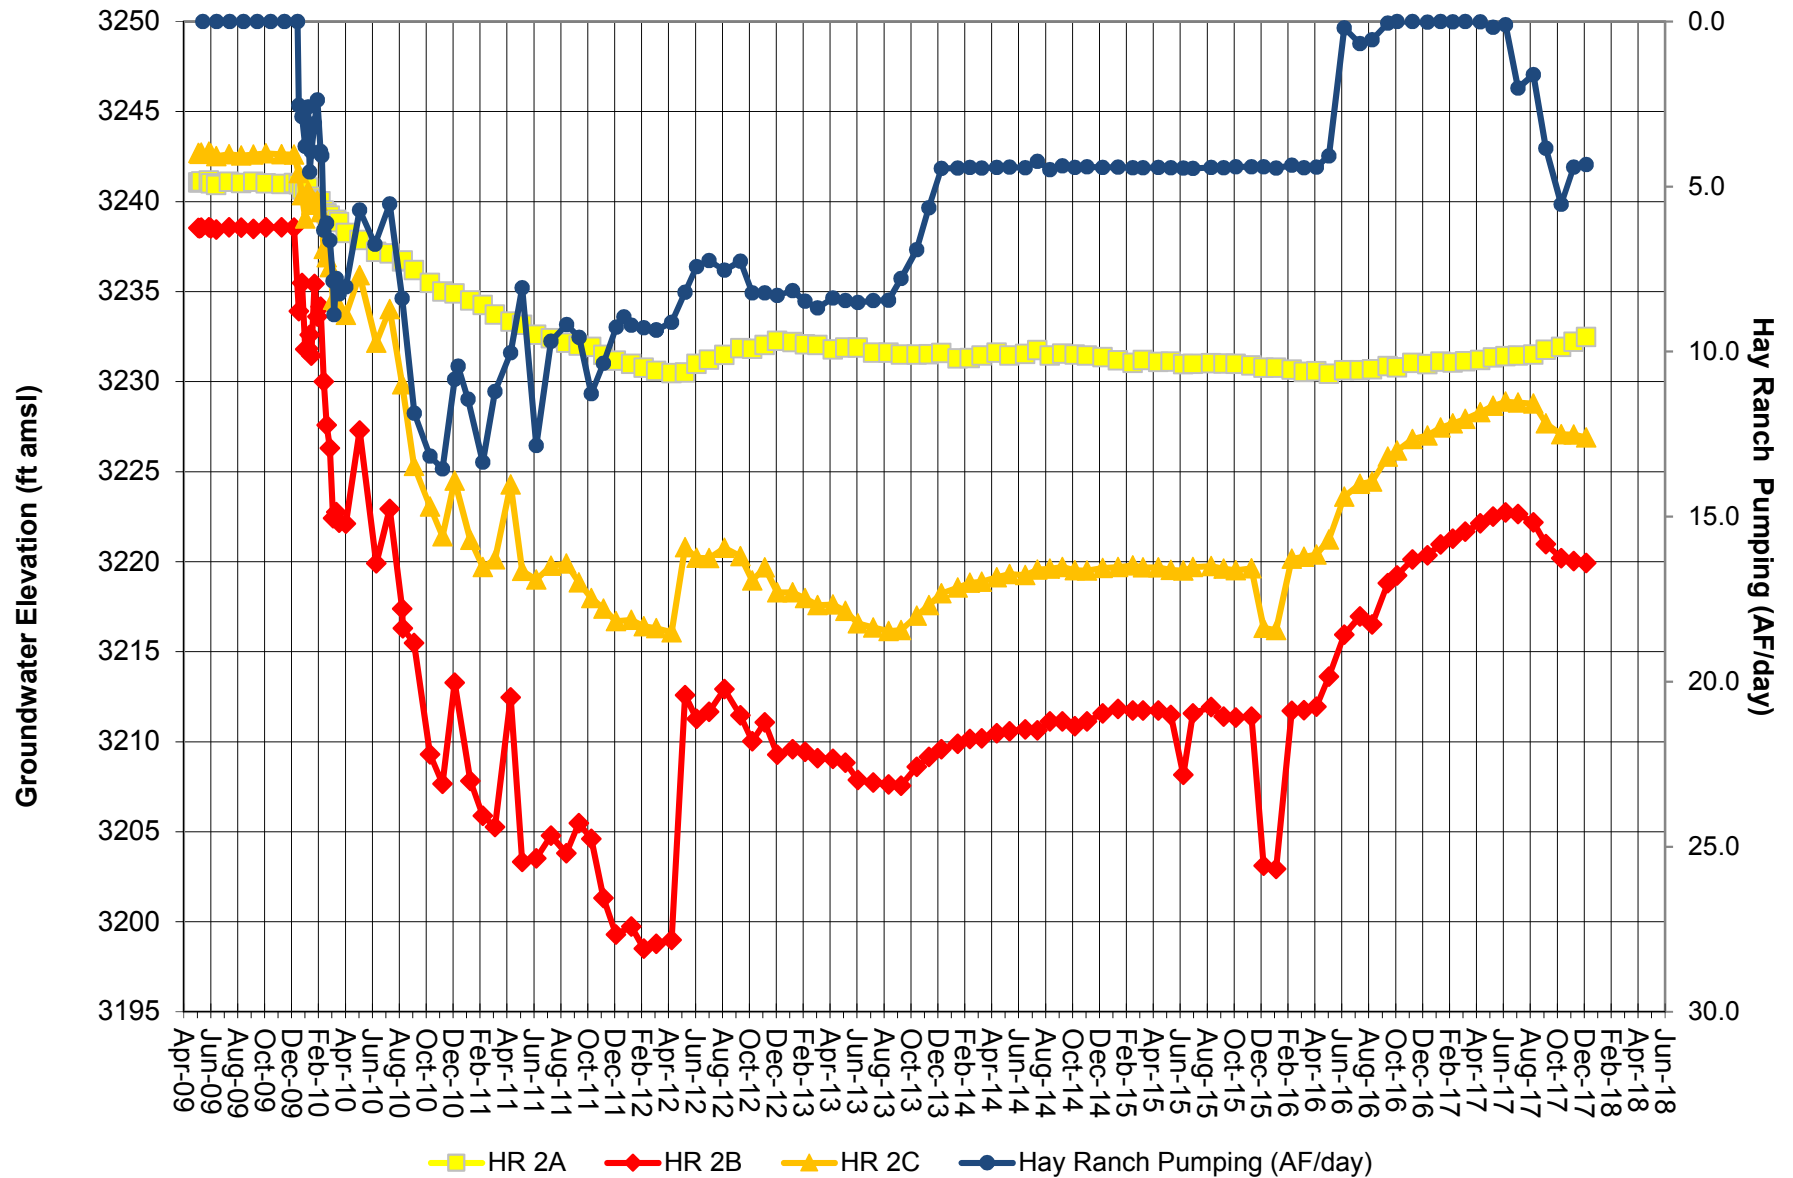
Note: GWE data based on manual DTW measurements. Hay Ranch pumping is average acre feet per day.
Screened intervals: HR 2A 180-300 feet; HR 2B 519-584 feet; HR 2C 370-420 feet.
Coso Operating initiated Hay Ranch Project pumping on 12/25/09.

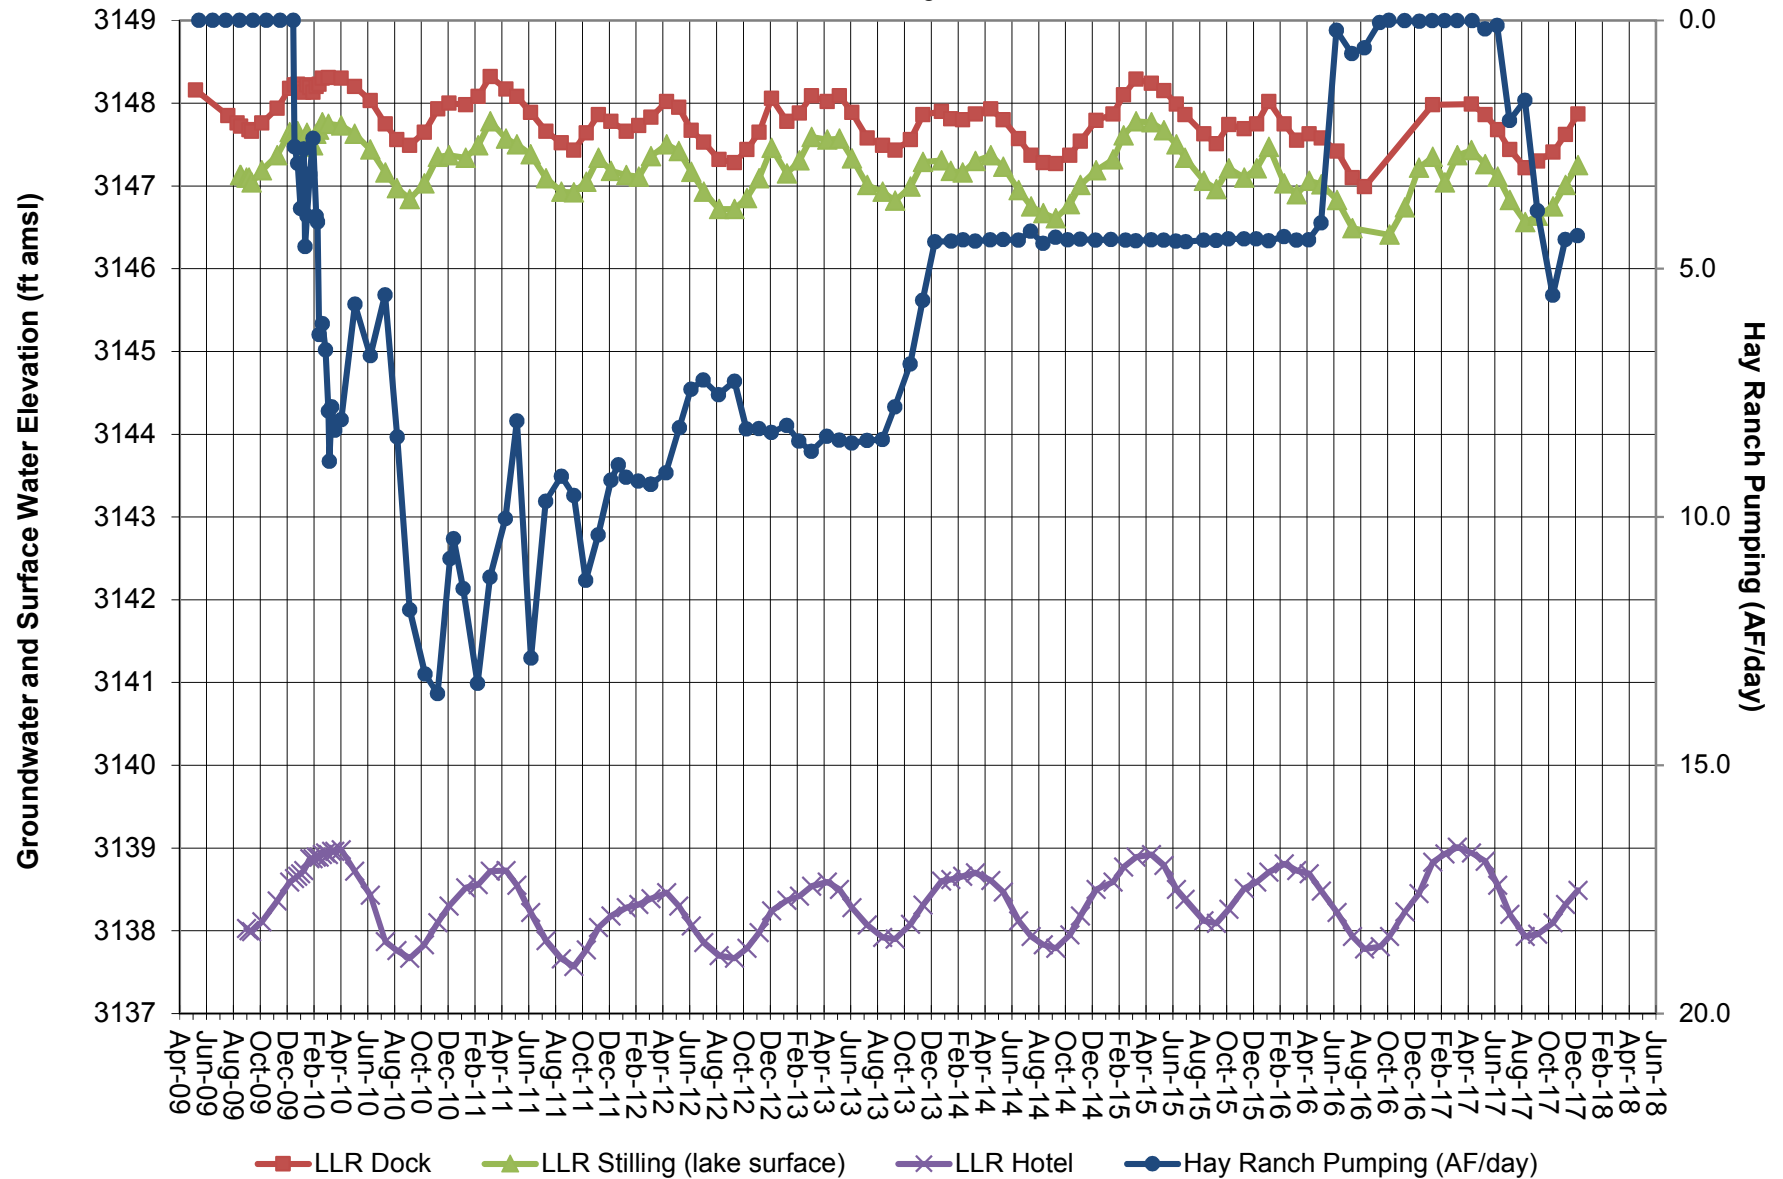
FIGURE 11

Note: Groundwater and surface water elevation data based on manual depth-to-water measurements.
Hay Ranch pumping is average acre feet per day.
Coso Operating initiated Hay Ranch Project pumping on 12/25/09.

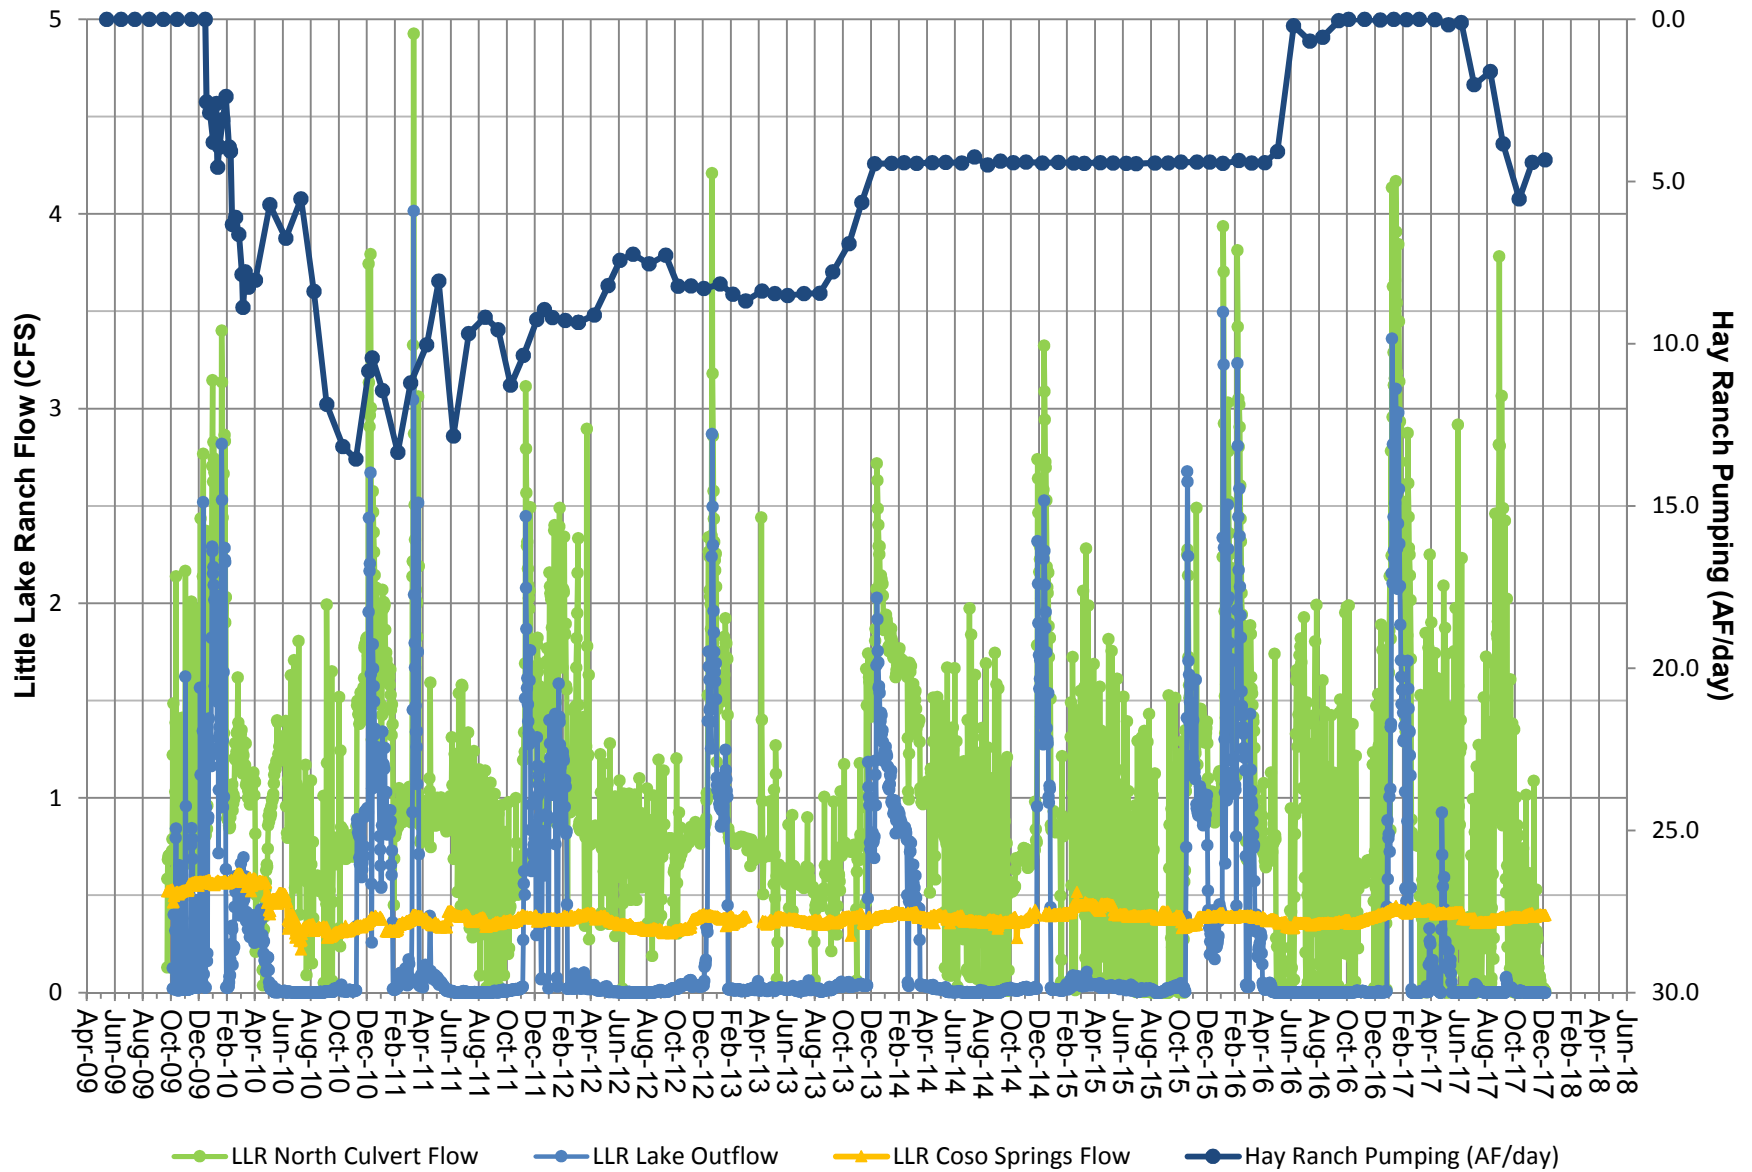
Note: Little Lake Ranch Flows are cubic feet per second.
 Hay Ranch pumping is average acre feet per day.

A hydrograph which compares surface water flows in the Little Lake Ranch area to Hay Ranch Project pumping rates over time is also included in this report as Figure 13. Surface water flows from Lake Outflow, Coso Springs Flow and North Culvert Flow are listed on the left axis, in cubic feet per second. Hay Ranch Project average daily pumping amounts, in acre-feet per day, are listed on the right axis in inverse order. As noted in Section 3.3, surface flow captured by the North Culvert Flow flume represents an accumulation of surface flows from Little Lake, Coso Springs and the Siphon Well flow.

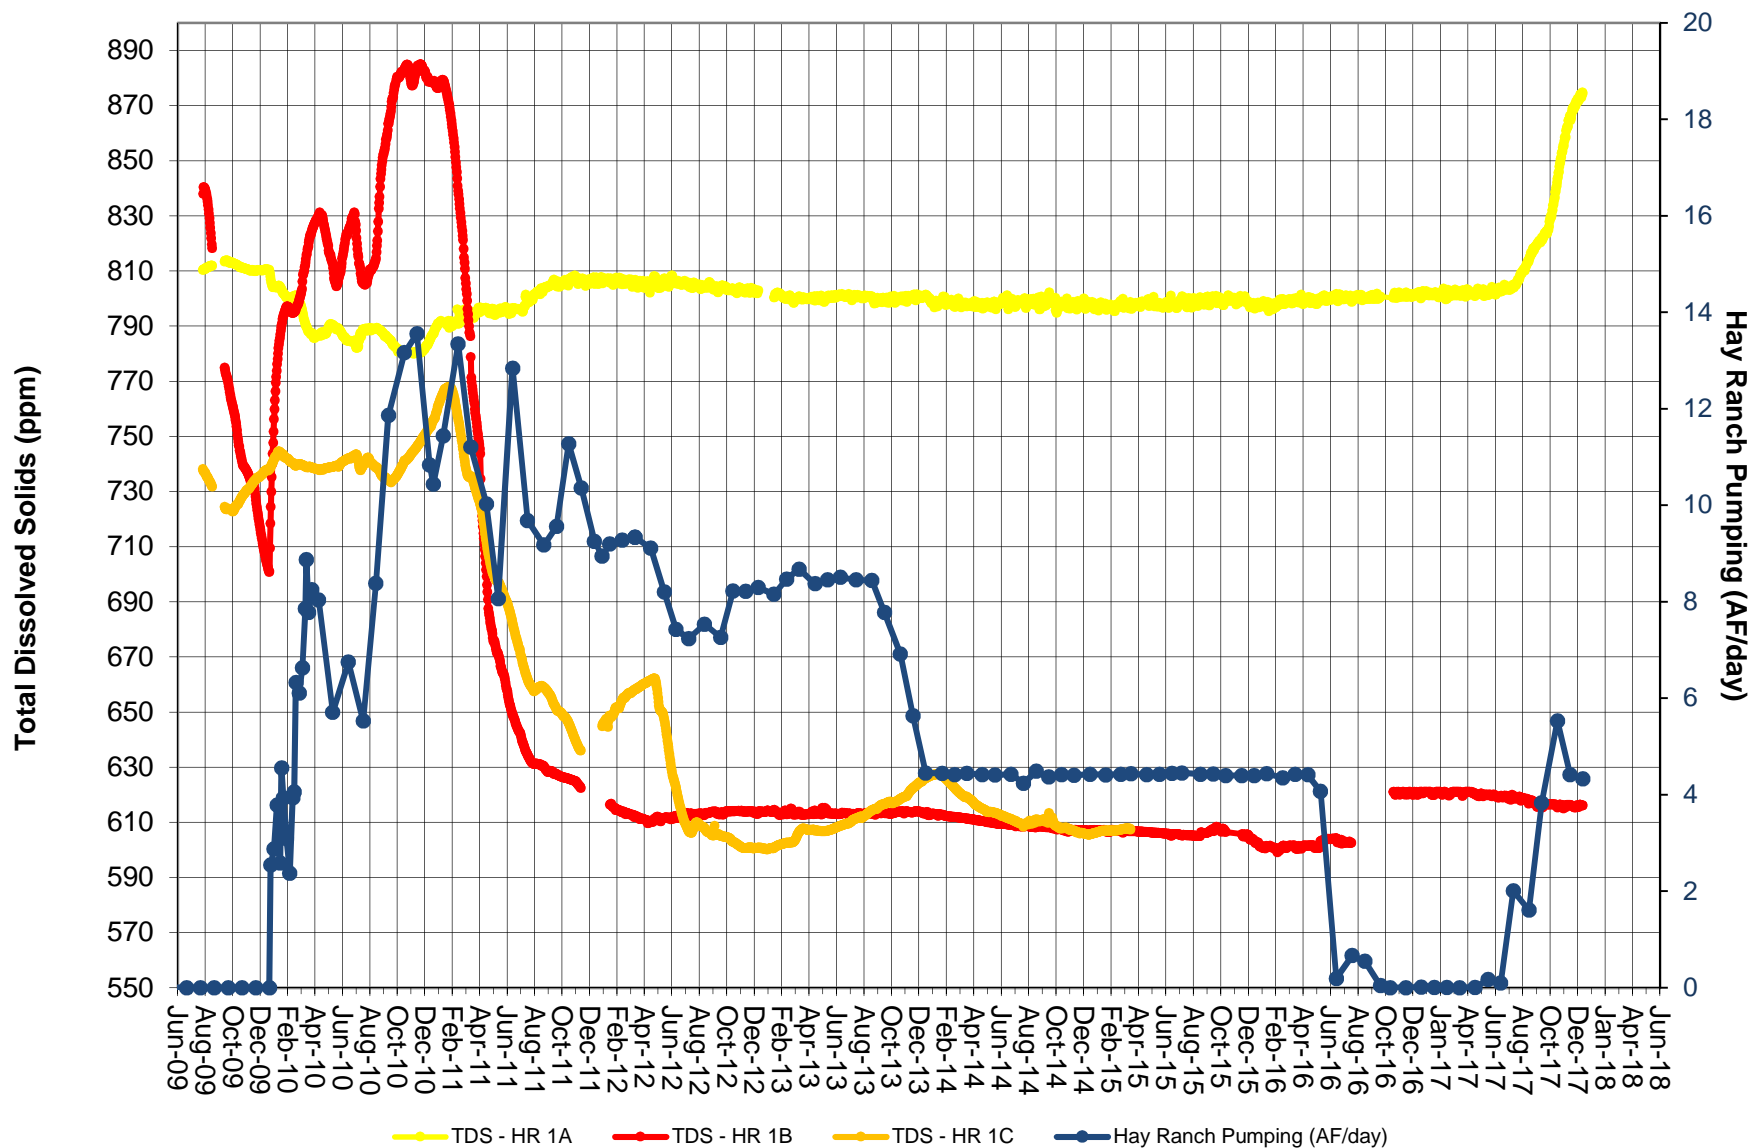
Note:
Screened intervals: HR 1A 170-260 feet; HR 1B 490-540 feet; HR 1C 340-405 feet.
HR 1A, 1B and 1C data gaps due to transducer malfunction or adjustment.
PT removed from HR1C in March 2015.

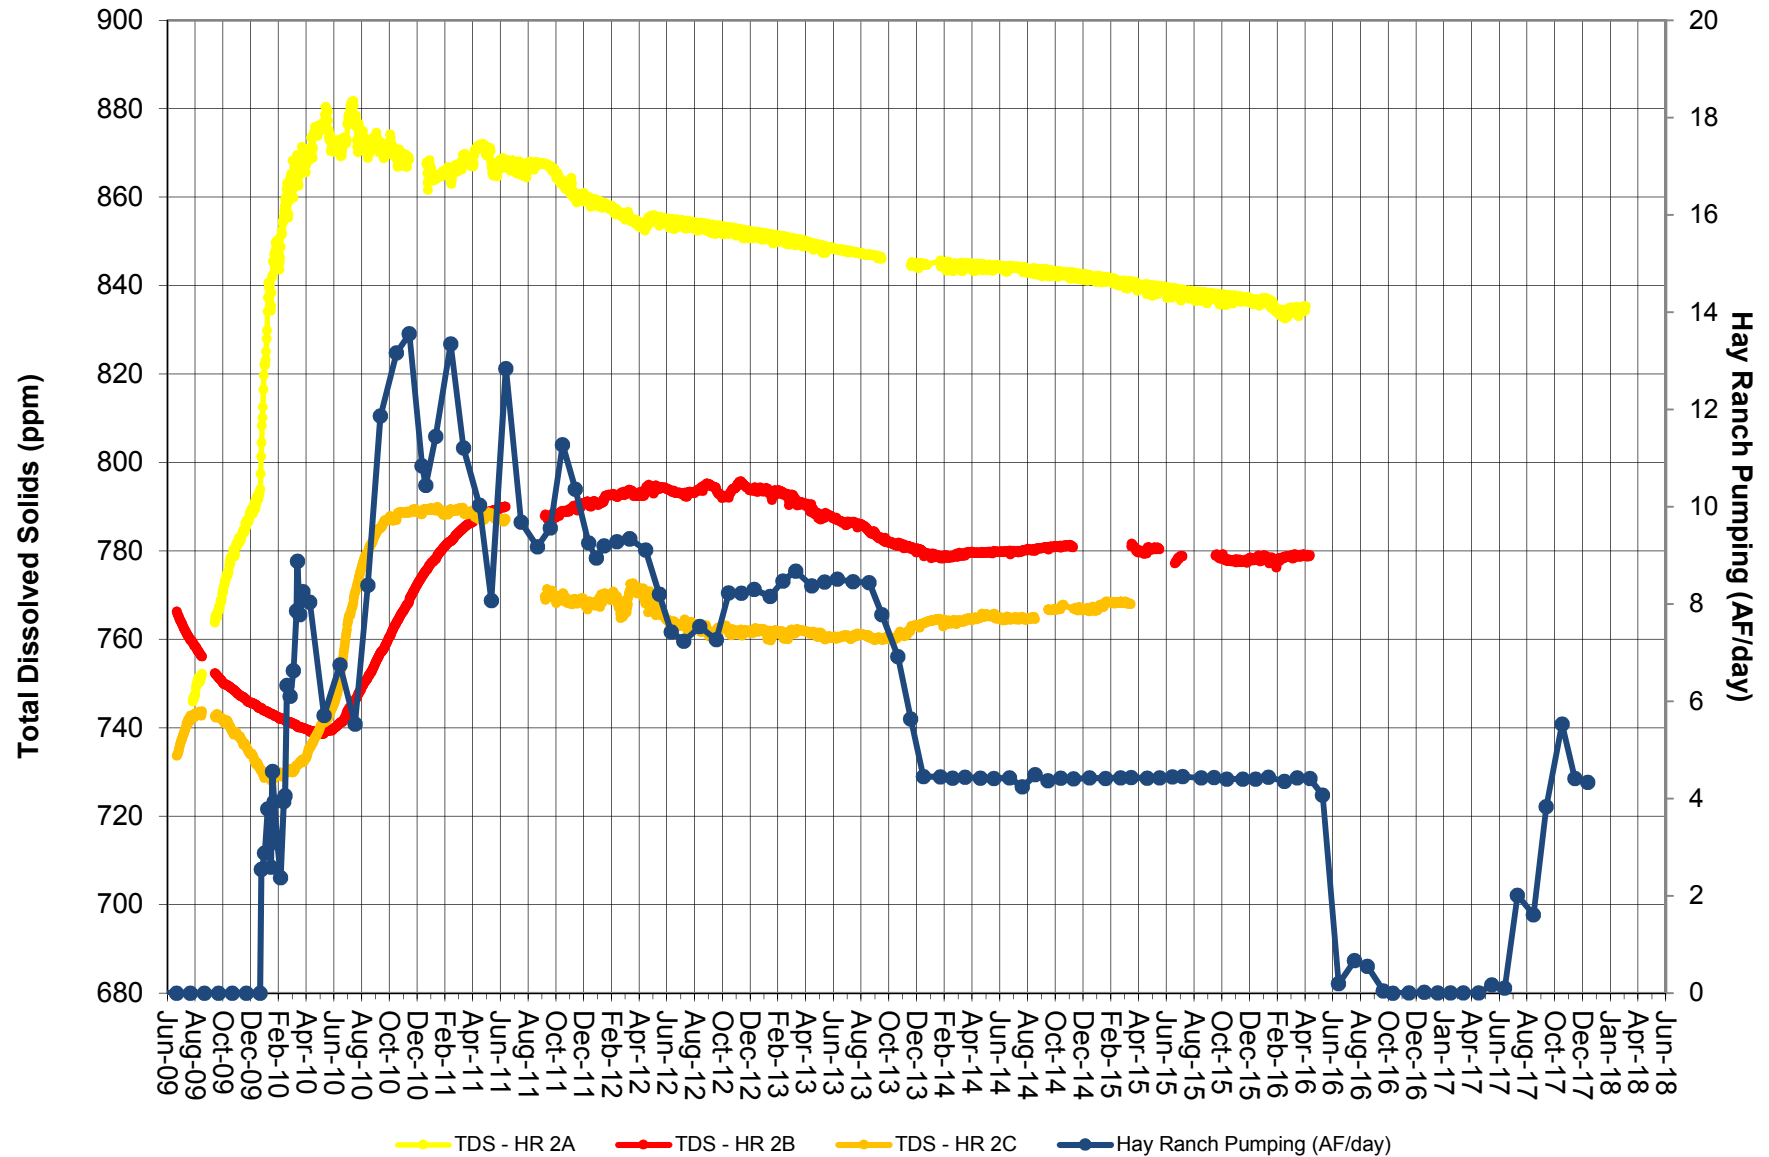
Note: Screened intervals: HR 2A 180-300 feet; HR 2B 519-584 feet; HR 2C 370-420 feet.
HR 2A, and 2B no longer record TDS as of April 2016.
PT removed from HR2C in March 2015.

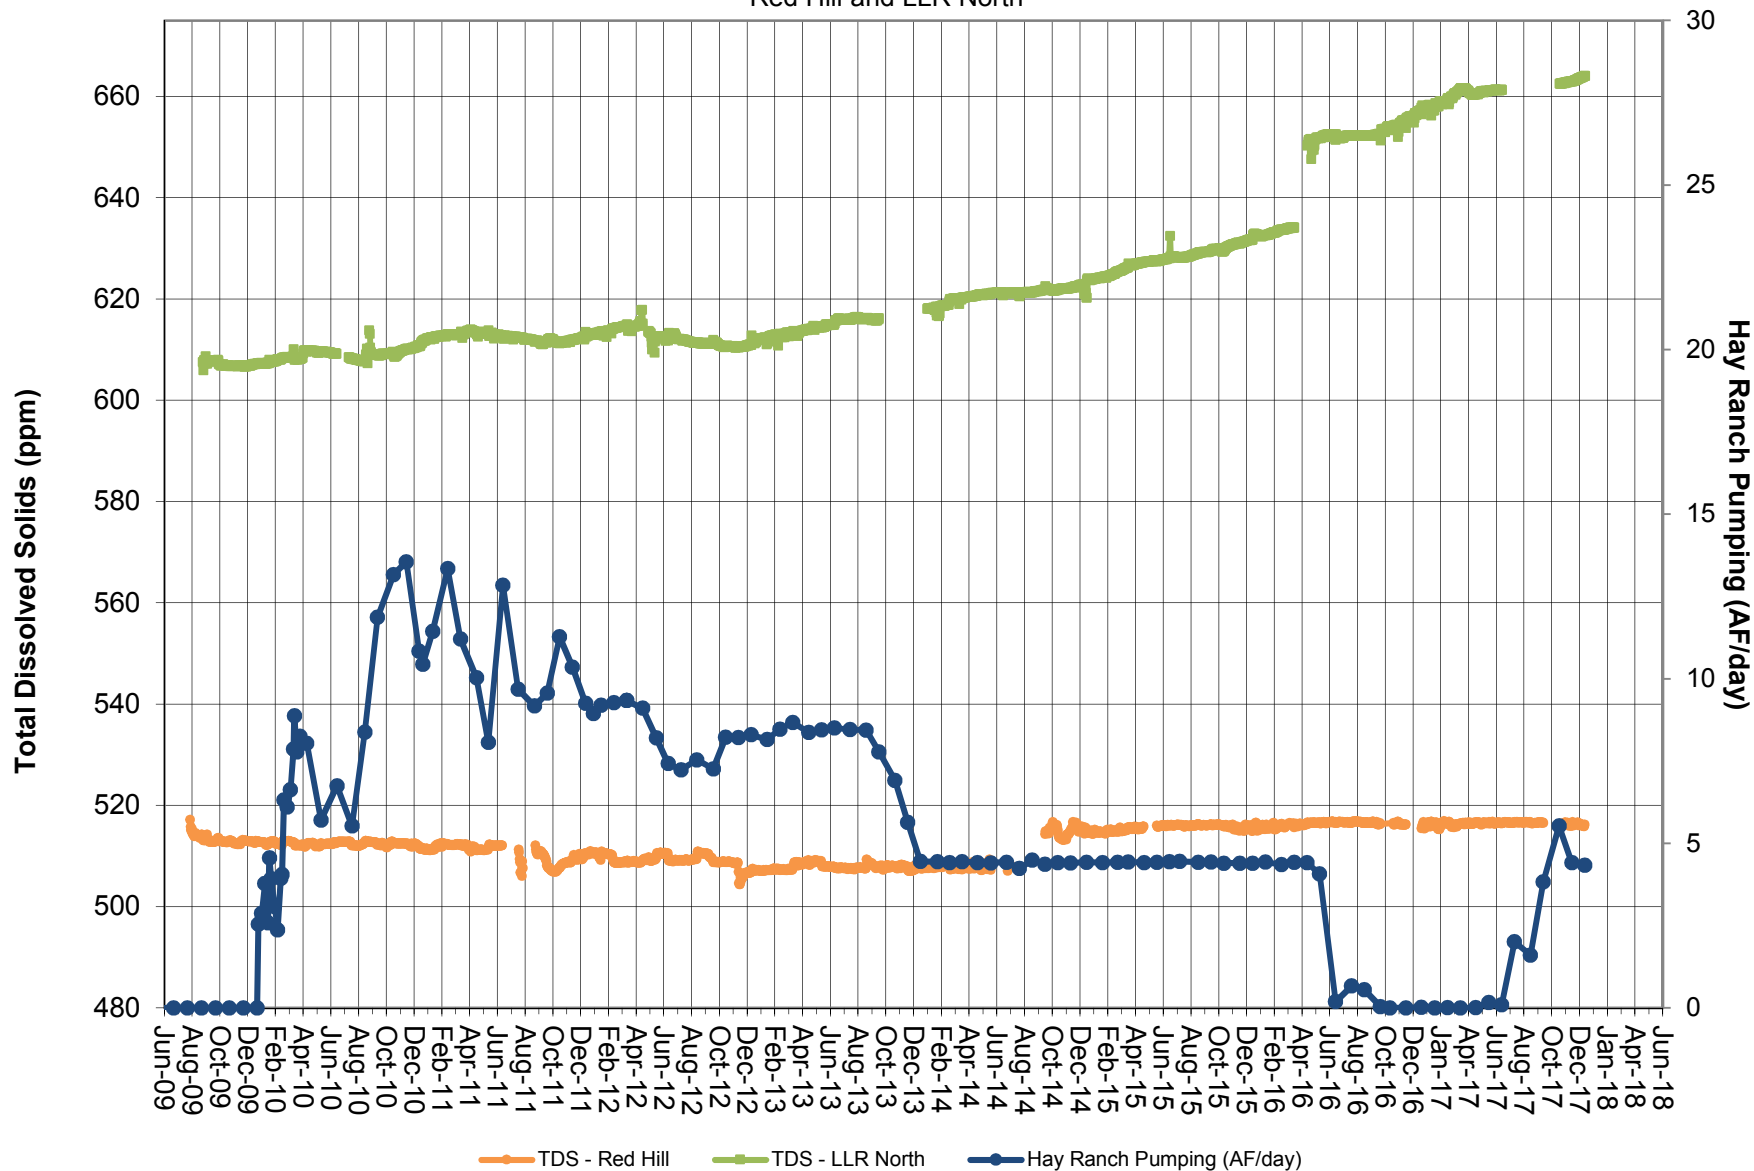
Note: TDS data from in-well transducers. Hay Ranch pumping is average acre feet per day.
Coso Operating initiated Hay Ranch Project pumping on 12/25/09.
Red Hill and LLR North data gaps due to transducer malfunction.

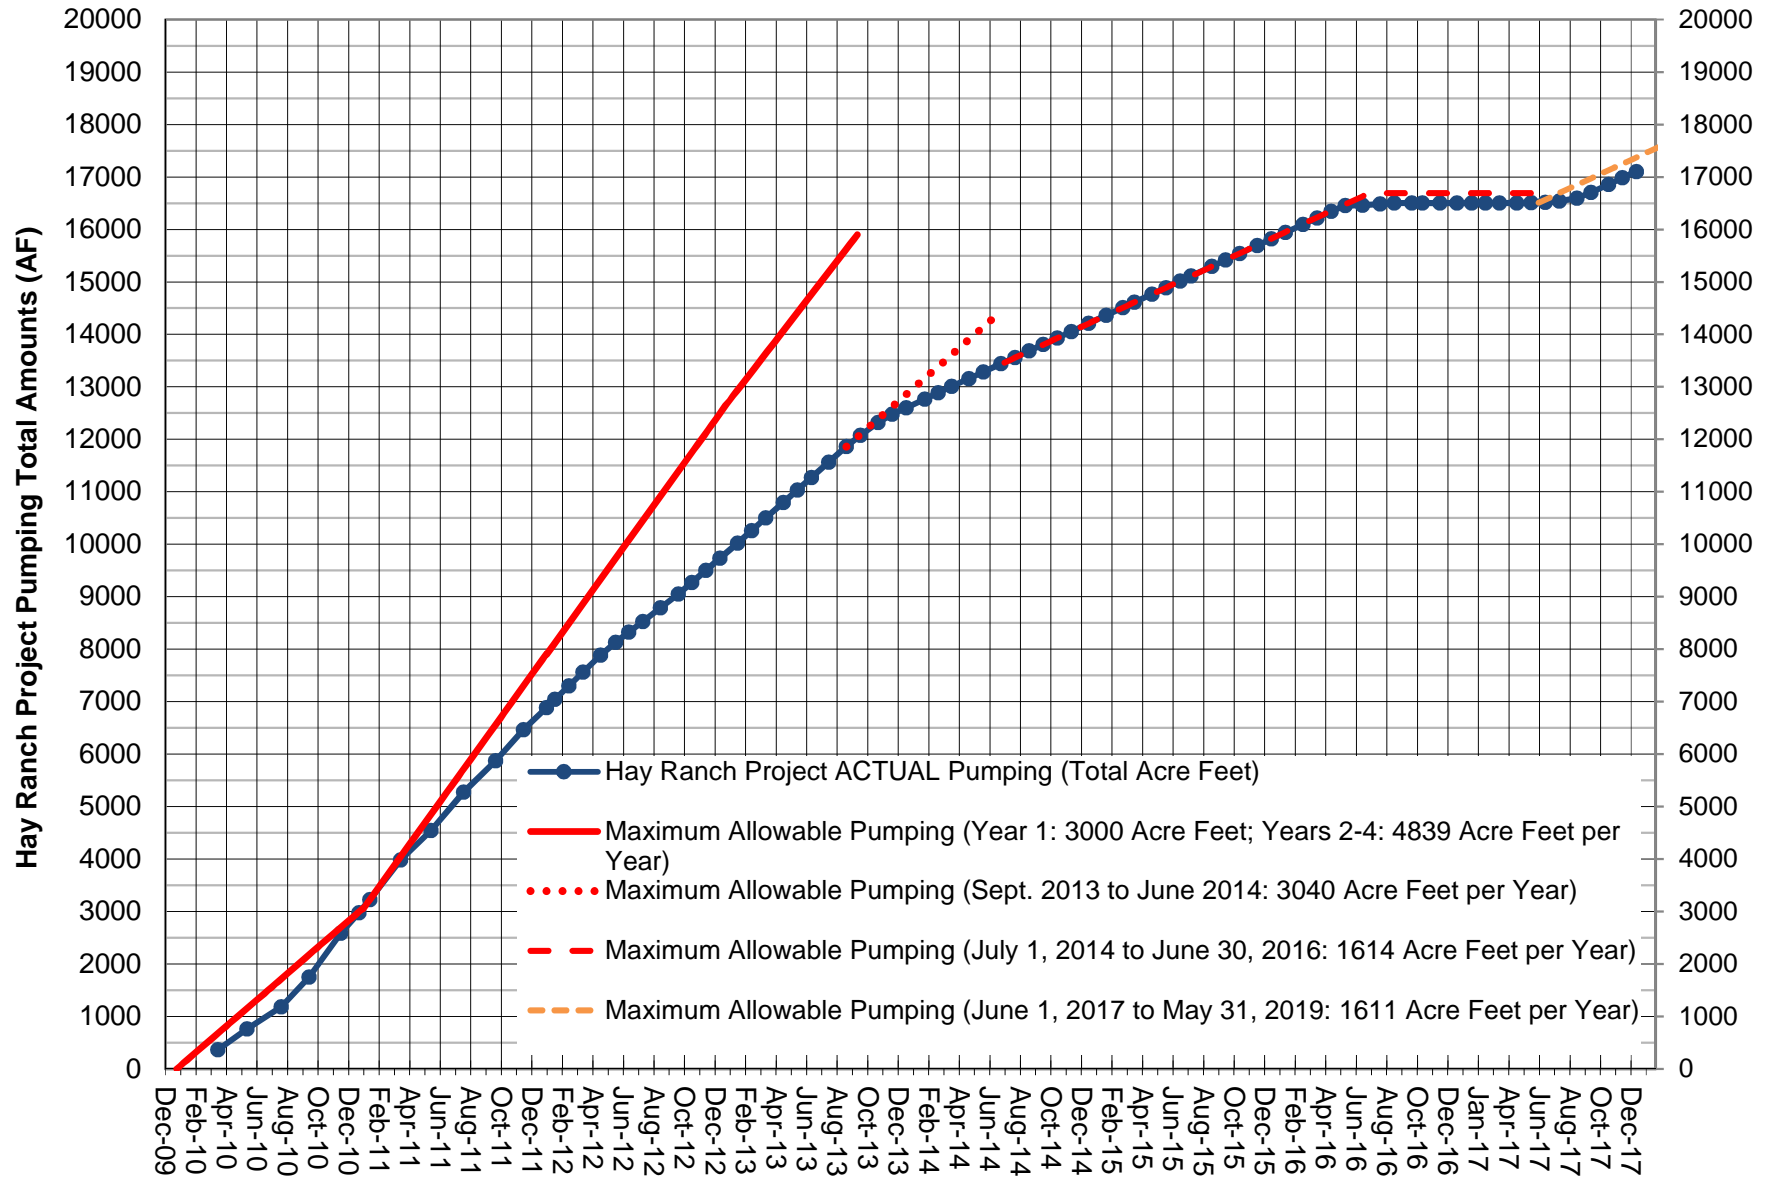
Note: Project pumping initiated 12/25/09. Maximum Allowable pumping rate was 3000 AF/yr for 12/09 to 12/10, 4839 AF/yr for 1/11-8/13, 3040 AF/yr for 9/13 to 6/14, 1614 AF/yr from 7/14 to 6/16 and 1611 AFY for 6/17 to 5/19.

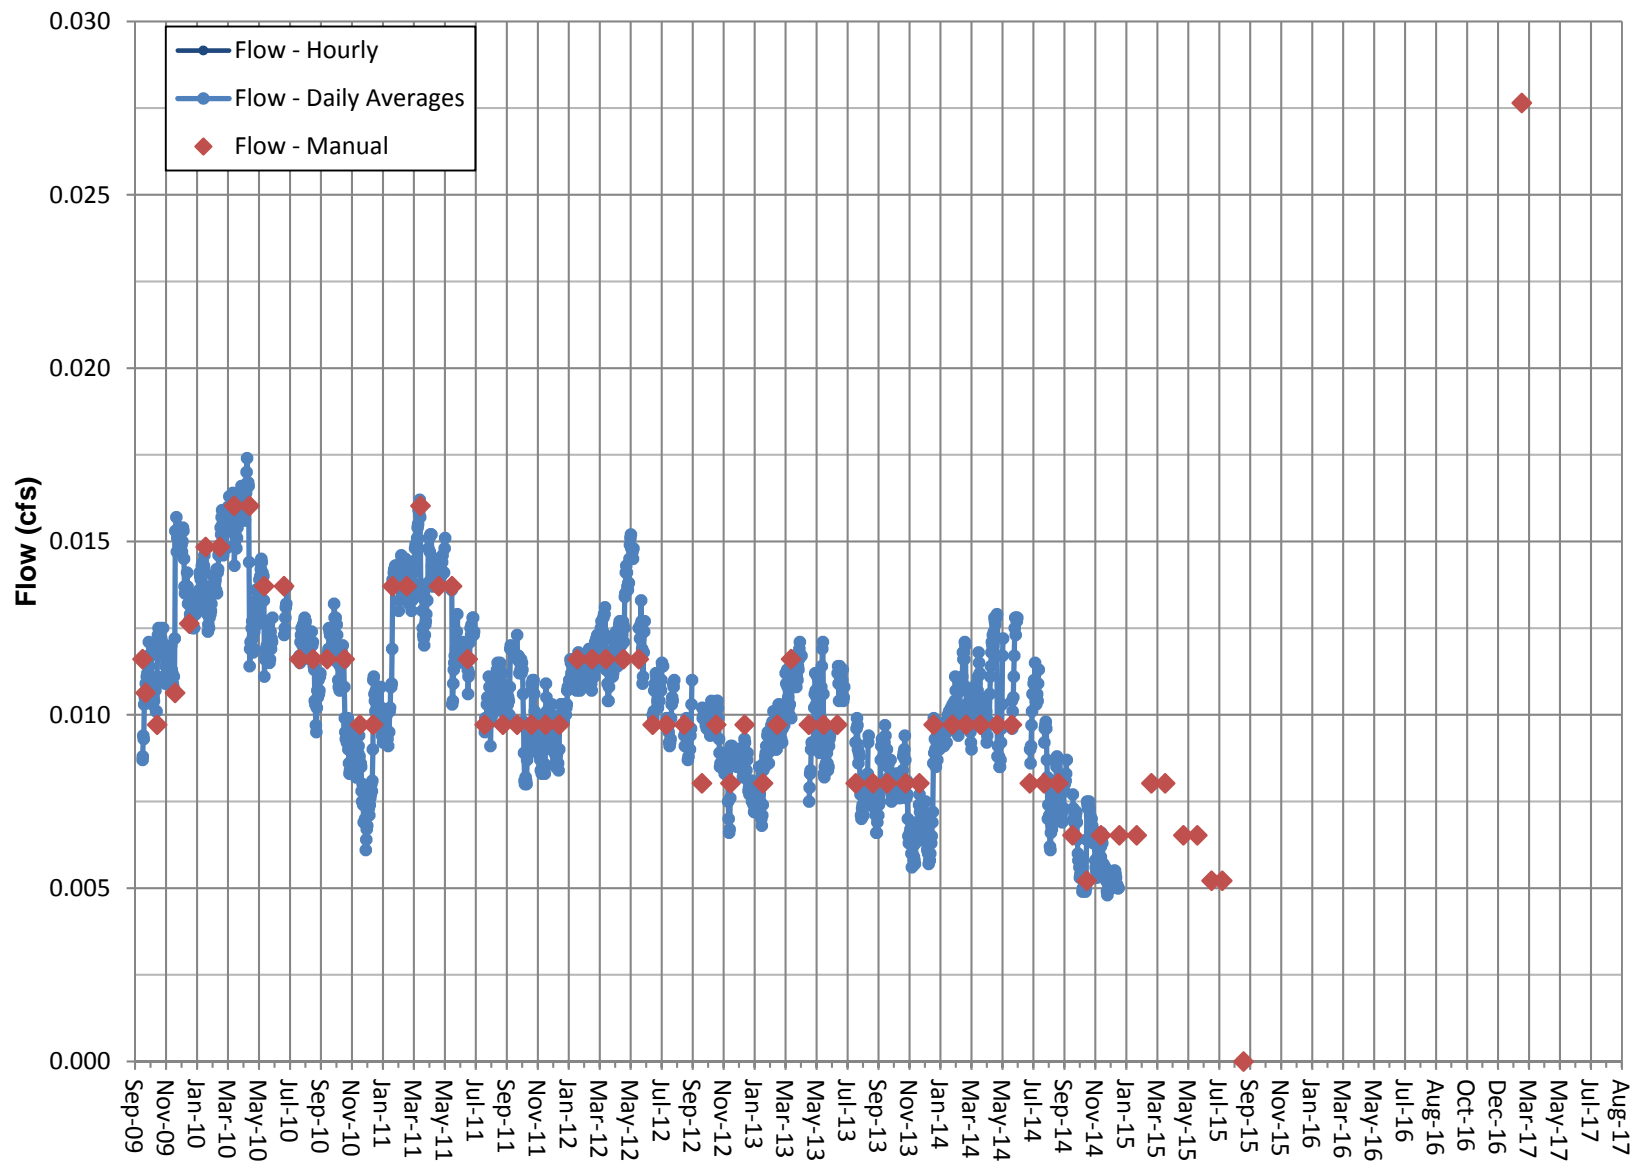
Note: Transducer removed in 2015, water supply pump was installed in DR South Well in July 2015. Pumped water can now bypass flume, flow not monitored as of Sept. 2015.
