HAY RANCH PROJECT CONDITIONAL USE PERMIT HYDROLOGIC MONITORING REPORT

**FIRST QUARTER 2017
INYO COUNTY, CALIFORNIA**

**RE: Hay Ranch Project Conditional Use Permit
Hydrologic Monitoring Report, First Quarter 2017
Inyo County, California**

TEAM Engineering & Management, Inc. (TEAM), is pleased to present the results of hydrologic monitoring activities, relating to the Hay Ranch Project Conditional Use Permit (#2007-003), conducted in Rose Valley from January to March 2017.

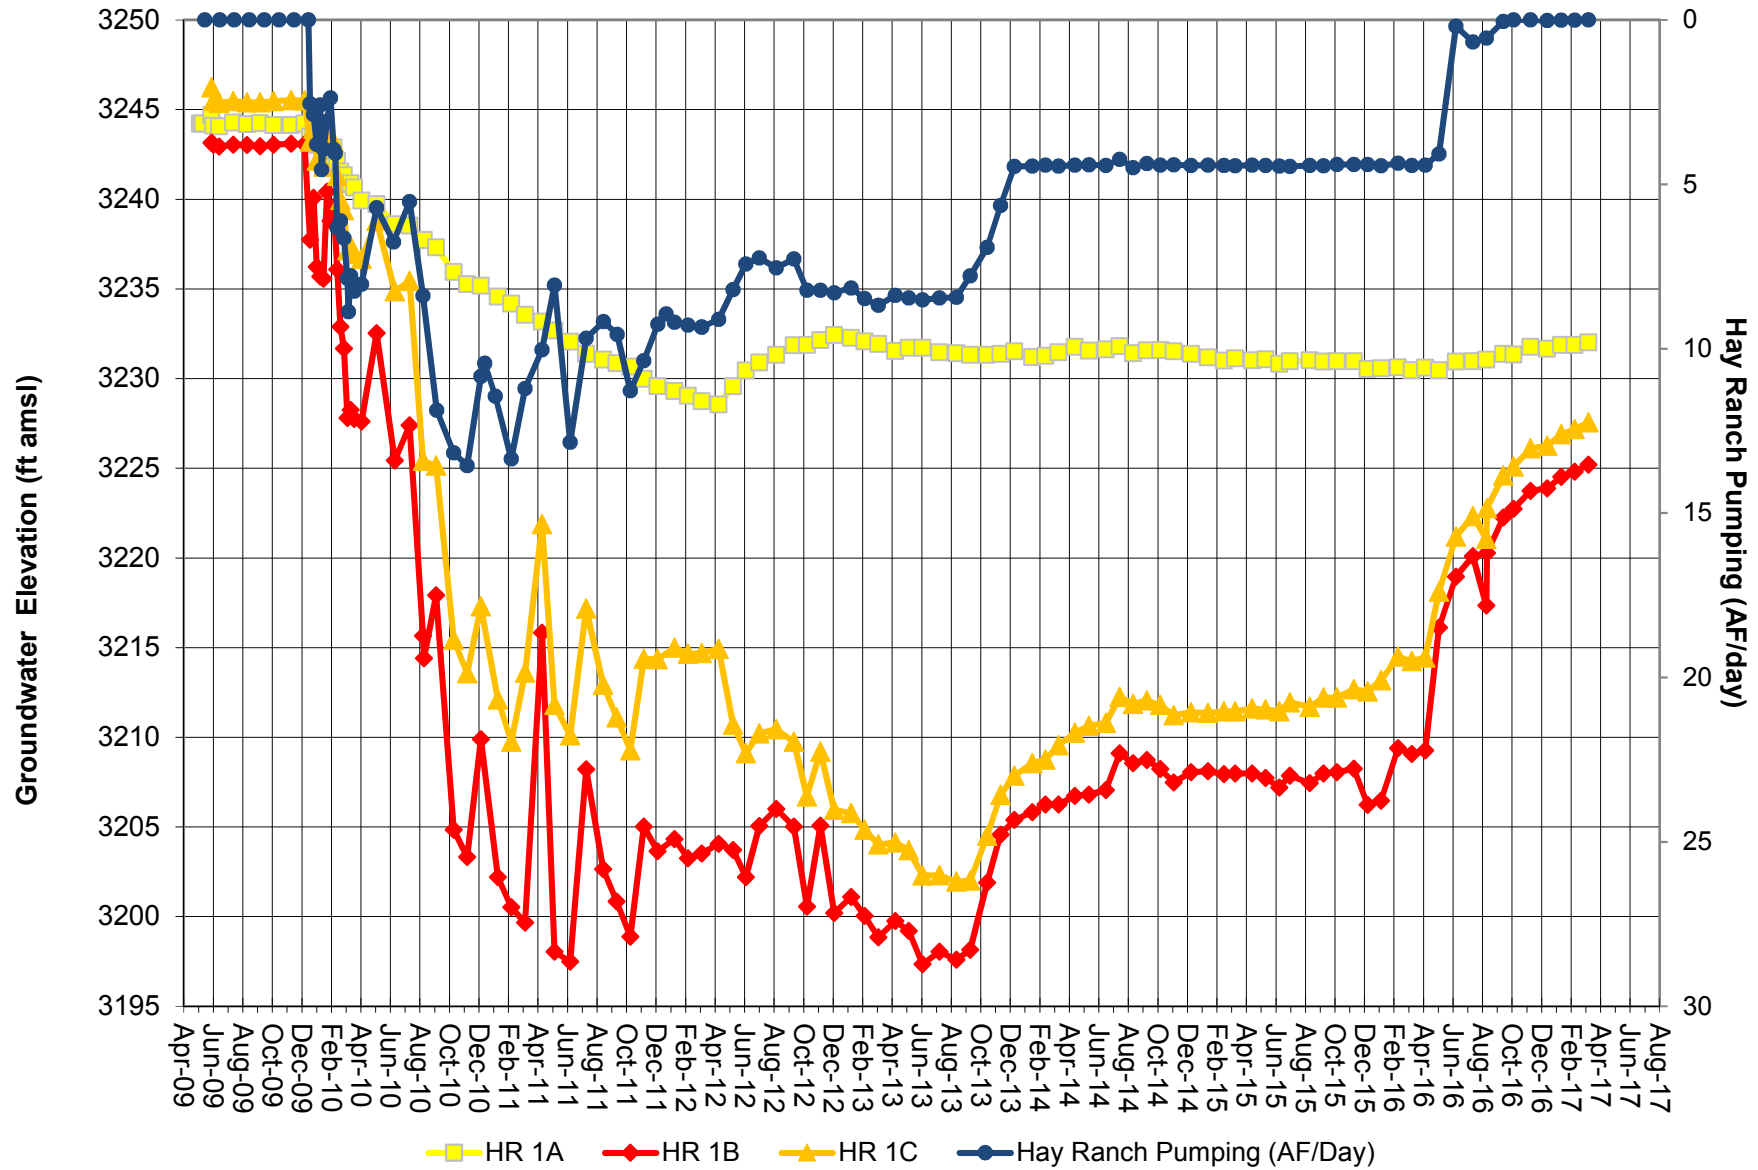
Note: GWE data based on manual DTW measurements. Hay Ranch pumping is average acre feet per day.
Screened intervals: HR 1A 170-260 feet; HR 1B 490-540 feet; HR 1C 340-405 feet.
Coso Operating initiated Hay Ranch Project pumping on 12/25/09.

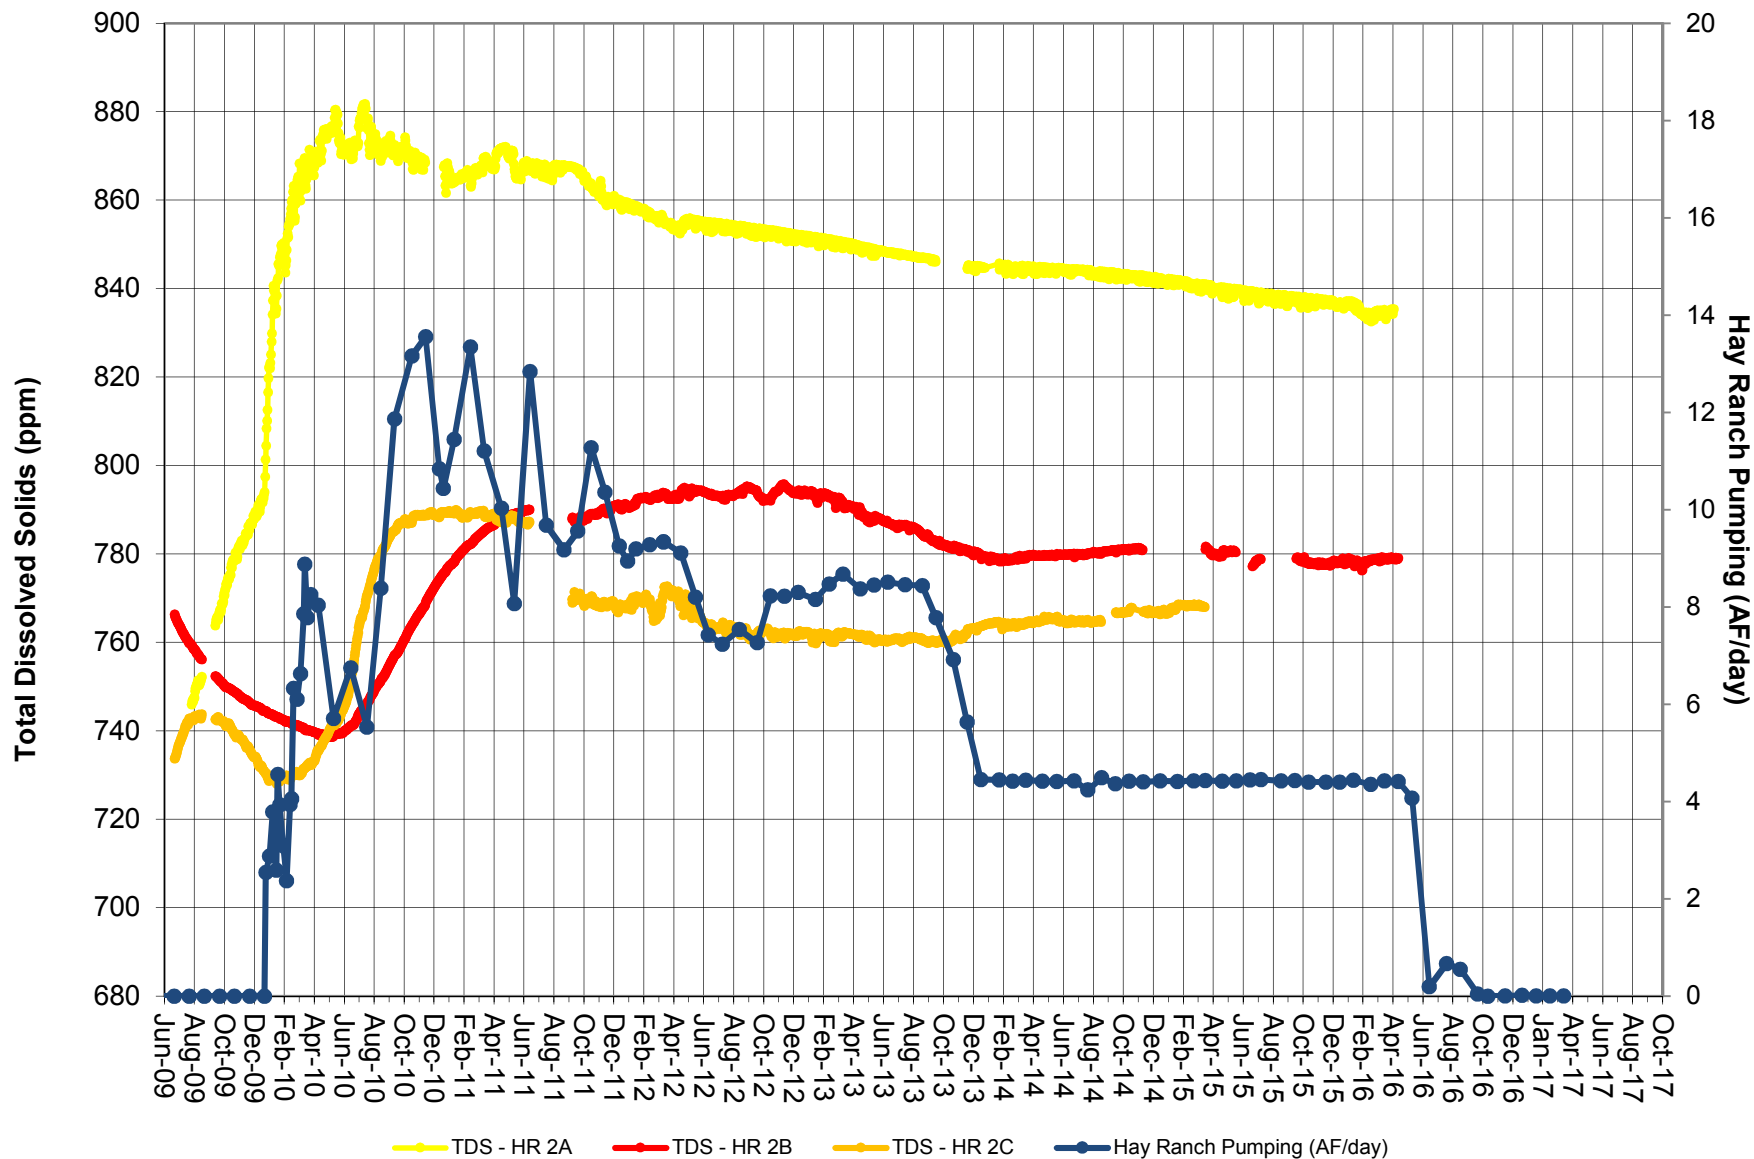
Note: Screened intervals: HR 2A 180-300 feet; HR 2B 519-584 feet; HR 2C 370-420 feet.
HR 2A, and 2B no longer record TDS as of April 2016.
PT removed from HR2C in March 2015.
