HAY RANCH PROJECT CONDITIONAL USE PERMIT HYDROLOGIC MONITORING REPORT

**FIRST QUARTER 2018
INYO COUNTY, CALIFORNIA**

APRIL 13, 2018

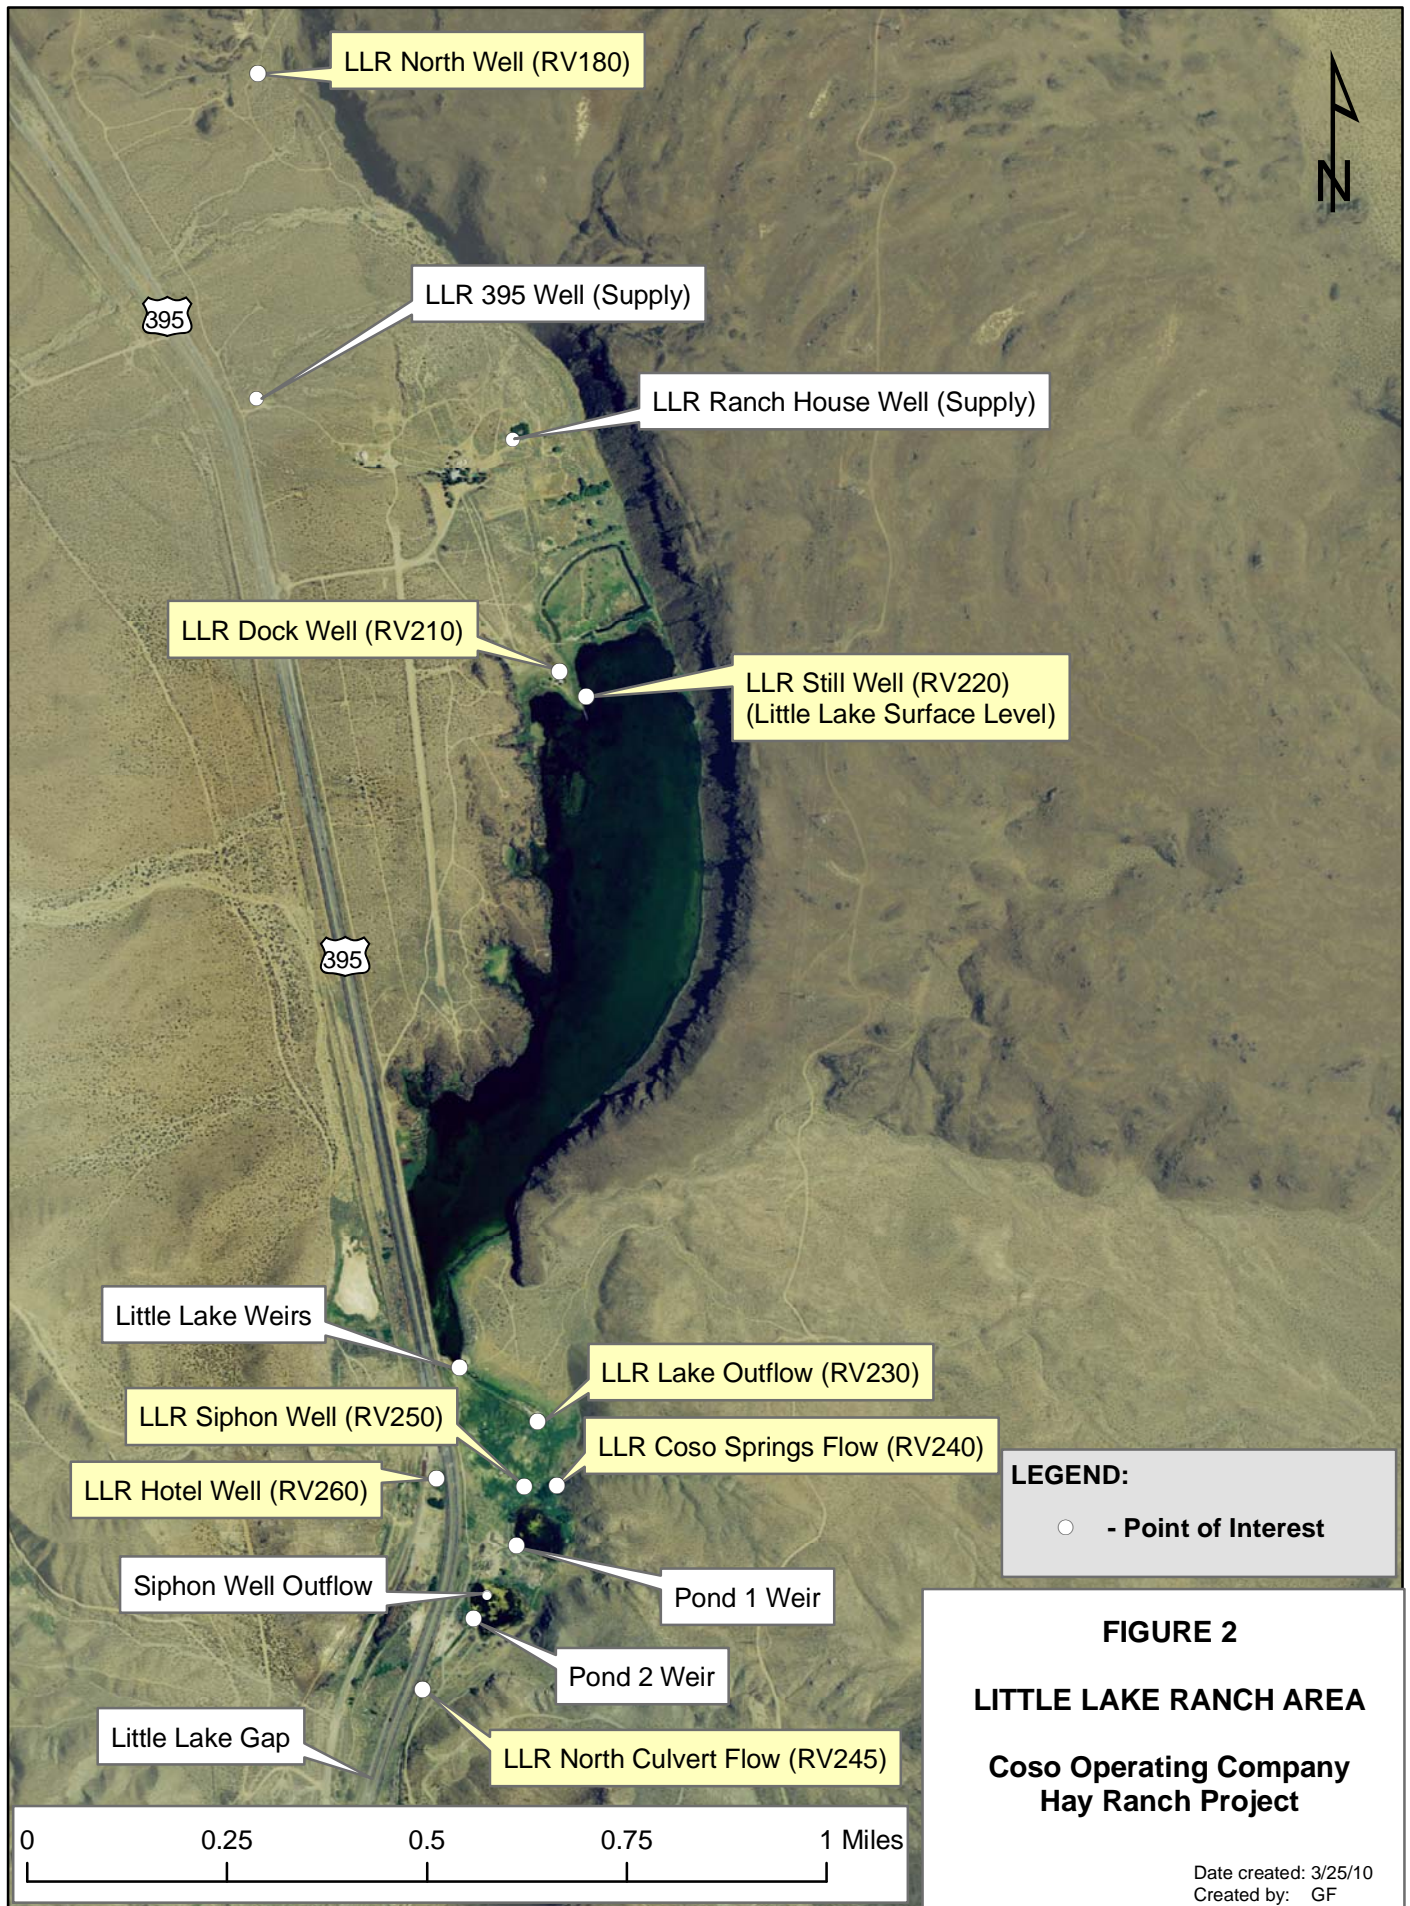
FIGURE 2

LITTLE LAKE RANCH AREA

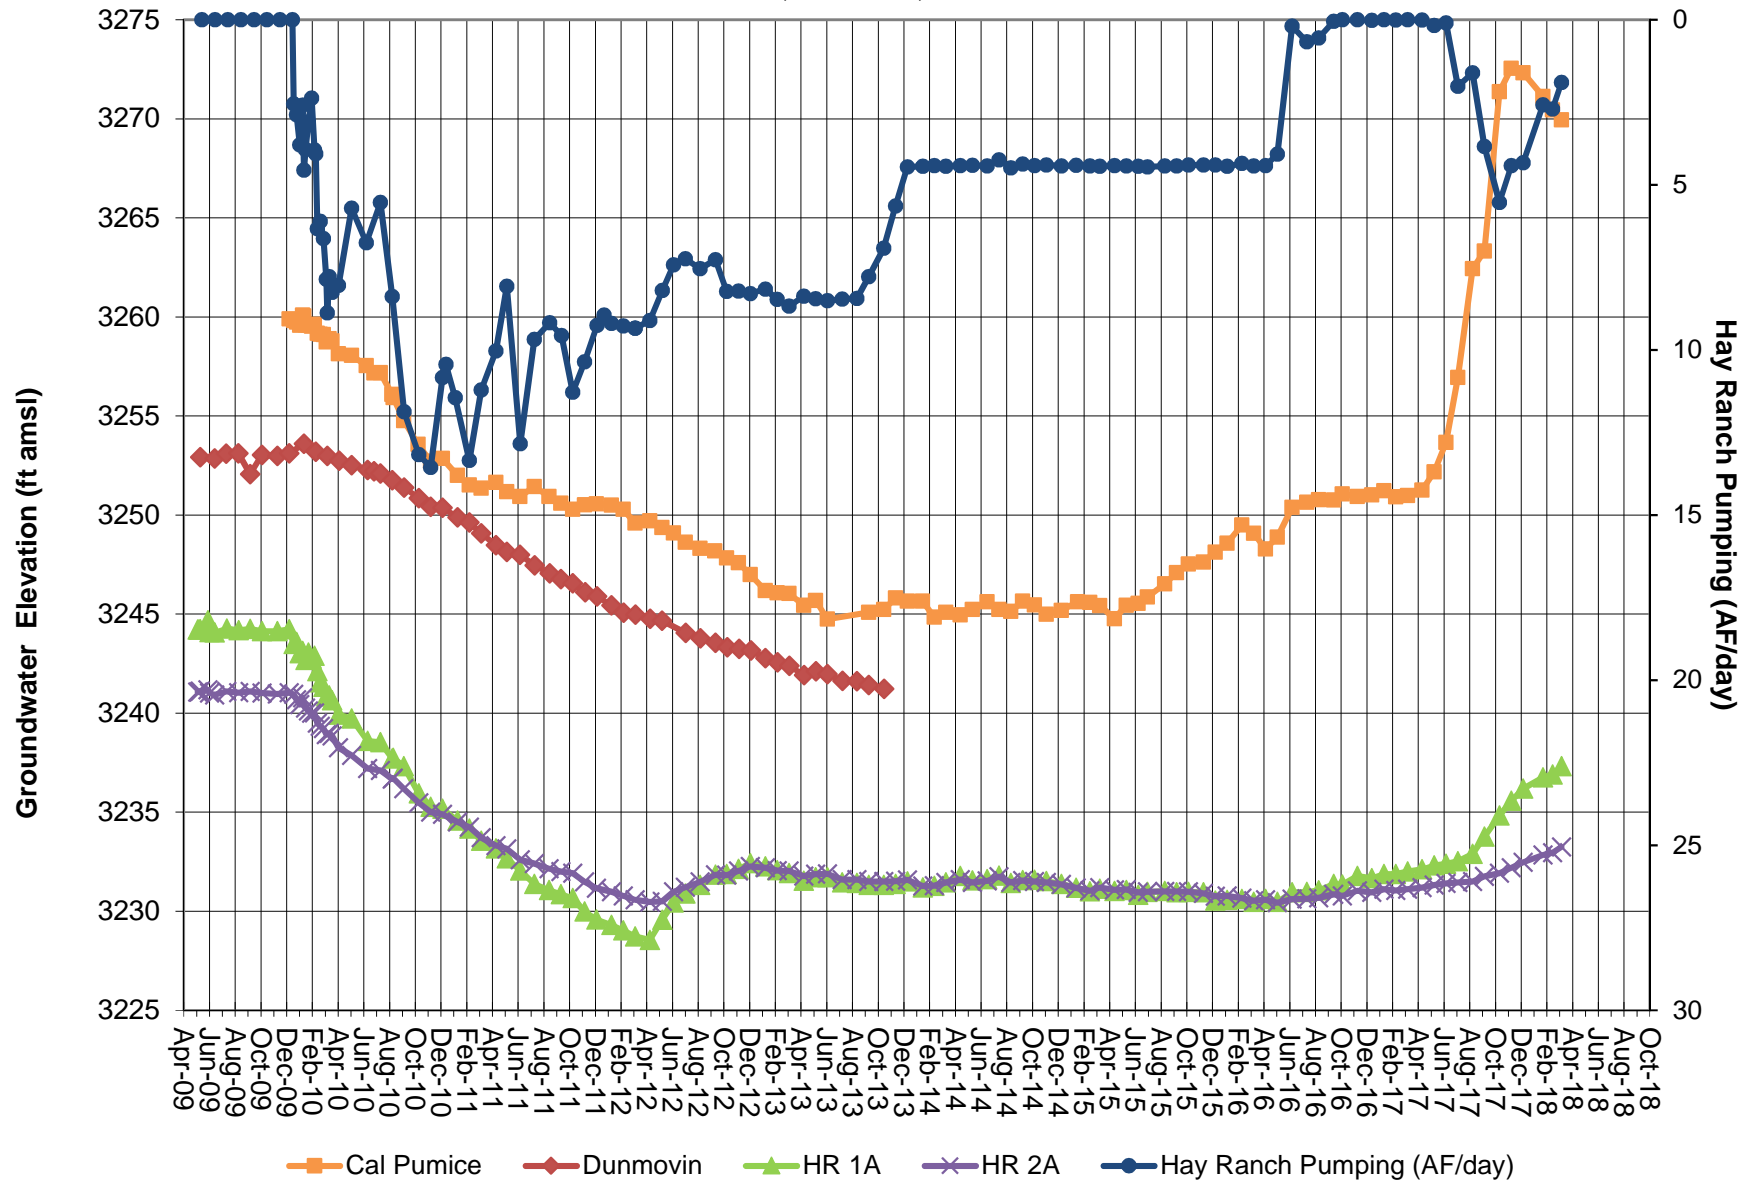
Note: Groundwater elevation data based on manual depth-to-water measurements.
Hay Ranch pumping is average acre feet per day.
Coso Operating initiated Hay Ranch Project pumping on 12/25/09.

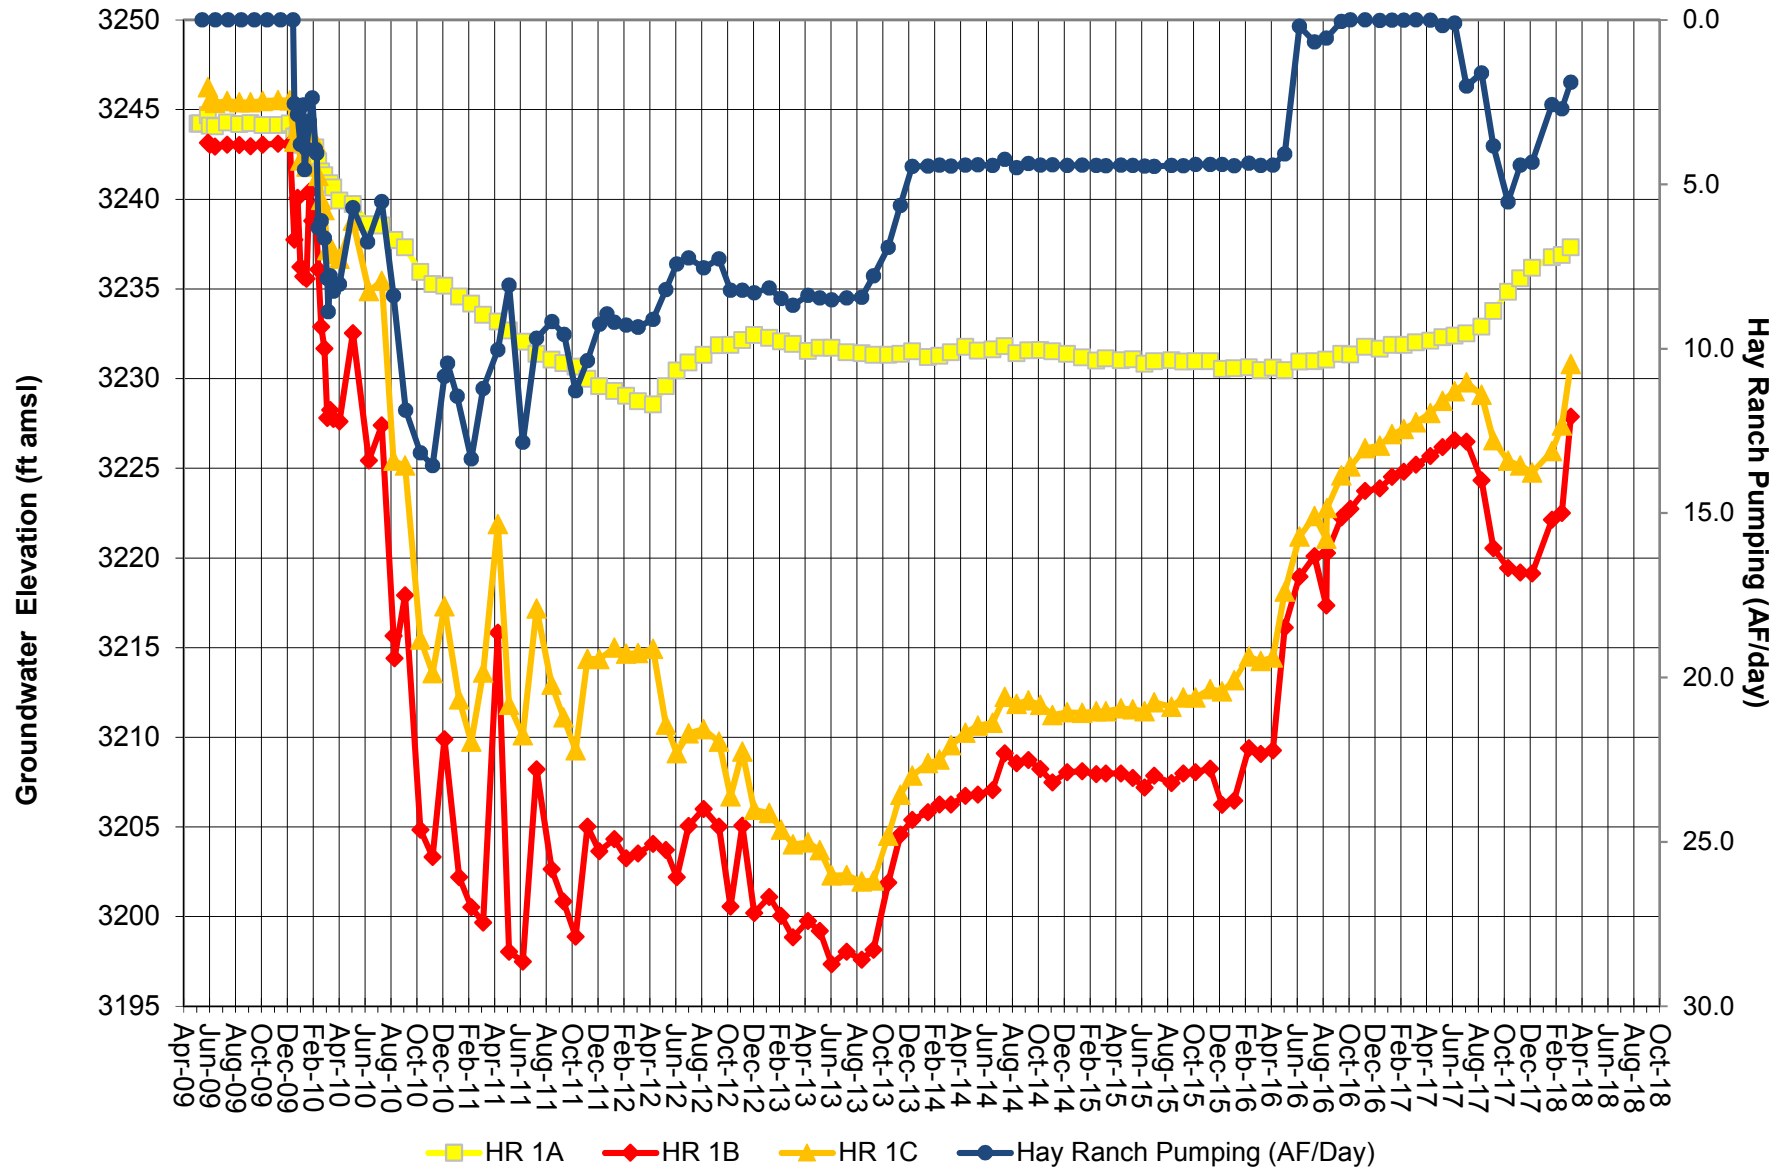
Note: GWE data based on manual DTW measurements. Hay Ranch pumping is average acre feet per day.
Screened intervals: HR 1A 170-260 feet; HR 1B 490-540 feet; HR 1C 340-405 feet.
Coso Operating initiated Hay Ranch Project pumping on 12/25/09.

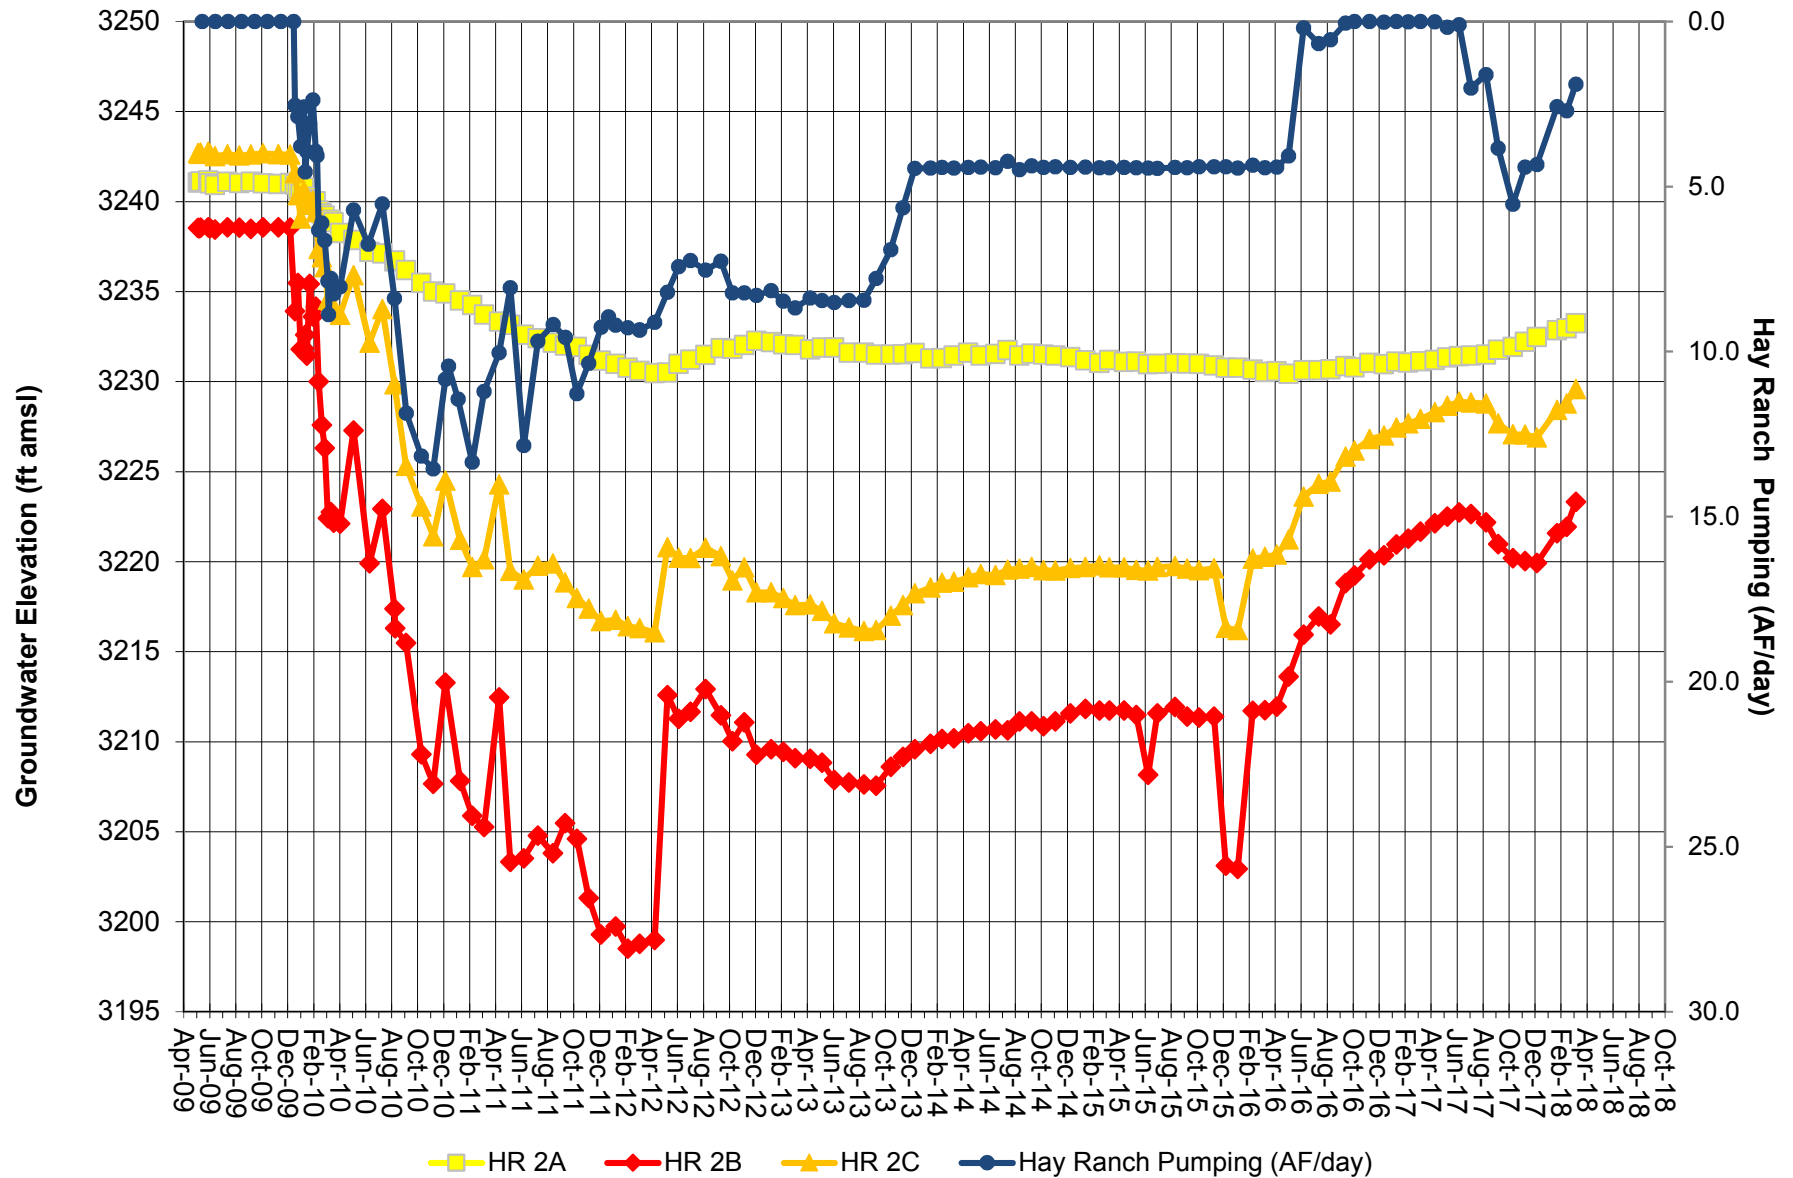
Note: GWE data based on manual DTW measurements. Hay Ranch pumping is average acre feet per day.
Screened intervals: HR 2A 180-300 feet; HR 2B 519-584 feet; HR 2C 370-420 feet.
Coso Operating initiated Hay Ranch Project pumping on 12/25/09.

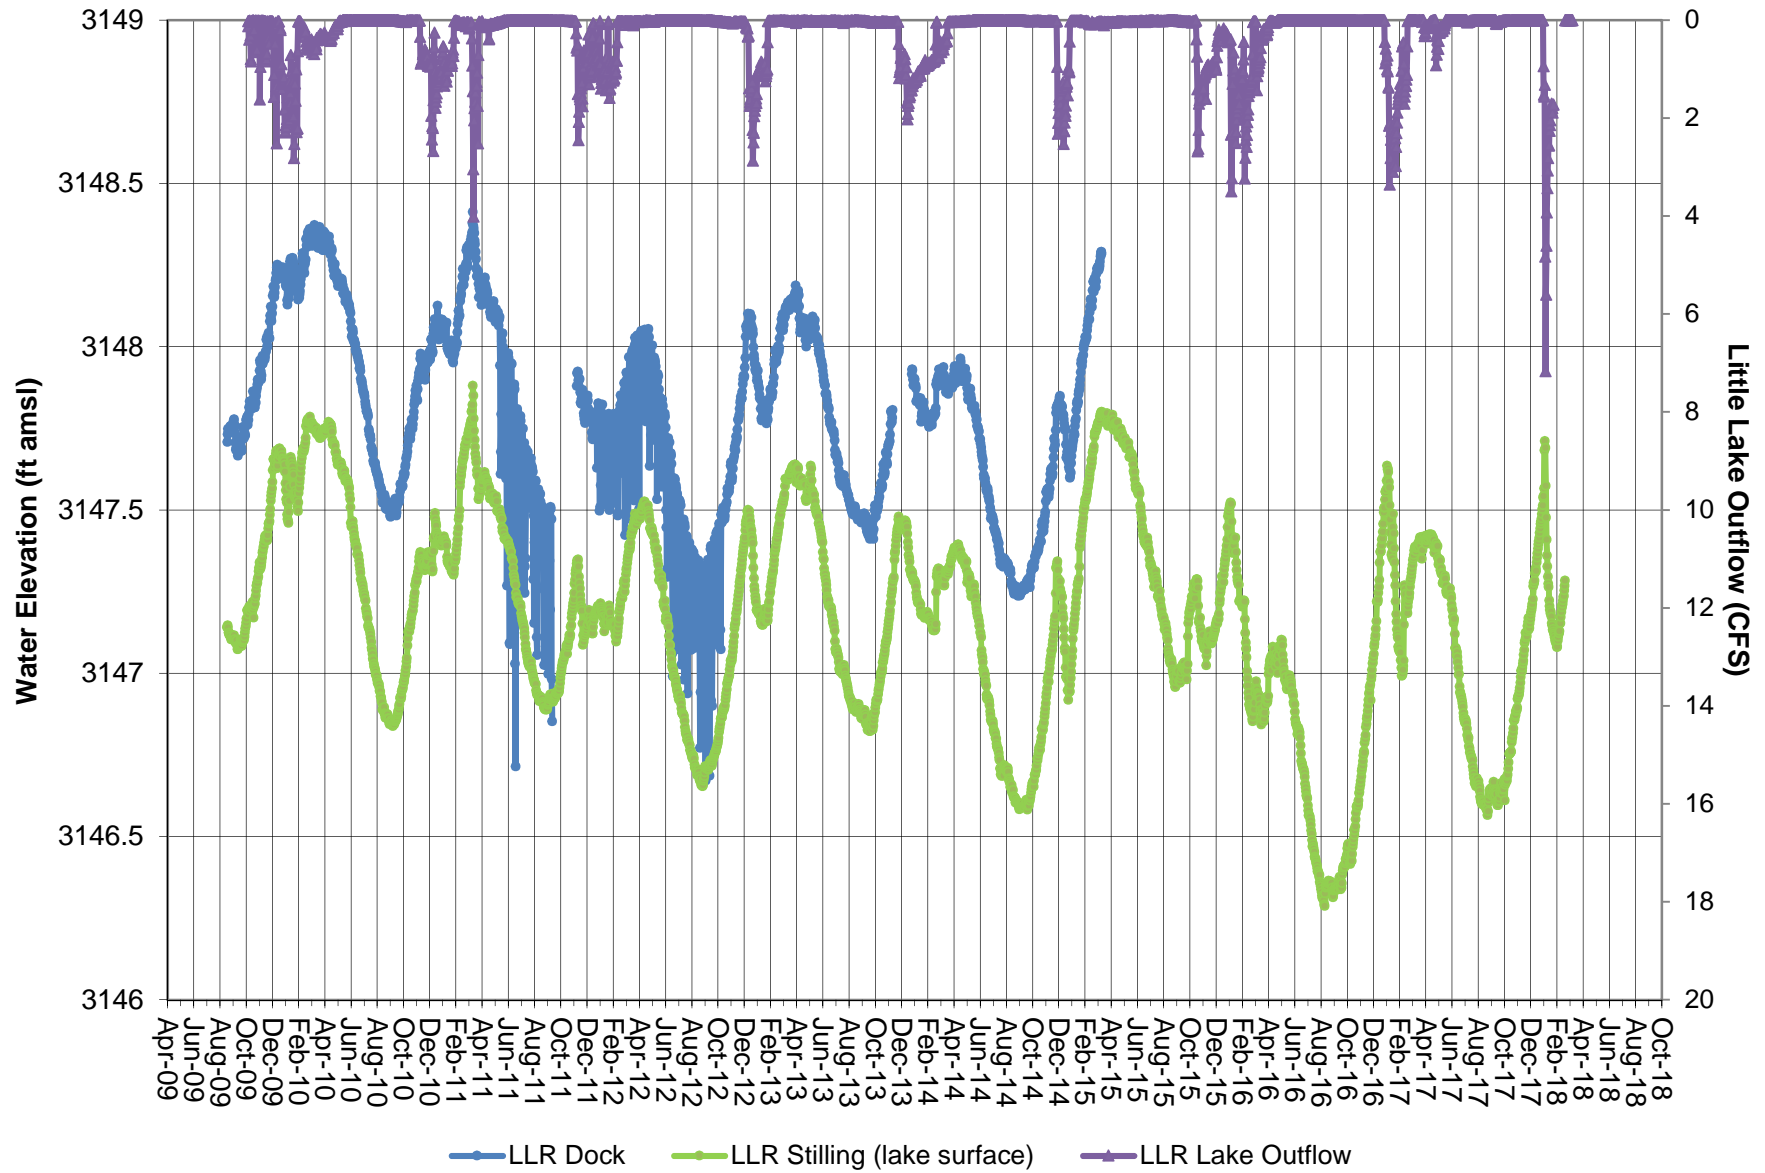
Note: Little Lake Outflow in cubic feet per second.
 LLR staff conducted water intermittent pumping from 2011-2012.
 Pressure Transducer removed from Dock Well in March 2015.

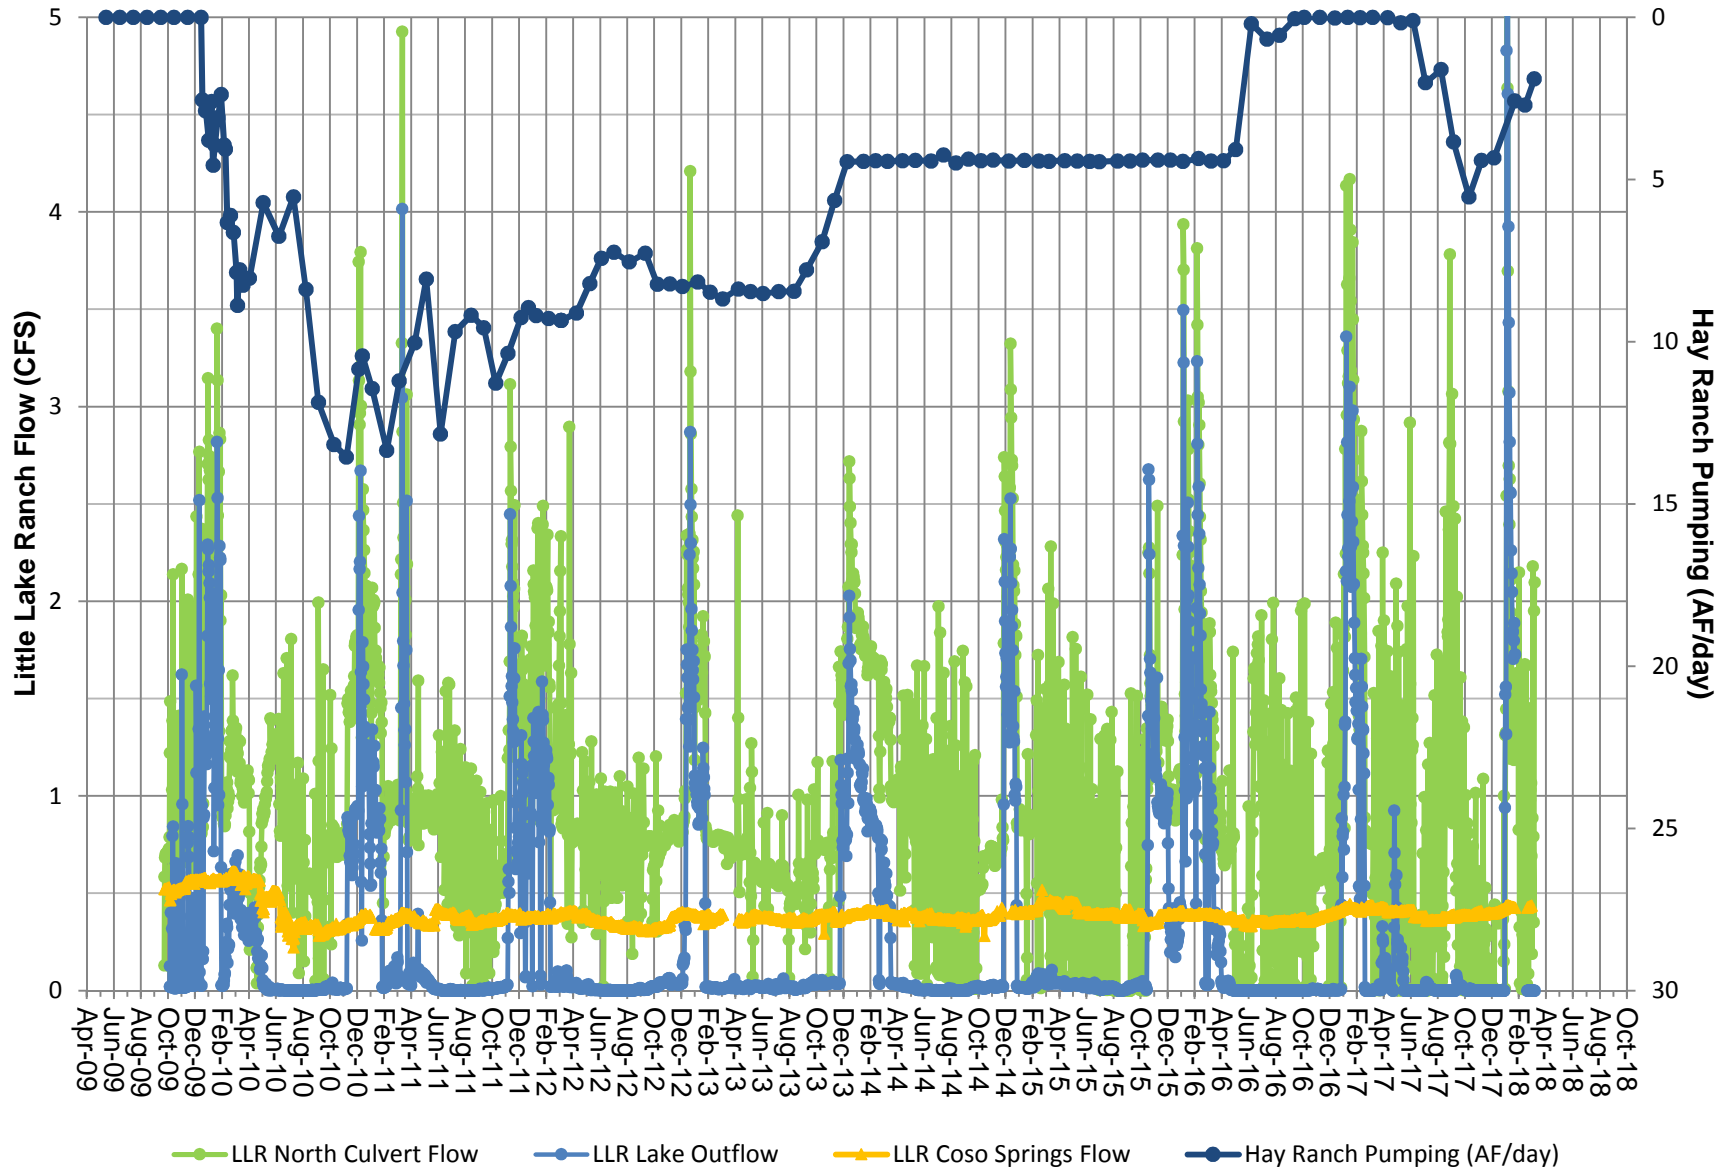
Note: Little Lake Ranch Flows are cubic feet per second.
Hay Ranch pumping is average acre feet per day.

A hydrograph which compares surface water flows in the Little Lake Ranch area to Hay Ranch Project pumping rates over time is also included in this report as Figure 13. Surface water flows from Lake Outflow, Coso Springs Flow and North Culvert Flow are listed on the left axis, in cubic feet per second. Hay Ranch Project average daily pumping amounts, in acre-feet per day, are listed on the right axis in inverse order. As noted in Section 3.3, surface flow captured by the North Culvert Flow flume represents an accumulation of surface flows from Little Lake, Coso Springs and the Siphon Well flow.

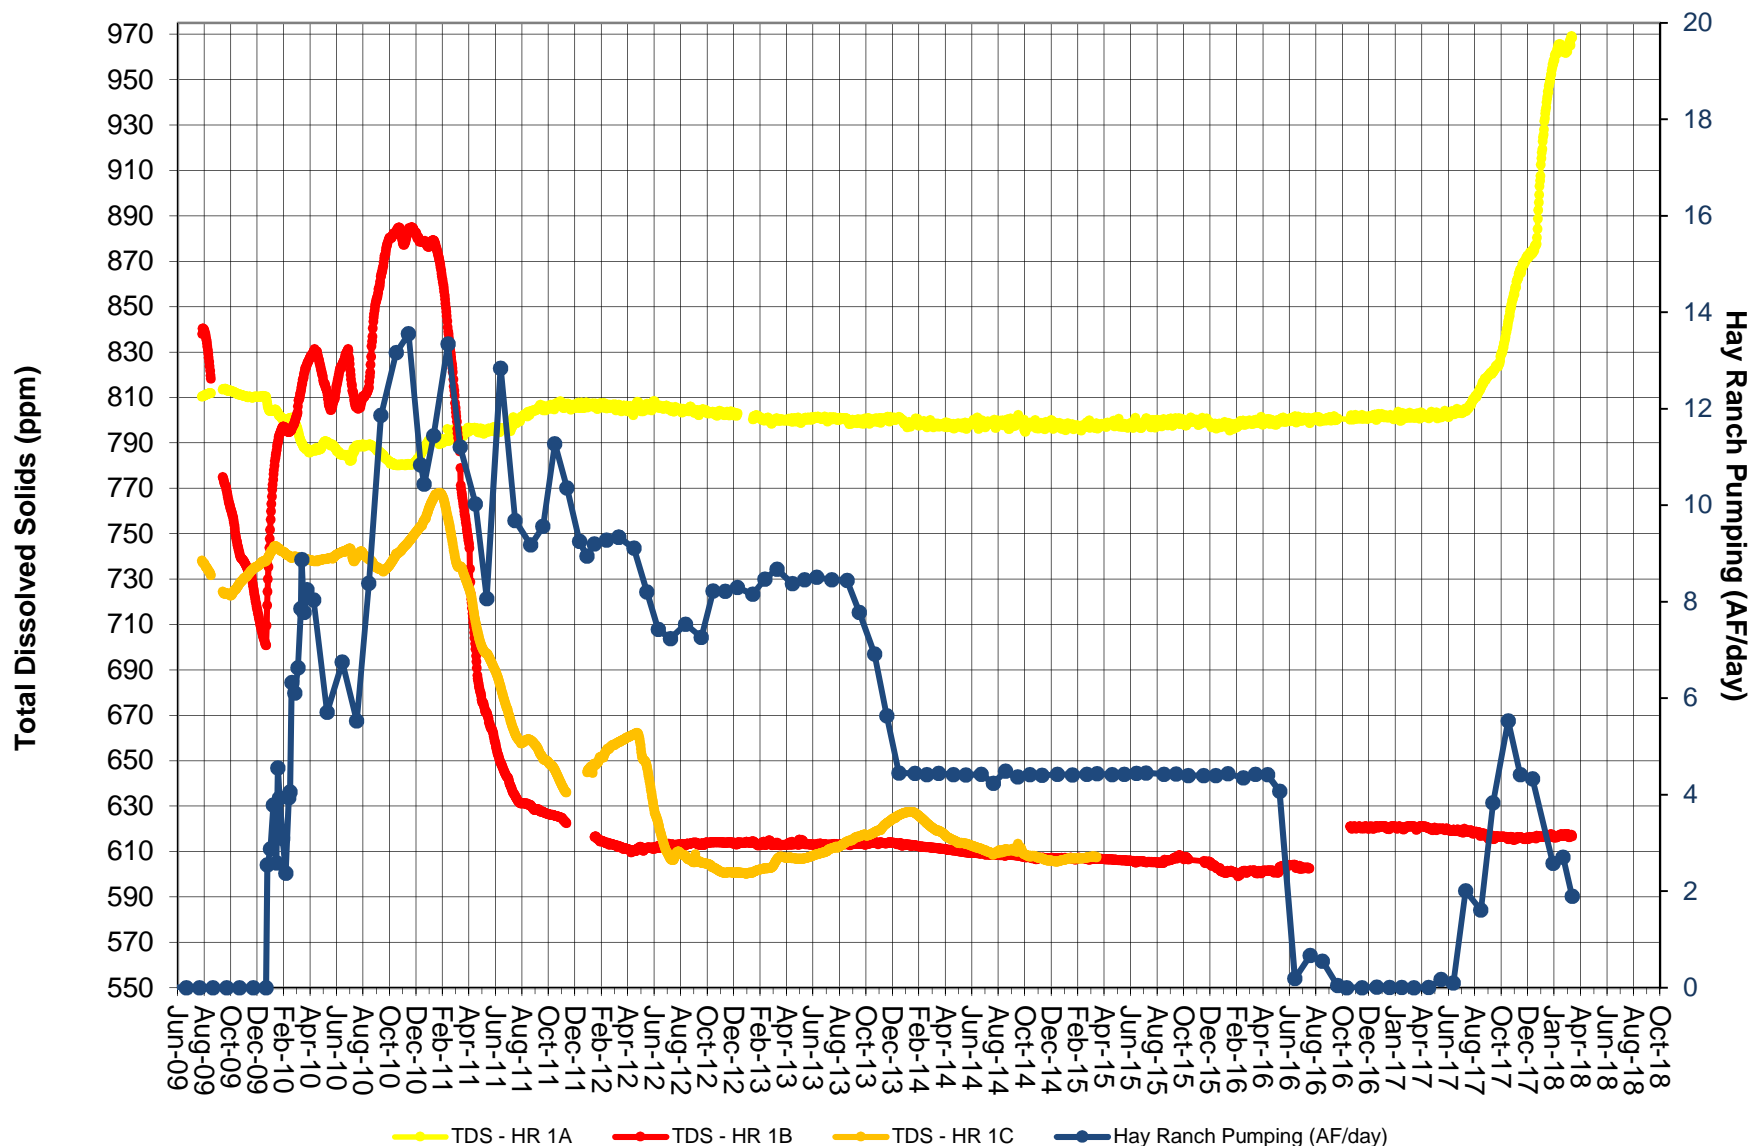
Note:
Screened intervals: HR 1A 170-260 feet; HR 1B 490-540 feet; HR 1C 340-405 feet.
HR 1A, 1B and 1C data gaps due to transducer malfunction or adjustment.
PT removed from HR1C in March 2015.

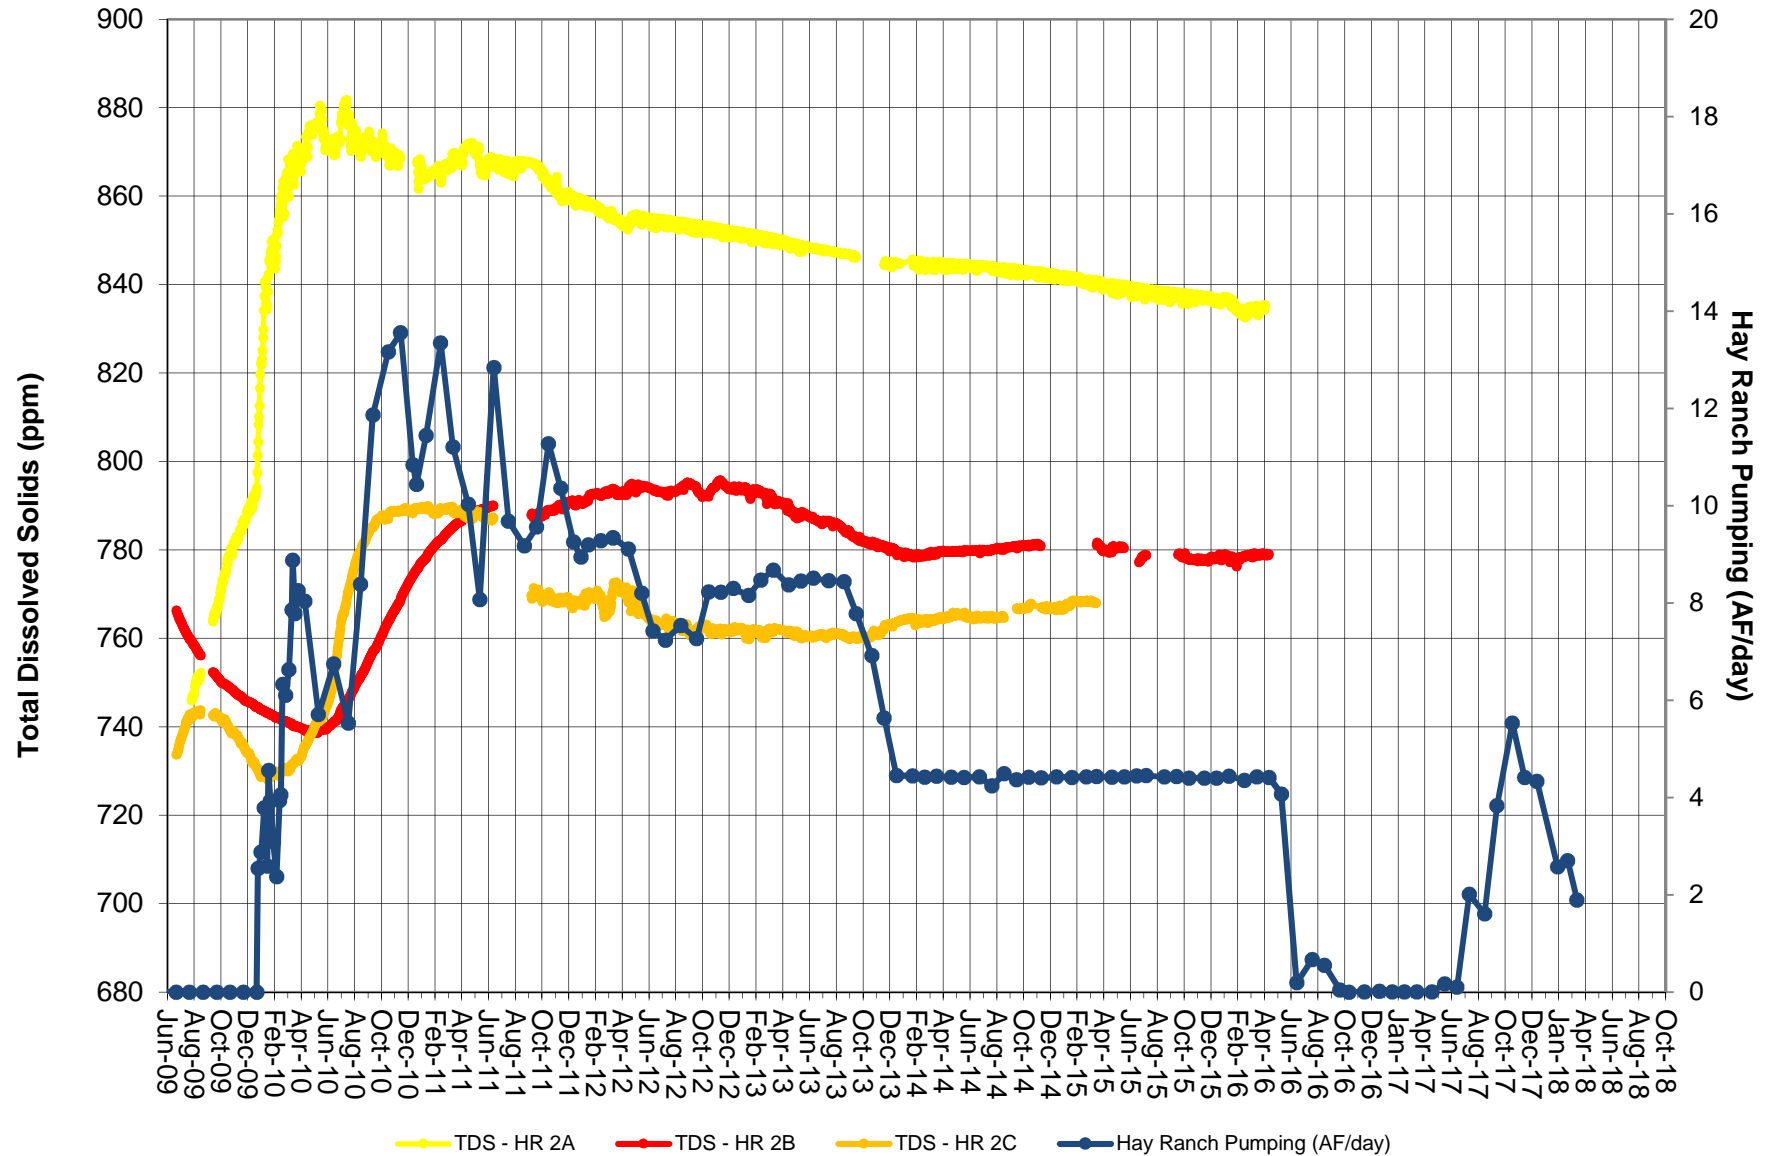
Note: Screened intervals: HR 2A 180-300 feet; HR 2B 519-584 feet; HR 2C 370-420 feet.
HR 2A, and 2B no longer record TDS as of April 2016.
PT removed from HR2C in March 2015.

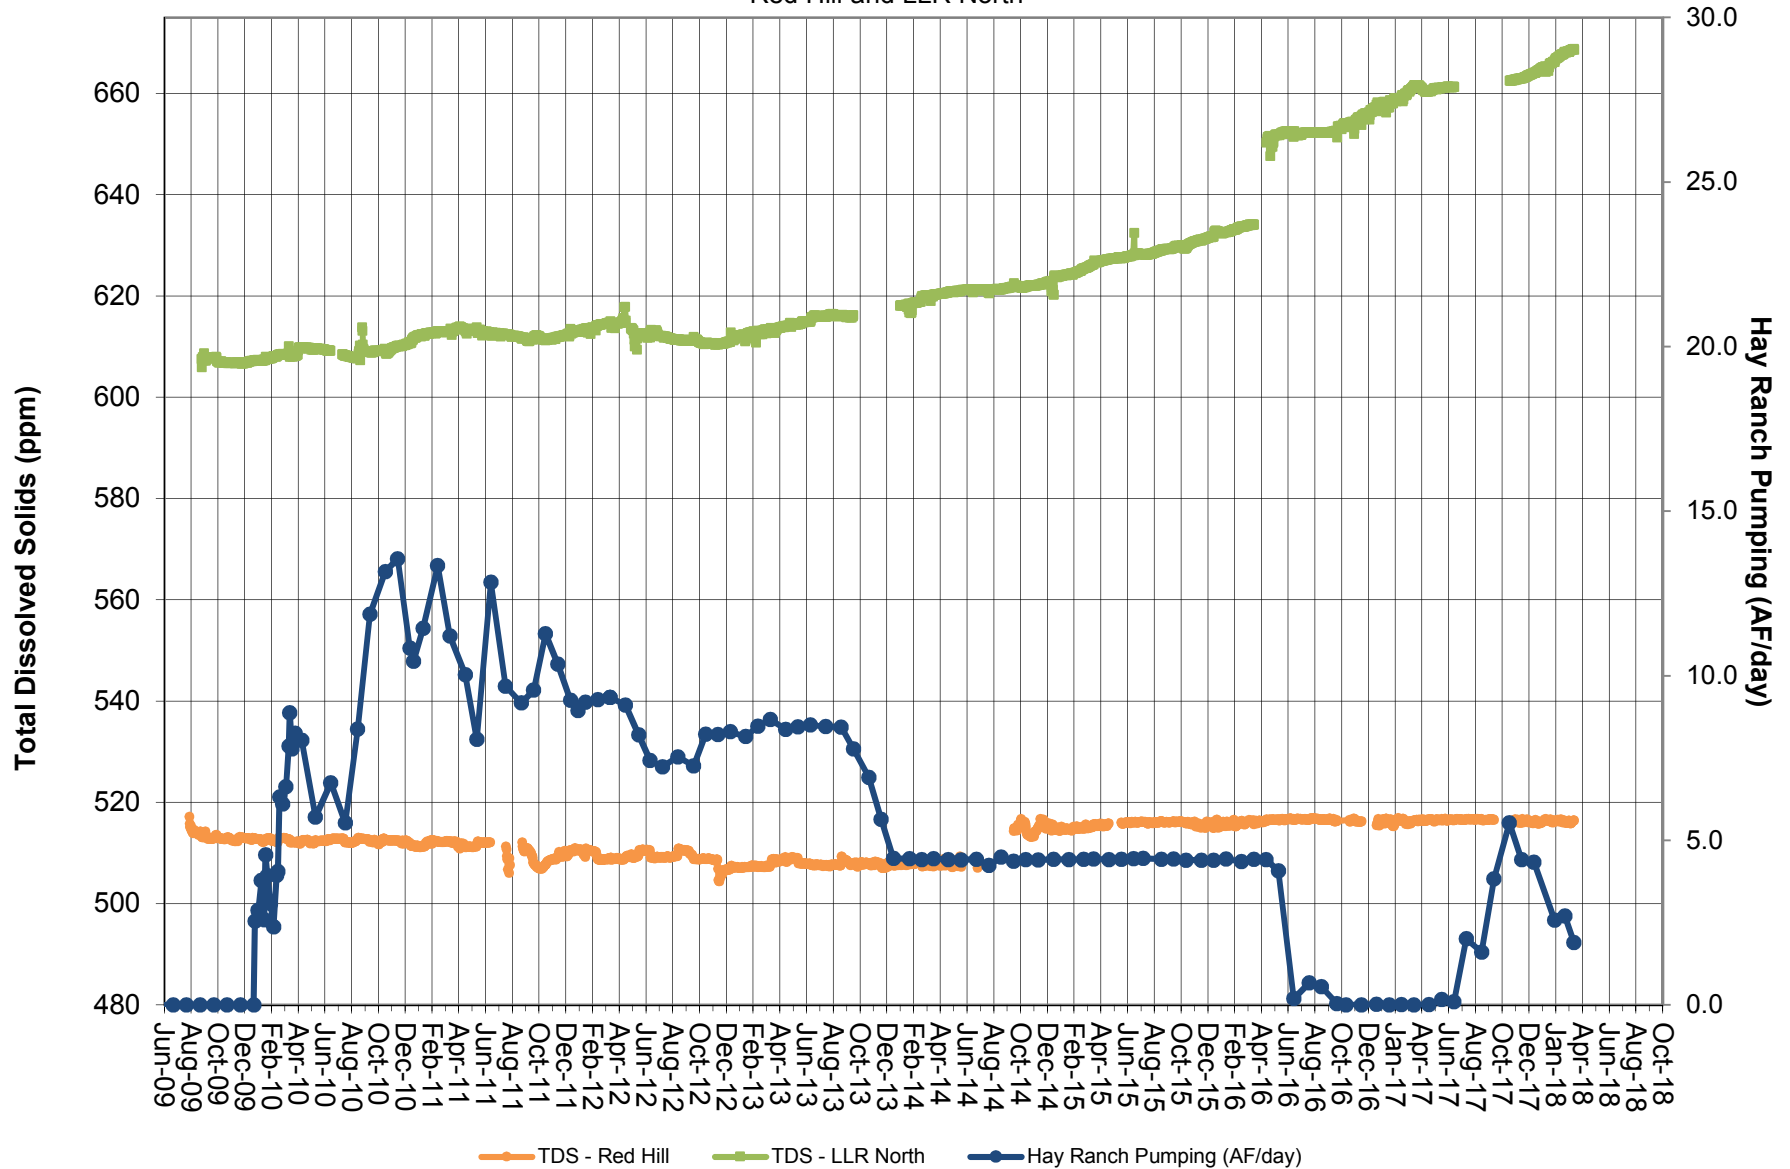
Note: TDS data from in-well transducers. Hay Ranch pumping is average acre feet per day.
Coso Operating initiated Hay Ranch Project pumping on 12/25/09.
Red Hill and LLR North data gaps due to transducer malfunction.

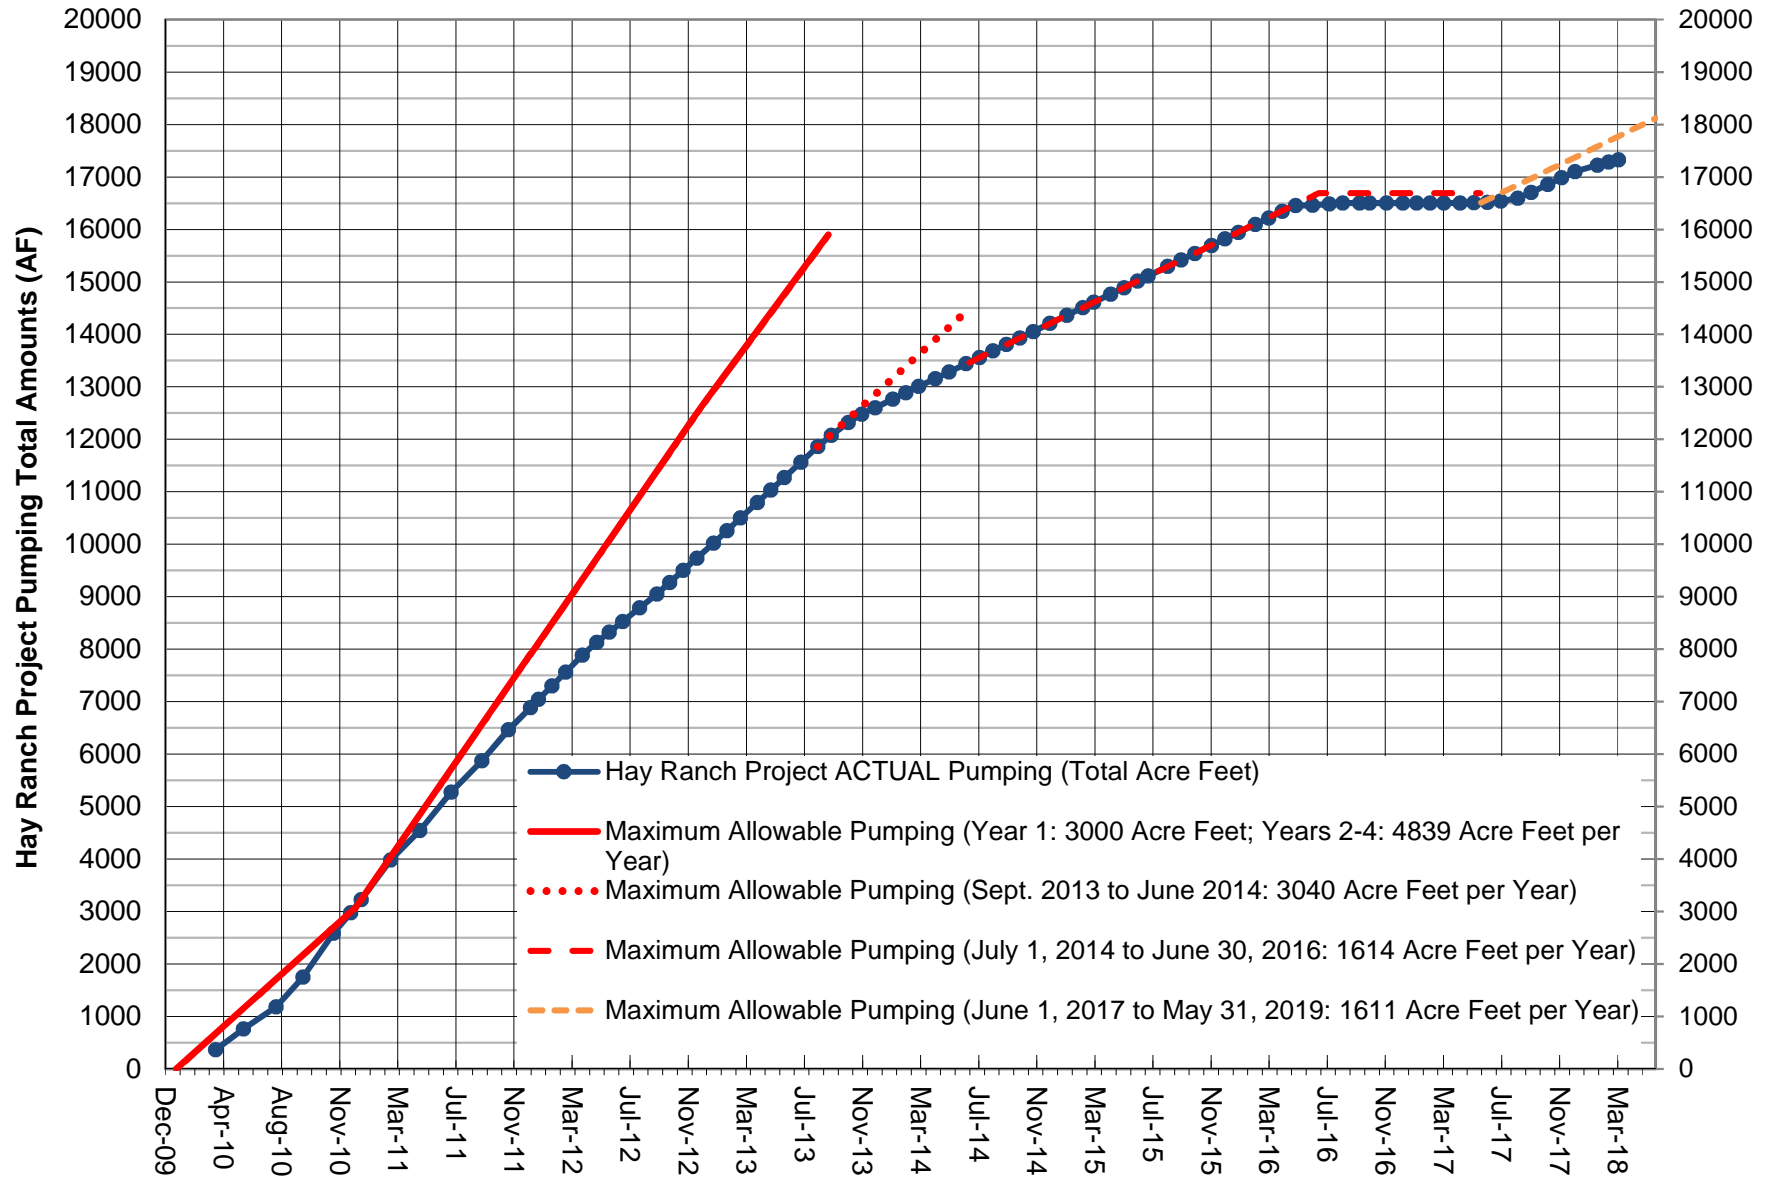
Note: Project pumping initiated 12/25/09. Maximum Allowable pumping rate was 3000 AF/yr for 12/09 to 12/10, 4839 AF/yr for 1/11-8/13, 3040 AF/yr for 9/13 to 6/14, 1614 AF/yr from 7/14 to 6/16 and 1611 AFY for 6/17 to 5/19.
