HAY RANCH PROJECT CONDITIONAL USE PERMIT HYDROLOGIC MONITORING REPORT

**FIRST QUARTER 2018
INYO COUNTY, CALIFORNIA**

APRIL 13, 2018

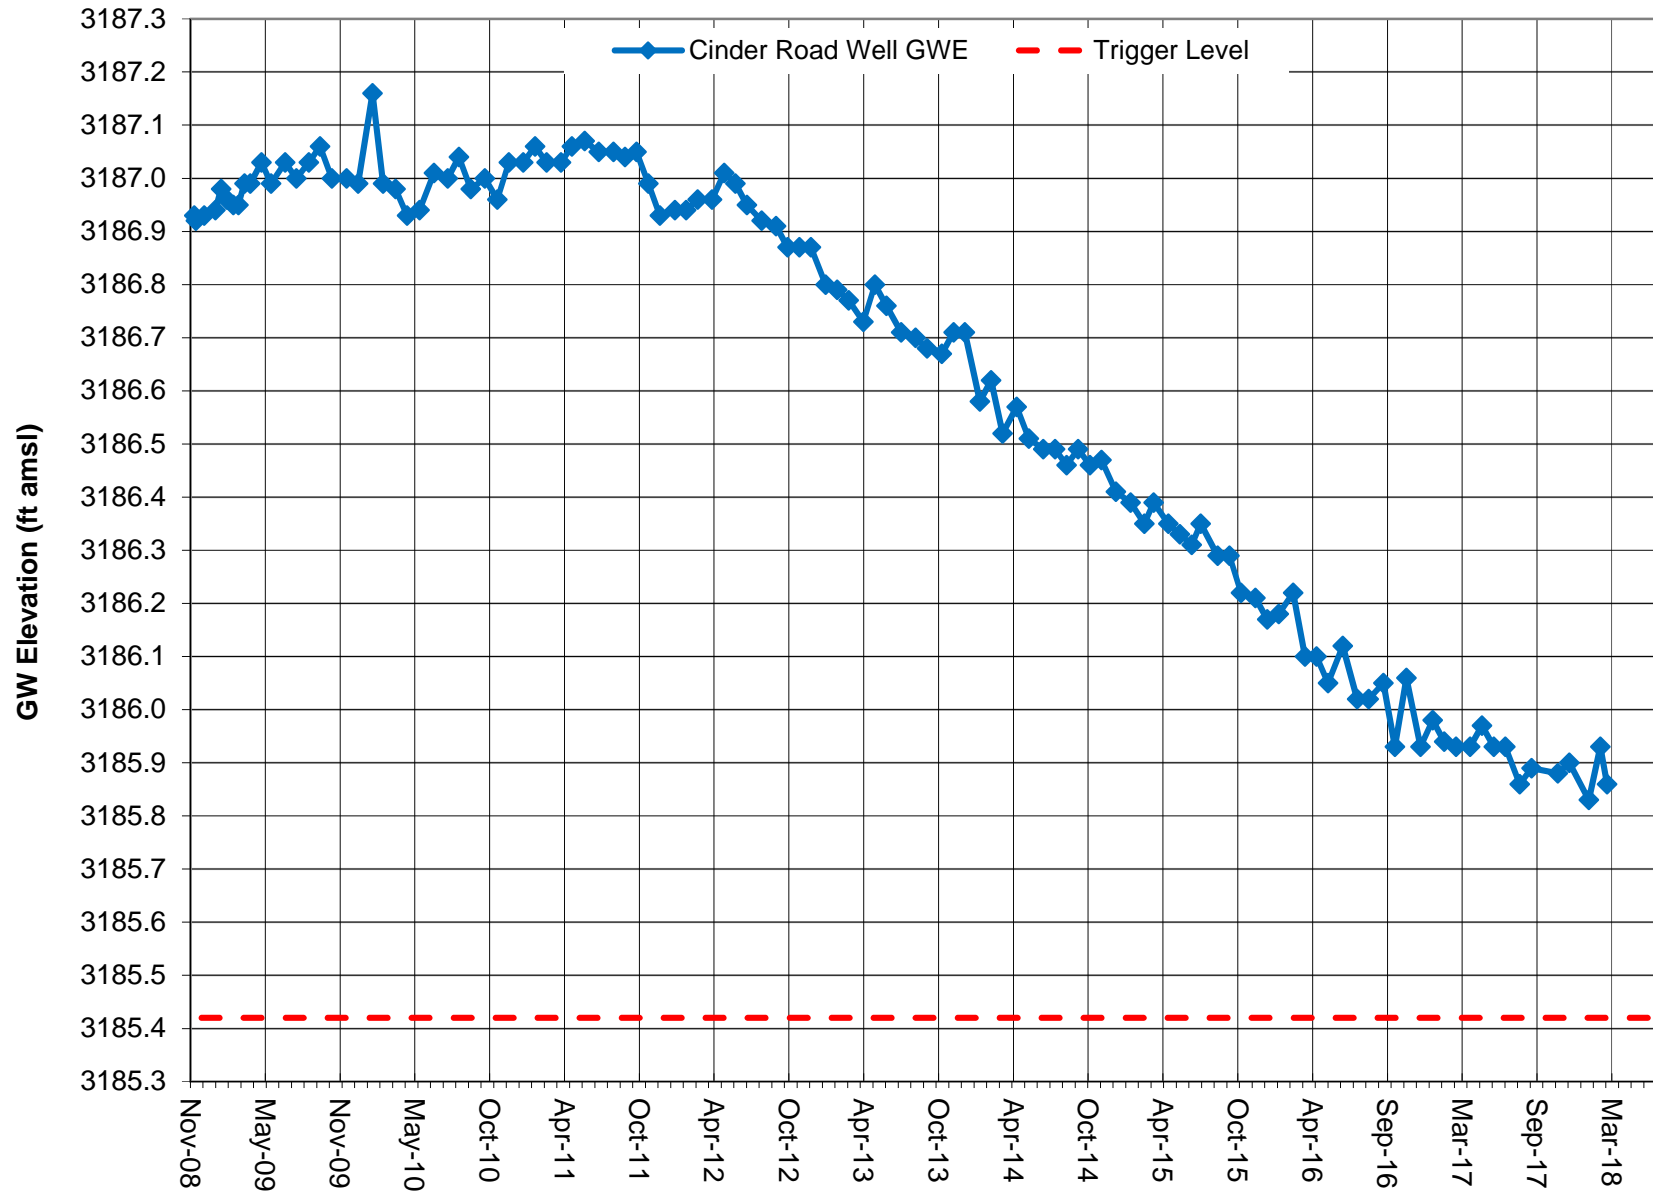
Note: GWE data based on manual depth-to-water measurements.
 COC initiated Hay Ranch Pumping on 12/25/09. Surveyed measuring point altered after October 2017.

3) Cinder Road well damaged in October 2017, surveyed measuring point removed. Accuracy of GWE calculation may be reduced.

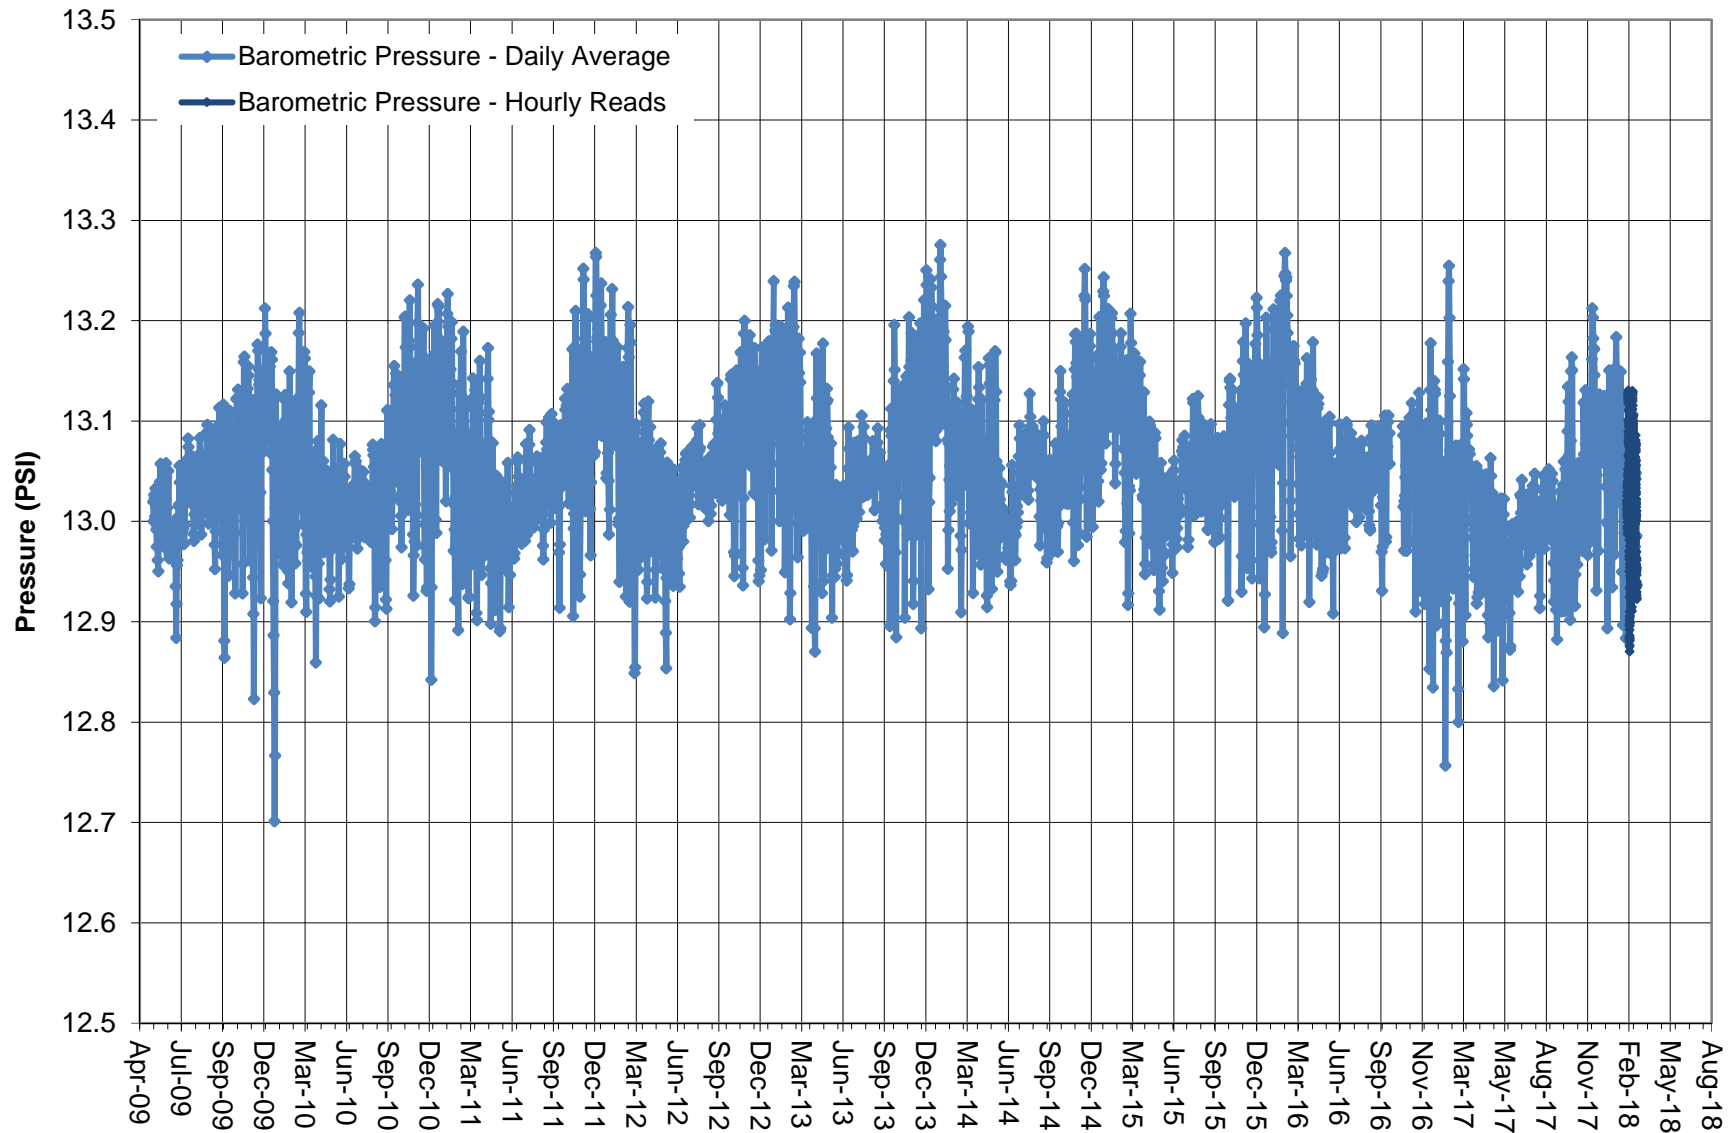
Note: BaroTroll located in well casing of well HR-2B.
Used to adjust pressure readings in non-vented transducers.
BaroTroll stopped working and was replaced 10/19/2016.

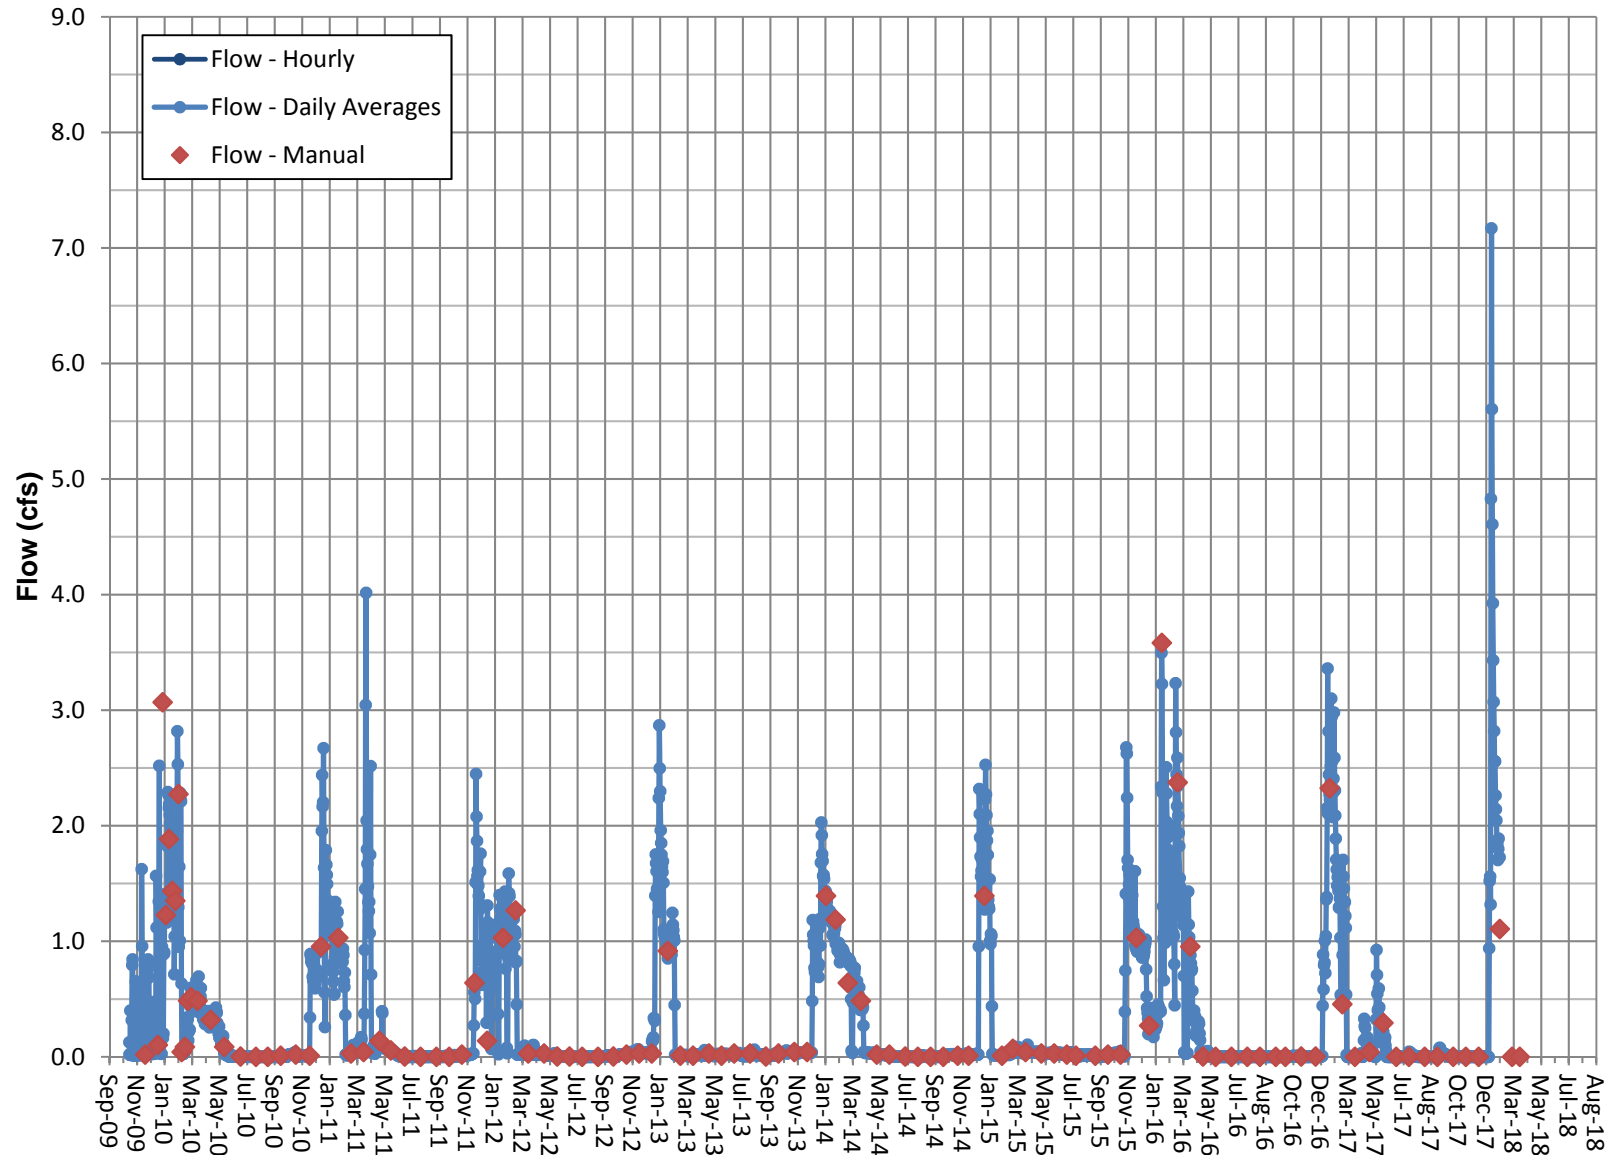
Note: Flows through Little Lake Outflow are influenced by natural and water management processes at Little Lake Ranch.
Jan. 30 to Feb. 21, 2018 data missing due to transducer programming error.

In January, a water level measurement was unable to be collected from the Red Hill Well (RV-120) as this well was inaccessible. In February, transducer data was unable to be collected from the weirs at the Little Lake Ranch due to a reprogramming error. The error was resolved and transducers were logging properly upon leaving site. Data from a backup transducer installed in the LLR North Culvert (RV-245) was retrieved in March and integrated into the hydrograph flow table. There were no other significant operational issues observed during the reporting period.

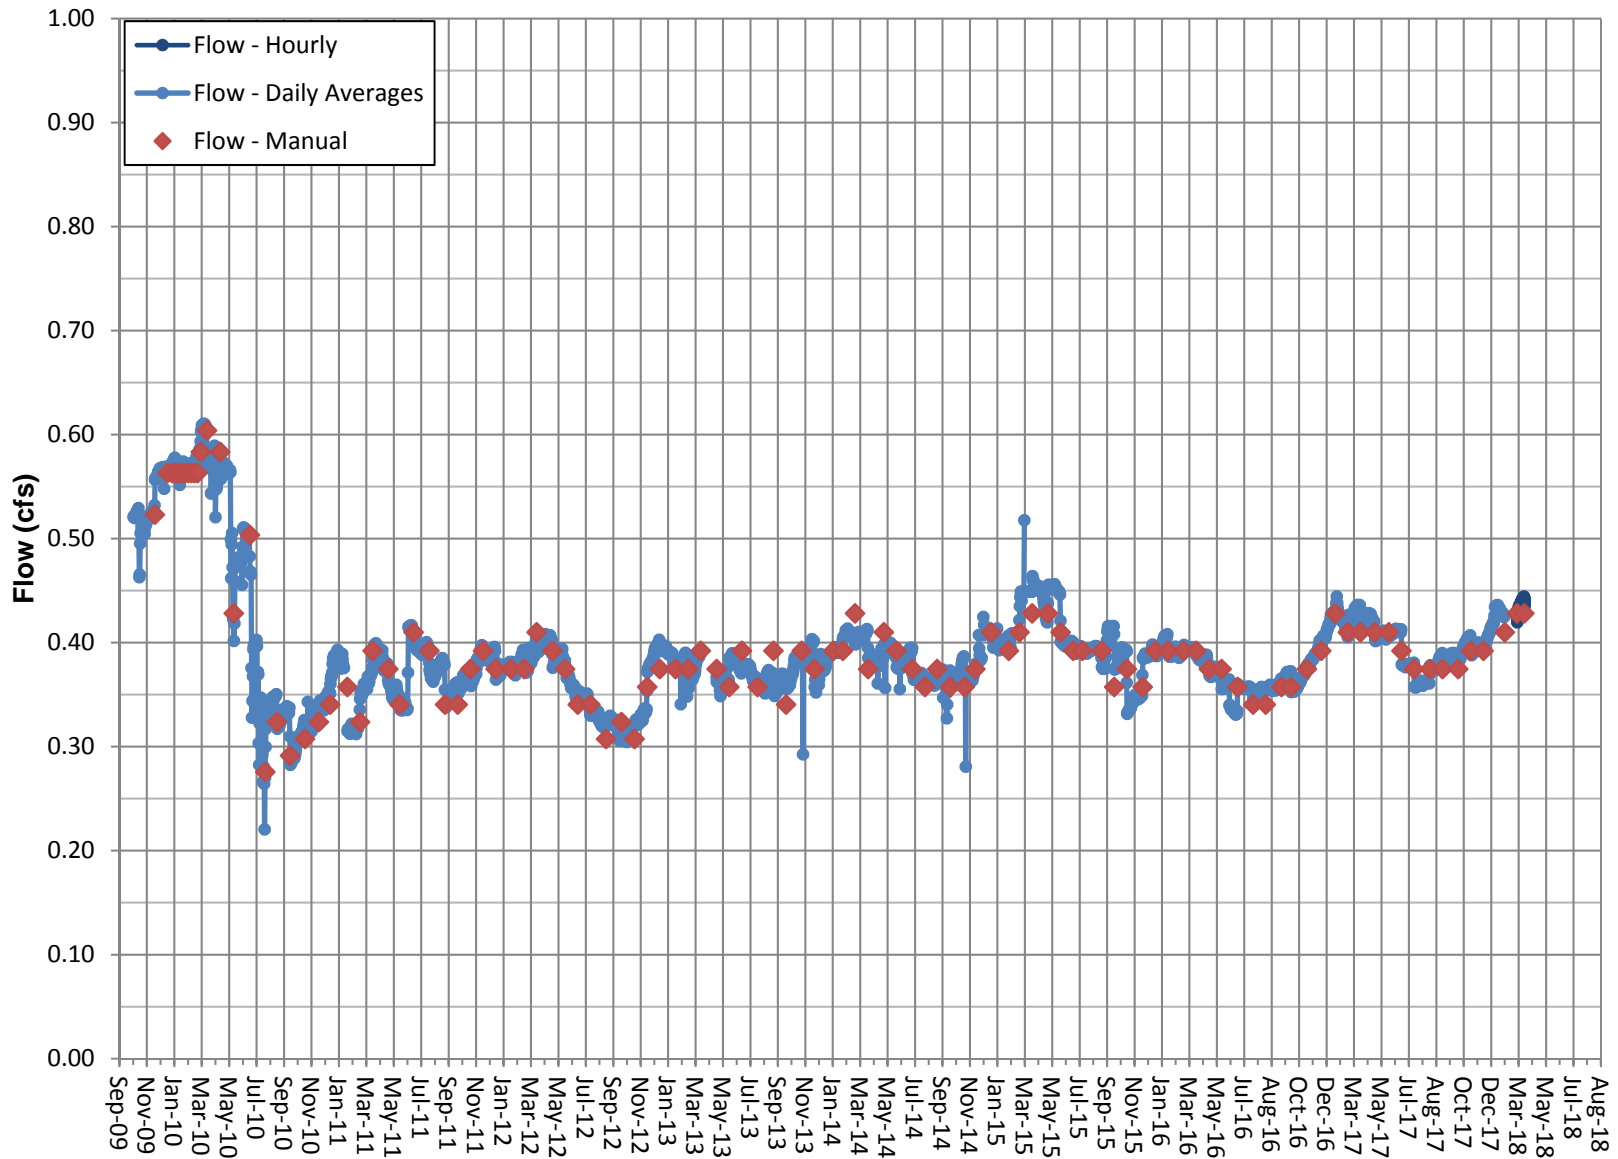
Note: Coso Springs is an artesian spring. Jan. 30 to Feb. 21, 2018 data missing due to transducer programming error.
