# **HAY RANCH PROJECT CONDITIONAL USE PERMIT HYDROLOGIC MONITORING REPORT**

**SECOND QUARTER 2016  
INYO COUNTY, CALIFORNIA**

**RE: Hay Ranch Project Conditional Use Permit  
Hydrologic Monitoring Report, Second Quarter 2016  
Inyo County, California**

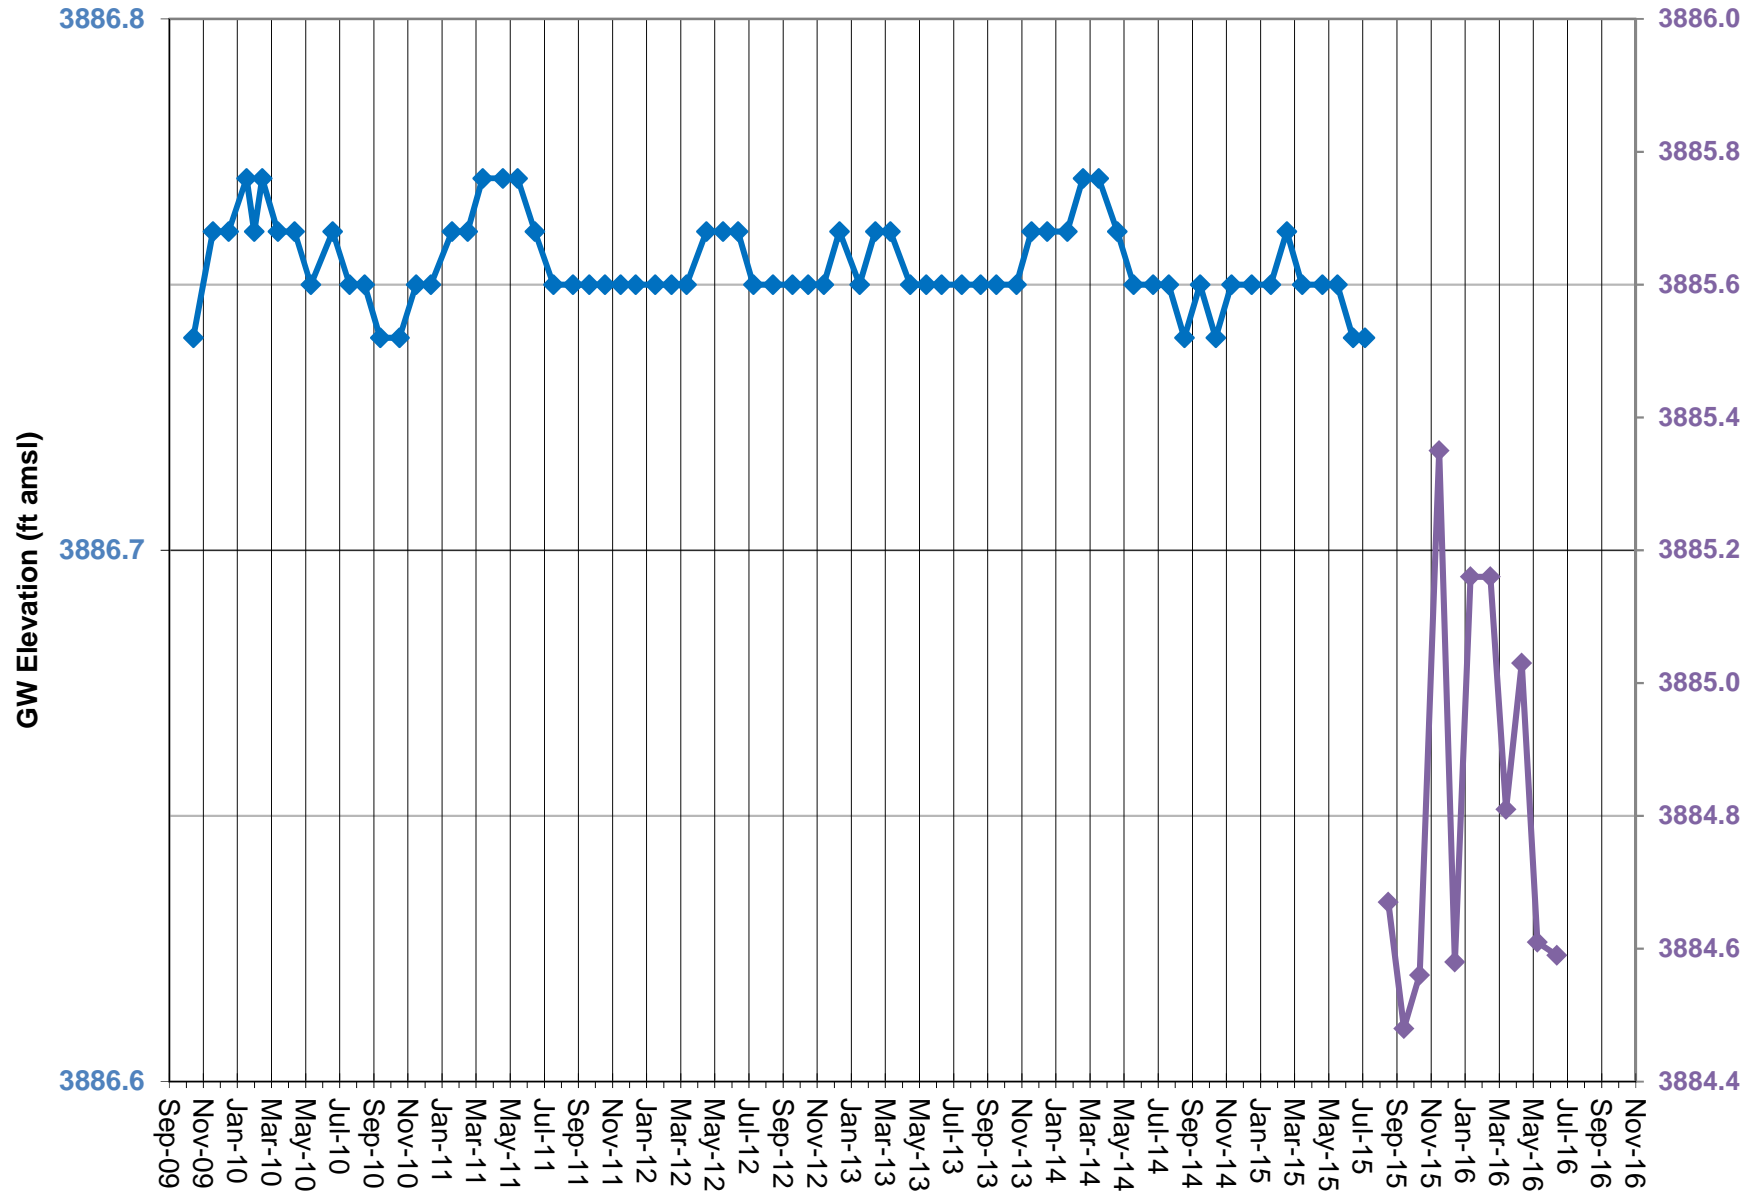
Note: Groundwater elevation data based on manual depth-to-water measurements.  
 Water-supply pump installed in DR South in July 2015.  
 Note secondary axis for GWEs post-pump installation.
