HAY RANCH PROJECT CONDITIONAL USE PERMIT HYDROLOGIC MONITORING REPORT

SECOND QUARTER 2017
INYO COUNTY, CALIFORNIA

**RE: Hay Ranch Project Conditional Use Permit
Hydrologic Monitoring Report, Second Quarter 2017
Inyo County, California**

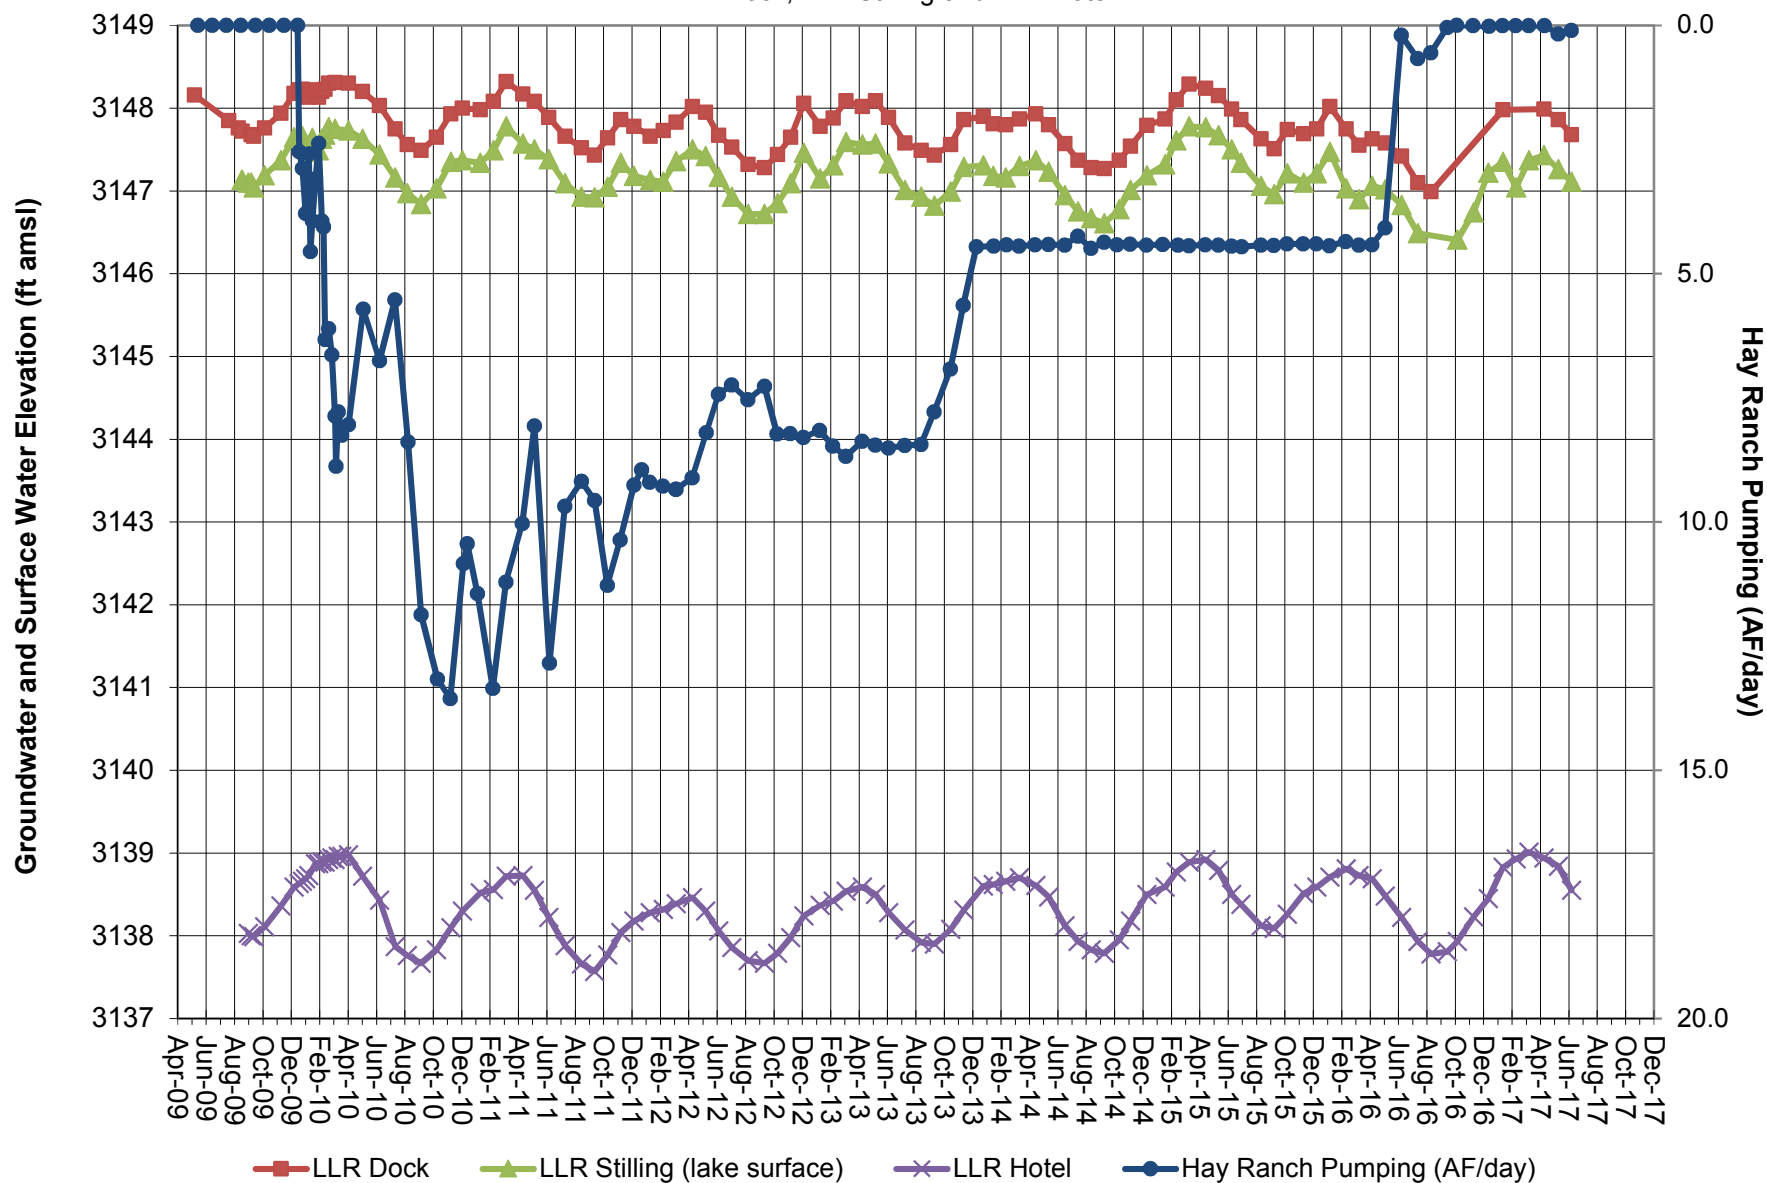
Note: Groundwater and surface water elevation data based on manual depth-to-water measurements.
 Hay Ranch pumping is average acre feet per day.
 Coso Operating initiated Hay Ranch Project pumping on 12/25/09.

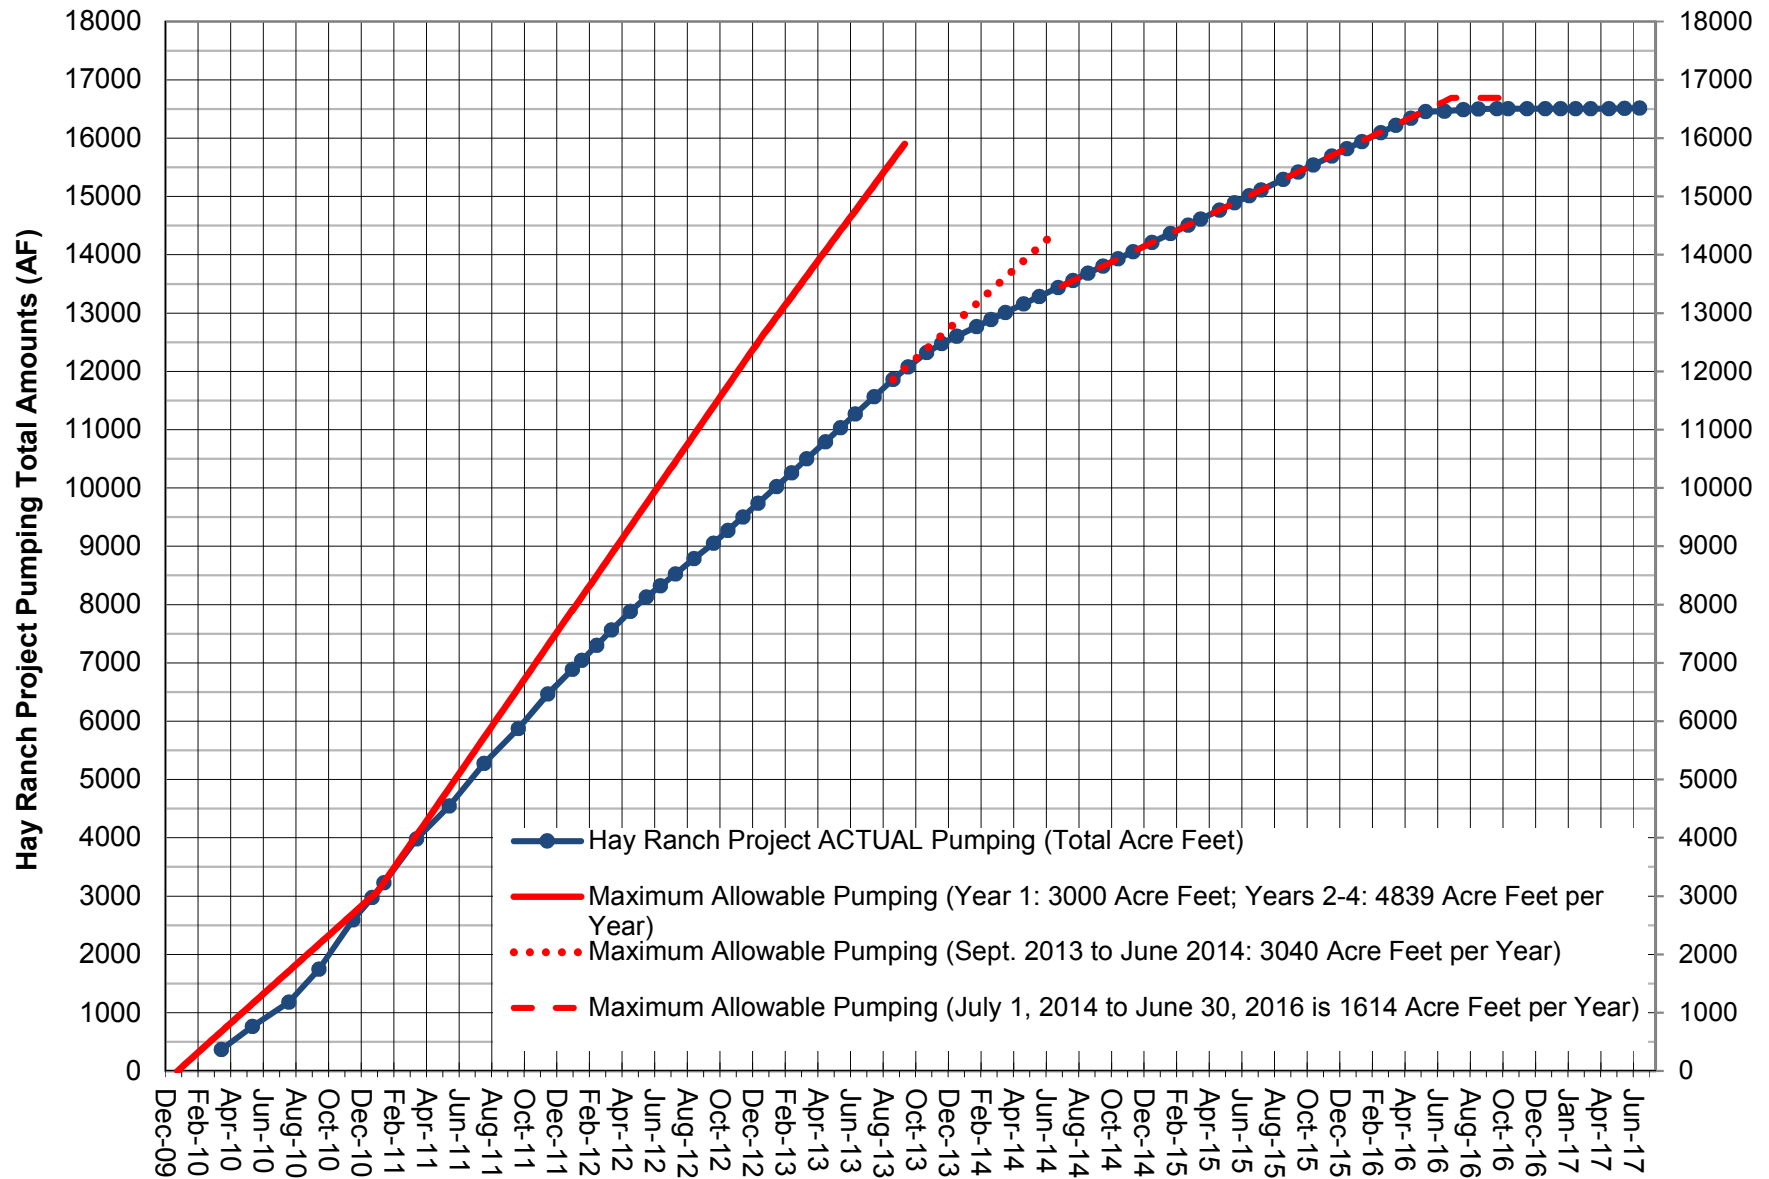
Note: Project pumping initiated 12/25/09. Maximum Allowable pumping rate was 3000 AF/yr for 12/09 to 12/10, 4839 AF/yr for 1/11-8/13, 3040 AF/yr for 9/13 to 6/14, and 1614 AF/yr from 7/14 to 6/16.
