HAY RANCH PROJECT CONDITIONAL USE PERMIT HYDROLOGIC MONITORING REPORT

FOURTH QUARTER 2016 INYO COUNTY, CALIFORNIA

JANUARY 6, 2017

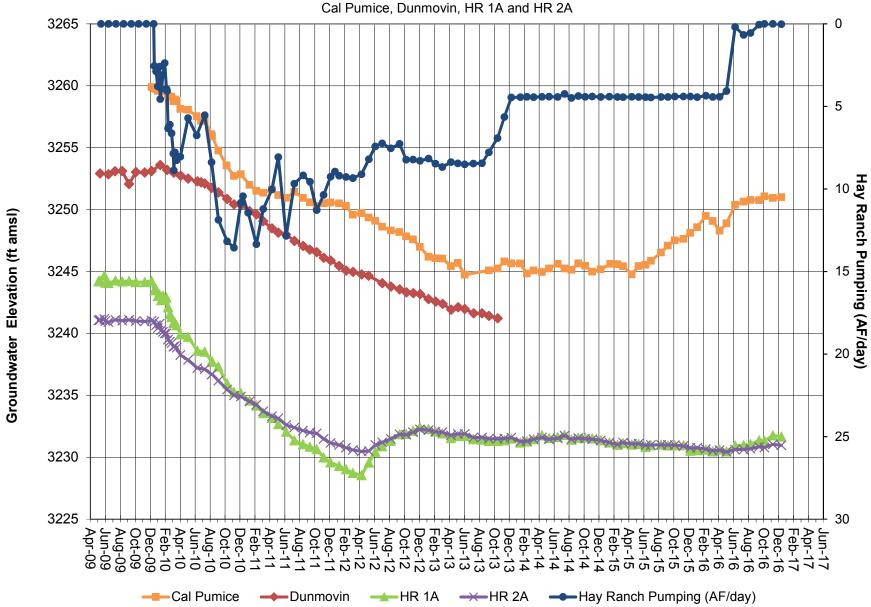
FIGURE 3 GROUNDWATER ELEVATION and HAY RANCH PUMPING

Note: Groundwater elevation data based on manual depth-to-water measurements. Hay Ranch pumping is average acre feet per day.

Coso Operating initiated Hay Ranch Project pumping on 12/25/09.

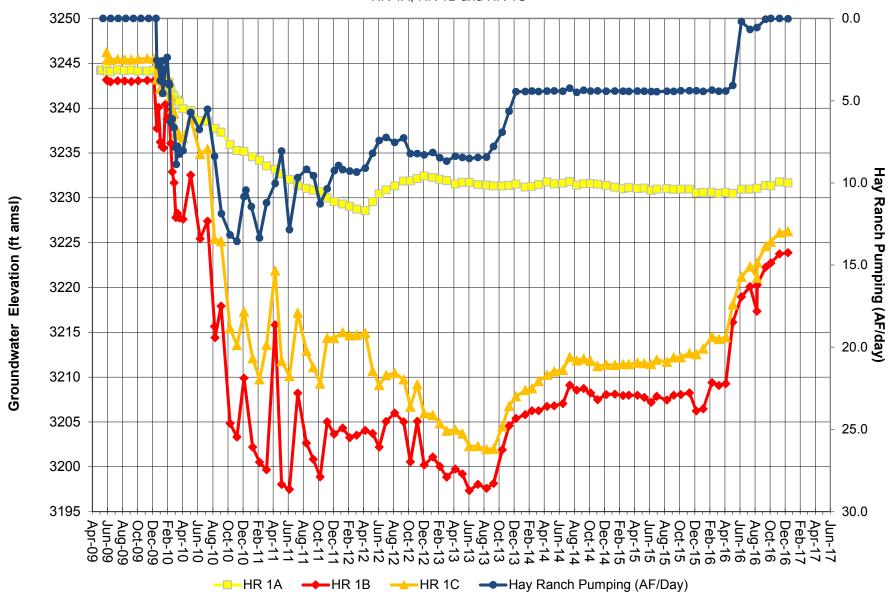
FIGURE 4
GROUNDWATER ELEVATION and HAY RANCH PUMPING
HR 1A, HR 1B and HR 1C

Note: GWE data based on manual DTW measurements. Hay Ranch pumping is average acre feet per day. Screened intervals: HR 1A 170-260 feet; HR 1B 490-540 feet; HR 1C 340-405 feet. Coso Operating initiated Hay Ranch Project pumping on 12/25/09.

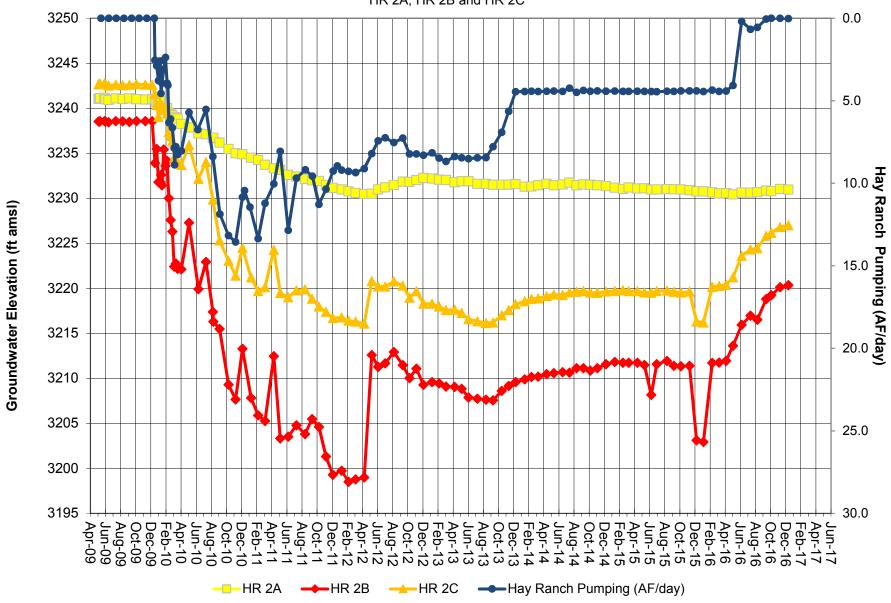
FIGURE 5
GROUNDWATER ELEVATION and HAY RANCH PUMPING
HR 2A, HR 2B and HR 2C

Note: GWE data based on manual DTW measurements. Hay Ranch pumping is average acre feet per day. Screened intervals: HR 2A 180-300 feet; HR 2B 519-584 feet; HR 2C 370-420 feet. Coso Operating initiated Hay Ranch Project pumping on 12/25/09.

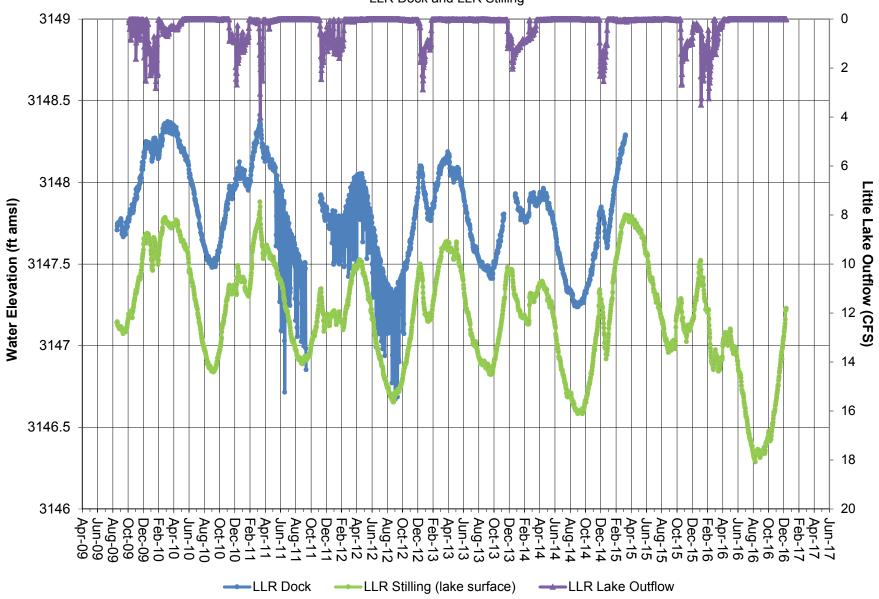
FIGURE 12
WATER ELEVATION and LITTLE LAKE OUTFLOW
LLR Dock and LLR Stilling

Note: Little Lake Outflow in cubic feet per second. LLR staff conducted water intermittent pumping from 2011-2012. Pressure Transducer removed from Dock Well in March 2015.

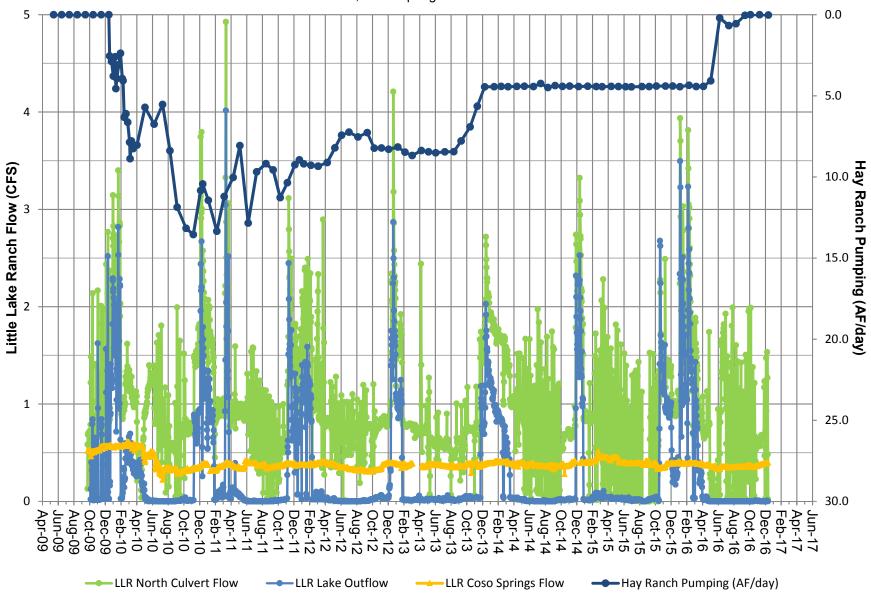
FIGURE 13
LLR FLOW and HAY RANCH PUMPING
North Culvert, Coso Springs and Little Lake Outflow

Note: Little Lake Ranch Flows are cubic feet per second. Hay Ranch pumping is average acre feet per day.

A spike in the LLR Lake Outflow hydrograph is typically indicative of water movement (removal of boards at the Little Lake Weirs) by LLR staff. After a time lag, increased outflow from Little Lake will also cause a spike in the LLR North Culvert Flow. A spike in the LLR North Culvert may also be caused by removal of boards at Pond 1 or 2; when only Pond boards are removed, the LLR Lake Outflow flume will not record increased flow, but the LLR North Culvert Flow will record a flow spike. Wind or weather events will cause a less dramatic increase in Lake Outflow and North Culvert Flow readings.

A hydrograph which compares surface water flows in the Little Lake Ranch area to Hay Ranch Project pumping rates over time is also included in this report as Figure 13. Surface water flows from Lake Outflow, Coso Springs Flow and North Culvert Flow are listed on the left axis, in cubic feet per second. Hay Ranch Project average daily pumping amounts, in acre-feet per day, are listed on the right axis in inverse order. As noted in Section 3.3, surface flow captured by the North Culvert Flow flume represents an accumulation of surface flows from Little Lake, Coso Springs and the Siphon Well flow.

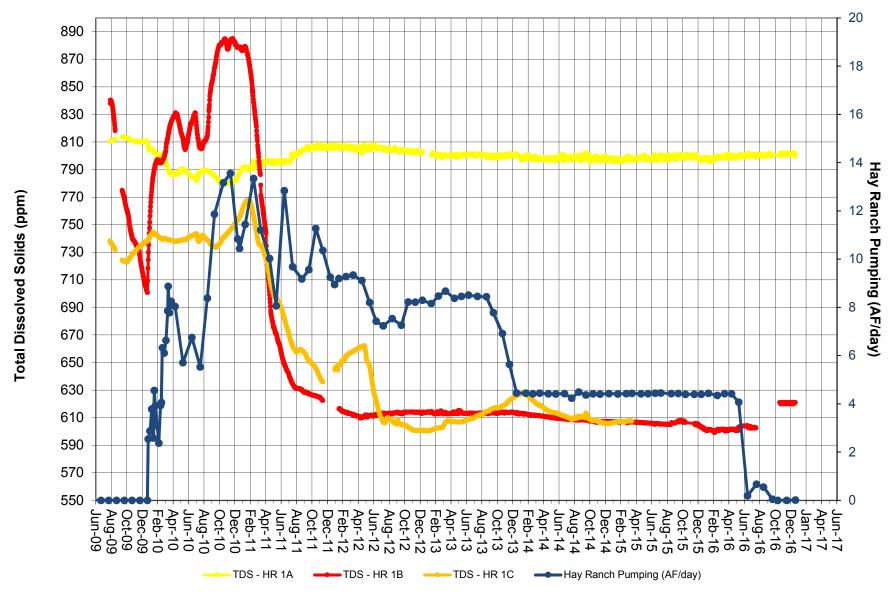
FIGURE 14
TOTAL DISSOLVED SOLIDS (TDS) and HAY RANCH PUMPING
HR 1A, HR 1B and HR 1C

Note: Screened intervals: HR 1A 170-260 feet; HR 1B 490-540 feet; HR 1C 340-405 feet. HR 1A, 1B and 1C data gaps due to transducer malfunction or adjustment. PT removed from HR1C in Dec. 2016.

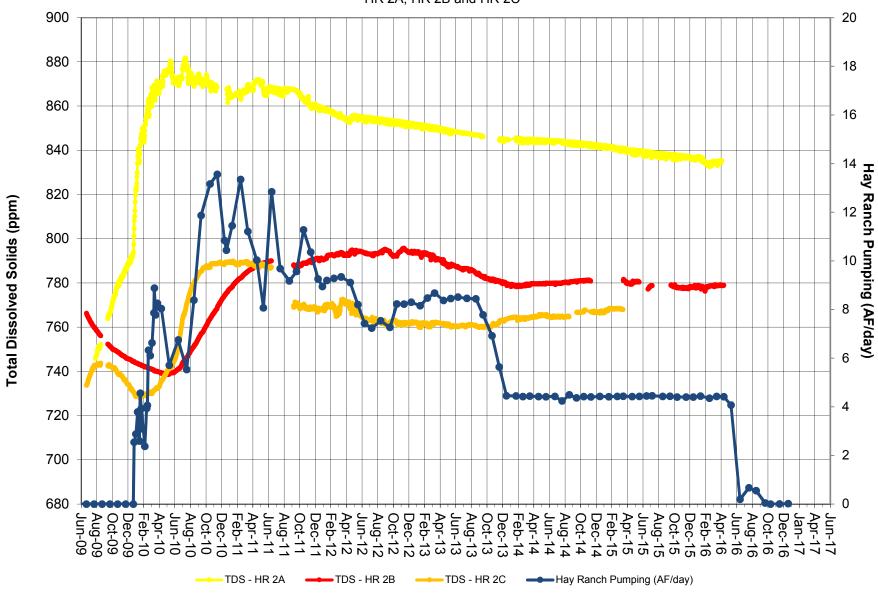
FIGURE 15
TOTAL DISSOLVED SOLIDS (TDS) and HAY RANCH PUMPING
HR 2A, HR 2B and HR 2C

Note: Screened intervals: HR 2A 180-300 feet; HR 2B 519-584 feet; HR 2C 370-420 feet. HR 2A, and 2B no longer record TDS as of April 2016. PT removed from HR2C in March 2015.

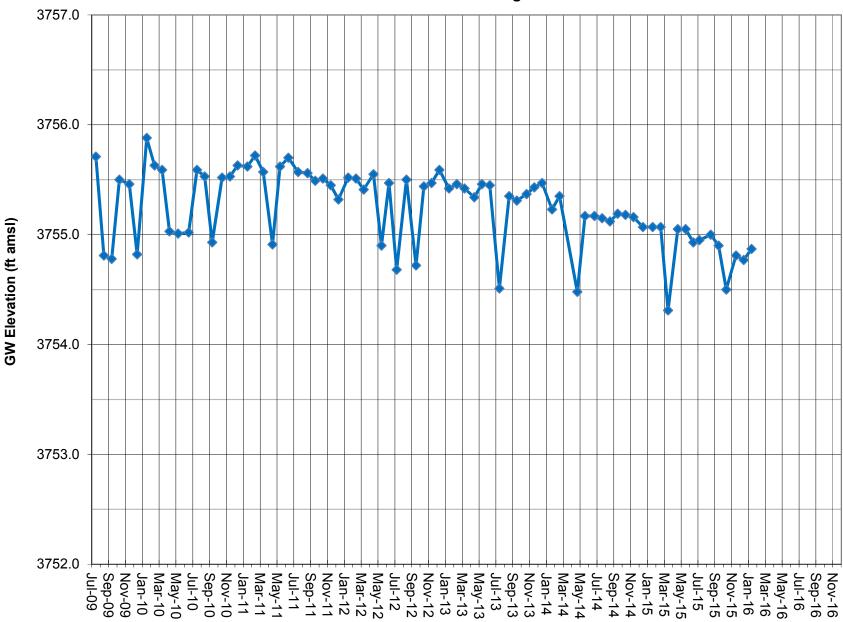
GROUNDWATER ELEVATION DATA - Long-Term (Manual) RV010 - Enchanted Village Well

Note: Groundwater elevation data based on manual depth-to-water measurements. Enchanted Village Well (Dews) is an actively pumped domestic supply well. Monitoring discontinued Feb. 2016 per ICWD

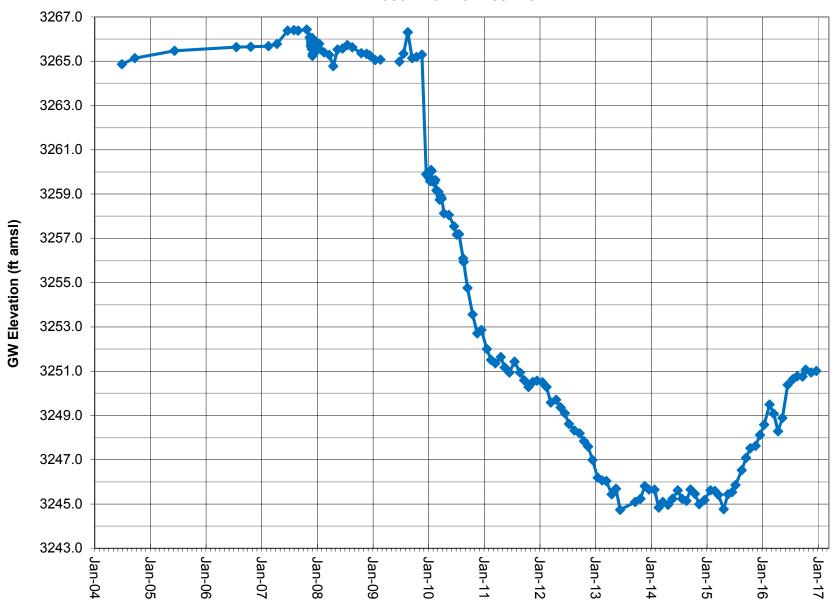
GROUNDWATER ELEVATION DATA - Long-Term (Manual) RV030 - Cal Pumice Well

Note: A data gap exists in 2009 during a pump test on a nearby well. The notable DTW change in late 2009 was confirmed by in-well PT. Coso Operating Co. initiated Hay Ranch Project pumping on 12/25/09.

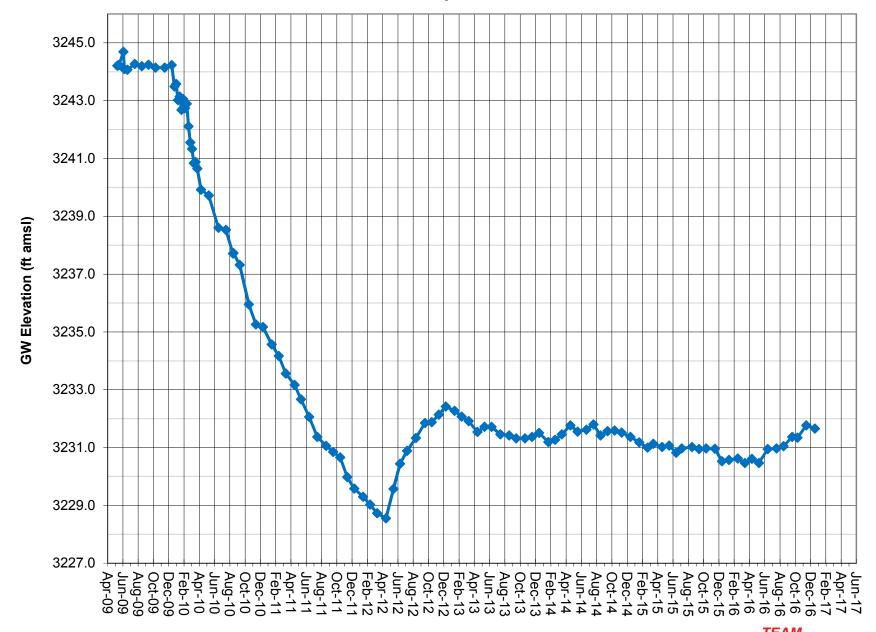
GROUNDWATER ELEVATION DATA - Long-Term (Manual) RV060 - Hay Ranch 1A Well

Note: Groundwater elevation data based on manual depth-to-water measurements. Lines between data points are approximations. Screened interval is 170-260 feet.

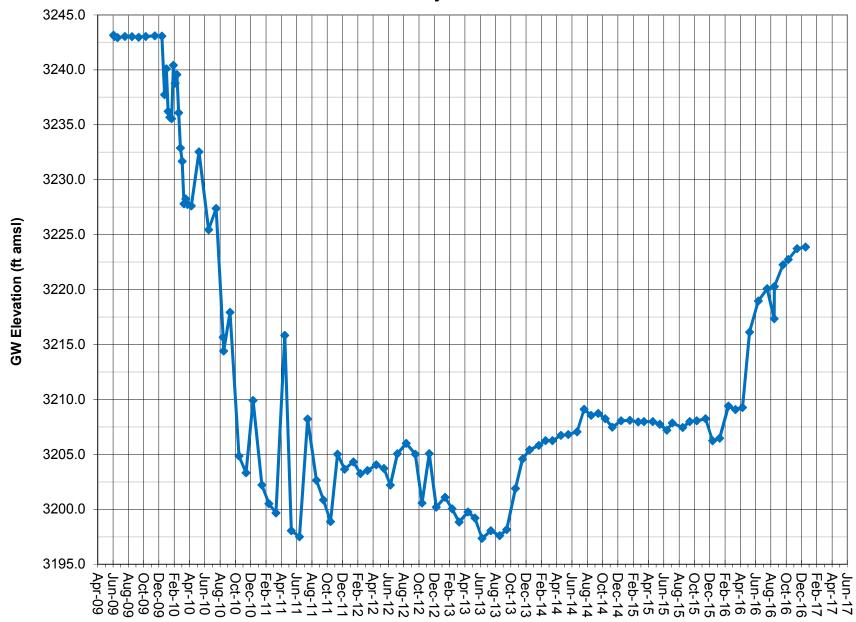
GROUNDWATER ELEVATION DATA - Long-Term (Manual) RV061 - Hay Ranch 1B Well

Note: Groundwater elevation data based on manual depth-to-water measurements. Lines between data points are approximations. Screened interval is 490-540 feet.

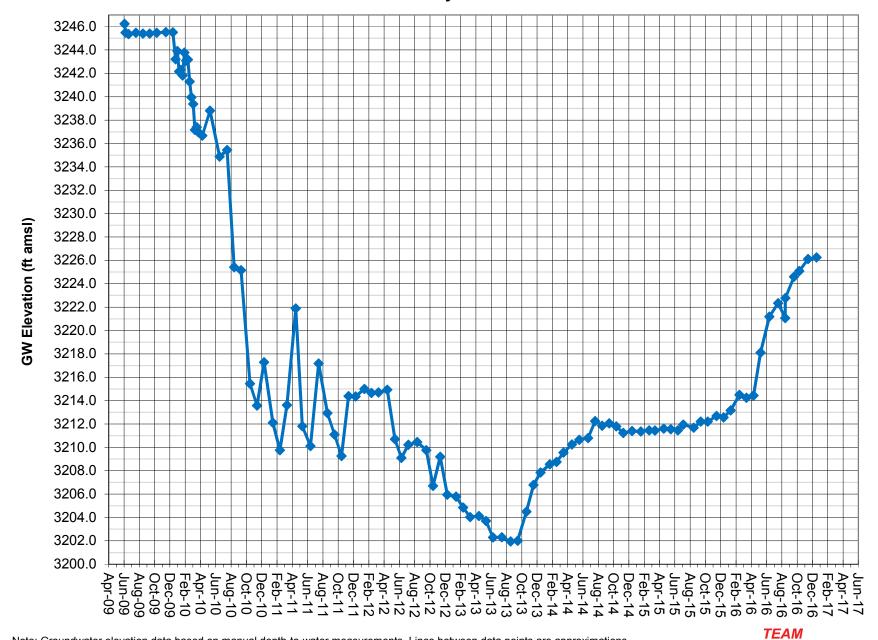
GROUNDWATER ELEVATION DATA - Long-Term (Manual) RV062 - Hay Ranch 1C Well

Note: Groundwater elevation data based on manual depth-to-water measurements. Lines between data points are approximations. Screened interval is 340-405 feet.

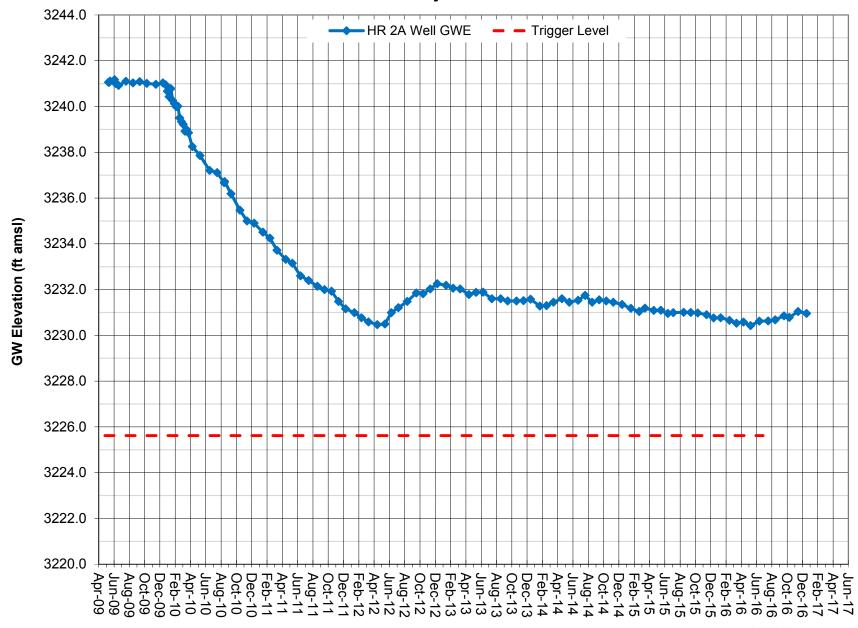
GROUNDWATER ELEVATION DATA - Long-Term (Manual) RV080- Hay Ranch 2A Well

Note: Groundwater elevation data based on manual depth-to-water measurements. Lines between data points are approximations. Screened interval is 180-300 feet.

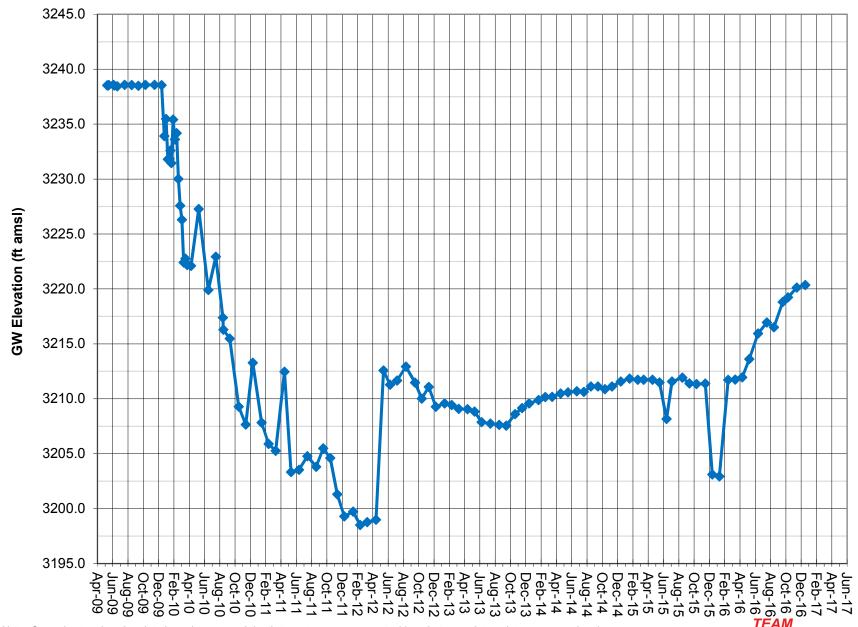
GROUNDWATER ELEVATION DATA - Long-Term (Manual) RV081 - Hay Ranch 2B Well

Note: Groundwater elevation data based on manual depth-to-water measurements. Lines between data points are approximations. Screened interval is 519-584 feet.

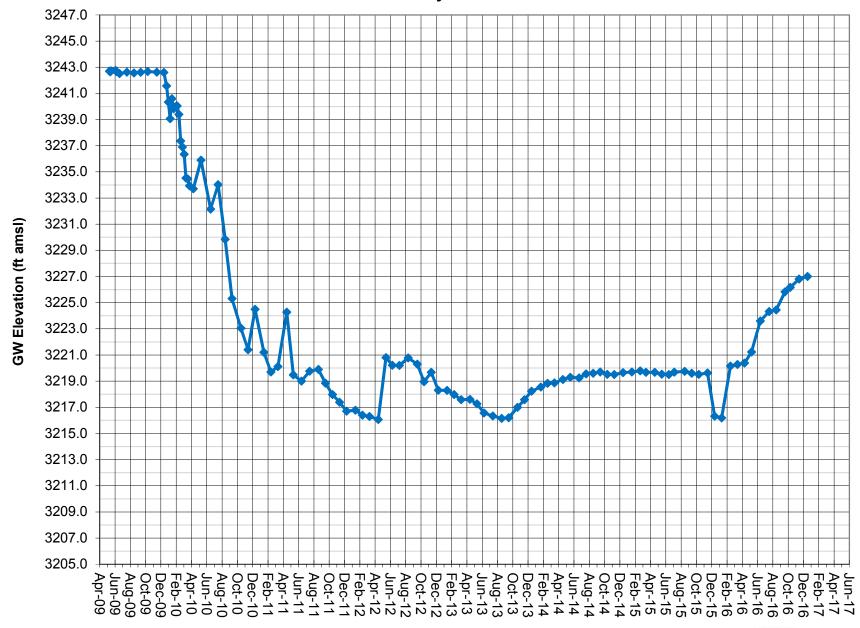
GROUNDWATER ELEVATION DATA - Long-Term (Manual) RV082 - Hay Ranch 2C Well

Note: Groundwater elevation data based on manual depth-to-water measurements. Lines between data points are approximations. Screened interval is 370-420 feet.

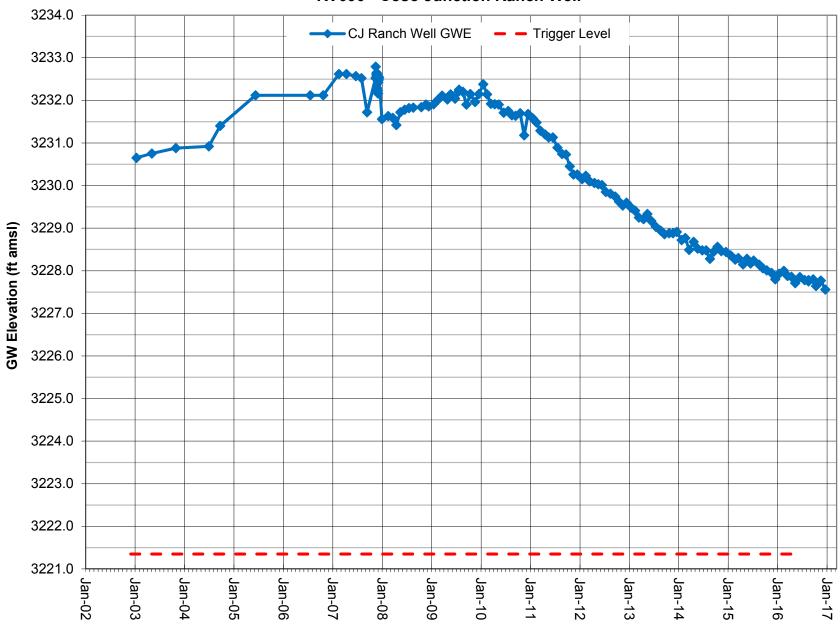
GROUNDWATER ELEVATION DATA - Long-Term (Manual) RV090 - Coso Junction Ranch Well

Note: Groundwater elevation data based on manual depth-to-water measurements.

Coso Operating Co. conducted a pump test on the Hay Ranch South Well in fourth quarter 2007.

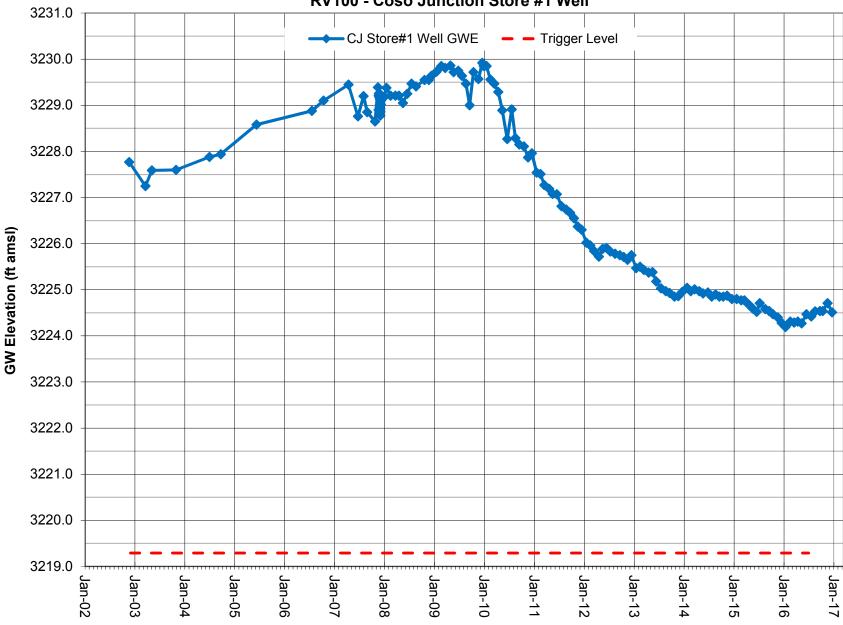
GROUNDWATER ELEVATION DATA - Long-Term (Manual) RV100 - Coso Junction Store #1 Well

Note: Groundwater elevation data based on manual depth-to-water measurements. Well is adjacent to actively pumped domestic well.

Coso Operating Co. initiated Hay Ranch Project pumping on 12/25/09.

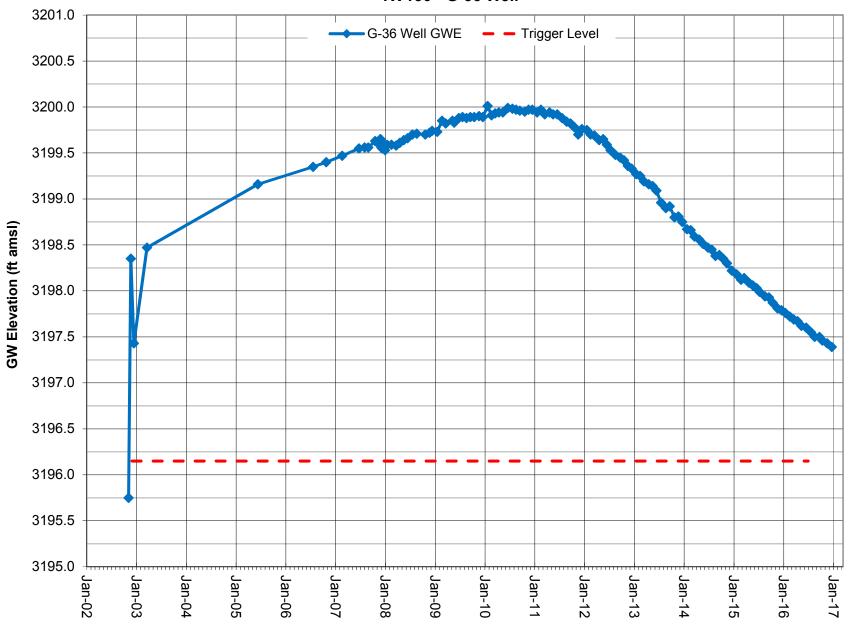
GROUNDWATER ELEVATION DATA - Long-Term (Manual) RV130 - G-36 Well

Note: Groundwater elevation data based on manual depth-to-water measurements.
Coso Operating Co. conducted a pump test on the Hay Ranch South Well in fourth quarter 2007.
Coso Operating Co. initiated Hay Ranch Project pumping on 12/25/09.

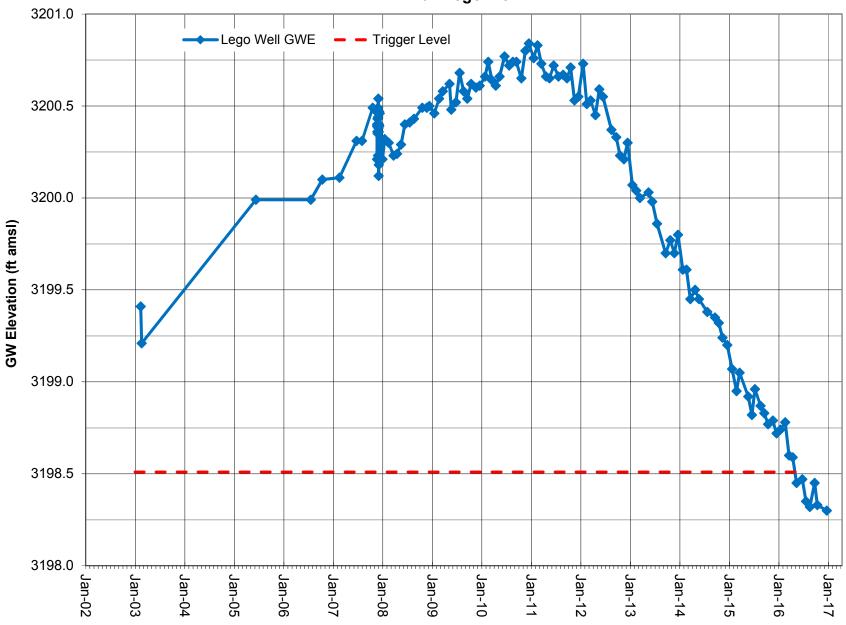
GROUNDWATER ELEVATION DATA - Long-Term (Manual) RV140 - Lego Well

Note: Groundwater elevation data based on manual depth-to-water measurements. Coso Operating Co. conducted a pump test on the Hay Ranch South Well in fourth quarter 2007. Coso Operating Co. initiated Hay Ranch Project pumping on 12/25/09.

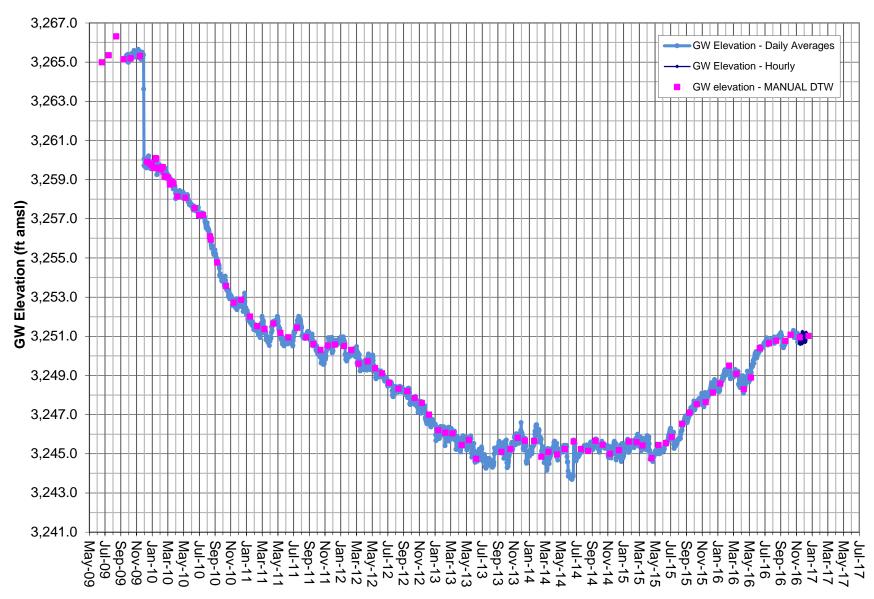
GROUNDWATER ELEVATION DATA - Transducer RV030 - Cal Pumice Well

Note: Transducer data adjusted by BaroTroll and correlated to Manual DTW. The 12/3/09 GWE decrease was confirmed by in-well PT and manual DTW. Coso Operating Co. initiated Hay Ranch Project pumping on 12/25/09.

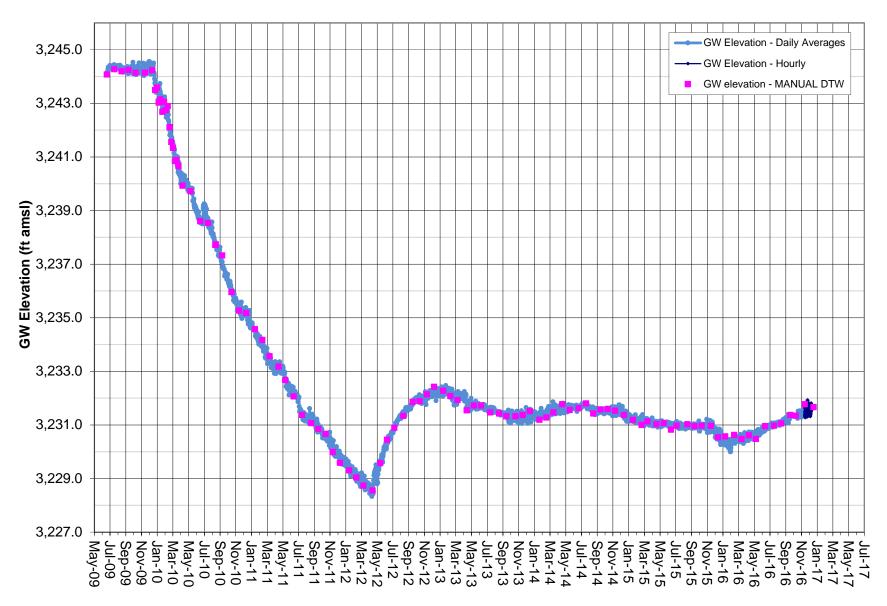
GROUNDWATER ELEVATION DATA - Transducer RV060 - HR 1A Well

Note: Screened interval 170-260 feet. Coso Operating Co. initiated Hay Ranch Project pumping on 12/25/09. HR 1A data gaps due to transducer malfunction.

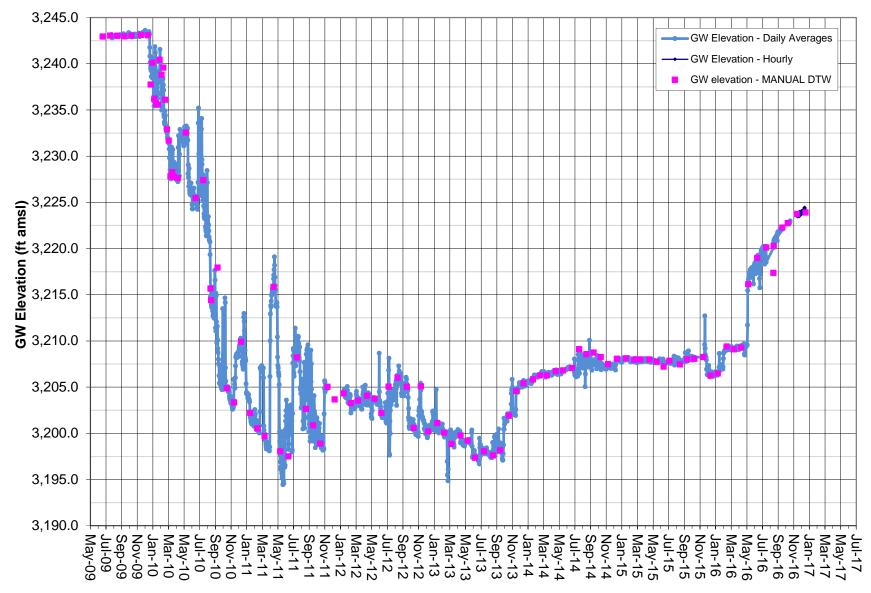
GROUNDWATER ELEVATION DATA - Transducer RV061 - HR 1B Well

Note: Transducer data (absolute pressure) adjusted by data logged from BaroTroll and correlated to Manual DTW measurements. Screened interval 490-540 feet.

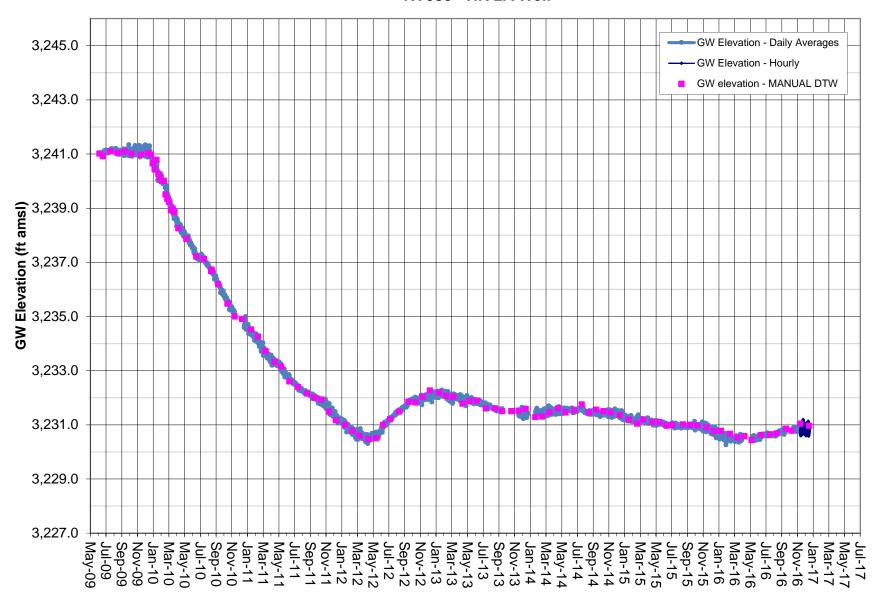
GROUNDWATER ELEVATION DATA - Transducer RV080 - HR 2A Well

Note: Screened interval 180-300 feet.

Coso Operating Co. initiated Hay Ranch Project pumping on 12/25/09.

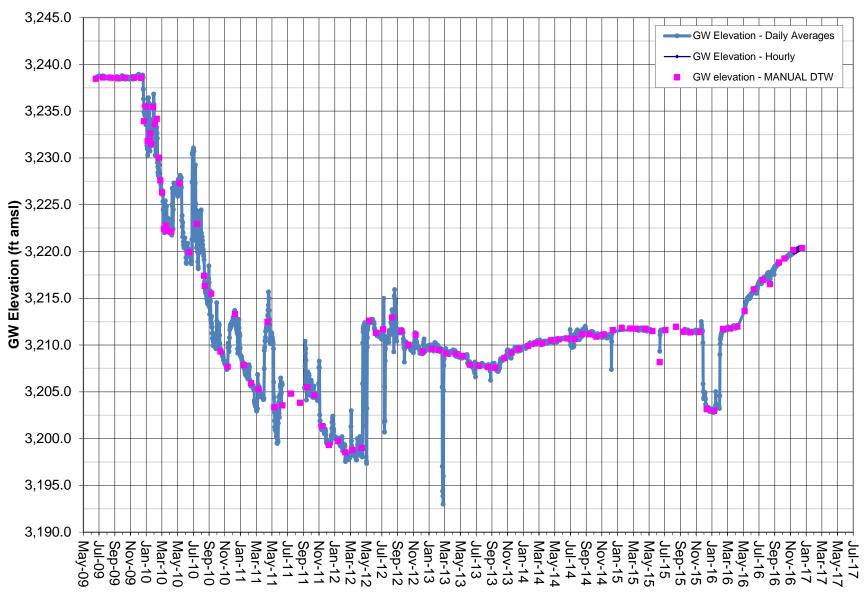
GROUNDWATER ELEVATION DATA - Transducer RV081 - HR 2B Well

Note: HR 2B data gaps due to transducer malfunction.

Screened interval 519-584 feet.

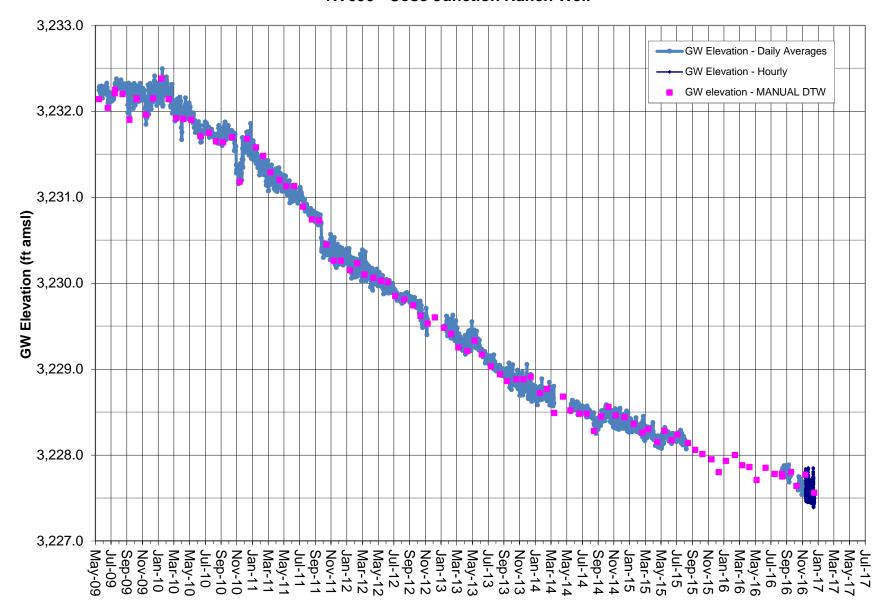
GROUNDWATER ELEVATION DATA - Transducer RV090 - Coso Junction Ranch Well

Note: Transducer data (absolute pressure) adjusted by data logged from BaroTroll and correlated to Manual DTW measurements. Coso Operating Co. initiated Hay Ranch Project pumping on 12/25/09.

Pressure Transducer removed in 2015.

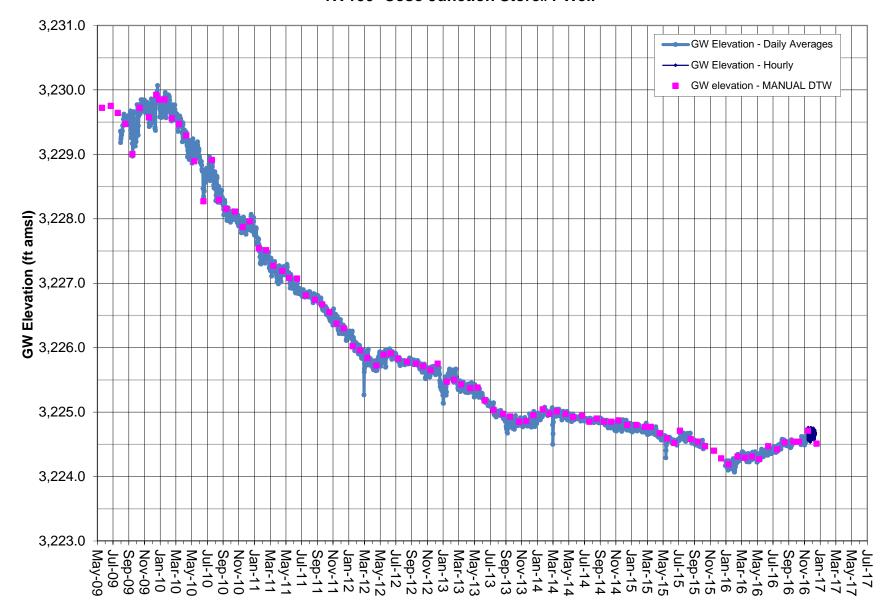
GROUNDWATER ELEVATION DATA - Transducer RV100- Coso Junction Store#1 Well

Note: Transducer data adjusted by data logged from BaroTroll and correlated to Manual DTW. Data gap from Oct.-Dec. due to pressure transducer malfunction.

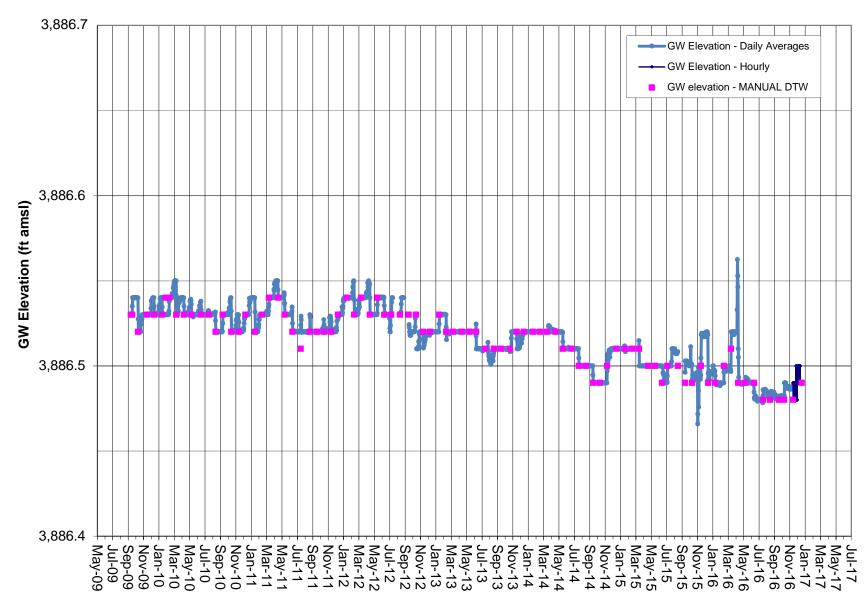
GROUNDWATER ELEVATION DATA - Transducer RV110 - Davis Ranch North Well

Note: Vented transducer data correlated to Manual DTW measurements. DTW measured to .01 foot; GWE calculated using approximate surface elevation. Coso Operating Co. initiated Hay Ranch Project pumping on 12/25/09.

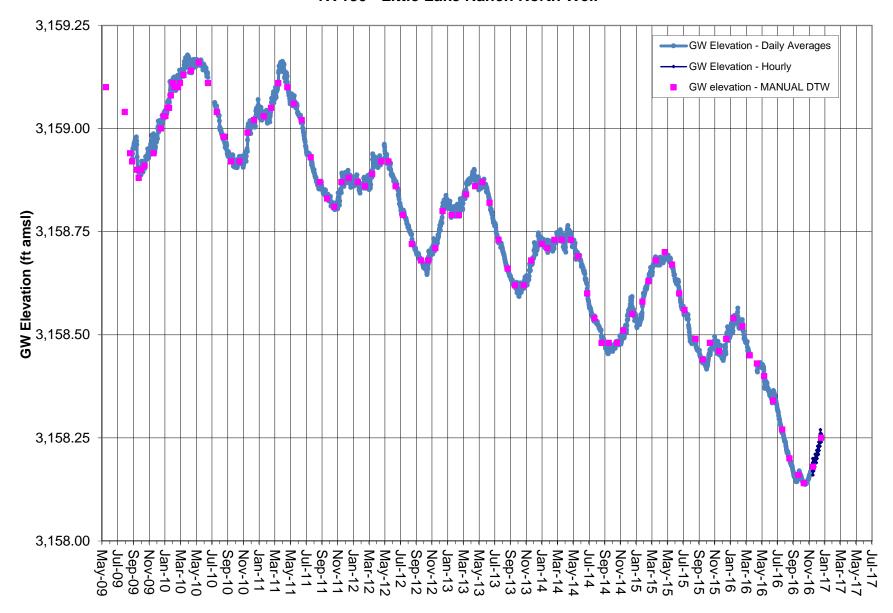
GROUNDWATER ELEVATION DATA - Transducer RV180 - Little Lake Ranch North Well

Note: Vented transducer data correlated to Manual DTW measurements. Coso Operating Co. initiated Hay Ranch Project pumping on 12/25/09. LLR North data gaps due to transducer malfunction.

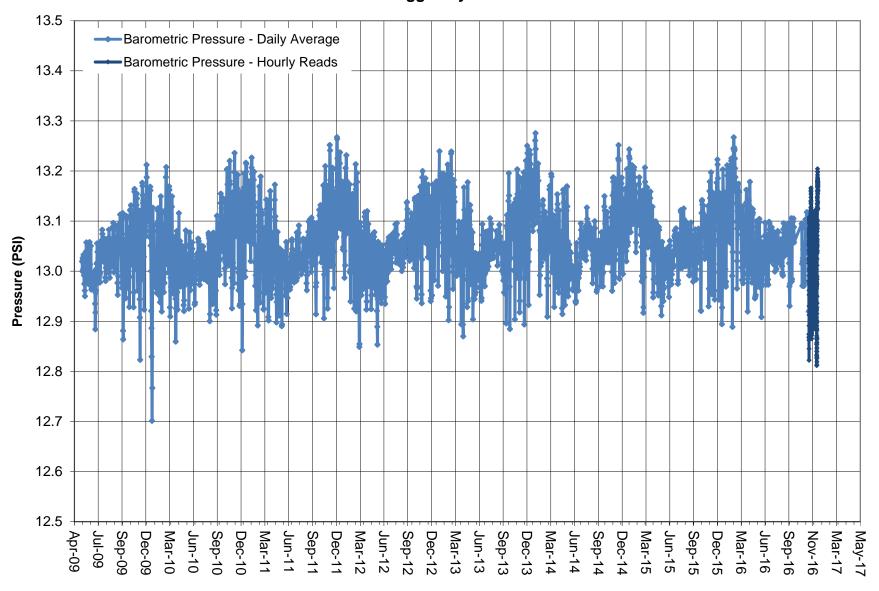
BAROMETRIC PRESSURE as Logged by BaroTroll

Note: BaroTroll located in well casing of well HR-2B. Used to adjust pressure readings in non-vented transducers. BaroTroll stopped working and was replaced 10/19/2016.

During the October 2016 monitoring event, the BaroTroll transducer, which measures barometric pressure and is used to adjust non-vented project transducers, ceased to work. The BaroTroll was replaced on October 19, 2016. Due to the inability to adjust non-vented project transducers for barometric flux, transducer data for the reporting period was not used in hydrographs. During the November 2016 monitoring event the Navy Wells (18-28 and Lego Wells) were inaccessible, however water levels were collected in December 2016. During the December 2016 event, the transducer in HR 1C (RV-62) became inoperable and was removed. This transducer is not anticipated to be replaced. A water level measurement was not collected from the Red Hill Well (RV-120) as this well was inaccessible in December, water level and transducer data are anticipated to be collected from this location in January 2017 if possible. During the October through December 2016 period, there were no other significant operational issues.
