# HAY RANCH PROJECT CONDITIONAL USE PERMIT HYDROLOGIC MONITORING REPORT

# FIRST QUARTER 2016 INYO COUNTY, CALIFORNIA

RE: Hay Ranch Project Conditional Use Permit Hydrologic Monitoring Report, First Quarter 2016

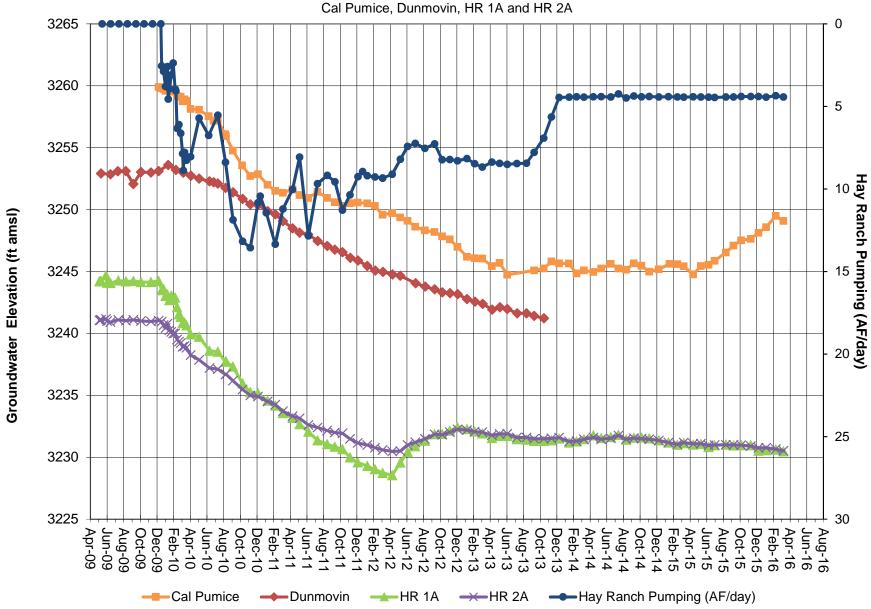
FIGURE 3
GROUNDWATER ELEVATION and HAY RANCH PUMPING
Cal Pumice Dummovin, HR 1A and HR 2A

Note: Groundwater elevation data based on manual depth-to-water measurements.

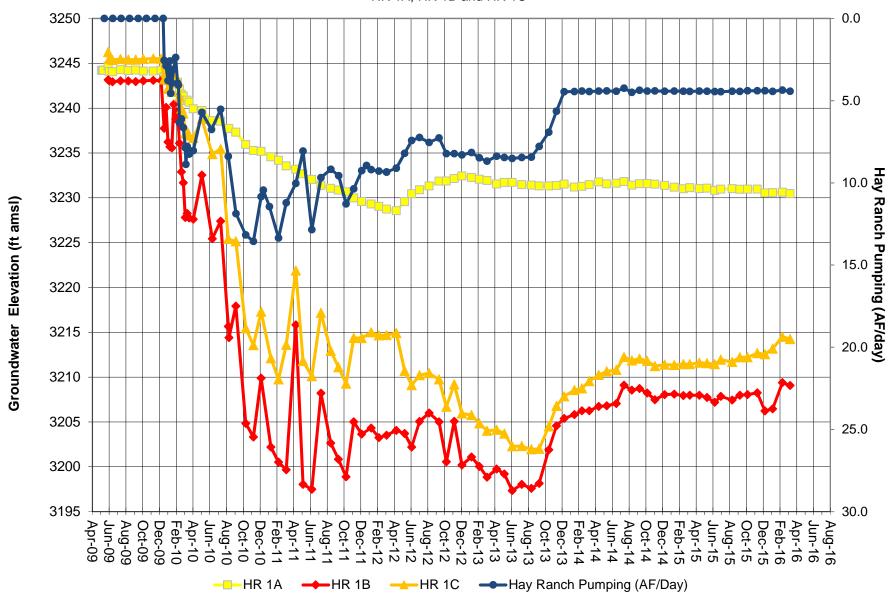
FIGURE 4
GROUNDWATER ELEVATION and HAY RANCH PUMPING
HR 1A, HR 1B and HR 1C

Note: GWE data based on manual DTW measurements. Hay Ranch pumping is average acre feet per day. Screened intervals: HR 1A 170-260 feet; HR 1B 490-540 feet; HR 1C 340-405 feet. Coso Operating initiated Hay Ranch Project pumping on 12/25/09.

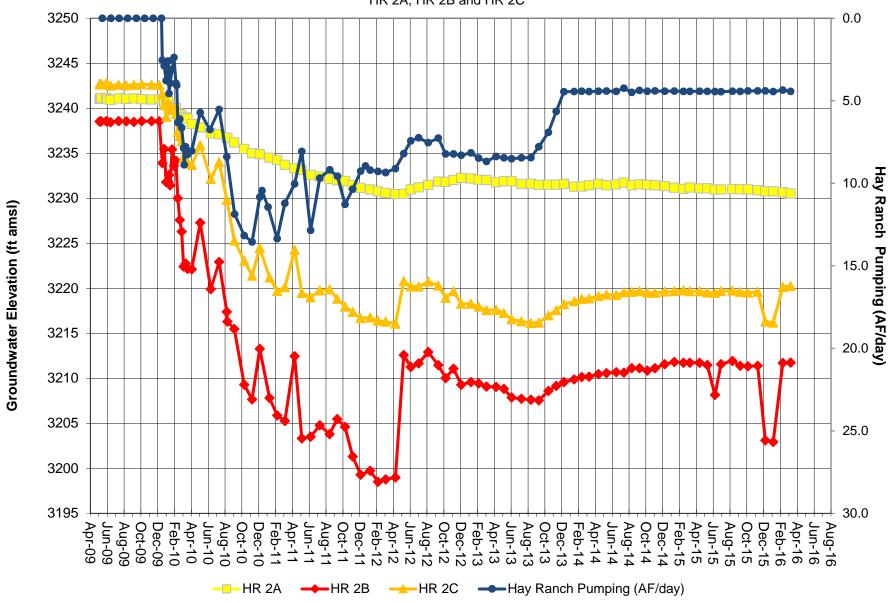
FIGURE 5
GROUNDWATER ELEVATION and HAY RANCH PUMPING
HR 2A, HR 2B and HR 2C

Note: GWE data based on manual DTW measurements. Hay Ranch pumping is average acre feet per day. Screened intervals: HR 2A 180-300 feet; HR 2B 519-584 feet; HR 2C 370-420 feet. Coso Operating initiated Hay Ranch Project pumping on 12/25/09.

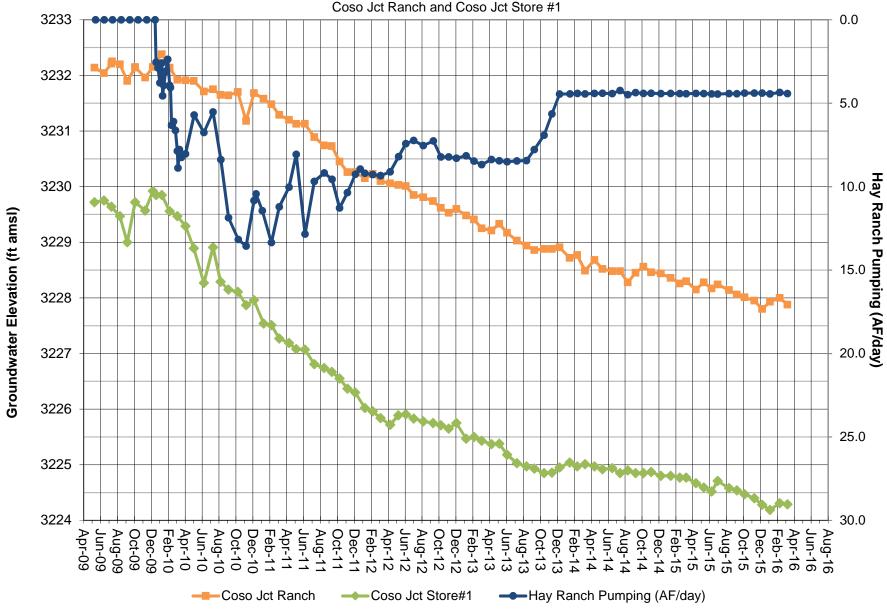
FIGURE 6A
GROUNDWATER ELEVATION and HAY RANCH PUMPING

Note: Groundwater elevation data based on manual depth-to-water measurements. Hay Ranch pumping is average acre feet per day.

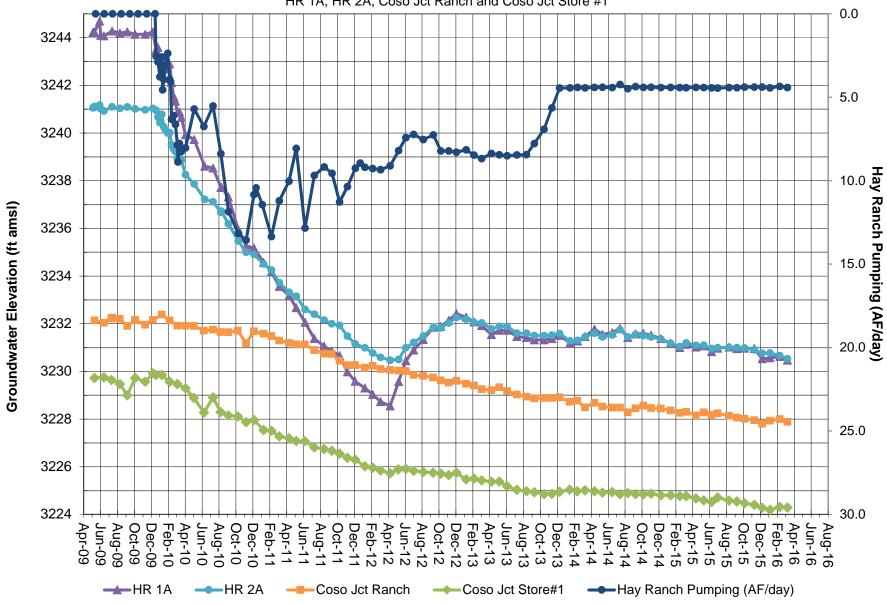
FIGURE 6B
GROUNDWATER ELEVATION and HAY RANCH PUMPING
HR 1A, HR 2A, Coso Jct Ranch and Coso Jct Store #1

Note: Groundwater elevation data based on manual depth-to-water measurements. Hay Ranch pumping is average acre feet per day. Coso Operating initiated Hay Ranch Project pumping on 12/25/09.

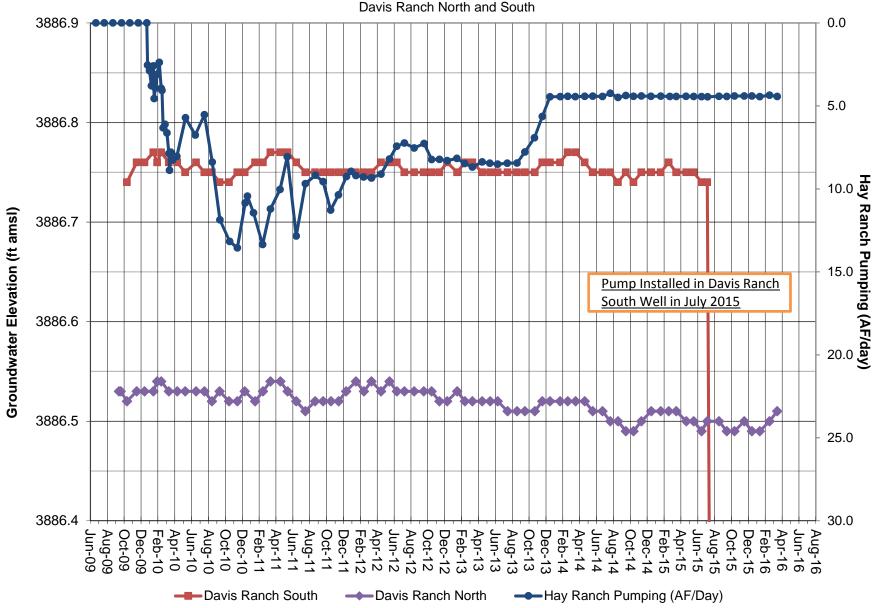
FIGURE 7
GROUNDWATER ELEVATION and HAY RANCH PUMPING

Note: Groundwater elevation data based on manual depth-to-water measurements. Hay Ranch pumping is average acre feet per day. Coso Operating initiated Hay Ranch Project pumping on 12/25/09.

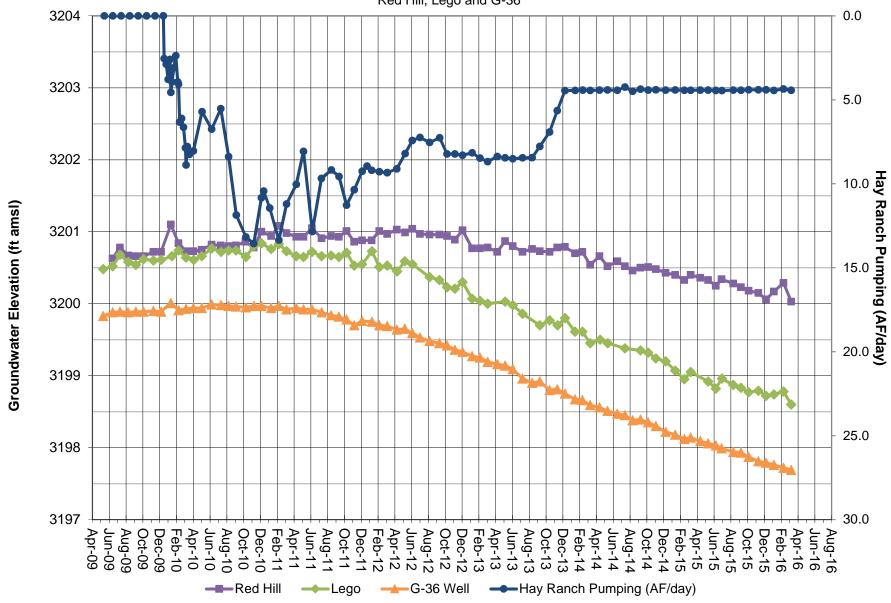
FIGURE 8
GROUNDWATER ELEVATION and HAY RANCH PUMPING
Red Hill, Lego and G-36

Note: Groundwater elevation data based on manual depth-to-water measurements. Hay Ranch pumping is average acre feet per day.

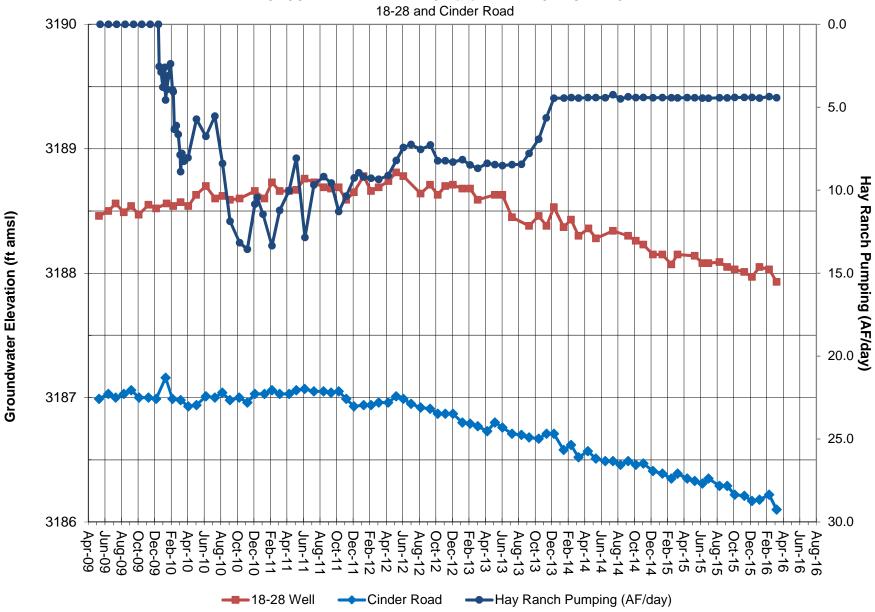
FIGURE 9
GROUNDWATER ELEVATION and HAY RANCH PUMPING

Note: Groundwater elevation data based on manual depth-to-water measurements. Hay Ranch pumping is average acre feet per day. Coso Operating initiated Hay Ranch Project pumping on 12/25/09.

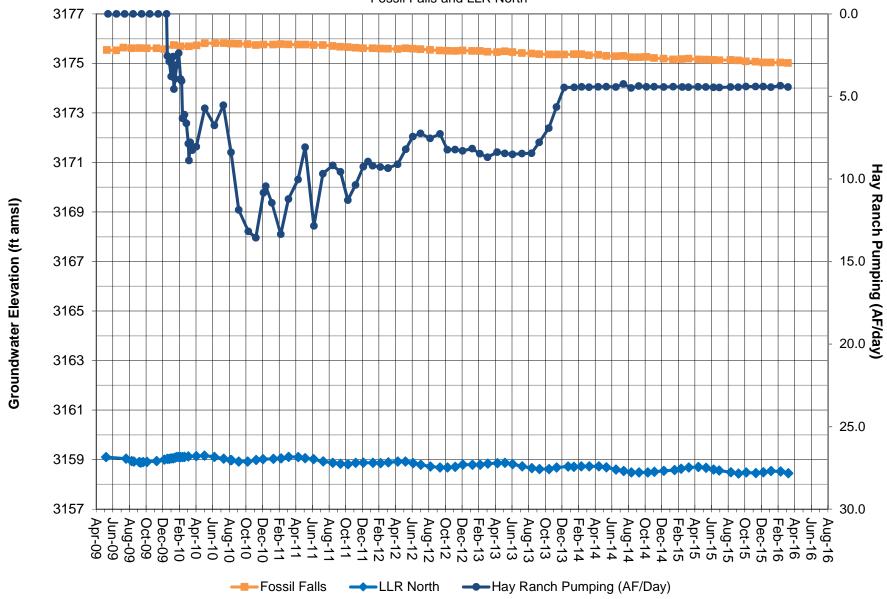
FIGURE 10
GROUNDWATER ELEVATION and HAY RANCH PUMPING
Fossil Falls and LLR North

Note: Groundwater elevation data based on manual depth-to-water measurements. Hay Ranch pumping is average acre feet per day.

During the First Quarter 2016, a battery backup was installed in HR2B (RV-81). The Little Lake Ranch North Well (RV-180) pressure transducer experienced failure; this transducer was removed from the well and a new transducer is anticipated to be installed in April.

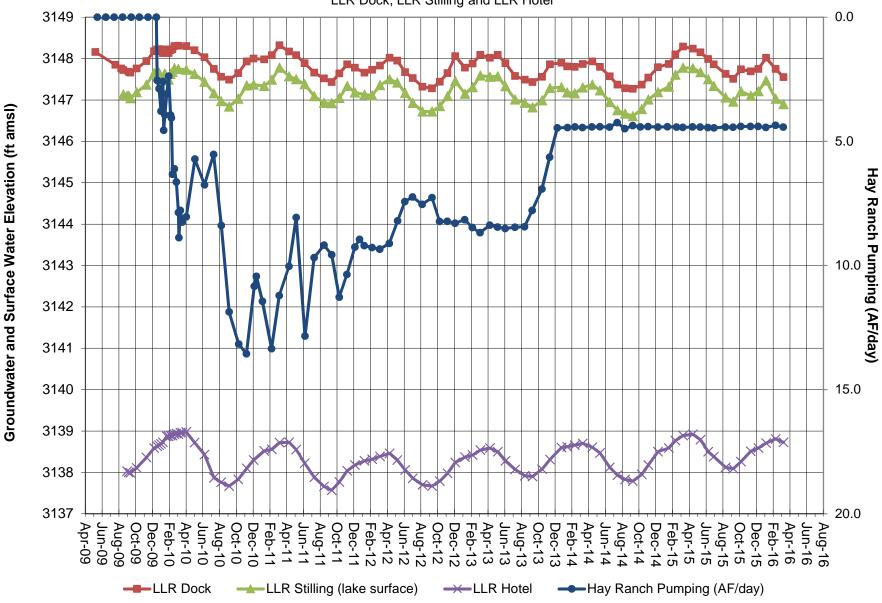
FIGURE 11
WATER ELEVATION and HAY RANCH PUMPING
LLR Dock, LLR Stilling and LLR Hotel

Note: Groundwater and surface water elevation data based on manual depth-to-water measurements. Hay Ranch pumping is average acre feet per day.

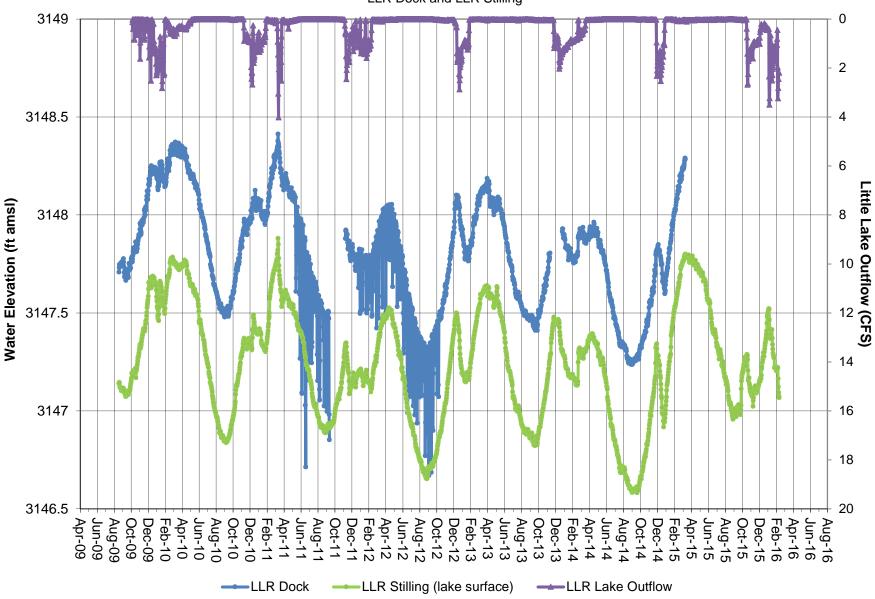
FIGURE 12
WATER ELEVATION and LITTLE LAKE OUTFLOW
LLR Dock and LLR Stilling

During the First Quarter 2016, LLR staff continued seasonal water management on the LLR property which included primarily a pattern where the lake weir boards were pulled and flow was released from the lake (see Figures 12 and 13). Also observed during the January monitoring event, a portion of the flow typically captured by the LLR North Culvert (RV-245) was not contained in the typical streambed upon arrival to take measurements on January 14, 2016. Water was flowing around the LLR North Culvert for an unknown duration of time and thus not all flow moving through this portion of Little Lake Ranch was able to be measured with the pressure transducer. Typical streamflow was restored before flow measurements and pressure transducer data were collected.

Note: Little Lake Outflow in cubic feet per second. LLR staff conducted water intermittent pumping from 2011-2012. Pressure Transducer removed from Dock Well in March 2015.

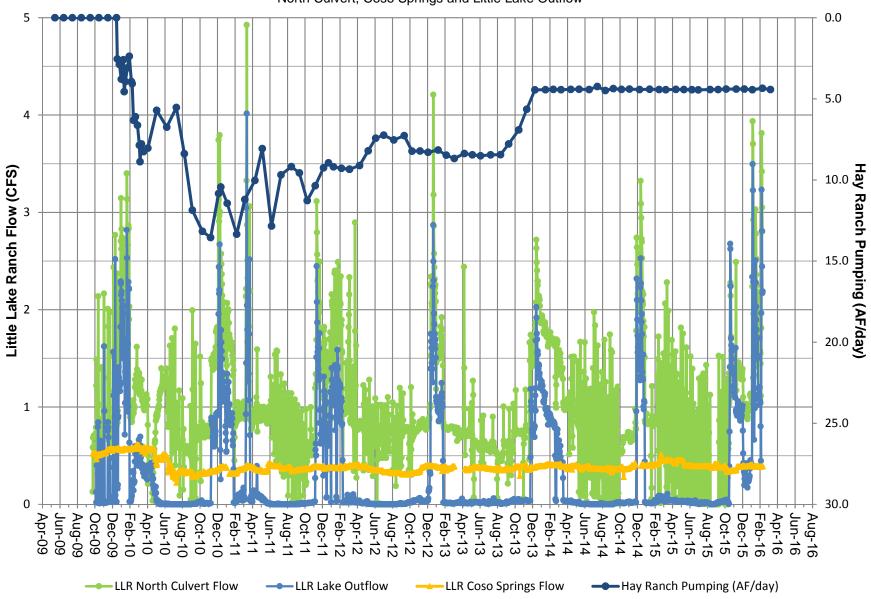
FIGURE 13
LLR FLOW and HAY RANCH PUMPING
North Culvert, Coso Springs and Little Lake Outflow

A spike in the LLR Lake Outflow hydrograph is typically indicative of water movement (removal of boards at the Little Lake Weirs) by LLR staff. After a time lag, increased outflow from Little Lake will also cause a spike in the LLR North Culvert Flow. A spike in the LLR North Culvert may also be caused by removal of boards at Pond 1 or 2; when only Pond boards are removed, the LLR Lake Outflow flume will not record increased flow, but the LLR North Culvert Flow will record a flow spike. Wind or weather events will cause a less dramatic increase in Lake Outflow and North Culvert Flow readings.

A hydrograph which compares surface water flows in the Little Lake Ranch area to Hay Ranch Project pumping rates over time is also included in this report as Figure 13. Surface water flows from Lake Outflow, Coso Springs Flow and North Culvert Flow are listed on the left axis, in cubic feet per second. Hay Ranch Project average daily pumping amounts, in acre-feet per day, are listed on the right axis in inverse order. As noted in Section 3.3, surface flow captured by the North Culvert Flow flume represents an accumulation of surface flows from Little Lake, Coso Springs and the Siphon Well flow.

Note: Little Lake Ranch Flows are cubic feet per second. Hay Ranch pumping is average acre feet per day.

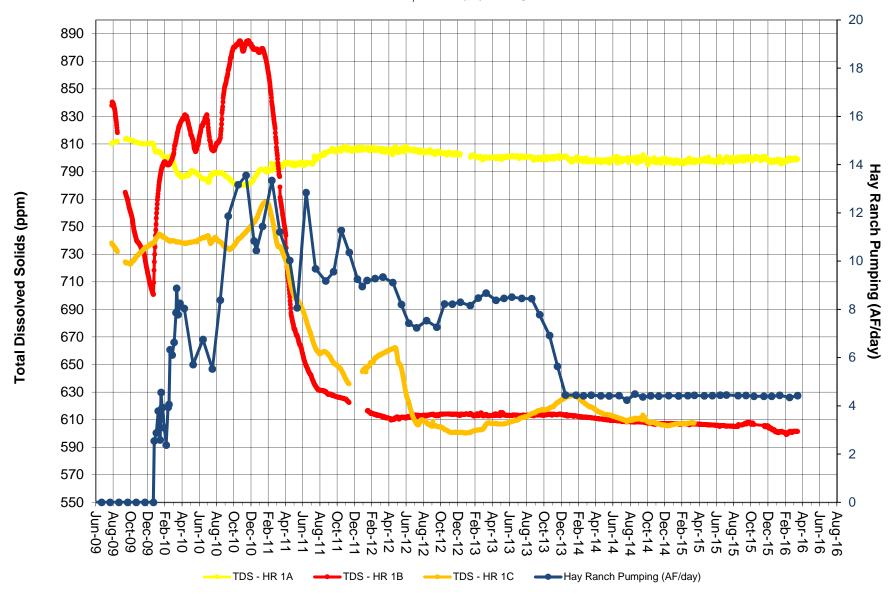
FIGURE 14
TOTAL DISSOLVED SOLIDS (TDS) and HAY RANCH PUMPING
HR 1A, HR 1B and HR 1C

Note: Screened intervals: HR 1A 170-260 feet; HR 1B 490-540 feet; HR 1C 340-405 feet. HR 1A, 1B and 1C data gaps due to transducer malfunction or adjustment. PT removed from HR1C in March 2015.

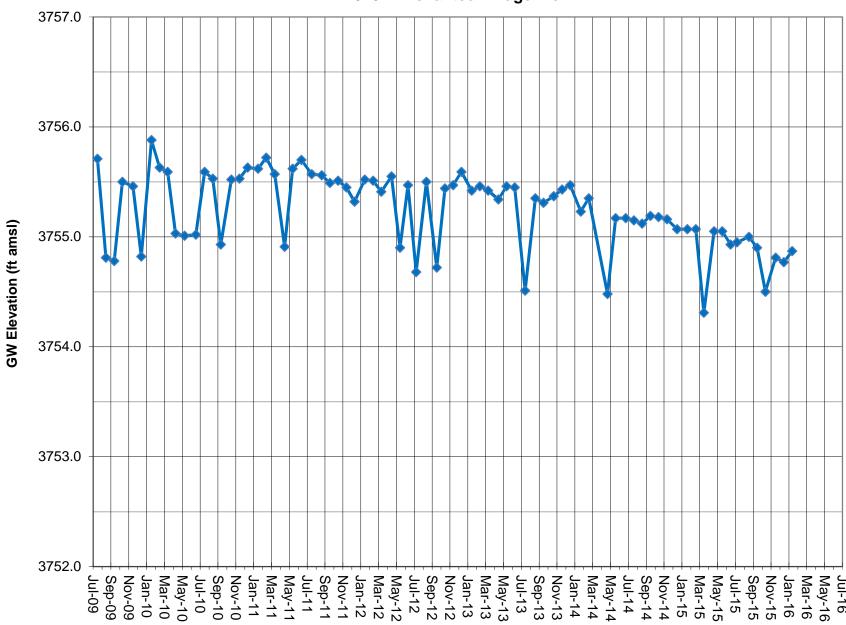
# GROUNDWATER ELEVATION DATA - Long-Term (Manual) RV010 - Enchanted Village Well

Note: Groundwater elevation data based on manual depth-to-water measurements. DTW measured to .01 foot; GWE calculated using approximate surface elevation. Dews Well is an actively pumped domestic supply well.

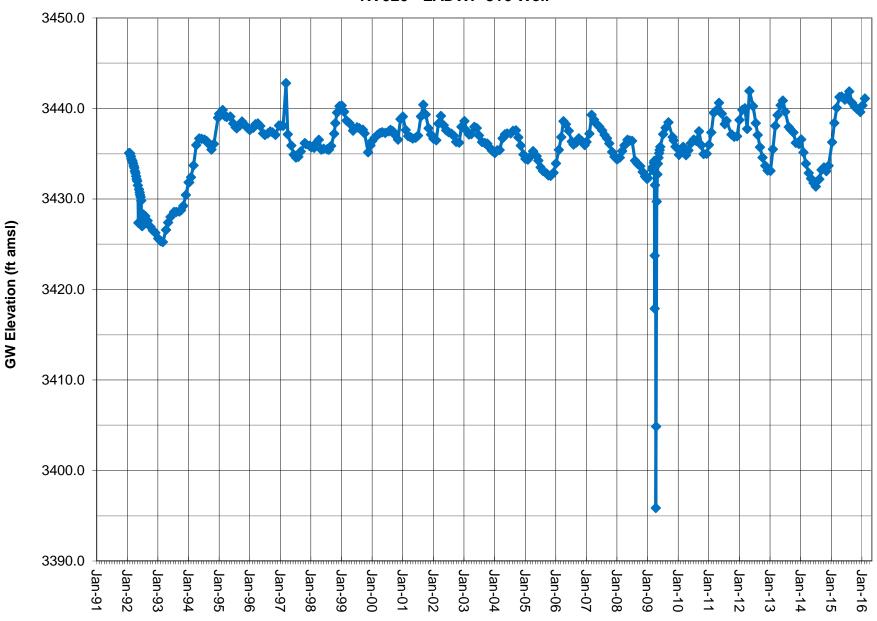
### GROUNDWATER ELEVATION DATA - Long-Term (Manual) RV020 - LADWP 816 Well

Note: Groundwater elevation data based on manual depth-to-water measurements. LADWP conducted a groundwater pump test on a nearby well in the first quarter 2009. Coso Operating Co. initiated Hay Ranch Project pumping on 12/25/09.

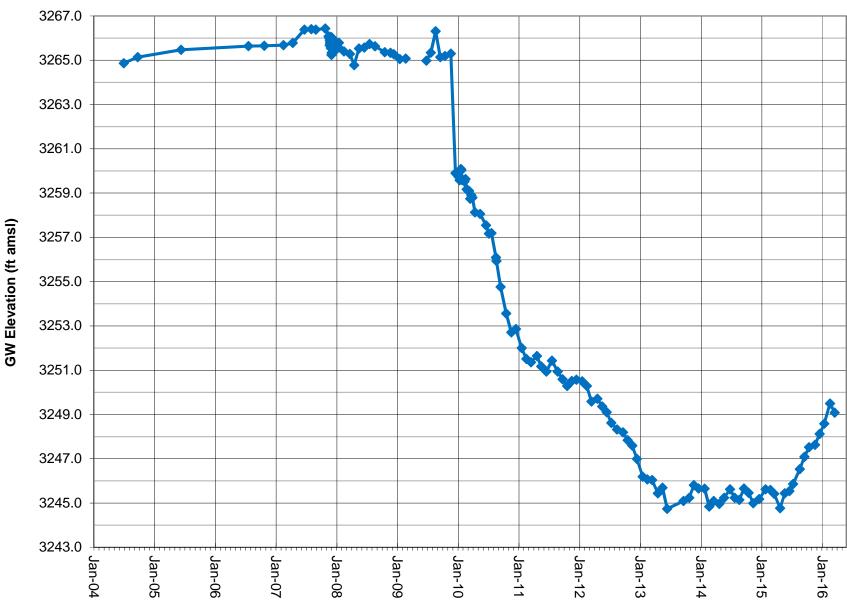
### GROUNDWATER ELEVATION DATA - Long-Term (Manual) RV030 - Cal Pumice Well

Note: A data gap exists in 2009 during a pump test on a nearby well. The notable DTW change in late 2009 was confirmed by in-well PT. Coso Operating Co. initiated Hay Ranch Project pumping on 12/25/09.

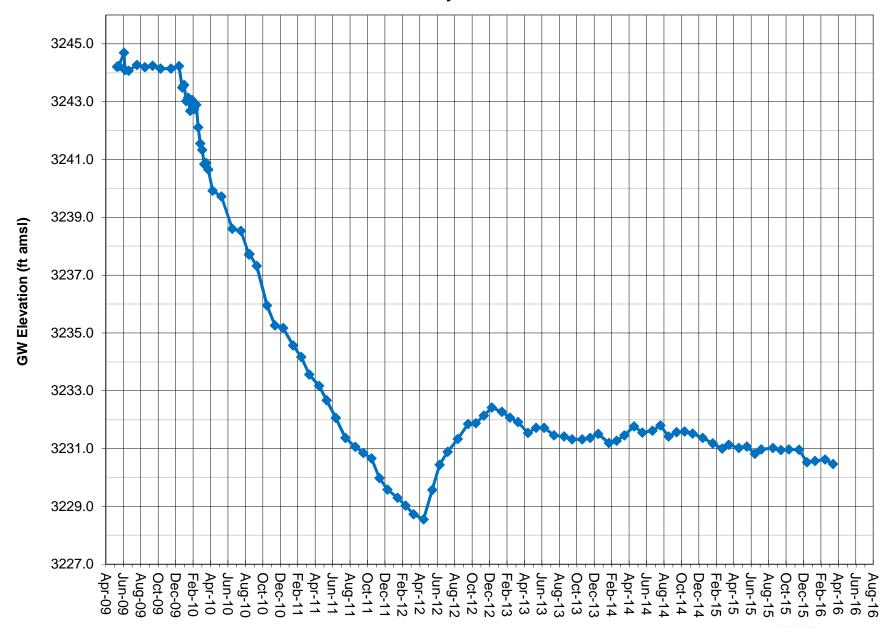
# GROUNDWATER ELEVATION DATA - Long-Term (Manual) RV060 - Hay Ranch 1A Well

Note: Groundwater elevation data based on manual depth-to-water measurements. Lines between data points are approximations. Screened interval is 170-260 feet.

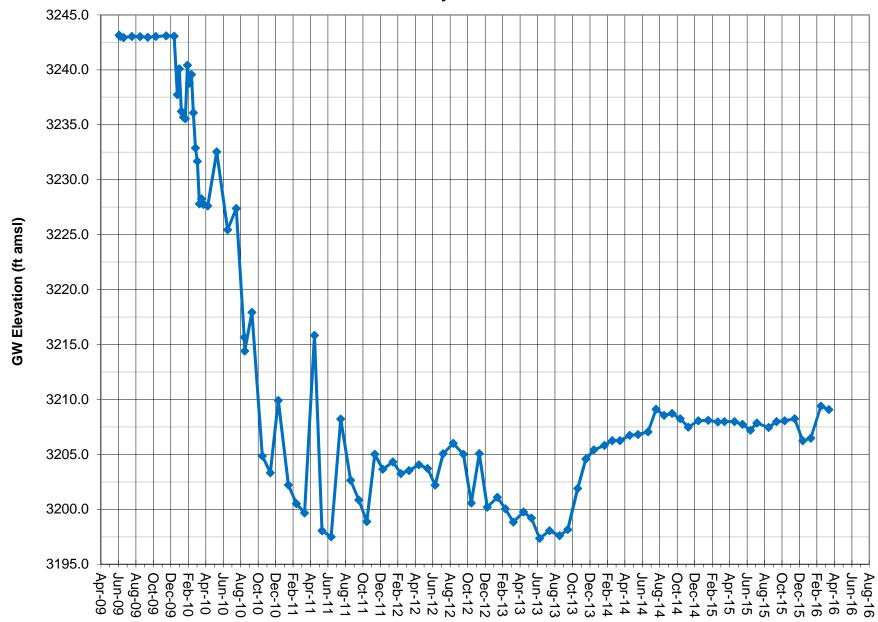
# GROUNDWATER ELEVATION DATA - Long-Term (Manual) RV061 - Hay Ranch 1B Well

Note: Groundwater elevation data based on manual depth-to-water measurements. Lines between data points are approximations. Screened interval is 490-540 feet.

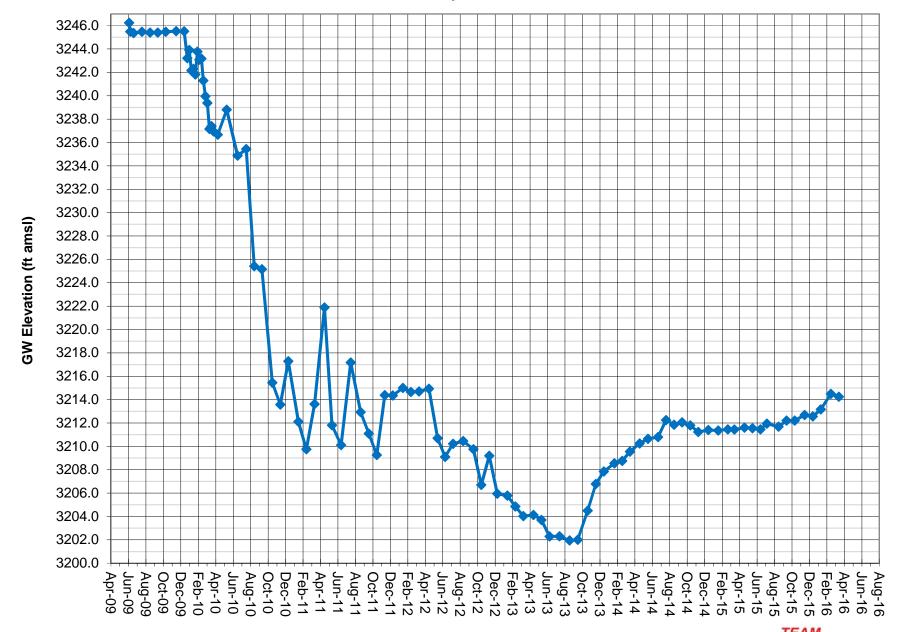
# GROUNDWATER ELEVATION DATA - Long-Term (Manual) RV062 - Hay Ranch 1C Well

Note: Groundwater elevation data based on manual depth-to-water measurements. Lines between data points are approximations. Screened interval is 340-405 feet.

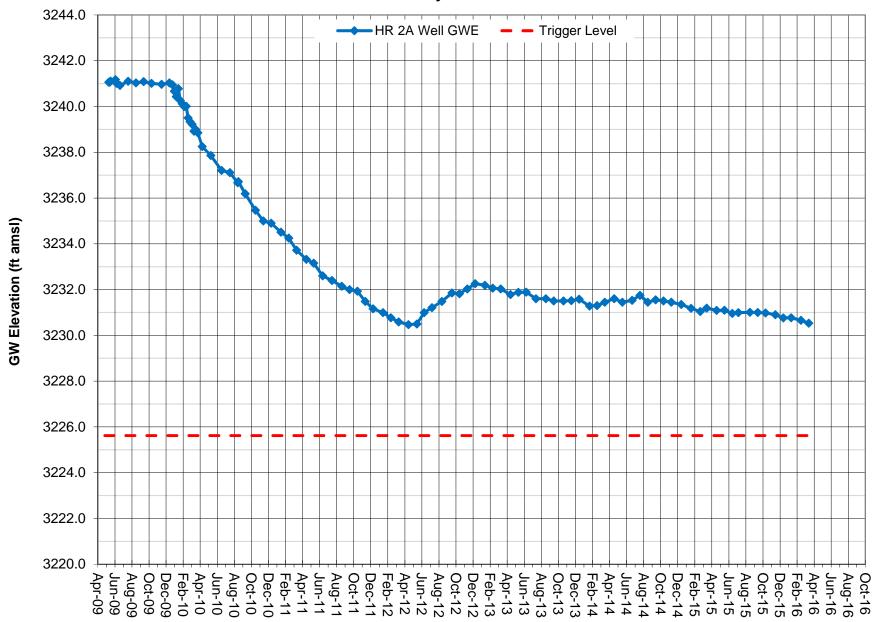
# GROUNDWATER ELEVATION DATA - Long-Term (Manual) RV080- Hay Ranch 2A Well

Note: Groundwater elevation data based on manual depth-to-water measurements. Lines between data points are approximations. Screened interval is 180-300 feet.

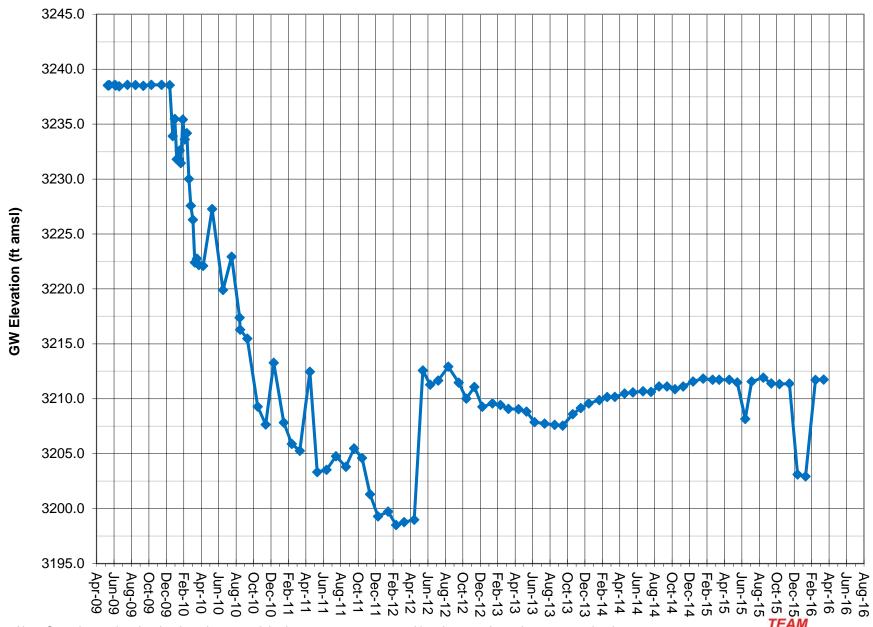
# GROUNDWATER ELEVATION DATA - Long-Term (Manual) RV081 - Hay Ranch 2B Well

Note: Groundwater elevation data based on manual depth-to-water measurements. Lines between data points are approximations. Screened interval is 519-584 feet.

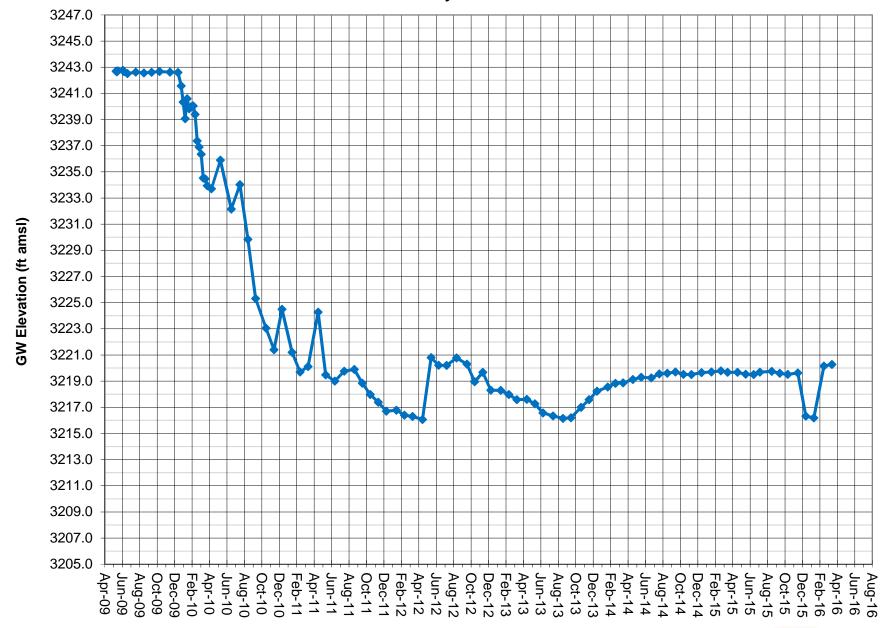
# GROUNDWATER ELEVATION DATA - Long-Term (Manual) RV082 - Hay Ranch 2C Well

Note: Groundwater elevation data based on manual depth-to-water measurements. Lines between data points are approximations. Screened interval is 370-420 feet.

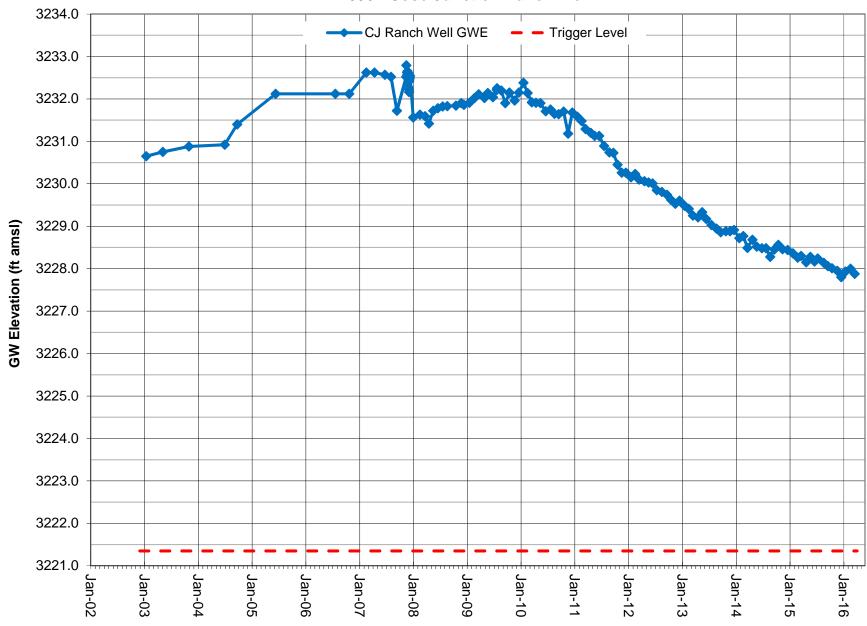
### GROUNDWATER ELEVATION DATA - Long-Term (Manual) RV090 - Coso Junction Ranch Well

Note: Groundwater elevation data based on manual depth-to-water measurements.

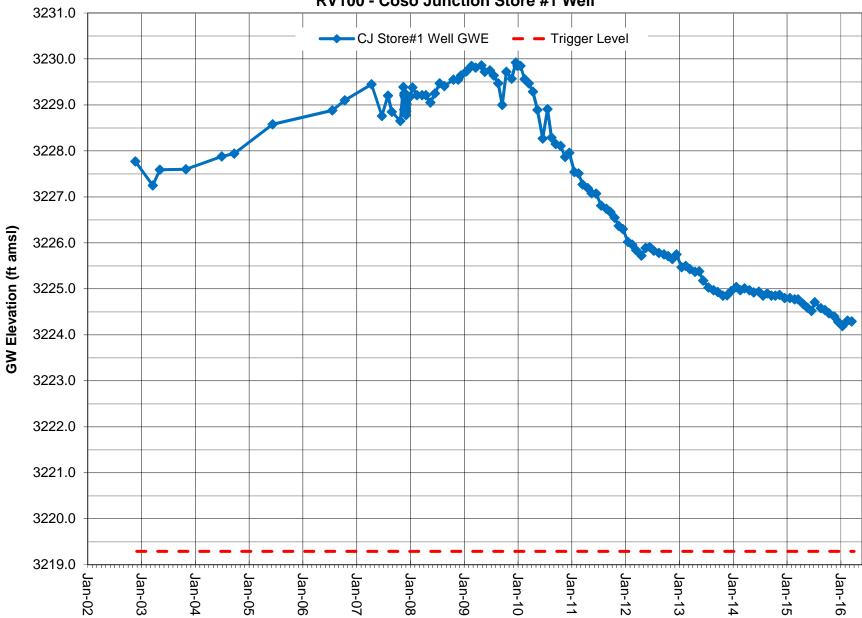
### GROUNDWATER ELEVATION DATA - Long-Term (Manual) RV100 - Coso Junction Store #1 Well

Note: Groundwater elevation data based on manual depth-to-water measurements. Well is adjacent to actively pumped domestic well.

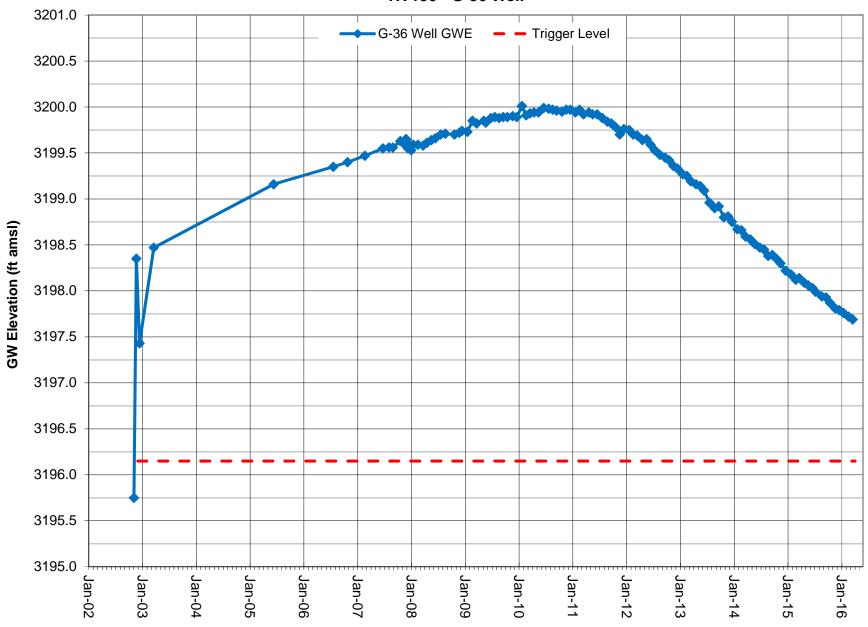
#### GROUNDWATER ELEVATION DATA - Long-Term (Manual) RV130 - G-36 Well

Note: Groundwater elevation data based on manual depth-to-water measurements.
Coso Operating Co. conducted a pump test on the Hay Ranch South Well in fourth quarter 2007.
Coso Operating Co. initiated Hay Ranch Project pumping on 12/25/09.

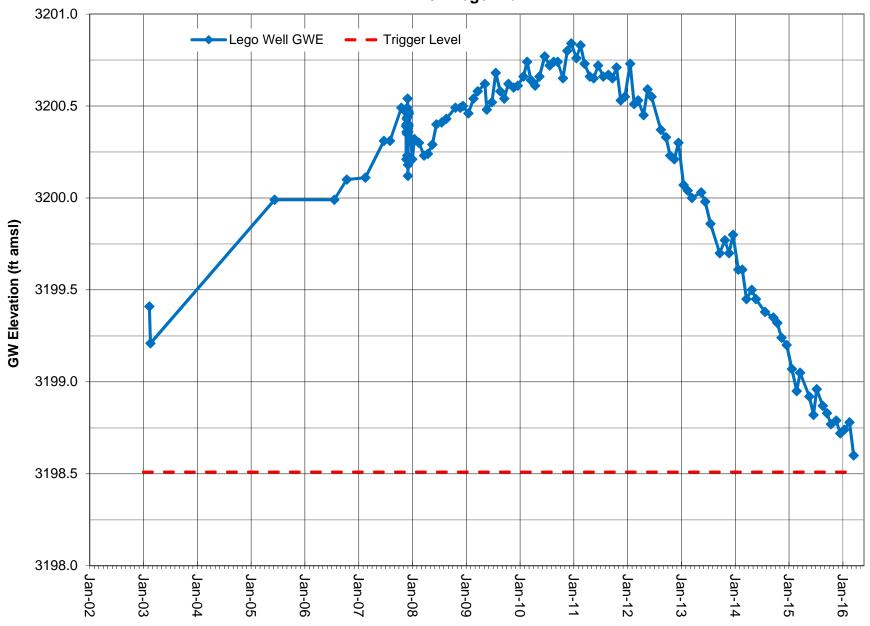
# GROUNDWATER ELEVATION DATA - Long-Term (Manual) RV140 - Lego Well

Note: Groundwater elevation data based on manual depth-to-water measurements. Coso Operating Co. conducted a pump test on the Hay Ranch South Well in fourth quarter 2007. Coso Operating Co. initiated Hay Ranch Project pumping on 12/25/09.

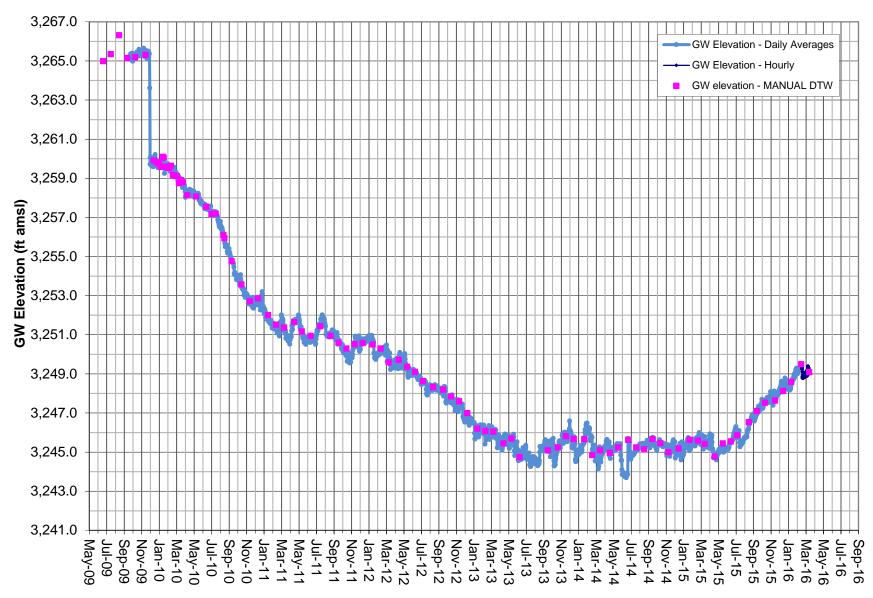
# GROUNDWATER ELEVATION DATA - Transducer RV030 - Cal Pumice Well

Note: Transducer data adjusted by BaroTroll and correlated to Manual DTW. The 12/3/09 GWE decrease was confirmed by in-well PT and manual DTW. Coso Operating Co. initiated Hay Ranch Project pumping on 12/25/09.

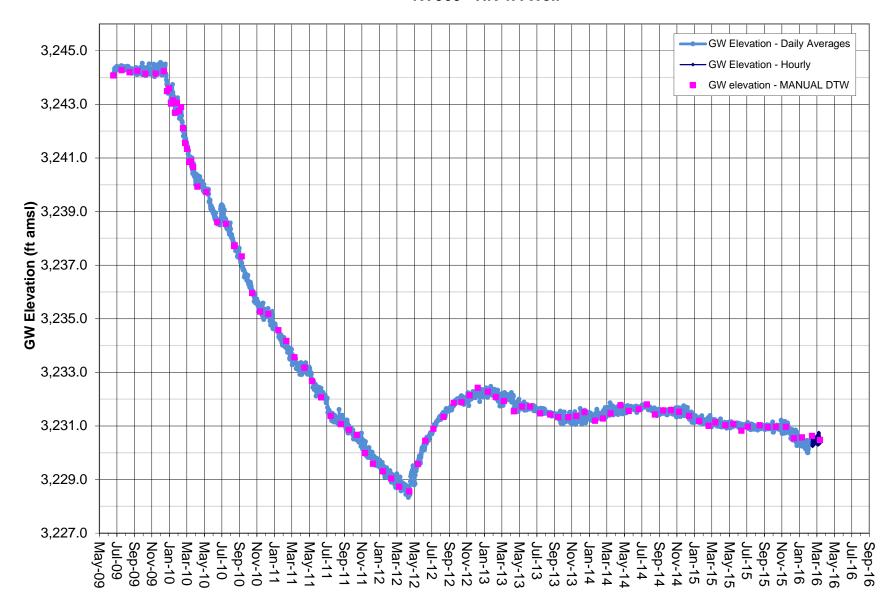
### GROUNDWATER ELEVATION DATA - Transducer RV060 - HR 1A Well

Note: Screened interval 170-260 feet. Coso Operating Co. initiated Hay Ranch Project pumping on 12/25/09. HR 1A data gap from 1/10/11 to 1/20/11 due to transducer malfunction.

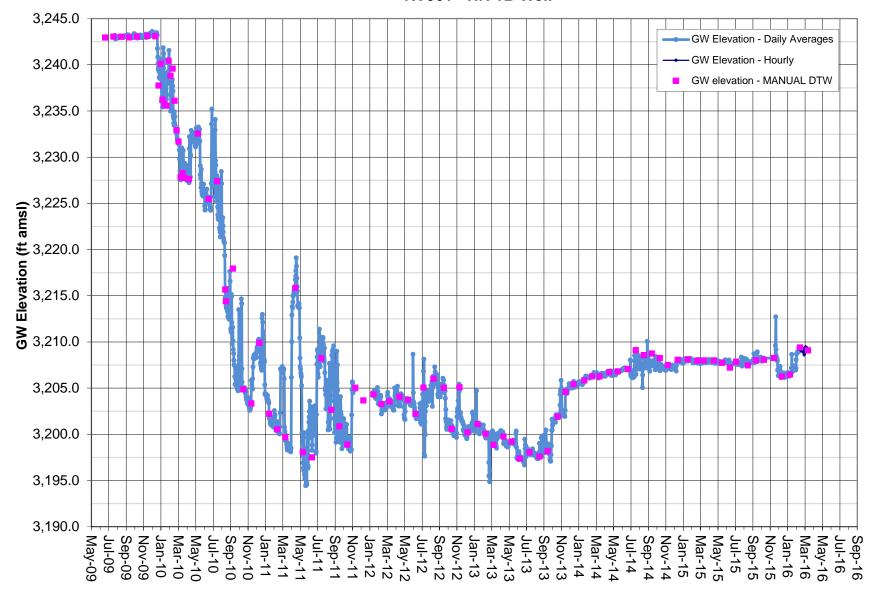
### GROUNDWATER ELEVATION DATA - Transducer RV061 - HR 1B Well

Note: Transducer data (absolute pressure) adjusted by data logged from BaroTroll and correlated to Manual DTW measurements. Screened interval 490-540 feet.

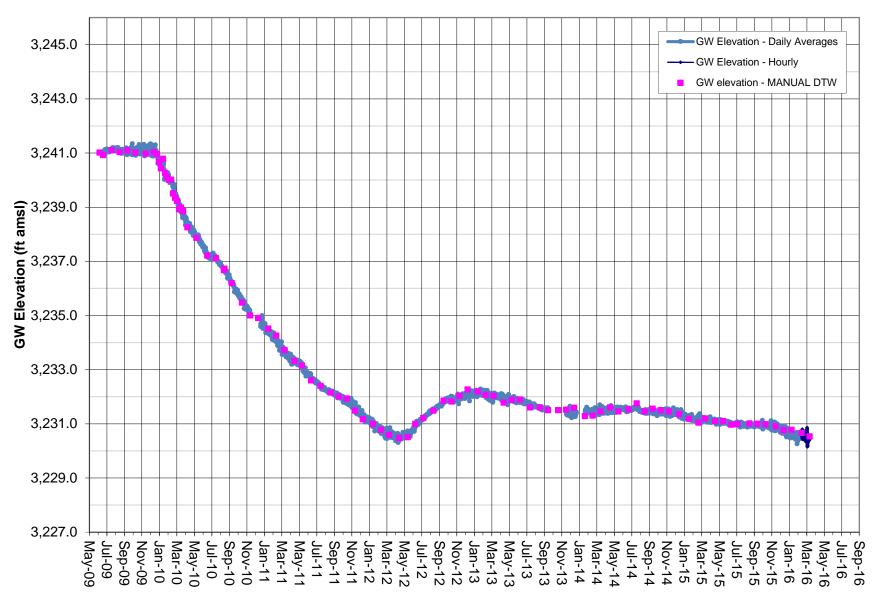
### GROUNDWATER ELEVATION DATA - Transducer RV080 - HR 2A Well

Note: Screened interval 180-300 feet. Coso Operating Co. initiated Hay Ranch Project pumping on 12/25/09. HR 2A data gaps due to pressure transducer malfunction.

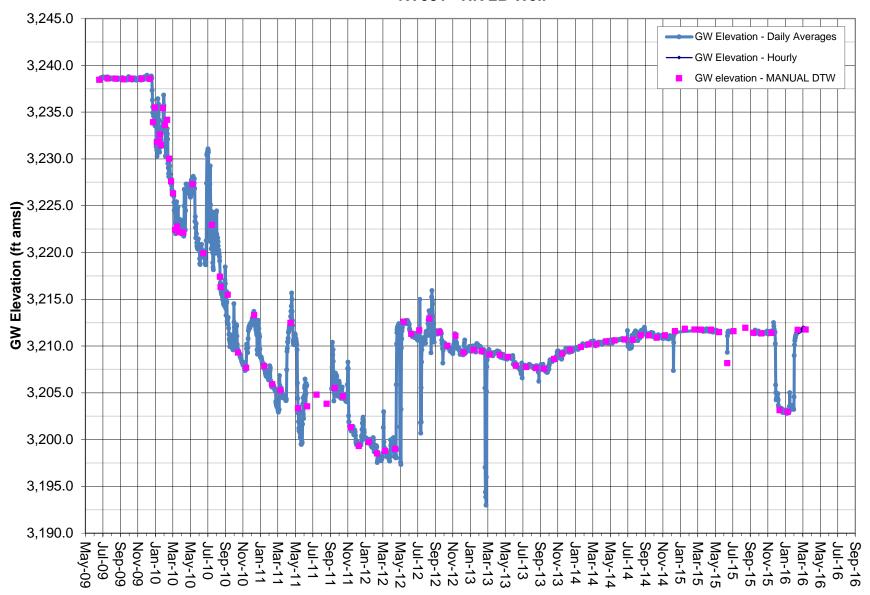
## GROUNDWATER ELEVATION DATA - Transducer RV081 - HR 2B Well

Note: HR 2B data gap from 2011 and 2015 due to transducer malfunction. Screened interval 519-584 feet.

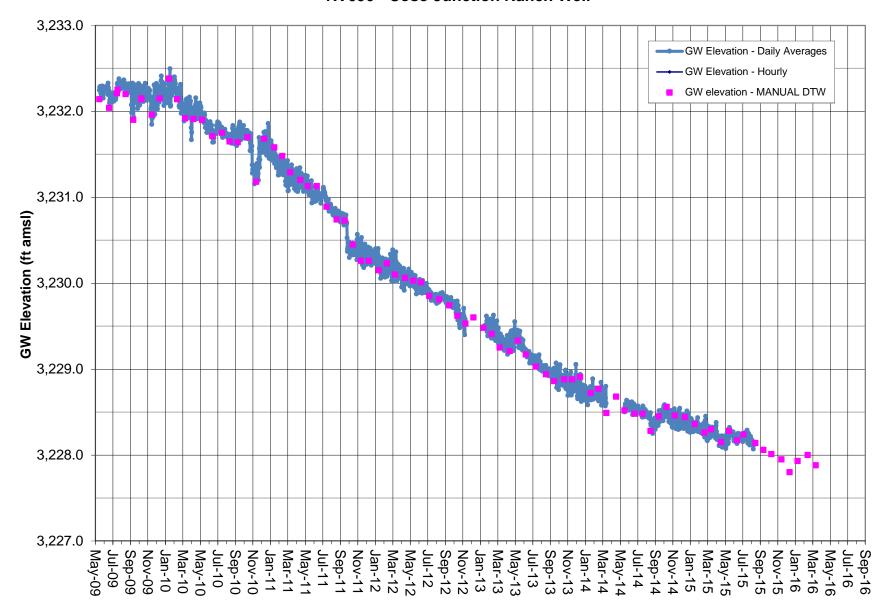
#### GROUNDWATER ELEVATION DATA - Transducer RV090 - Coso Junction Ranch Well

Note: Transducer data (absolute pressure) adjusted by data logged from BaroTroll and correlated to Manual DTW measurements. Coso Operating Co. initiated Hay Ranch Project pumping on 12/25/09.

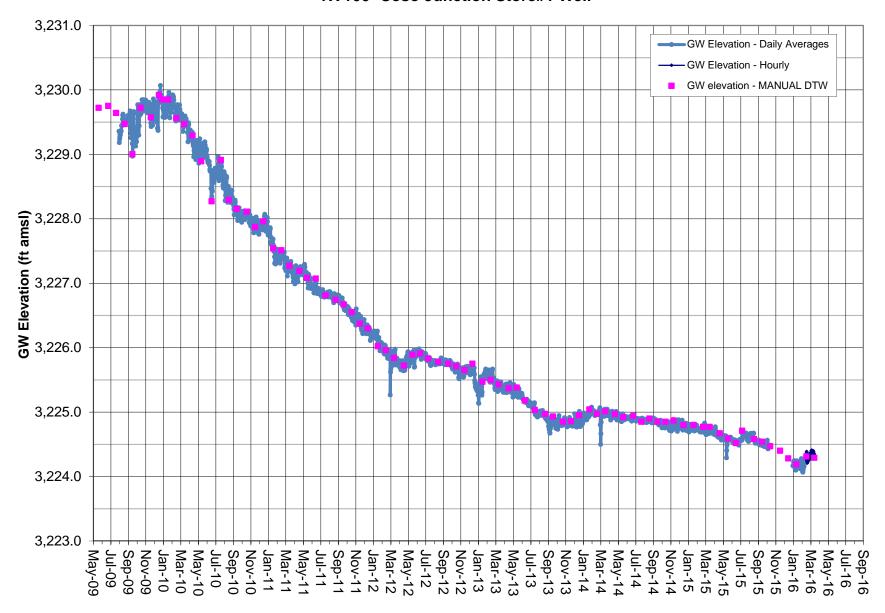
### GROUNDWATER ELEVATION DATA - Transducer RV100- Coso Junction Store#1 Well

Note: Transducer data adjusted by data logged from BaroTroll and correlated to Manual DTW. Data gap from Oct.-Dec. due to pressure transducer malfunction.

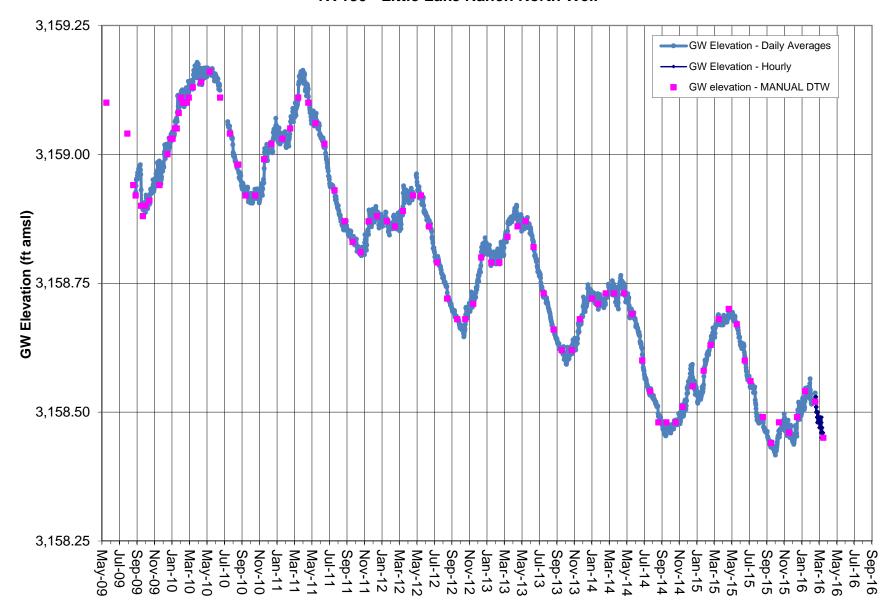
### GROUNDWATER ELEVATION DATA - Transducer RV180 - Little Lake Ranch North Well

Note: Vented transducer data correlated to Manual DTW measurements.
Coso Operating Co. initiated Hay Ranch Project pumping on 12/25/09.
LLR North data gap from 6/18/10 to 7/13/10, and 4/18/12 to 4/30/12 due to transducer malfunction.

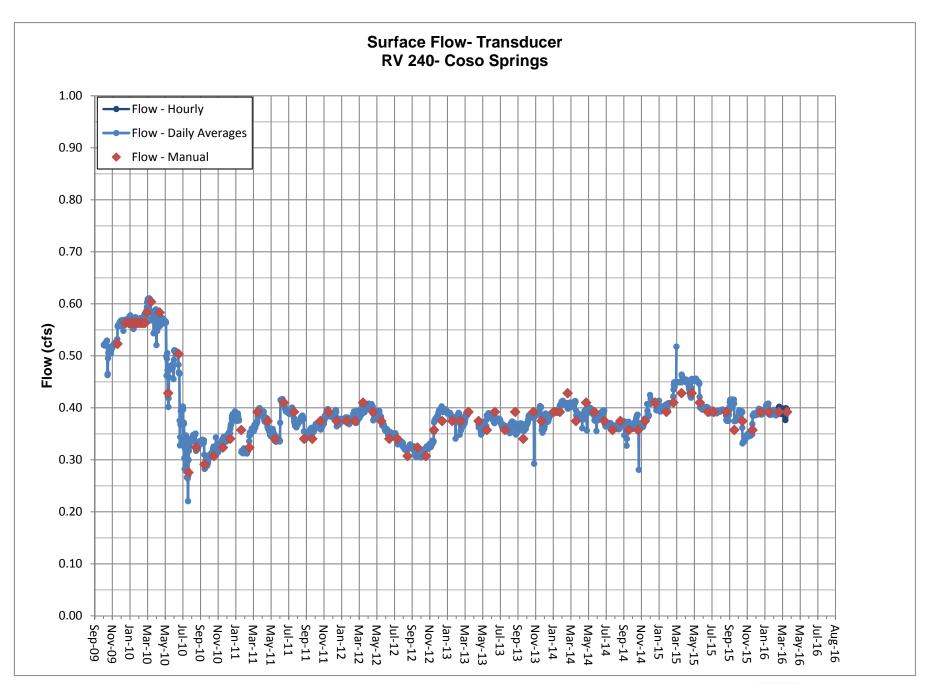
Note: Coso Springs is an artesian spring. Data gap from 1/2011 and 3/2013 due to transducer malfunction. Sept 2015 data collected from backup unit.
