HAY RANCH PROJECT CONDITIONAL USE PERMIT HYDROLOGIC MONITORING REPORT

**FIRST QUARTER 2019
INYO COUNTY, CALIFORNIA**

**RE: Hay Ranch Project Conditional Use Permit
Hydrologic Monitoring Report, First Quarter 2019
Inyo County, California**

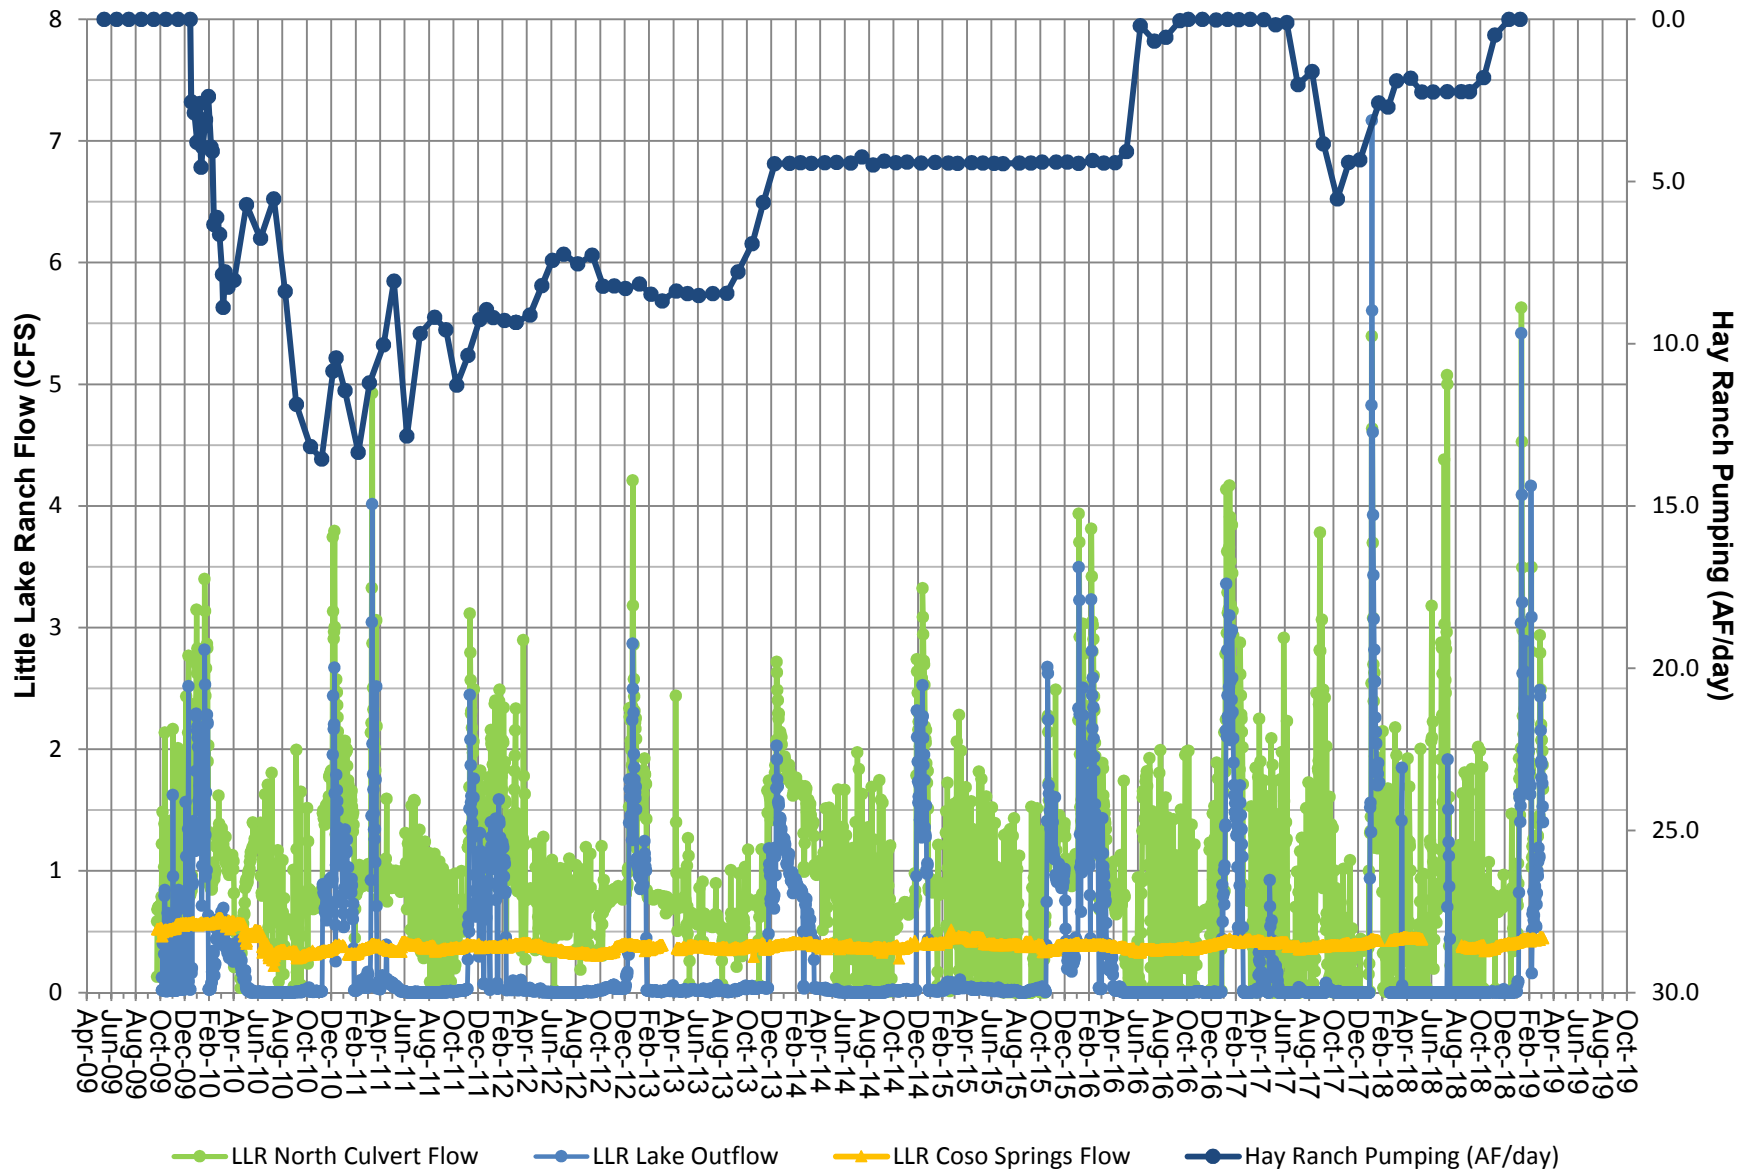
Note: Little Lake Ranch Flows are cubic feet per second.
 Hay Ranch pumping is average acre feet per day.

A hydrograph which compares surface water flows in the Little Lake Ranch area to Hay Ranch Project pumping rates over time is also included in this report as Figure 13. Surface water flows from Lake Outflow, Coso Springs Flow and North Culvert Flow are listed on the left axis, in cubic feet per second. Hay Ranch Project average daily pumping amounts, in acre-feet per day, are listed on the right axis in inverse order. As noted in Section 3.3, surface flow captured by the North Culvert Flow flume represents an accumulation of surface flows from Little Lake, Coso Springs and the Siphon Well flow.
