HAY RANCH PROJECT  
CONDITIONAL USE PERMIT

# HYDROLOGIC MONITORING REPORT

FIRST QUARTER 2023  
INYO COUNTY, CALIFORNIA

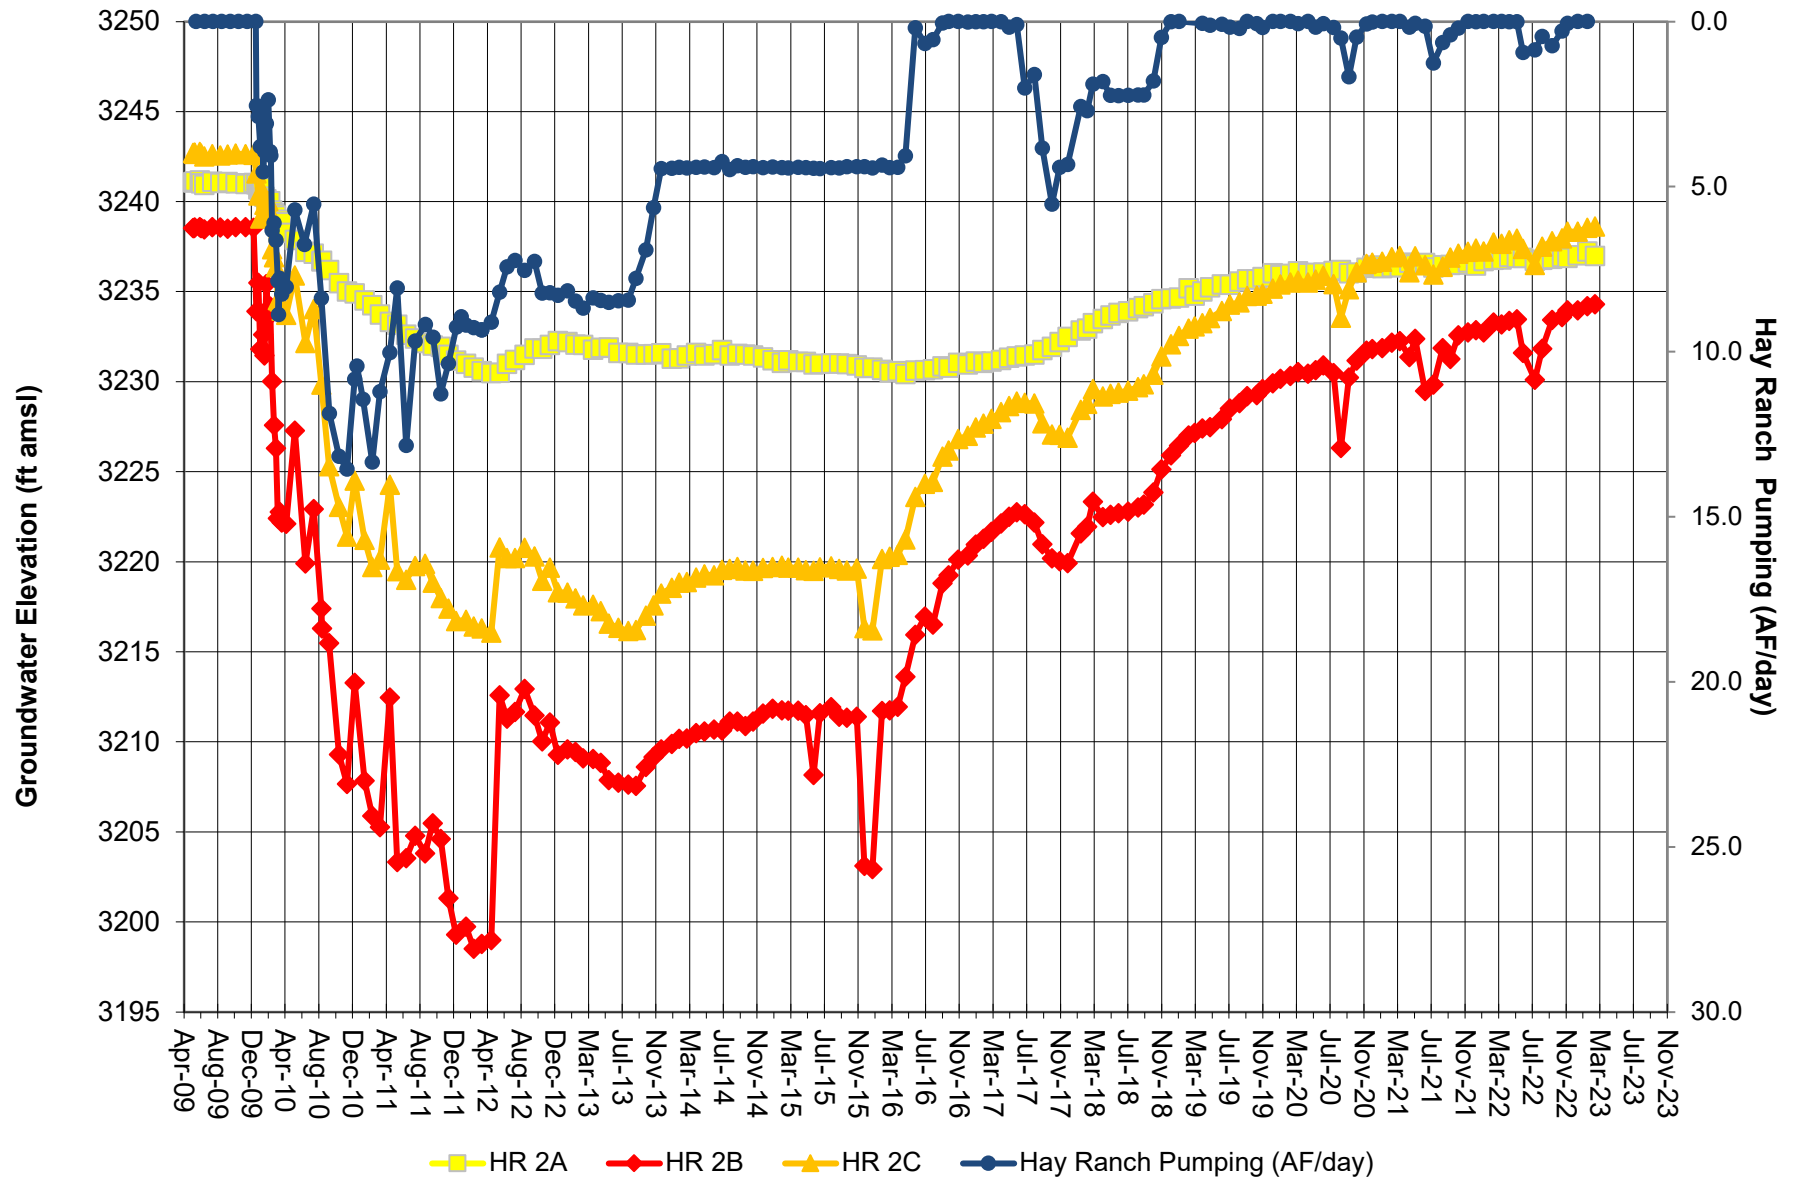
**FIGURE 5**  
GROUNDWATER ELEVATION and HAY RANCH PUMPING  
HR 2A, HR 2B and HR 2C

Note: Groundwater elevation data based on manual depth-to-water measurements.  
Hay Ranch pumping is average acre feet per day.  
Hay Ranch Totalizers not operational in Feb and March 2023
