**HAY RANCH PROJECT
INYO COUNTY CONDITIONAL USE PERMIT
HYDROLOGIC MONITORING REPORT**

FIRST QUARTER 2024

**RE: Hay Ranch Project Conditional Use Permit
Hydrologic Monitoring Report, First Quarter 2024
Inyo County, California**

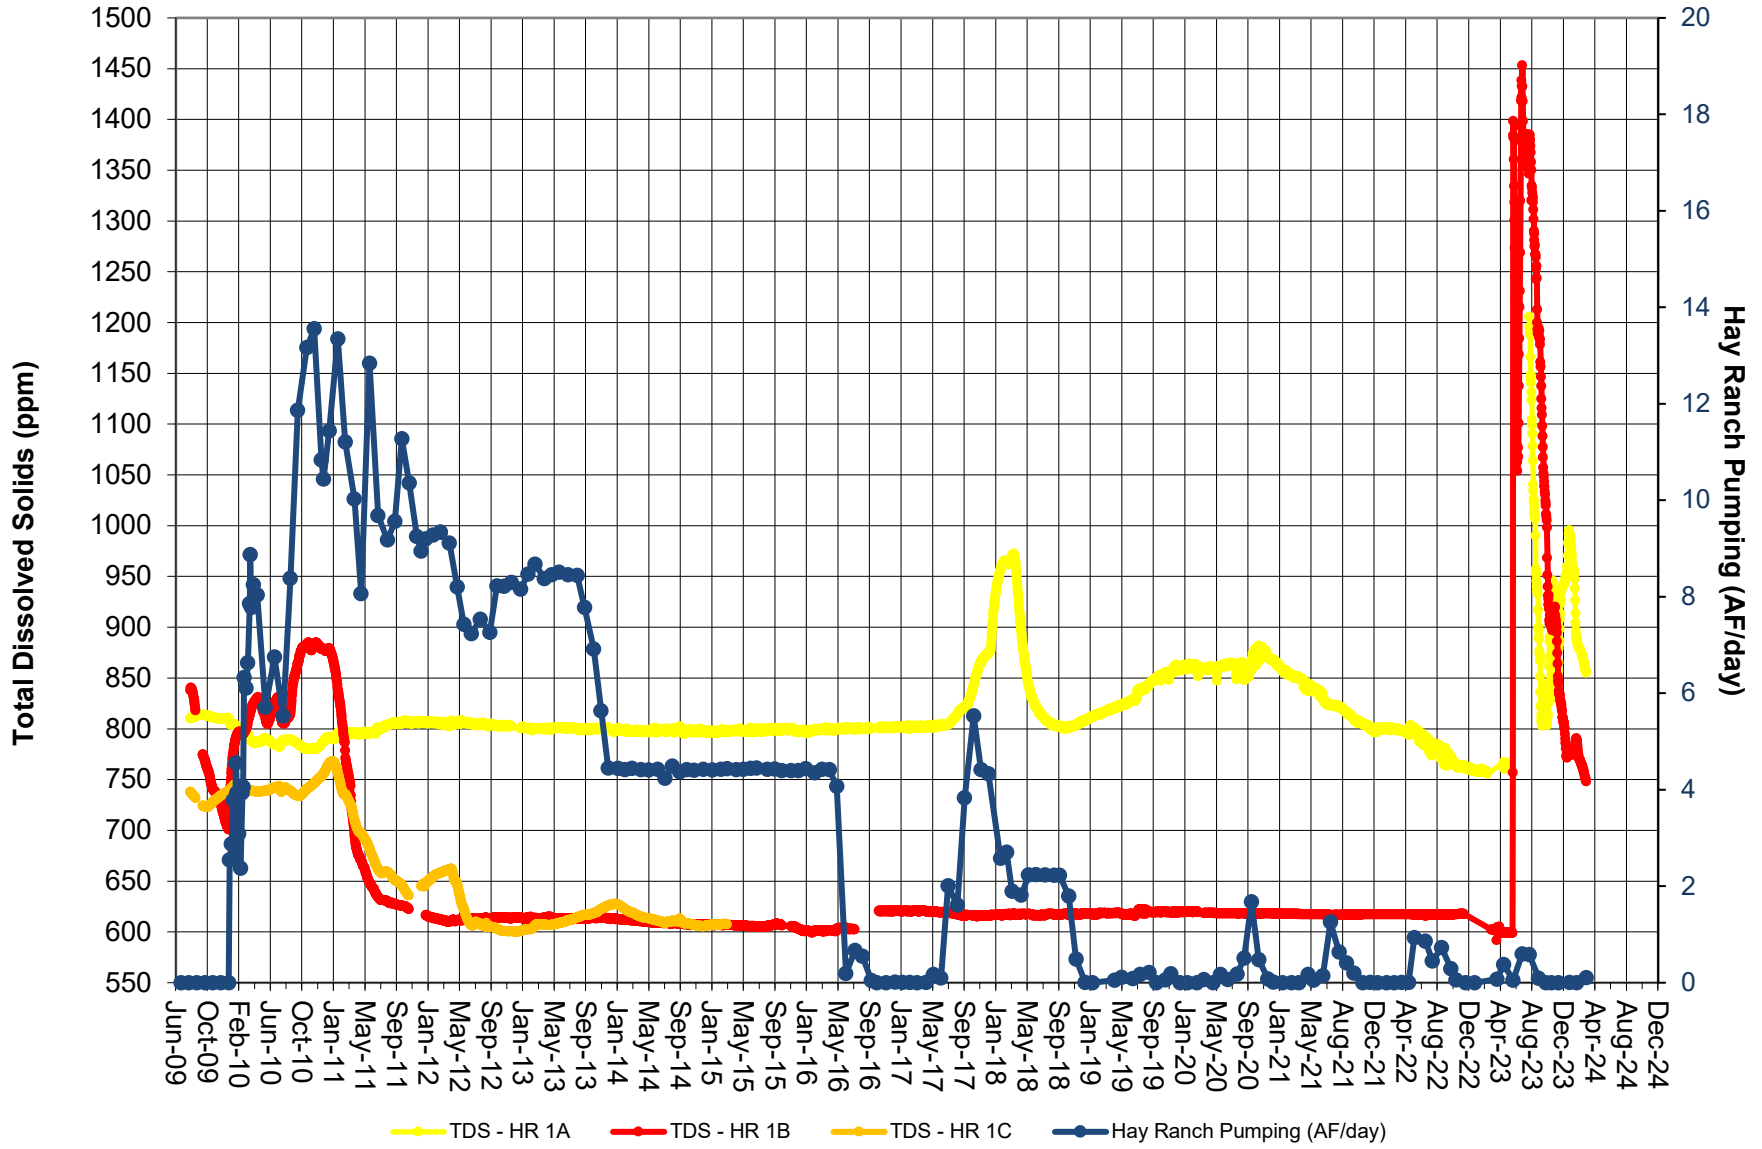
FIGURE 14
TOTAL DISSOLVED SOLIDS (TDS) and HAY RANCH PUMPING
HR 1A, HR 1B and HR 1C

Note: TDS data from in-well transducers.
 Screened intervals: HR1A 170-260 feet; HR1B 490-540 feet; HR1C 340-405 feet.
 HR1A transducer replaced 8/16/23
