**FIRST QUARTER 2025**

**RE: Hay Ranch Project Conditional Use Permit  
Hydrologic Monitoring Report, First Quarter 2025  
Inyo County, California**

TEAM Environmental (TEAM), is pleased to present the results of hydrologic monitoring activities relating to the Hay Ranch Project Conditional Use Permit (#2007-003), conducted in Rose Valley from January to March 2025.

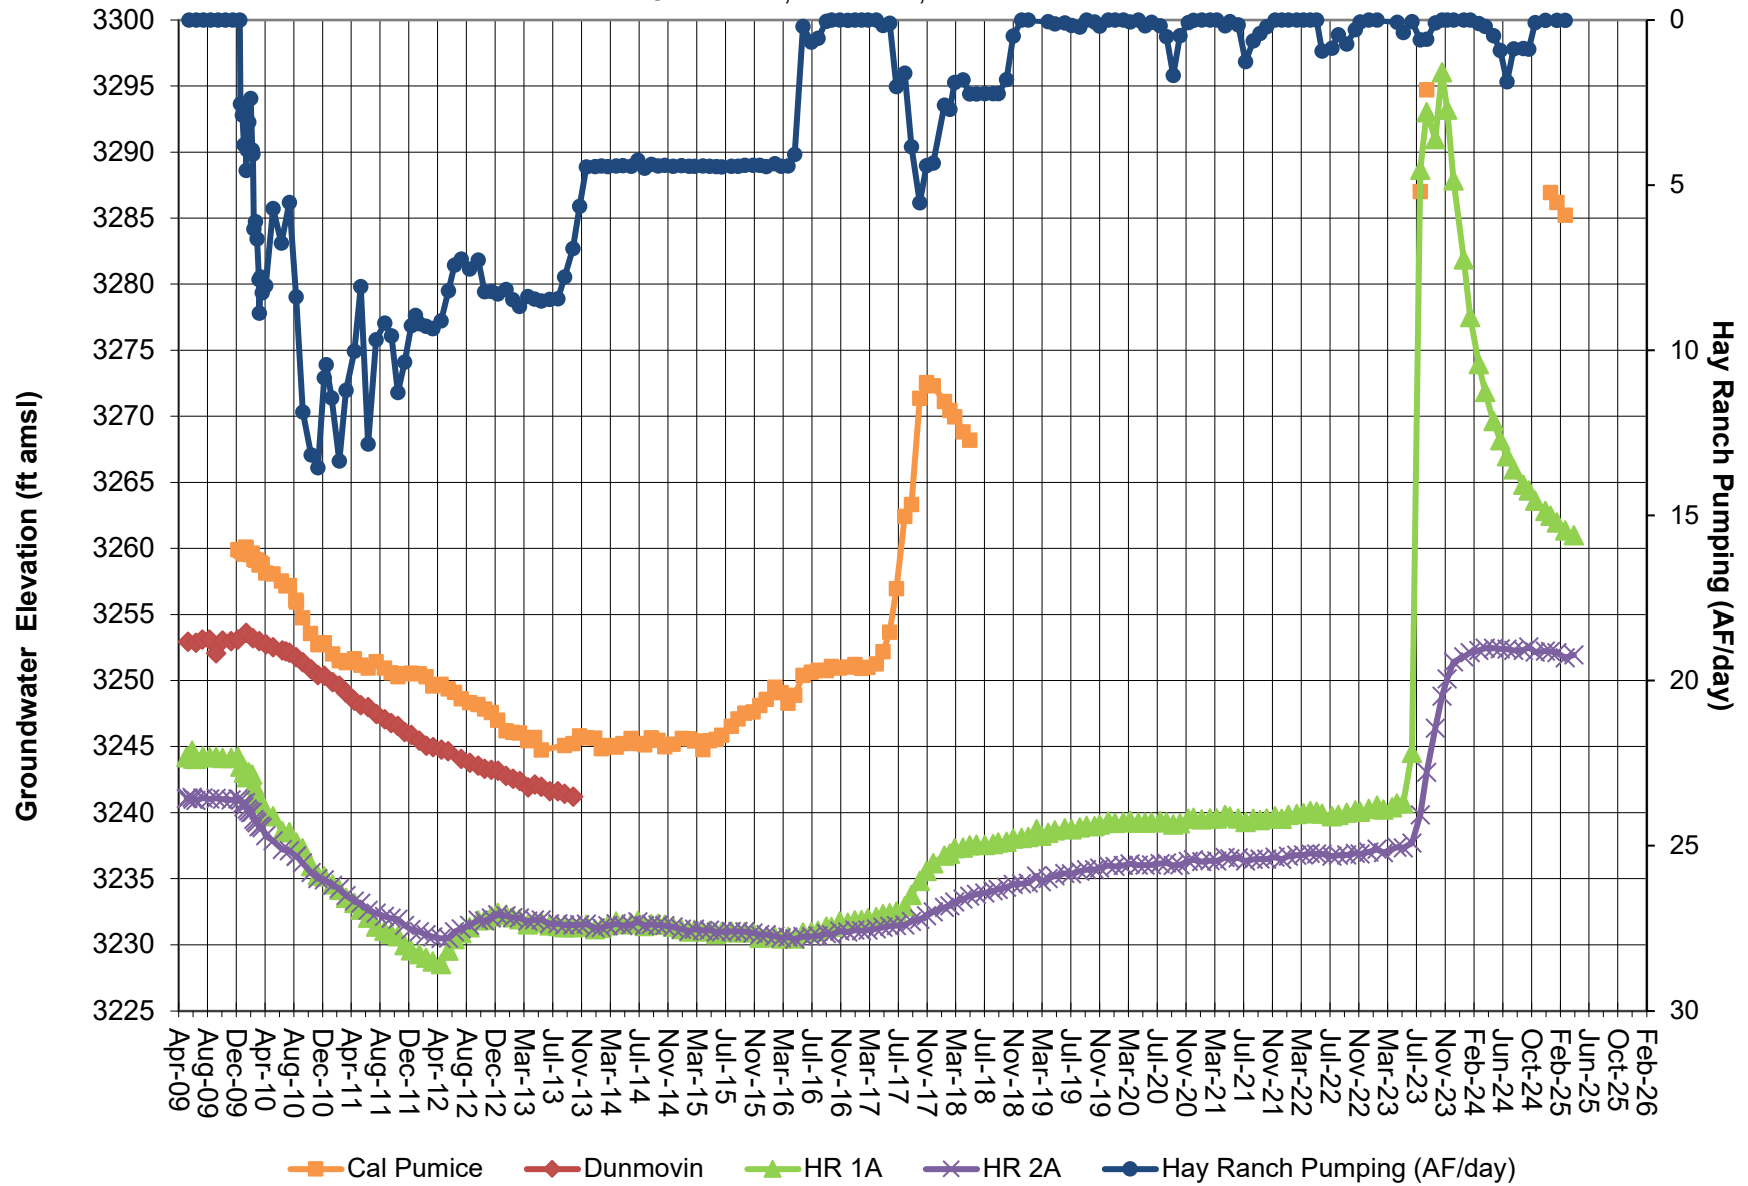
**FIGURE 3**  
GROUNDWATER ELEVATION and HAY RANCH PUMPING  
Cal Pumice, Dunmovin, HR 1A and HR 2A

Note: Groundwater elevation data based on manual depth-to-water measurements.  
Hay Ranch pumping is average acre feet per day.  
Blockage measured in CalPumice Well at approximately 238' in Nov. 2018.

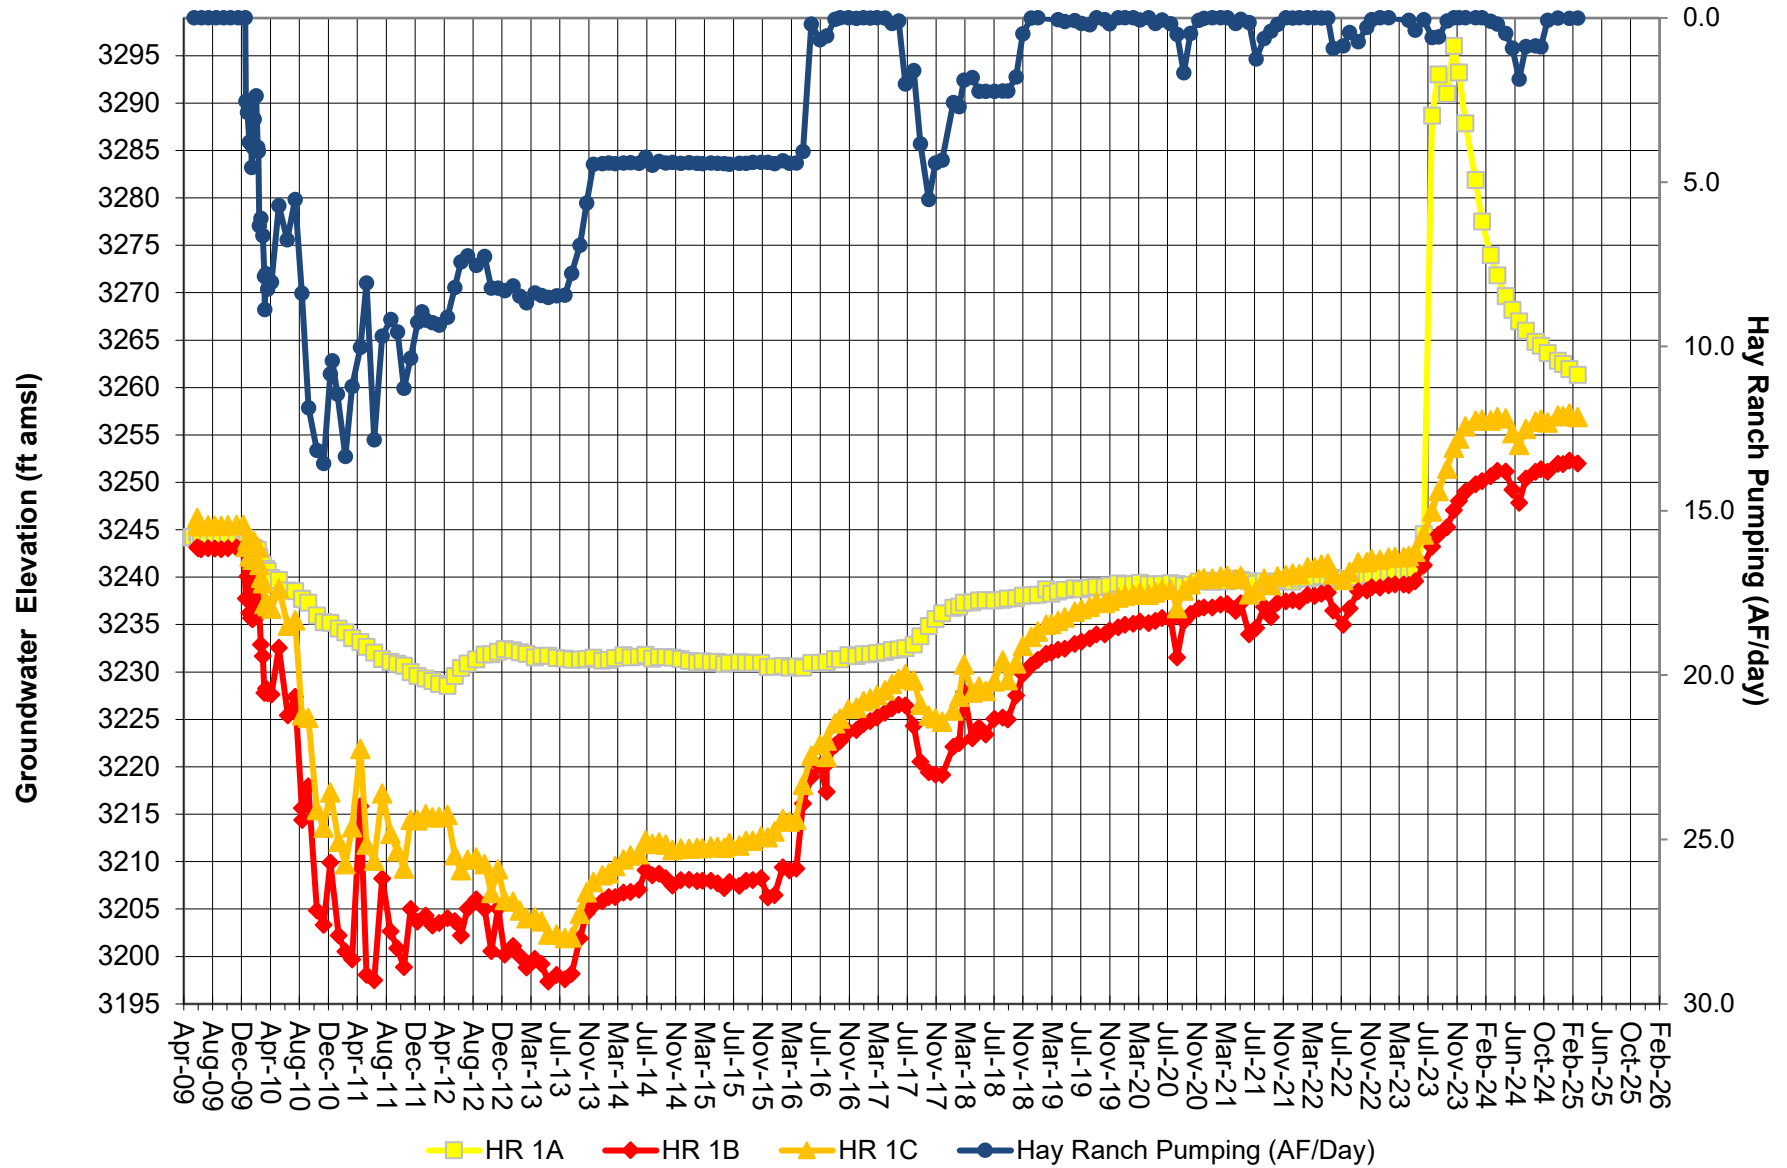
**FIGURE 4**  
GROUNDWATER ELEVATION and HAY RANCH PUMPING  
HR 1A, HR 1B and HR 1C

Note: Groundwater elevation data based on manual depth-to-water measurements.  
Hay Ranch pumping is average acre feet per day.

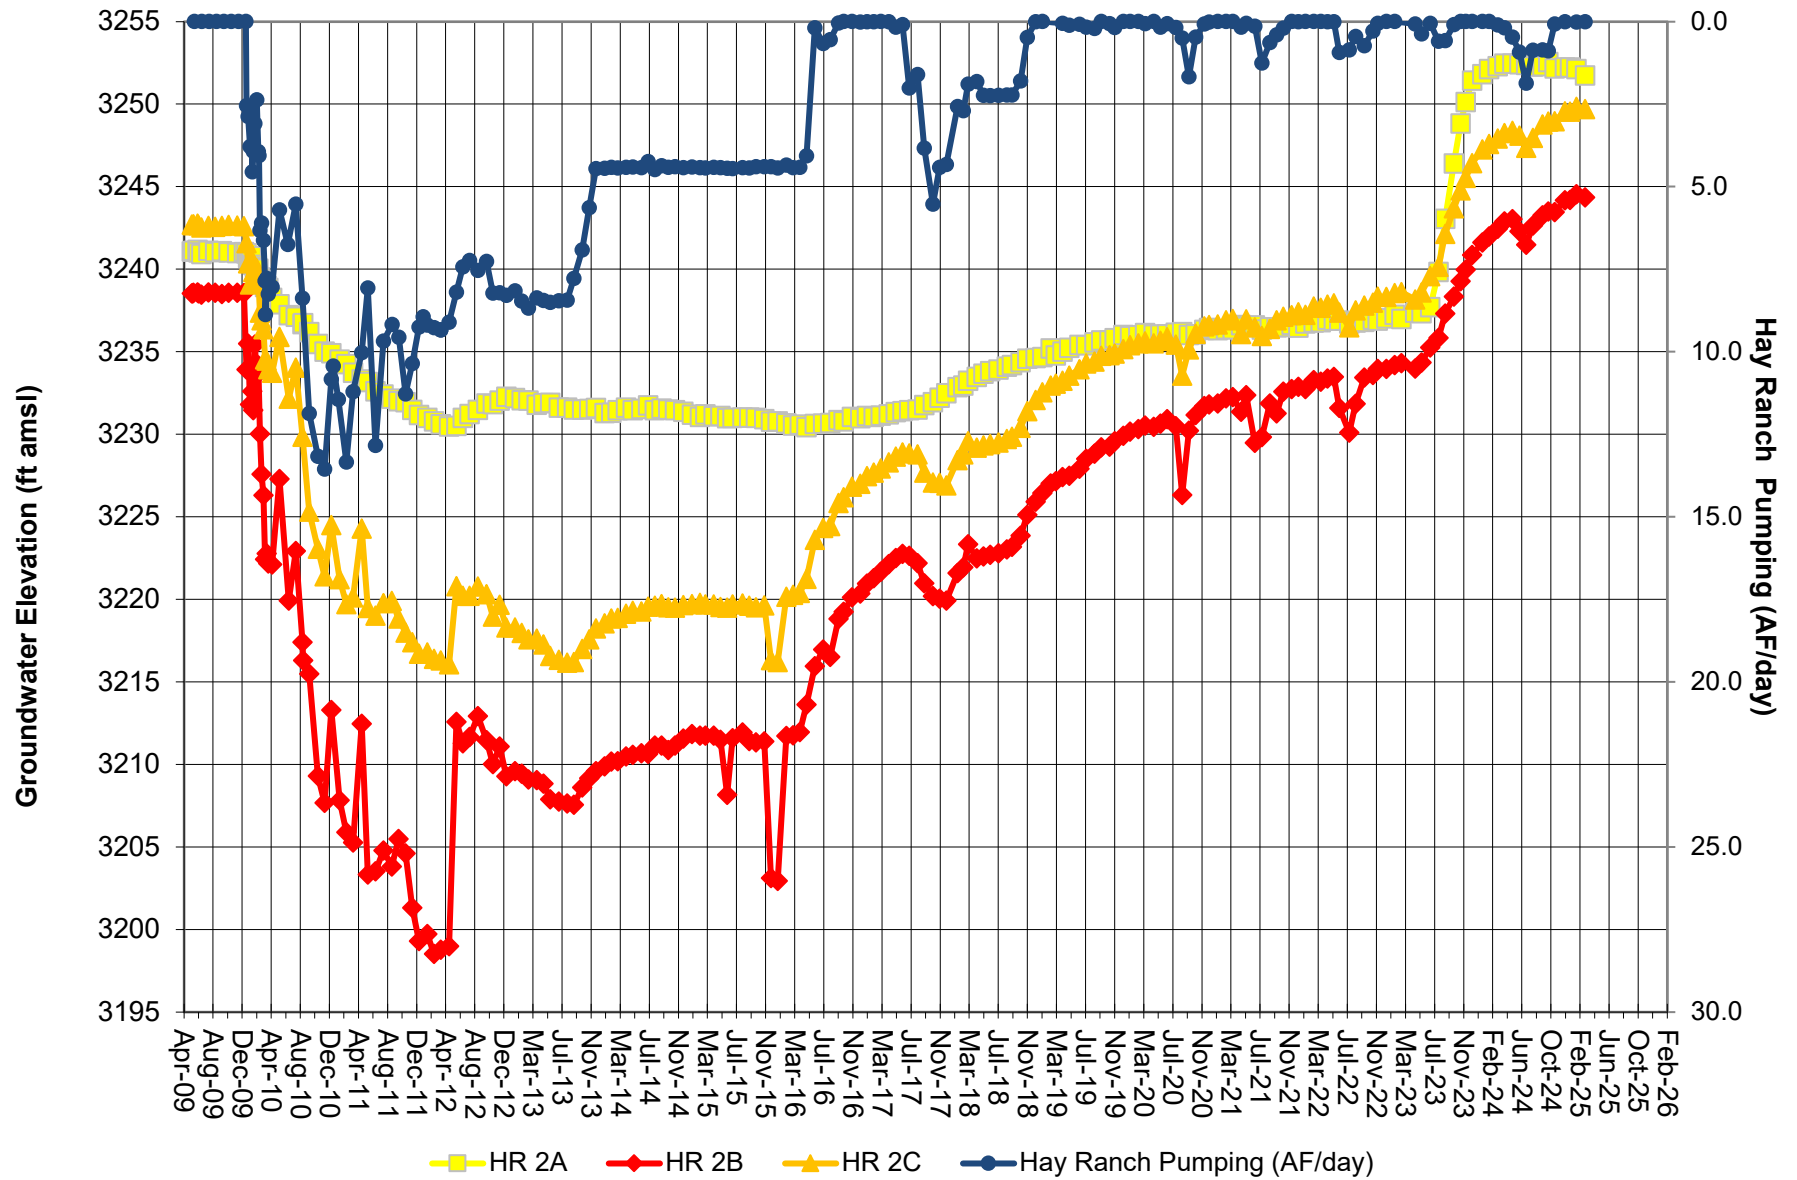
**FIGURE 5**  
GROUNDWATER ELEVATION and HAY RANCH PUMPING  
HR 2A, HR 2B and HR 2C

Note: Groundwater elevation data based on manual depth-to-water measurements.  
Hay Ranch pumping is average acre feet per day.

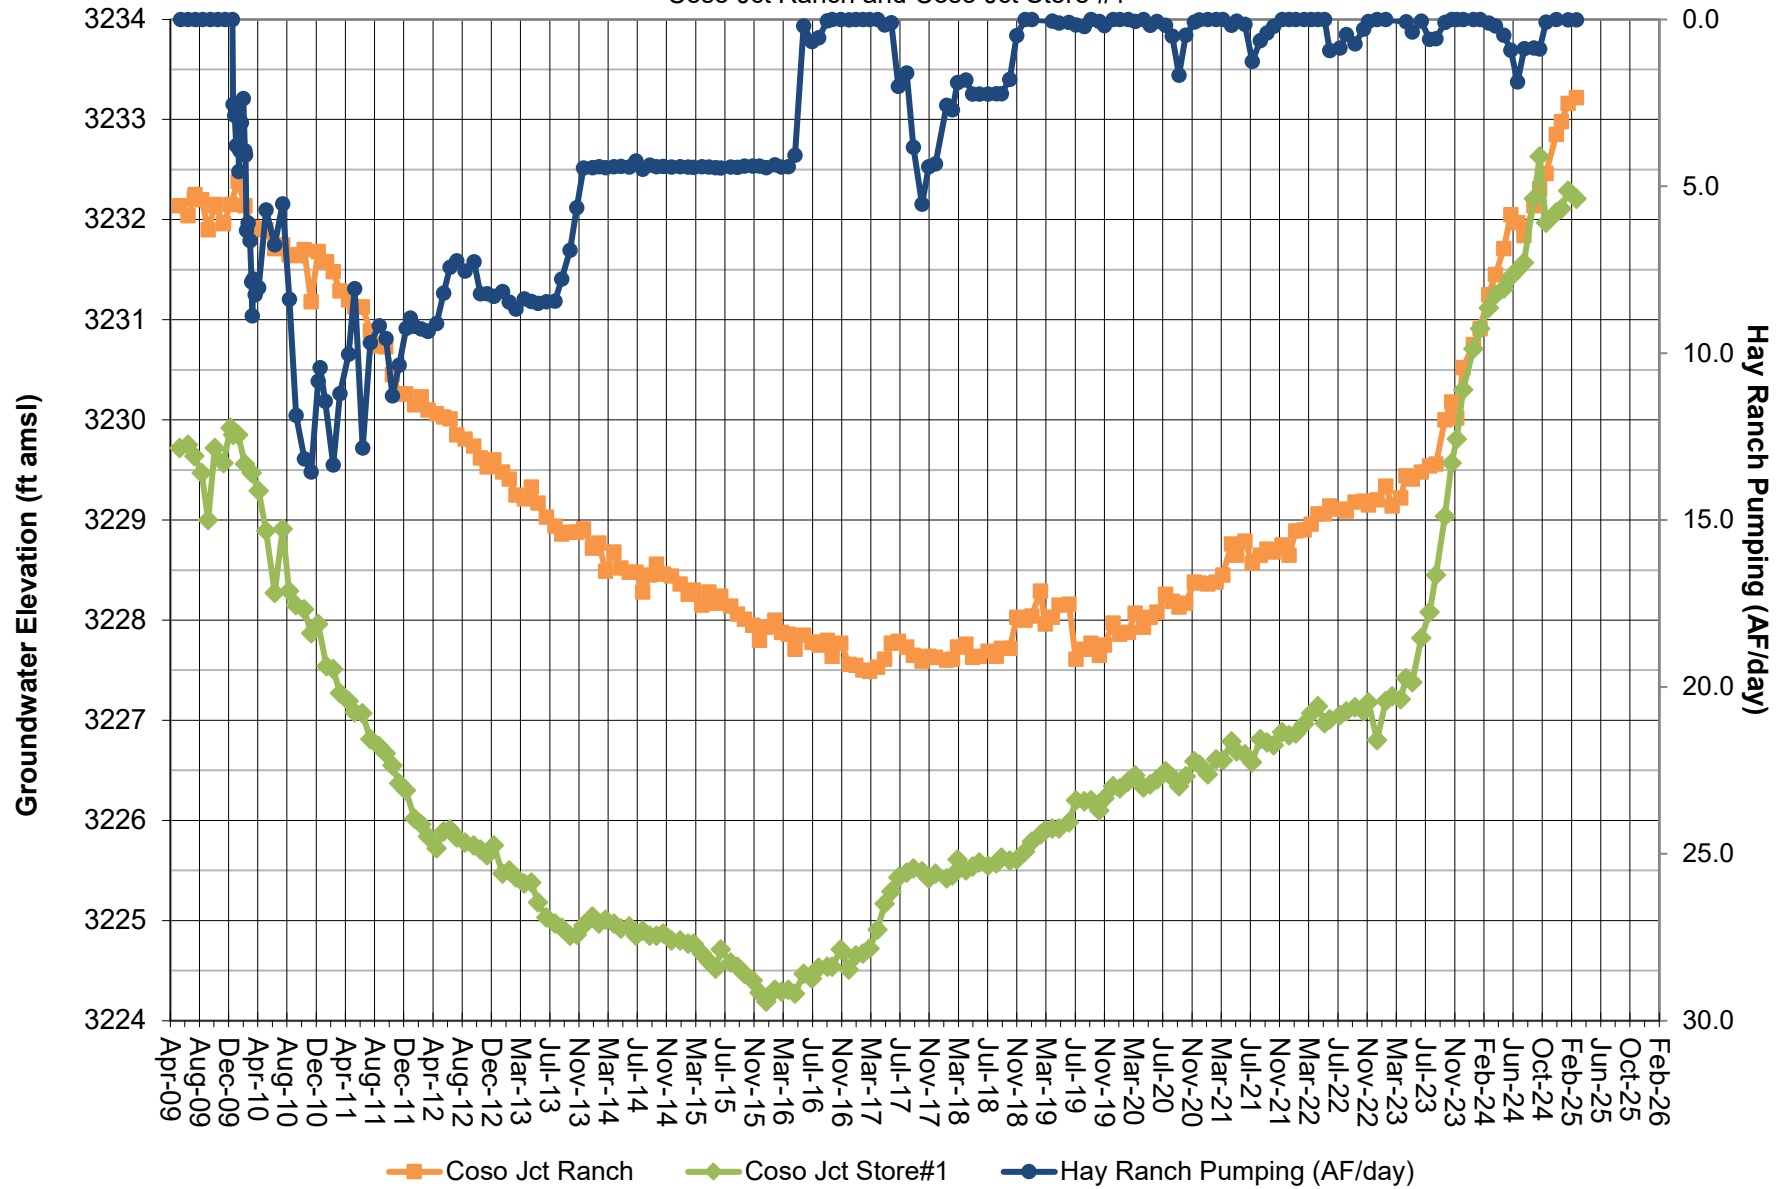
**FIGURE 6A**  
GROUNDWATER ELEVATION and HAY RANCH PUMPING  
Coso Jct Ranch and Coso Jct Store #1

Note: Groundwater elevation data based on manual depth-to-water measurements.  
Hay Ranch pumping is average acre feet per day.

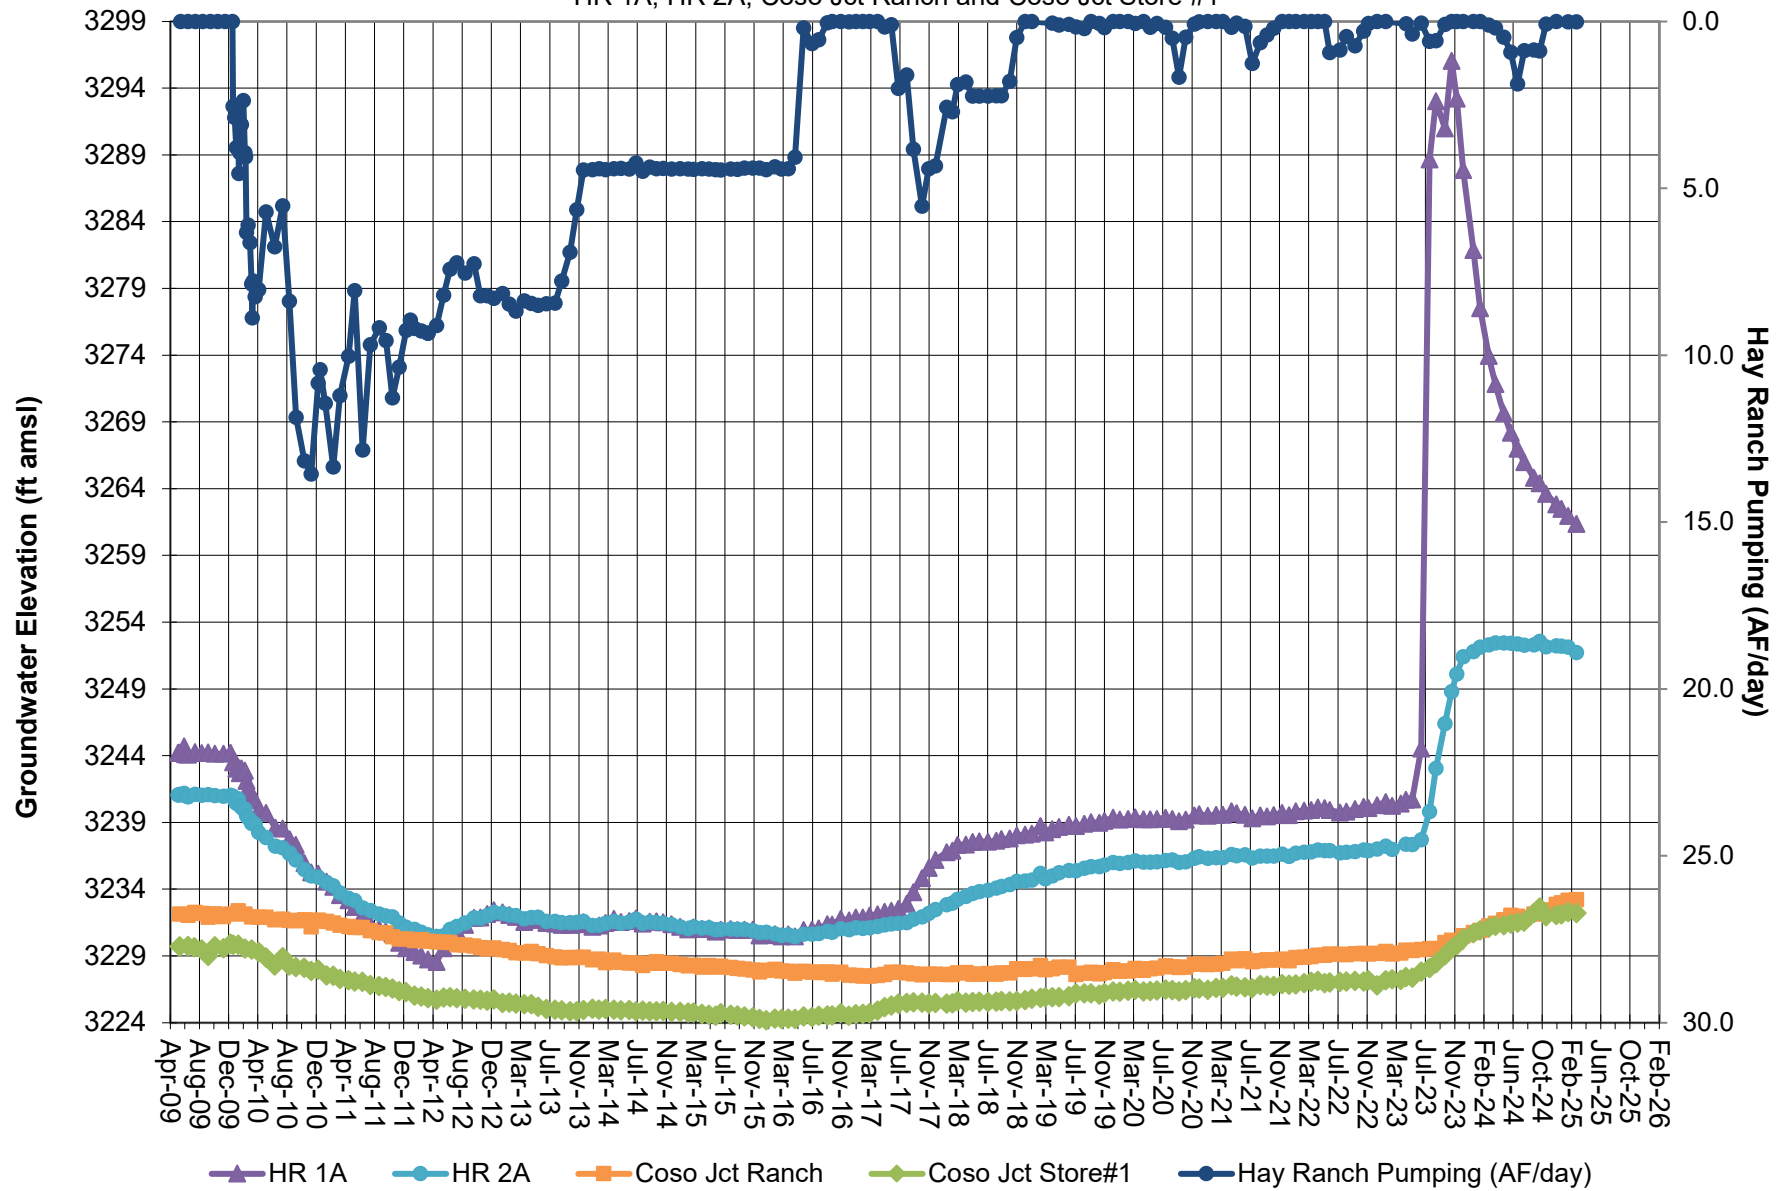
**FIGURE 6B**  
GROUNDWATER ELEVATION and HAY RANCH PUMPING  
HR 1A, HR 2A, Coso Jct Ranch and Coso Jct Store #1

Note: Groundwater elevation data based on manual depth-to-water measurements.  
Hay Ranch pumping is average acre feet per day.

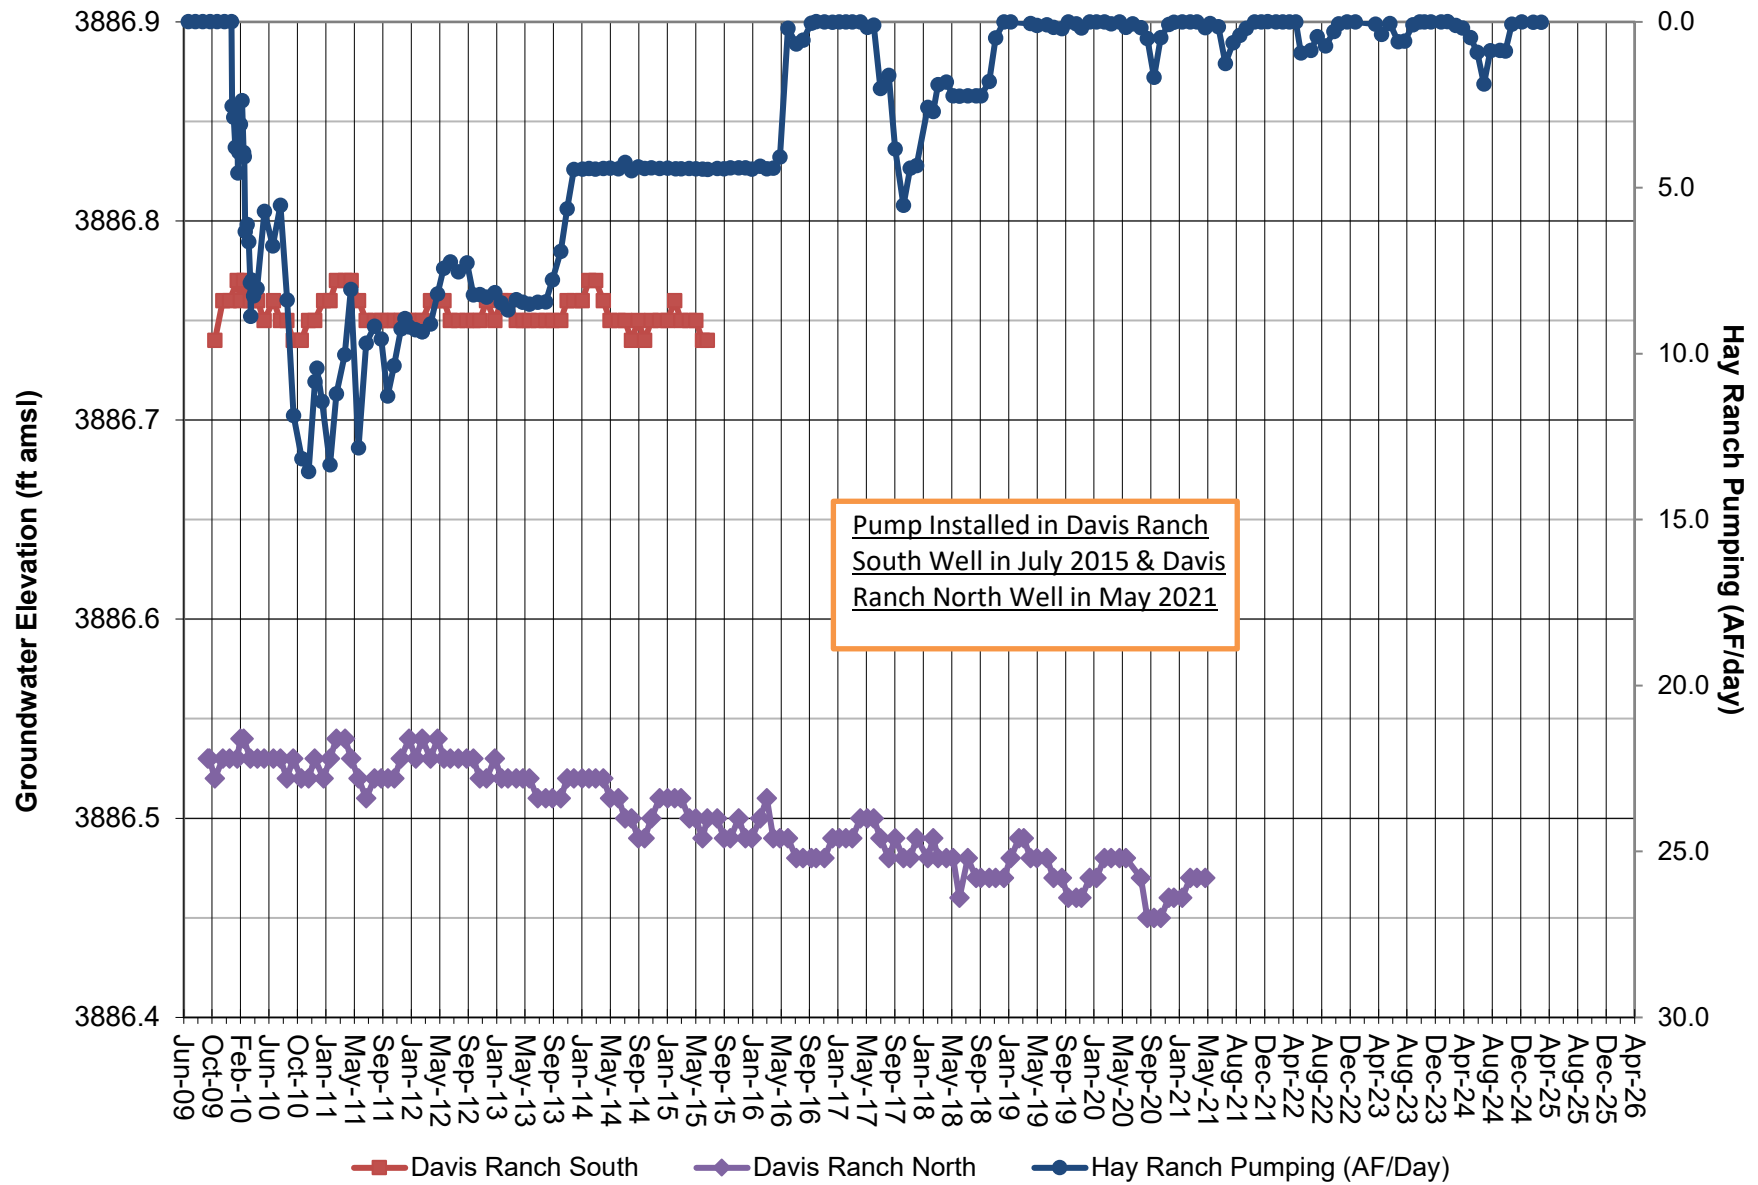
**FIGURE 7**  
GROUNDWATER ELEVATION and HAY RANCH PUMPING  
Davis Ranch North and South

Note: Groundwater elevation data based on manual depth-to-water measurements.  
Hay Ranch pumping is average acre feet per day.

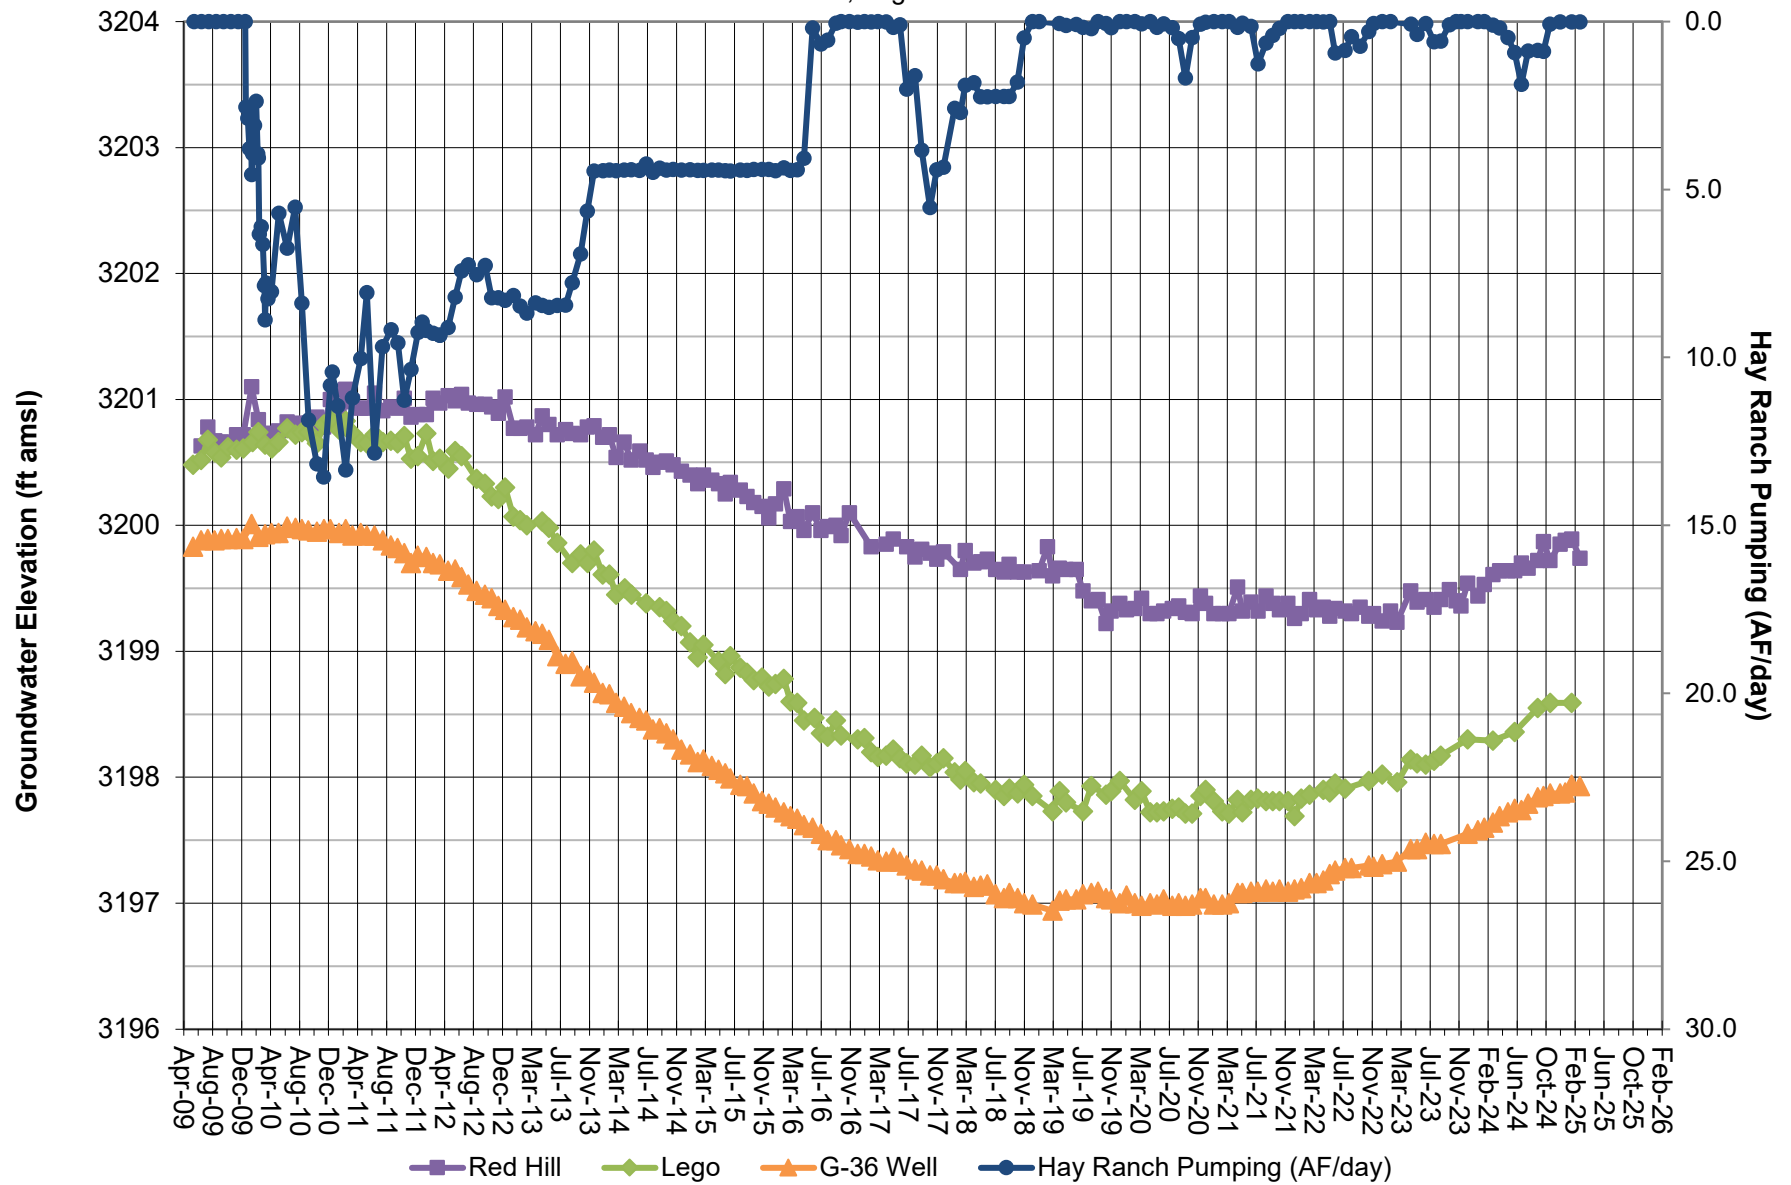
**FIGURE 8**  
GROUNDWATER ELEVATION and HAY RANCH PUMPING  
Red Hill, Lego and G-36

Note: Groundwater elevation data based on manual depth-to-water measurements.  
Hay Ranch pumping is average acre feet per day.

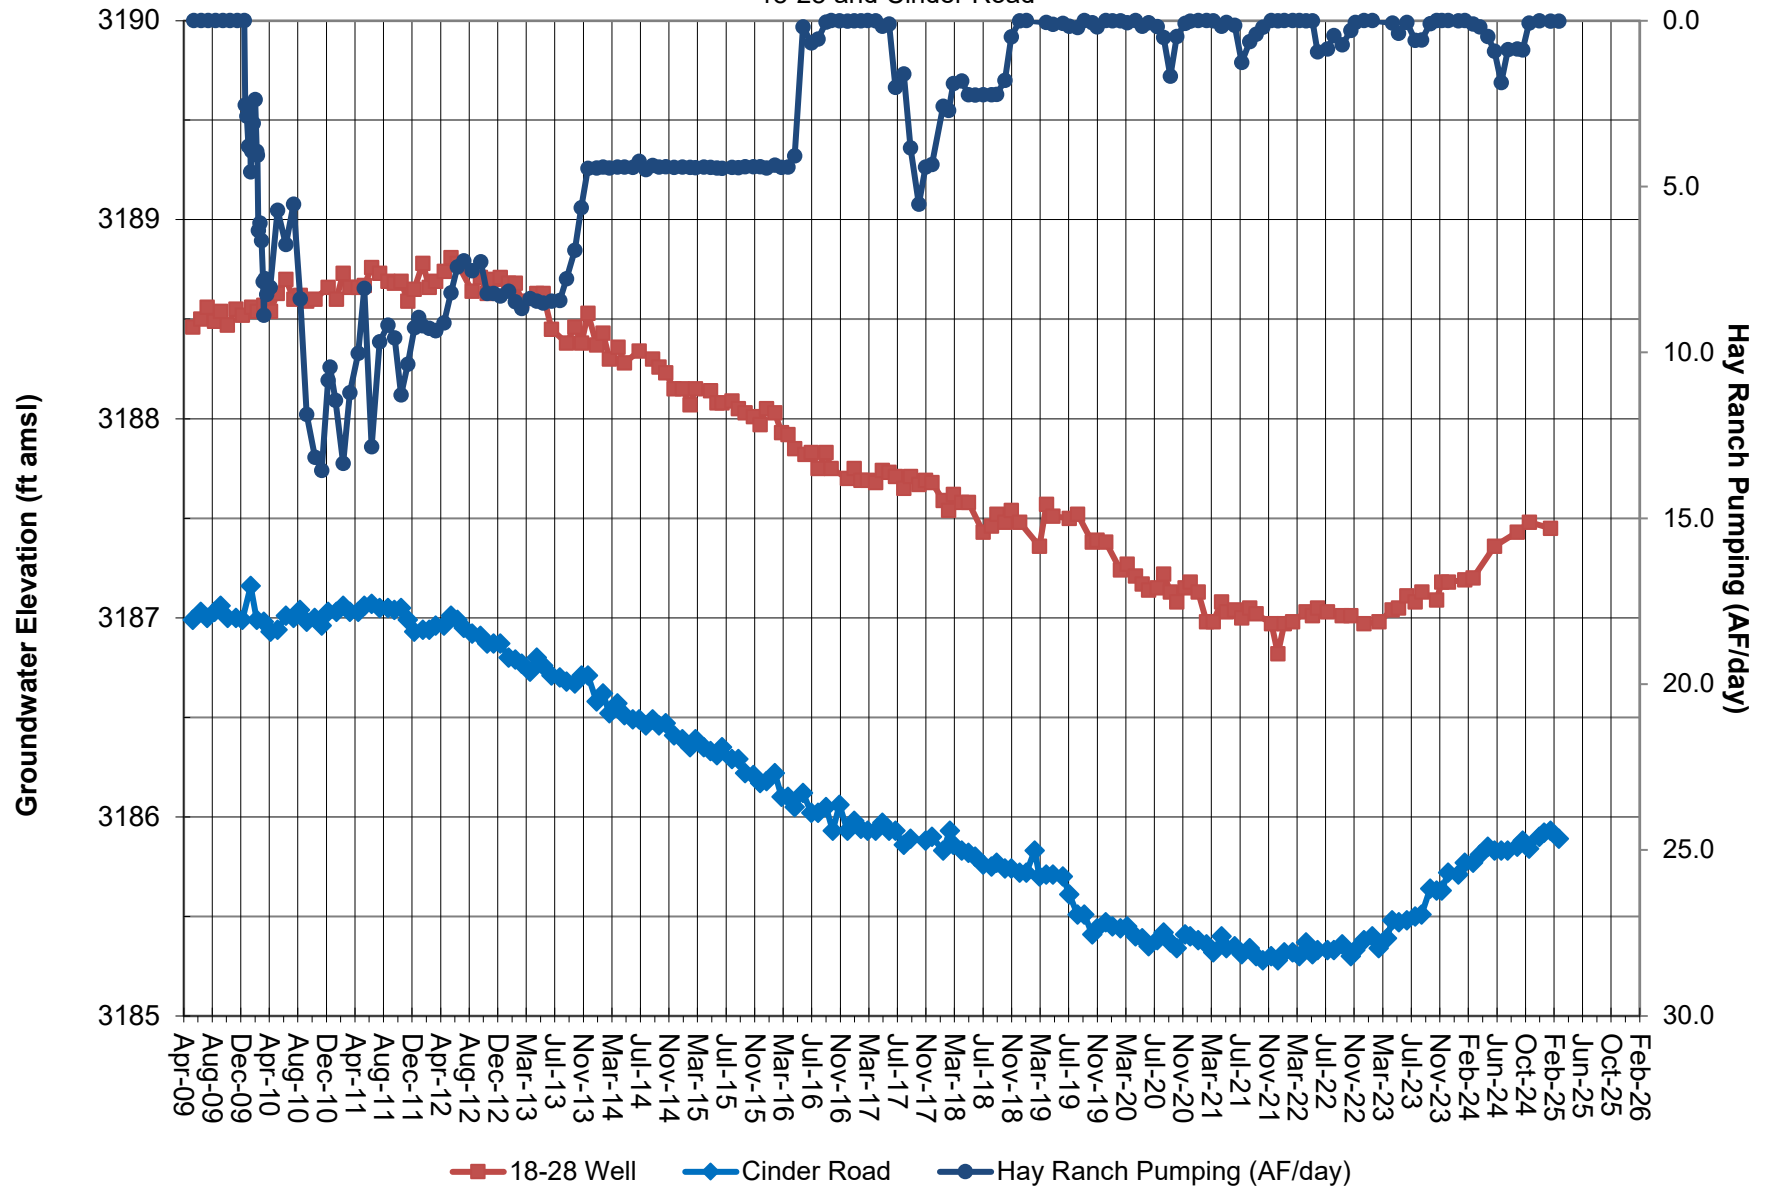
**FIGURE 9**  
GROUNDWATER ELEVATION and HAY RANCH PUMPING  
18-28 and Cinder Road

Note: Groundwater elevation data based on manual depth-to-water measurements.  
Hay Ranch pumping is average acre feet per day.

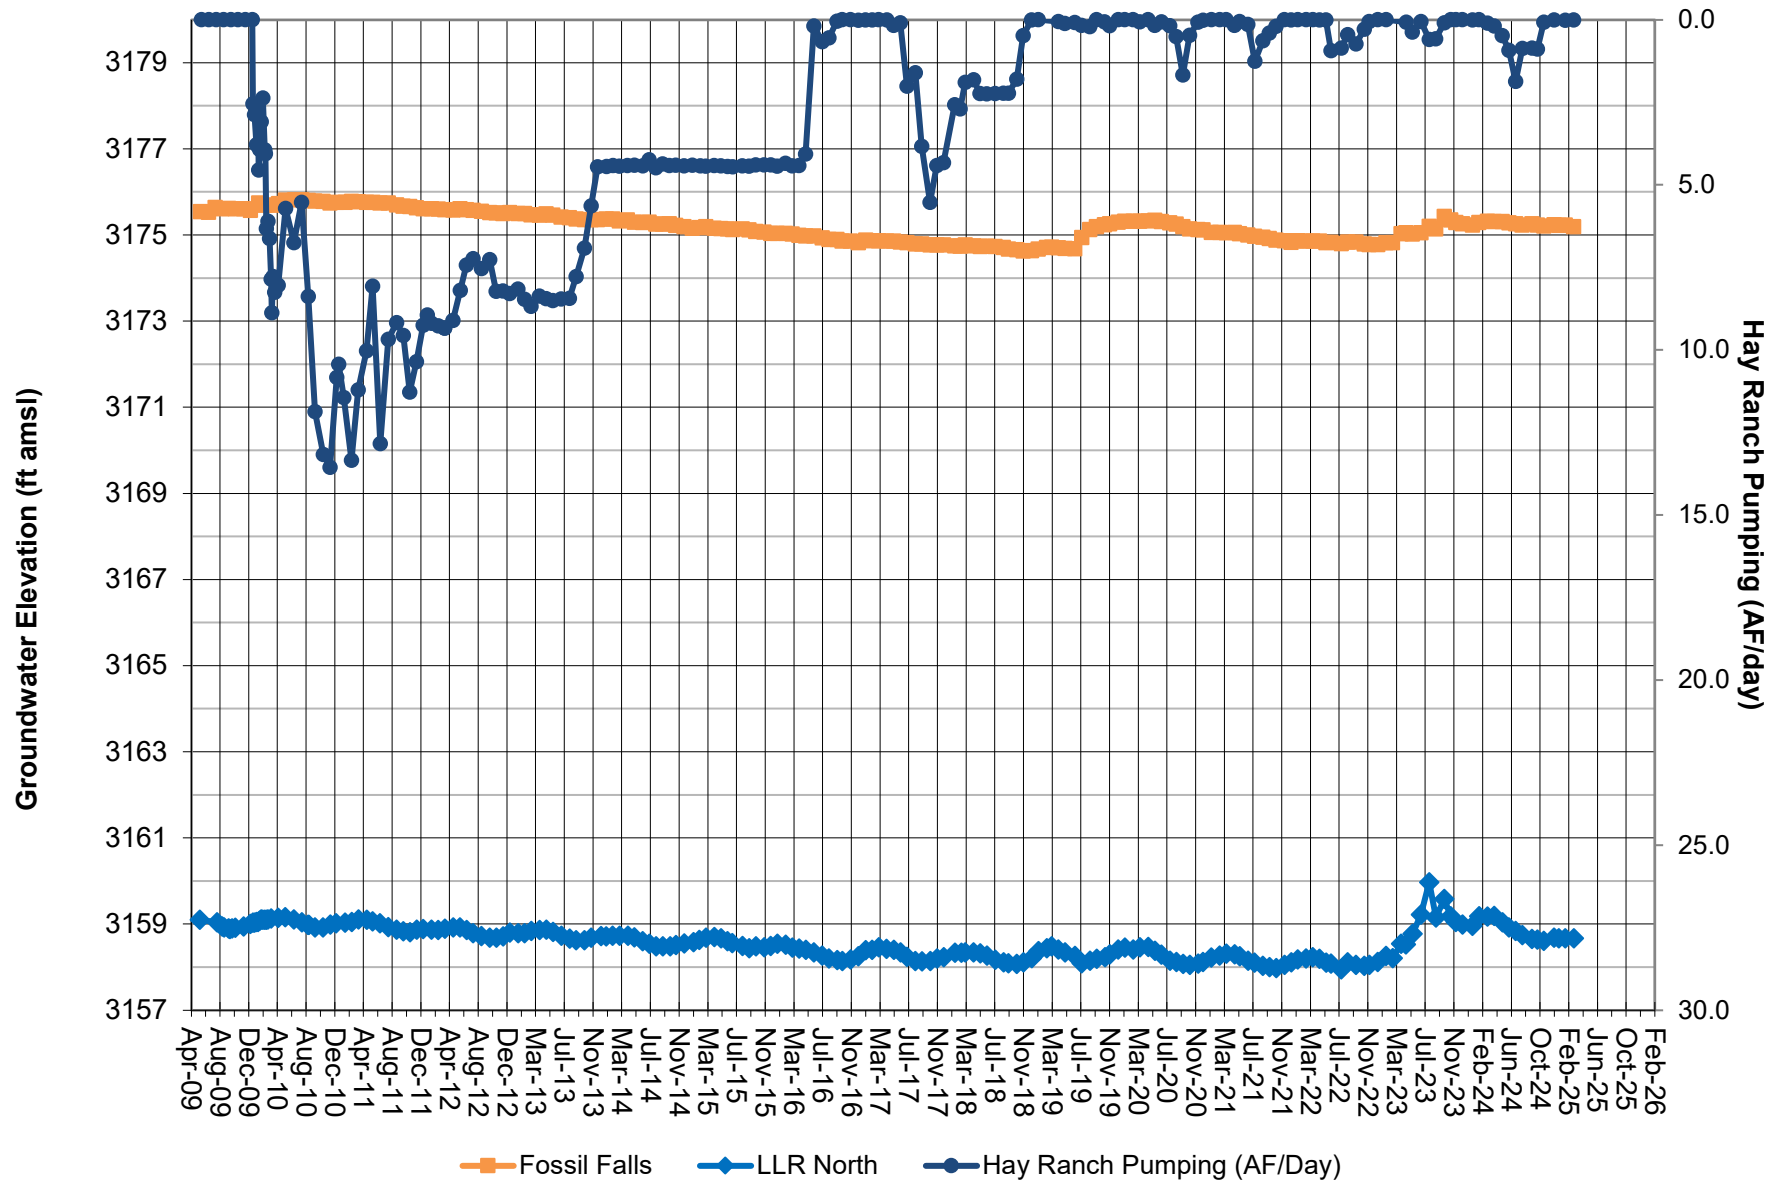
**FIGURE 10**  
GROUNDWATER ELEVATION and HAY RANCH PUMPING  
Fossil Falls and LLR North

Note: Groundwater elevation data based on manual depth-to-water measurements.  
Hay Ranch pumping is average acre feet per day.

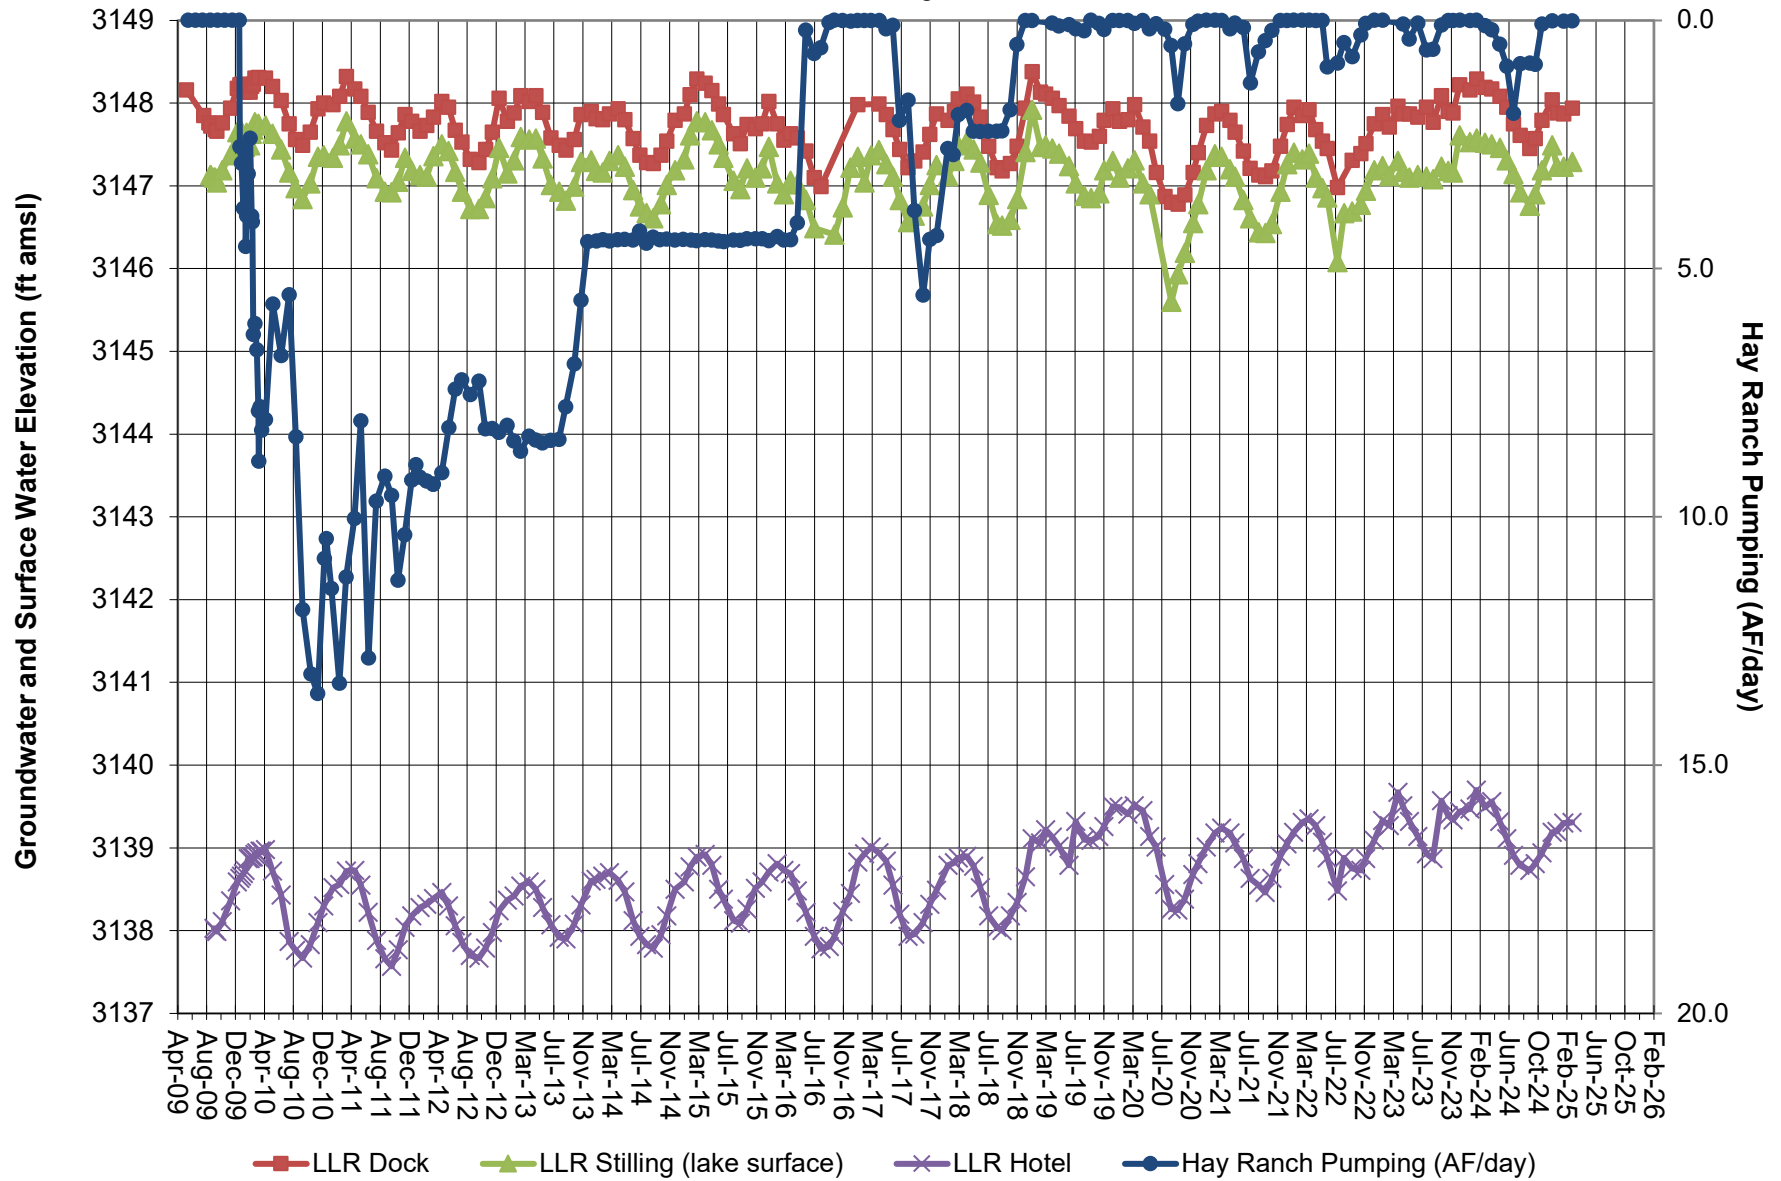
**FIGURE 11**  
**WATER ELEVATION and HAY RANCH PUMPING**  
 LLR Dock, LLR Stilling and LLR Hotel

Note: Groundwater elevation data based on manual depth-to-water measurements.  
 Hay Ranch pumping is average acre feet per day.
