**FIRST QUARTER 2025**

**RE: Hay Ranch Project Conditional Use Permit  
Hydrologic Monitoring Report, First Quarter 2025  
Inyo County, California**

TEAM Environmental (TEAM), is pleased to present the results of hydrologic monitoring activities relating to the Hay Ranch Project Conditional Use Permit (#2007-003), conducted in Rose Valley from January to March 2025.

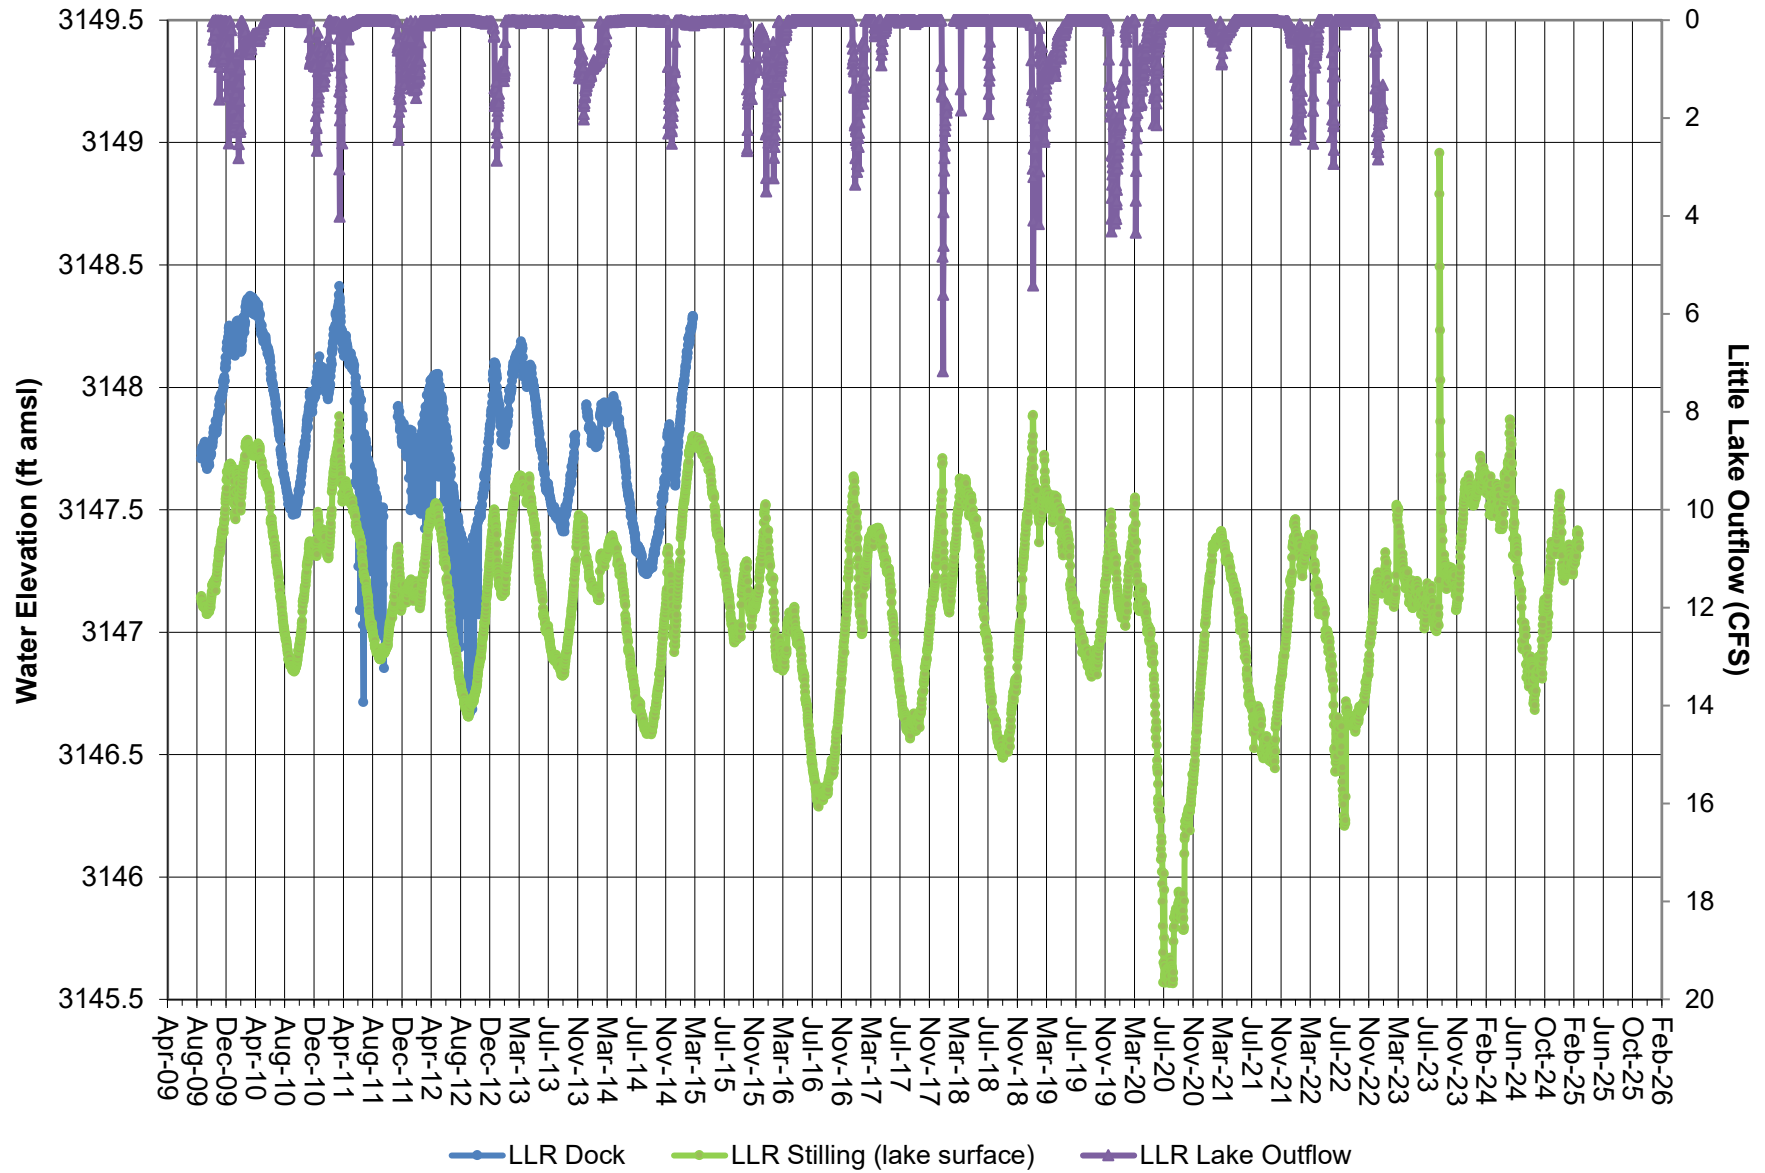
**FIGURE 12**  
**WATER ELEVATION and LITTLE LAKE OUTFLOW**  
**LLR Dock and LLR Stilling**

A hydrograph which compares groundwater and surface water elevations in the immediate vicinity of Little Lake to LLR Lake Outflow amounts over time is included in this report as Figure 12. Groundwater and surface water elevations at the LLR Dock and LLR Stilling Well (Little Lake surface level) are listed, in feet above mean sea level, on the left axis. Surface water outflow from Little Lake, captured by the LLR Lake Outflow flume in cubic feet per second, is listed on the right axis in inverse order. It should be noted that the LLR Lake Outflow flume has had known accuracy limitations since at least January 2020 due to a blockage of flow downstream causing flume submergence. Beginning in December 2022 the LLR Outflow flume data was not presented due to significant observed inaccuracy.

Note: Little Lake Outflow in cubic feet per second  
 Pressure transducer removed from Dock Well in March 2015  
 LLR Lake Outflow not presented since December 2022 due to accuracy concerns.

The LLR Lake Outflow flume (RV-230) has been noted to have accuracy limitations due to a restriction of flow downstream of the flume since at least January 2020. Maintenance has

been recommended by TEAM but not scheduled to be performed due to landowner restrictions. Beginning in December 2022, the data for the Little Lake Ranch Outflow Flume (RV-230) has not been presented as it is observed to be significantly inaccurate.

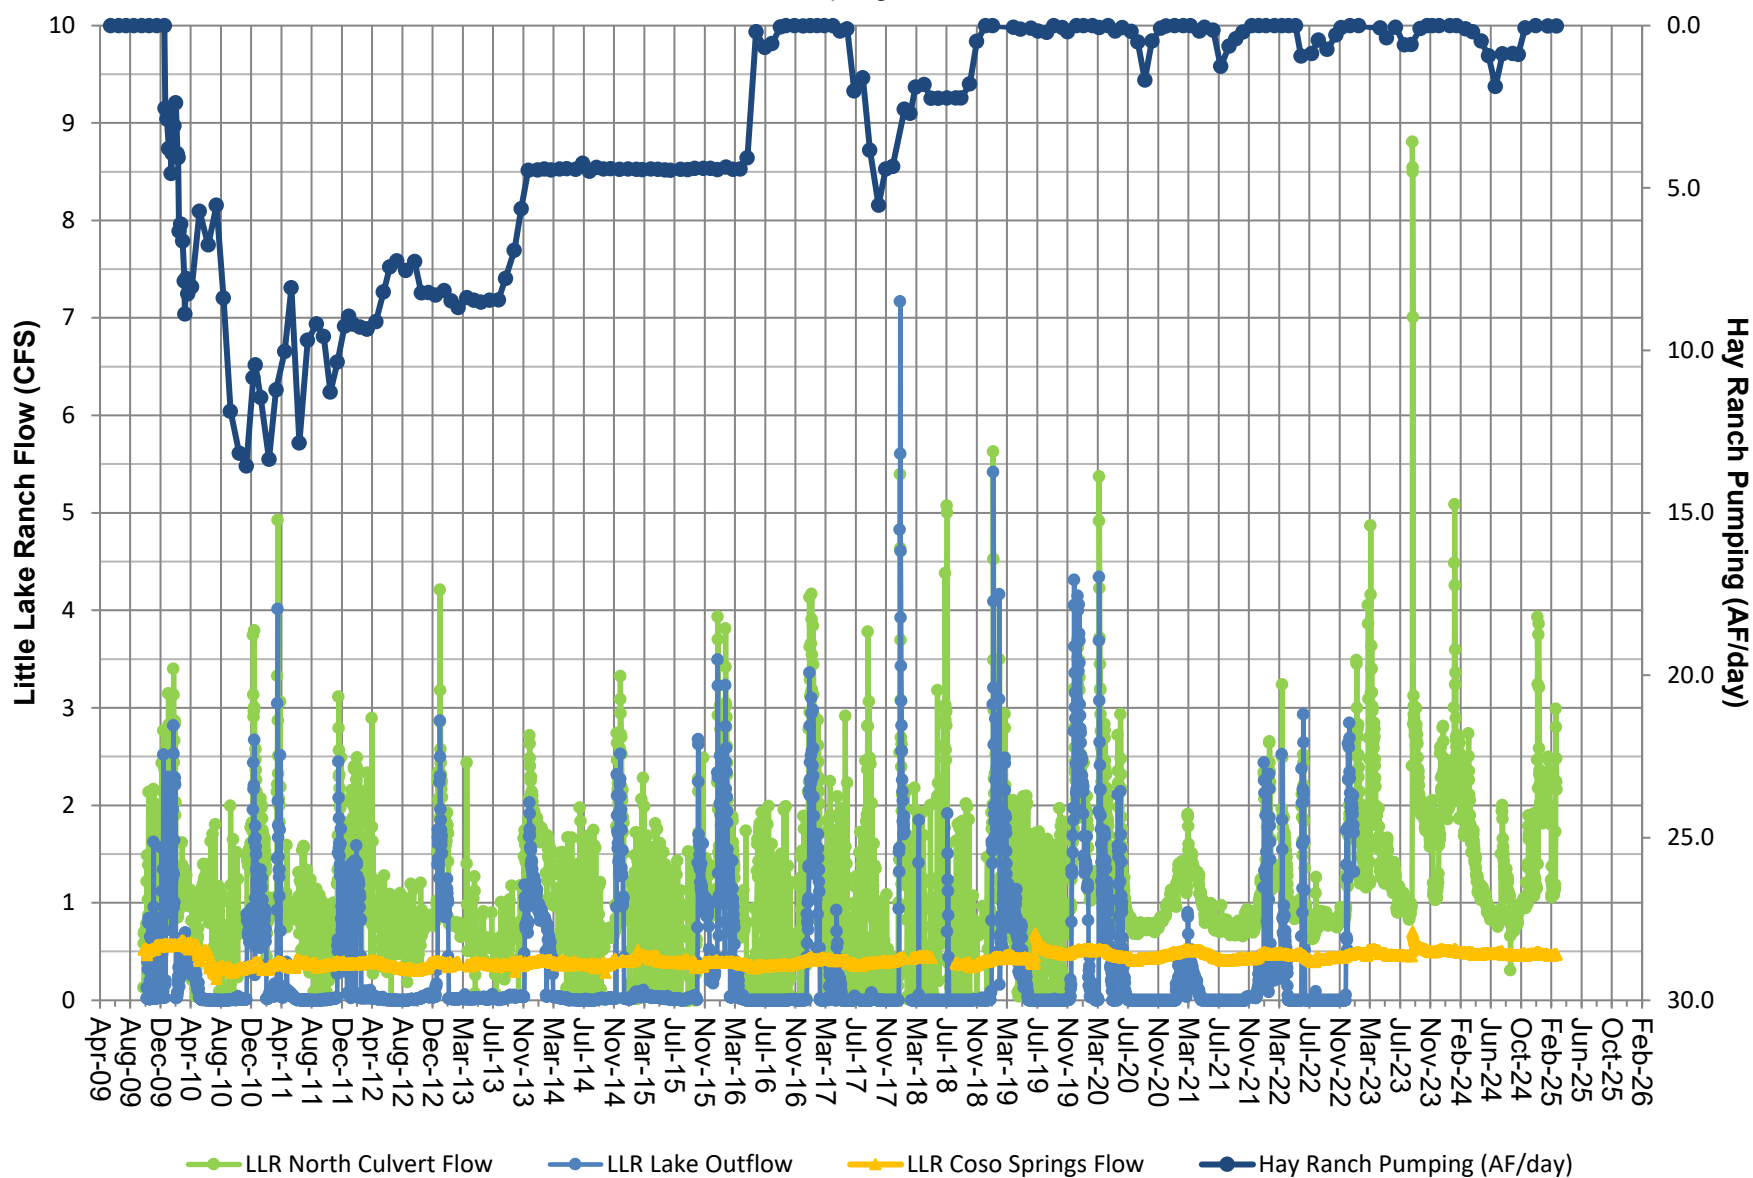
**FIGURE 13**  
 LLR FLOW and HAY RANCH PUMPING  
 North Culvert, Coso Springs and Little Lake Outflow

A hydrograph which compares surface water flows in the Little Lake Ranch area to Hay Ranch Project pumping rates over time is also included in this report as Figure 13. Surface water flows from Lake Outflow, Coso Springs Flow and North Culvert Flow are listed on the left axis, in cubic feet per second. Hay Ranch Project average daily pumping amounts, in acre-feet per day, are listed on the right axis in inverse order. As noted in Section 3.3, surface flow captured by the North Culvert Flow flume represents an accumulation of surface flows from Little Lake, Coso Springs and the Siphon Well flow.

Note: Little Lake Ranch Flows are cubic feet per second.

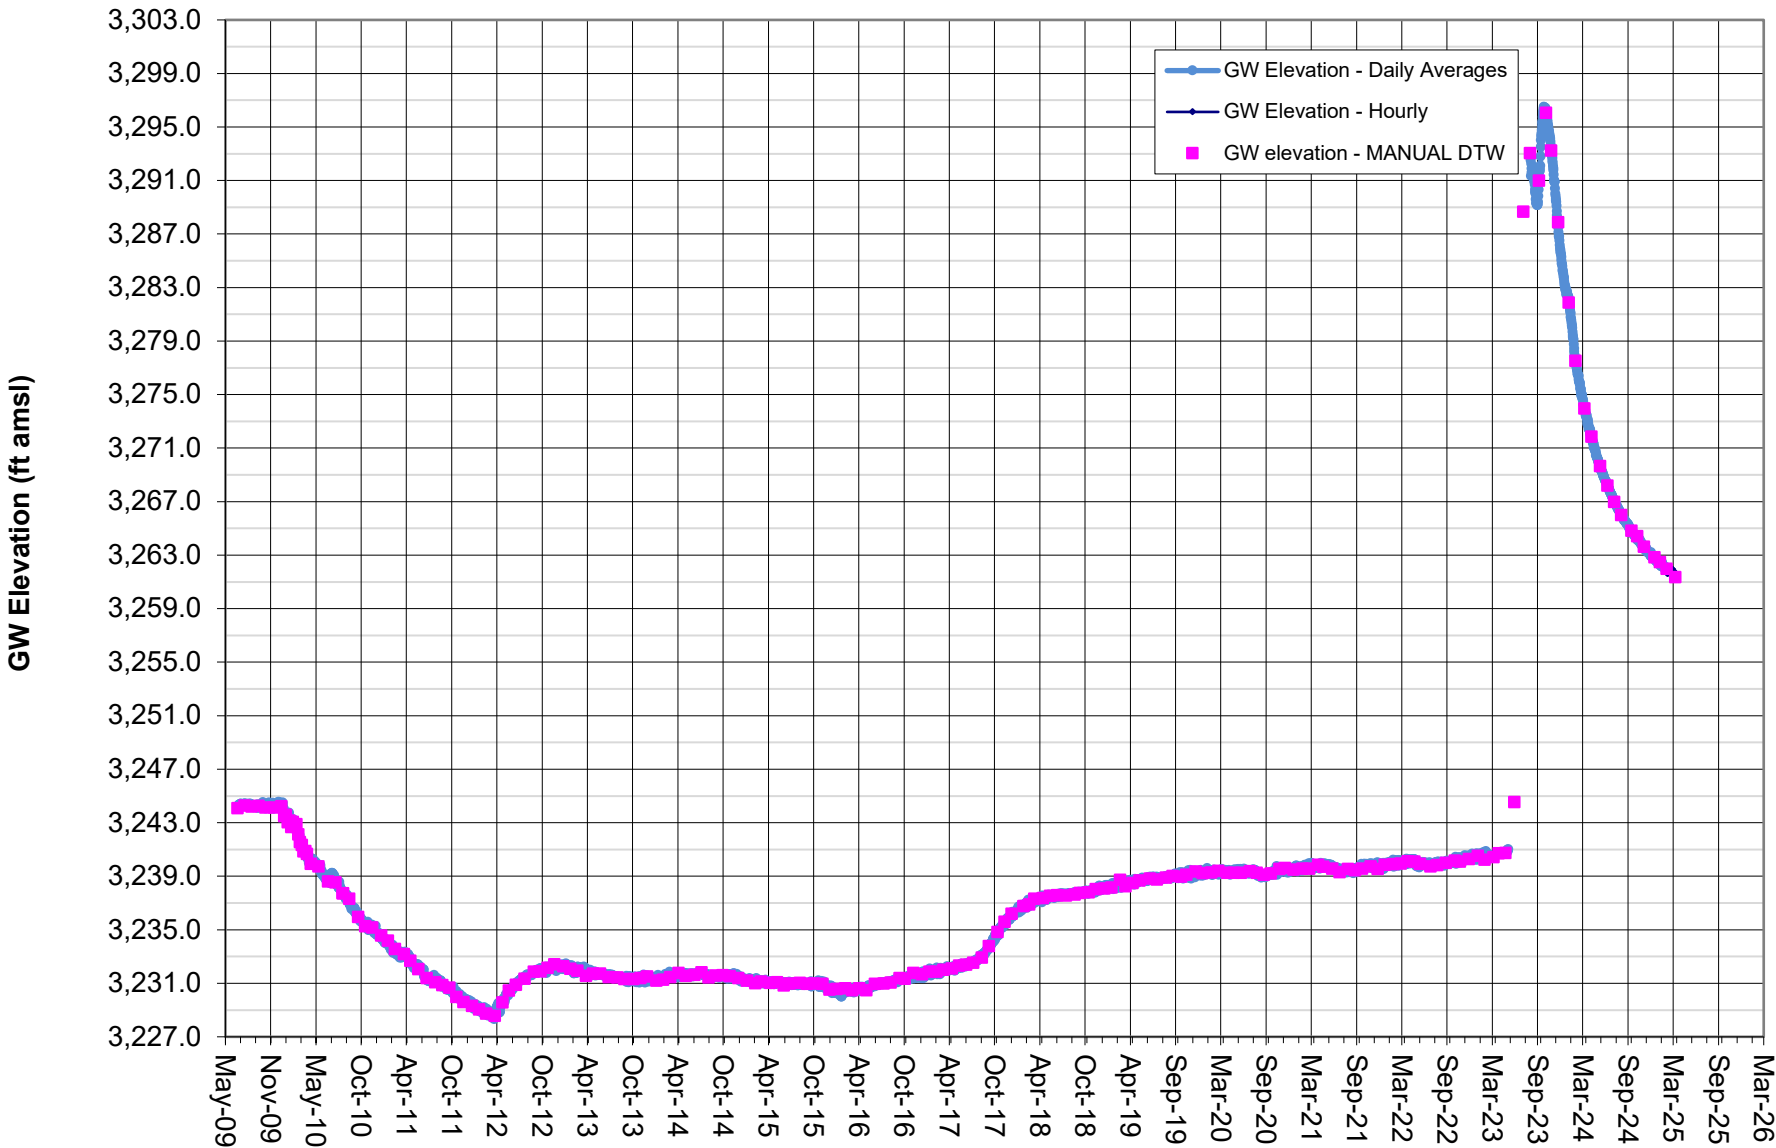
Note: Screened interval 170-260 feet.  
Coso Operating Co. initiated Hay Ranch Project pumping on 12/25/09.  
HR1A data gaps due to transducer malfunction. Transducer replaced 8/16/23

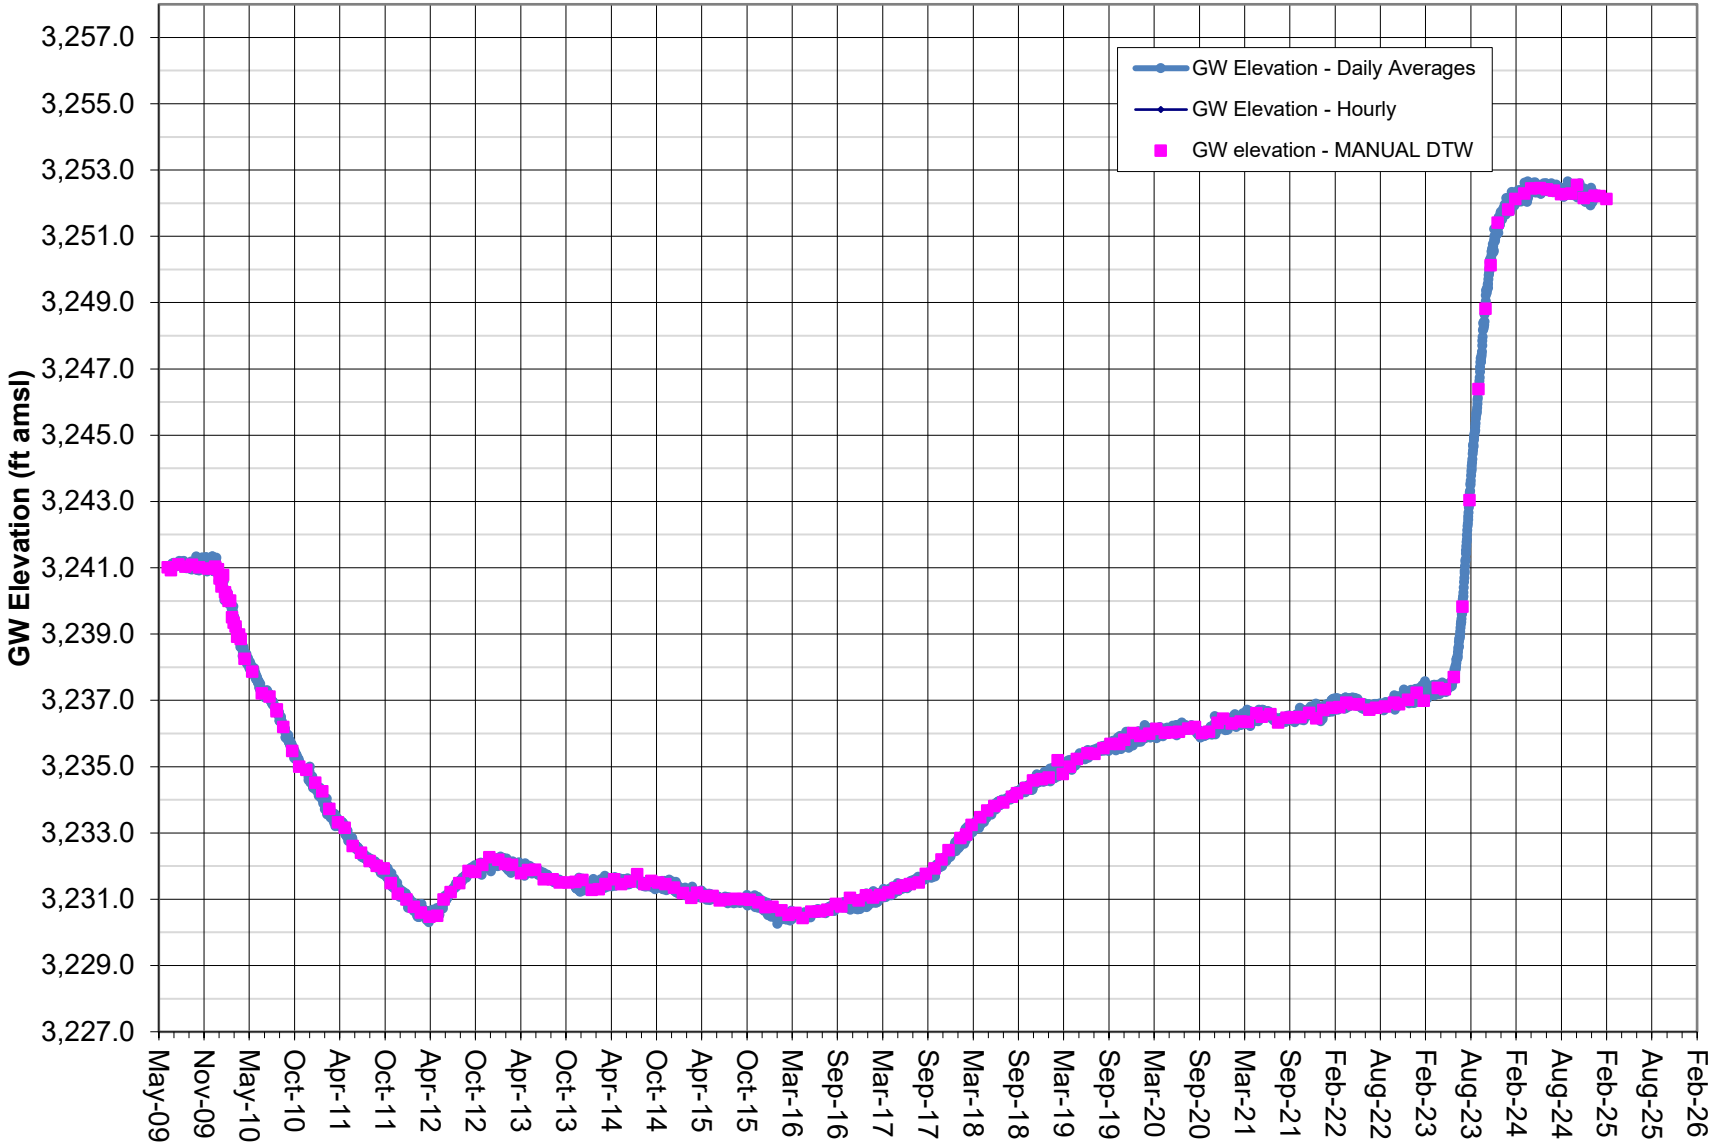
The Transducer in HR-2A became non-responsive in January 2025 and continued to be non-responsive in February 2025. It was removed from the well in March 2025 and Coso is currently working on a plan to resolve the issue. There were no other significant operational issues observed during the reporting period.

Note: Screened interval 180-300 feet.  
Coso Operating Co. initiated Hay Ranch Project pumping on 12/25/09.  
Transducer failed on 1/16/2025.

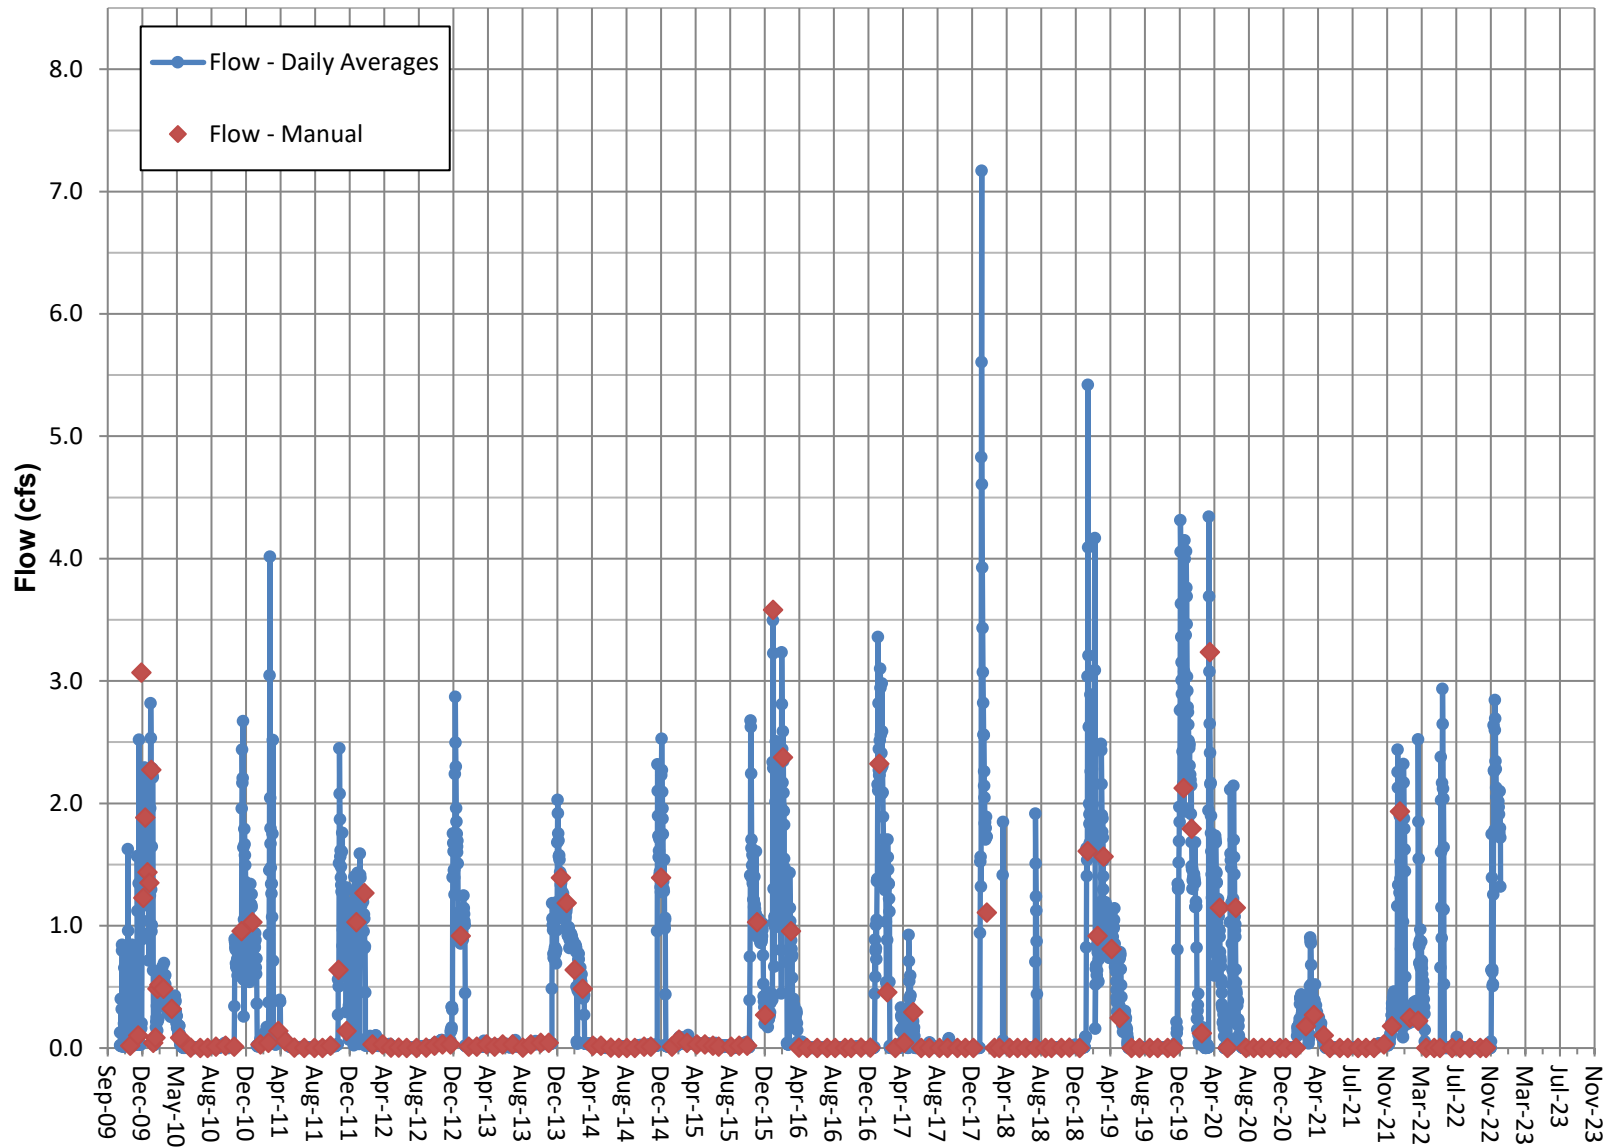
The flumes at Little Lake Ranch were checked for proper operation in January 2020 by TEAM Hydrologist Steve Keef. The LLR Lake Outflow flume (RV-230) was noted to have accuracy limitations due to a restriction of flow downstream of the flume. Maintenance has been recommended by TEAM but not scheduled to be performed due to landowner restrictions. During the December 2022 monitoring event the flow at Little Lake Outflow flume (RV-230) was observed to be backed-up and significantly over measuring flow. Due to the inaccuracy, data for this measuring point was not presented.

Note: Flows through Little Lake Outflow are influenced by natural and water management processes at Little Lake Ranch. Flume has known accuracy limitations, new data will not be presented due to inaccuracy.

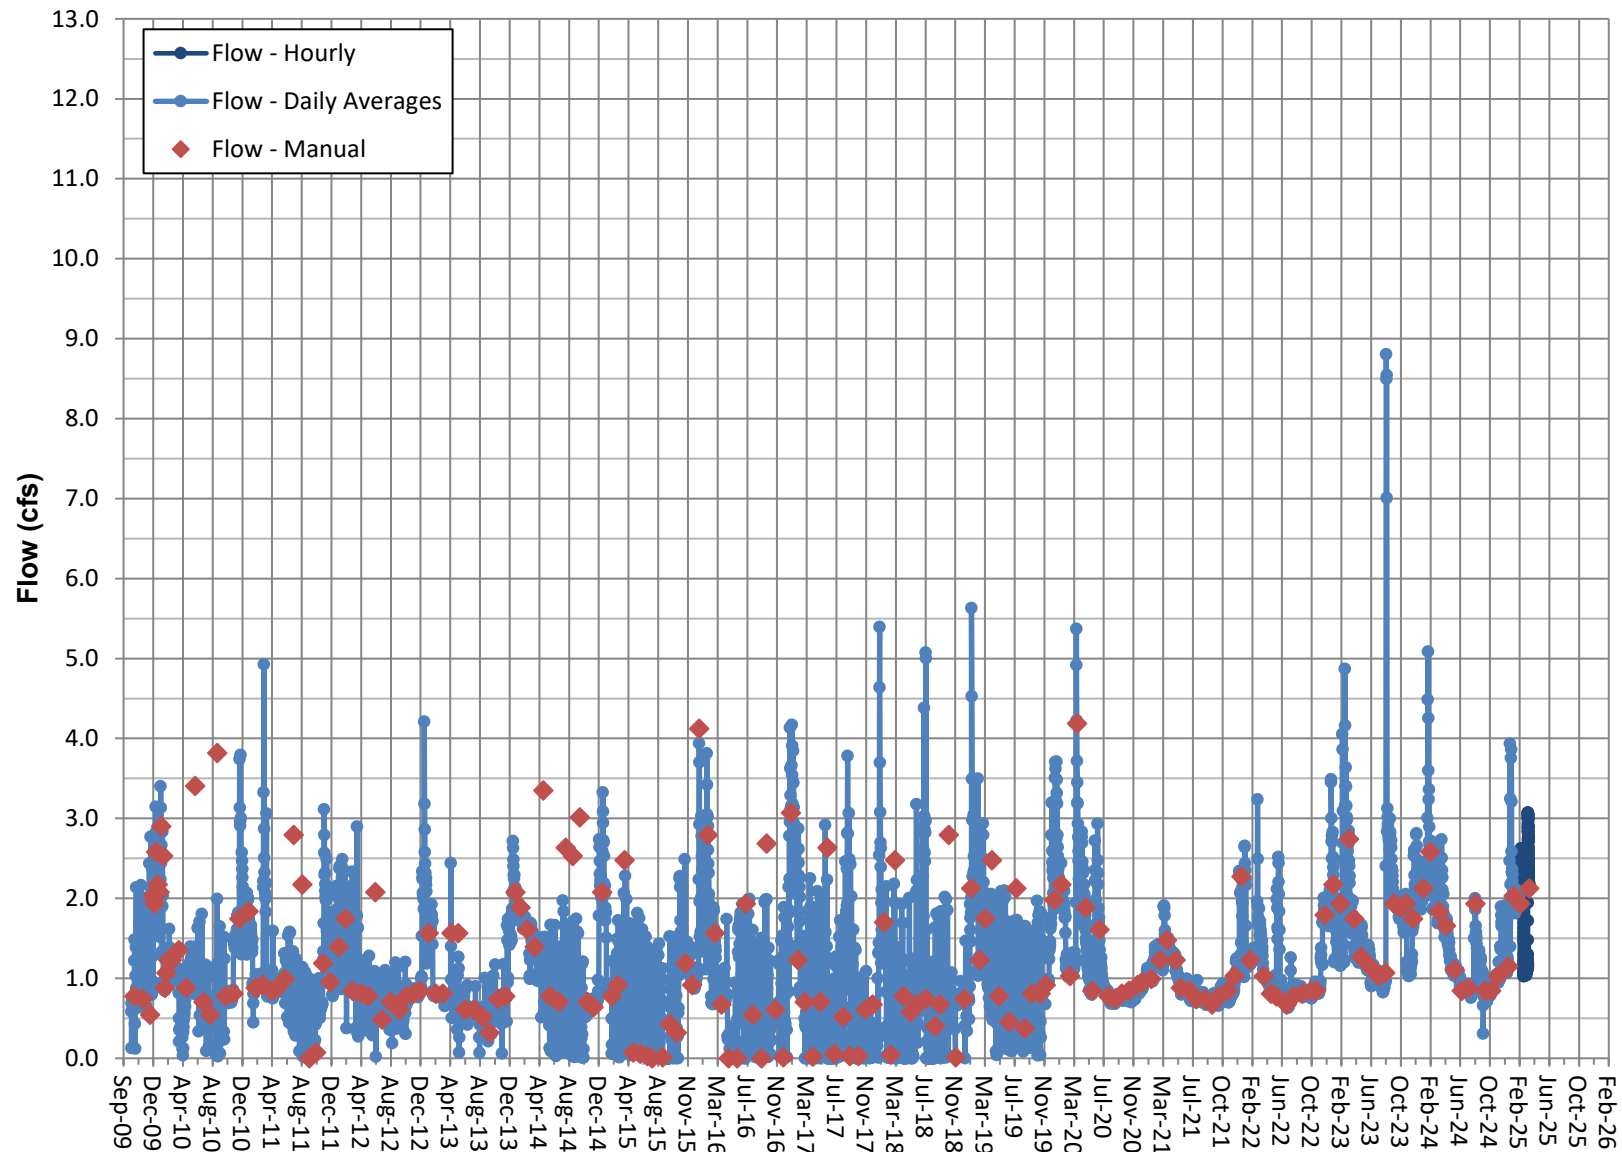
Note: Flows through North Culvert are influenced by natural and water mgmt. processes at LLR.  
Jan. 30 to Feb. 21, 2018 data from backup transducer, other data from primary InSitu transducer.
