# HAY RANCH PROJECT CONDITIONAL USE PERMIT HYDROLOGIC MONITORING REPORT

SECOND QUARTER 2021  
INYO COUNTY, CALIFORNIA

**HAY RANCH PROJECT CONDITIONAL USE PERMIT  
HYDROLOGIC MONITORING REPORT  
SECOND QUARTER 2021  
INYO COUNTY, CALIFORNIA**

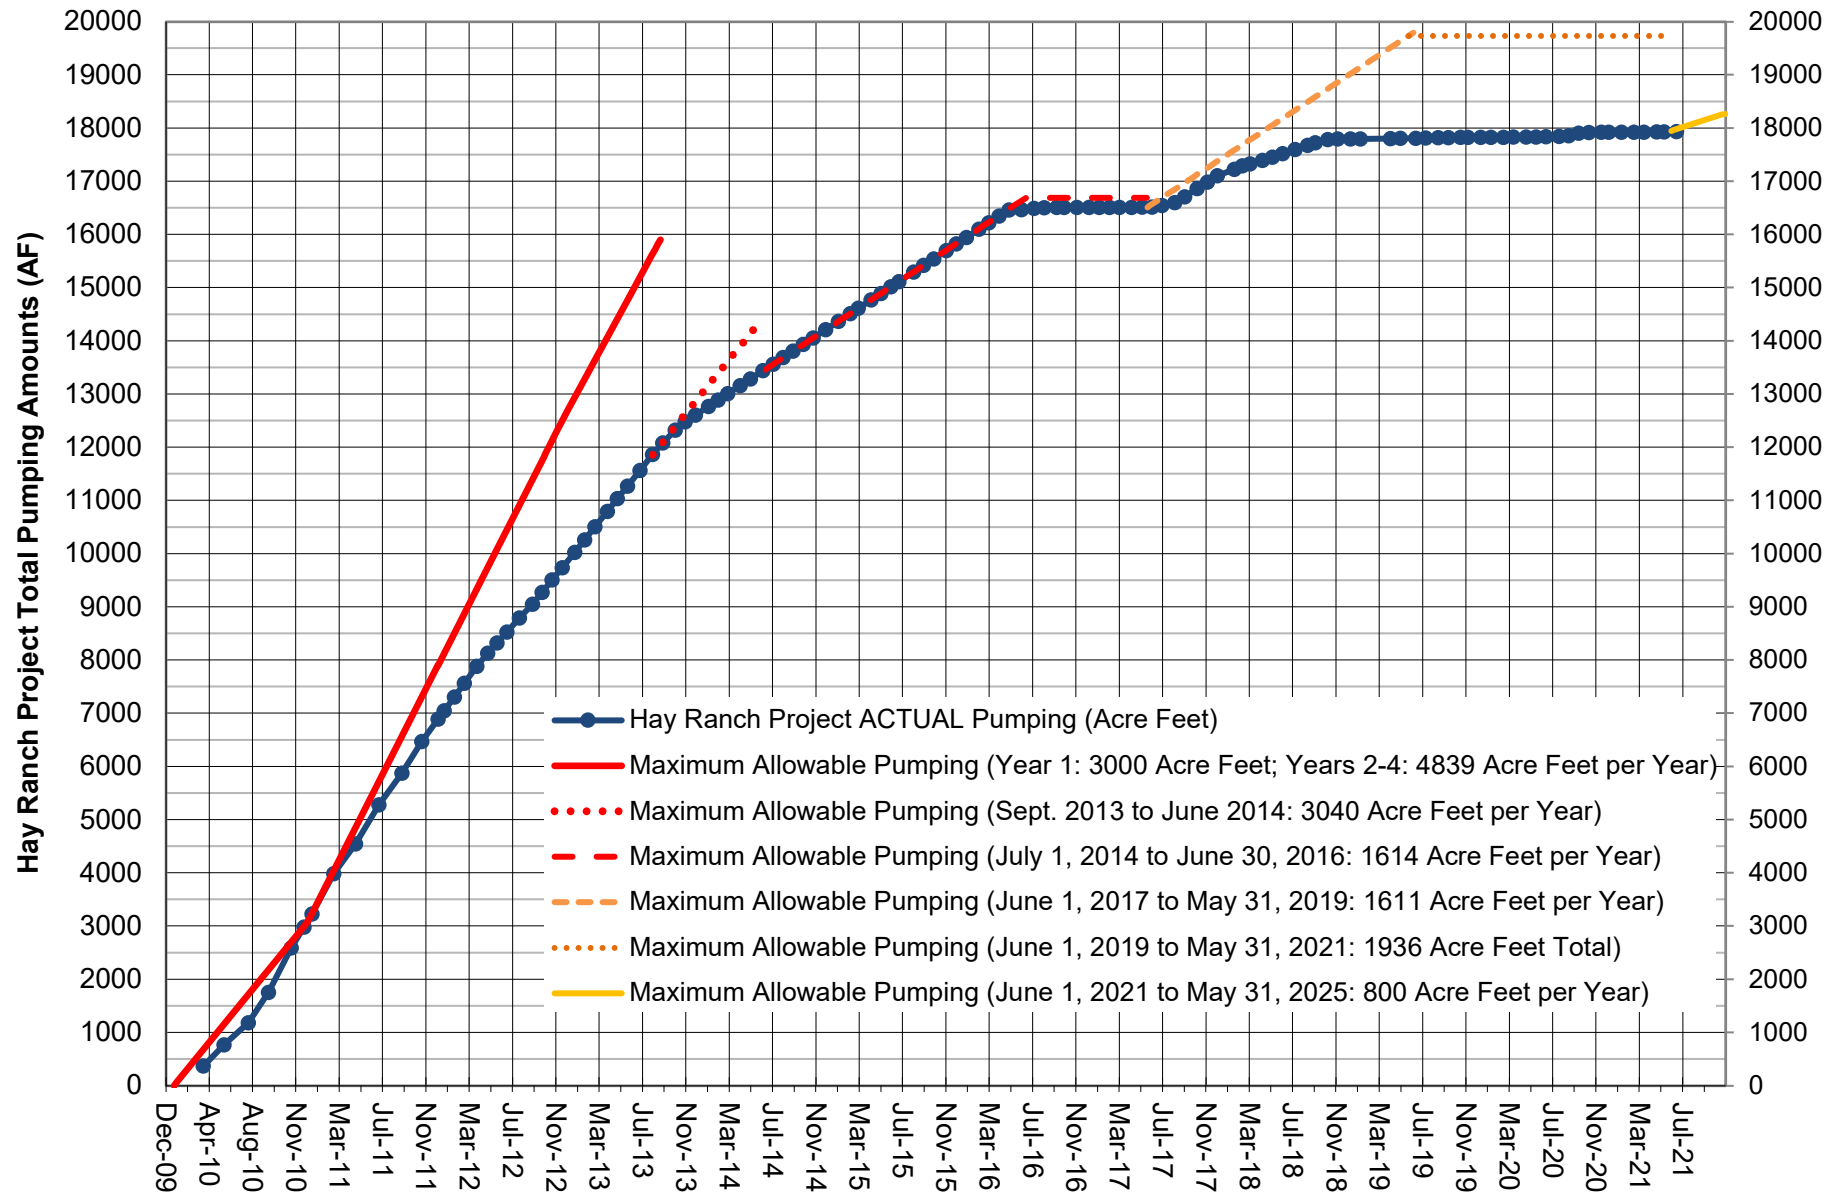
Note: The "maximum allowable pumping" is based on a pumping rate of 3000 AF/yr for 12/09 to 12/10, 4839 AF/yr for 1/11 to 8/13, 3040 AF/yr from 9/13 to 6/14, 1,614 AF/yr from 7/14 to 6/16 and 1611 AFY for 6/17 to 5/21.
