# **HAY RANCH PROJECT CONDITIONAL USE PERMIT**

## **HYDROLOGIC MONITORING REPORT**

**SECOND QUARTER 2022  
INYO COUNTY, CALIFORNIA**

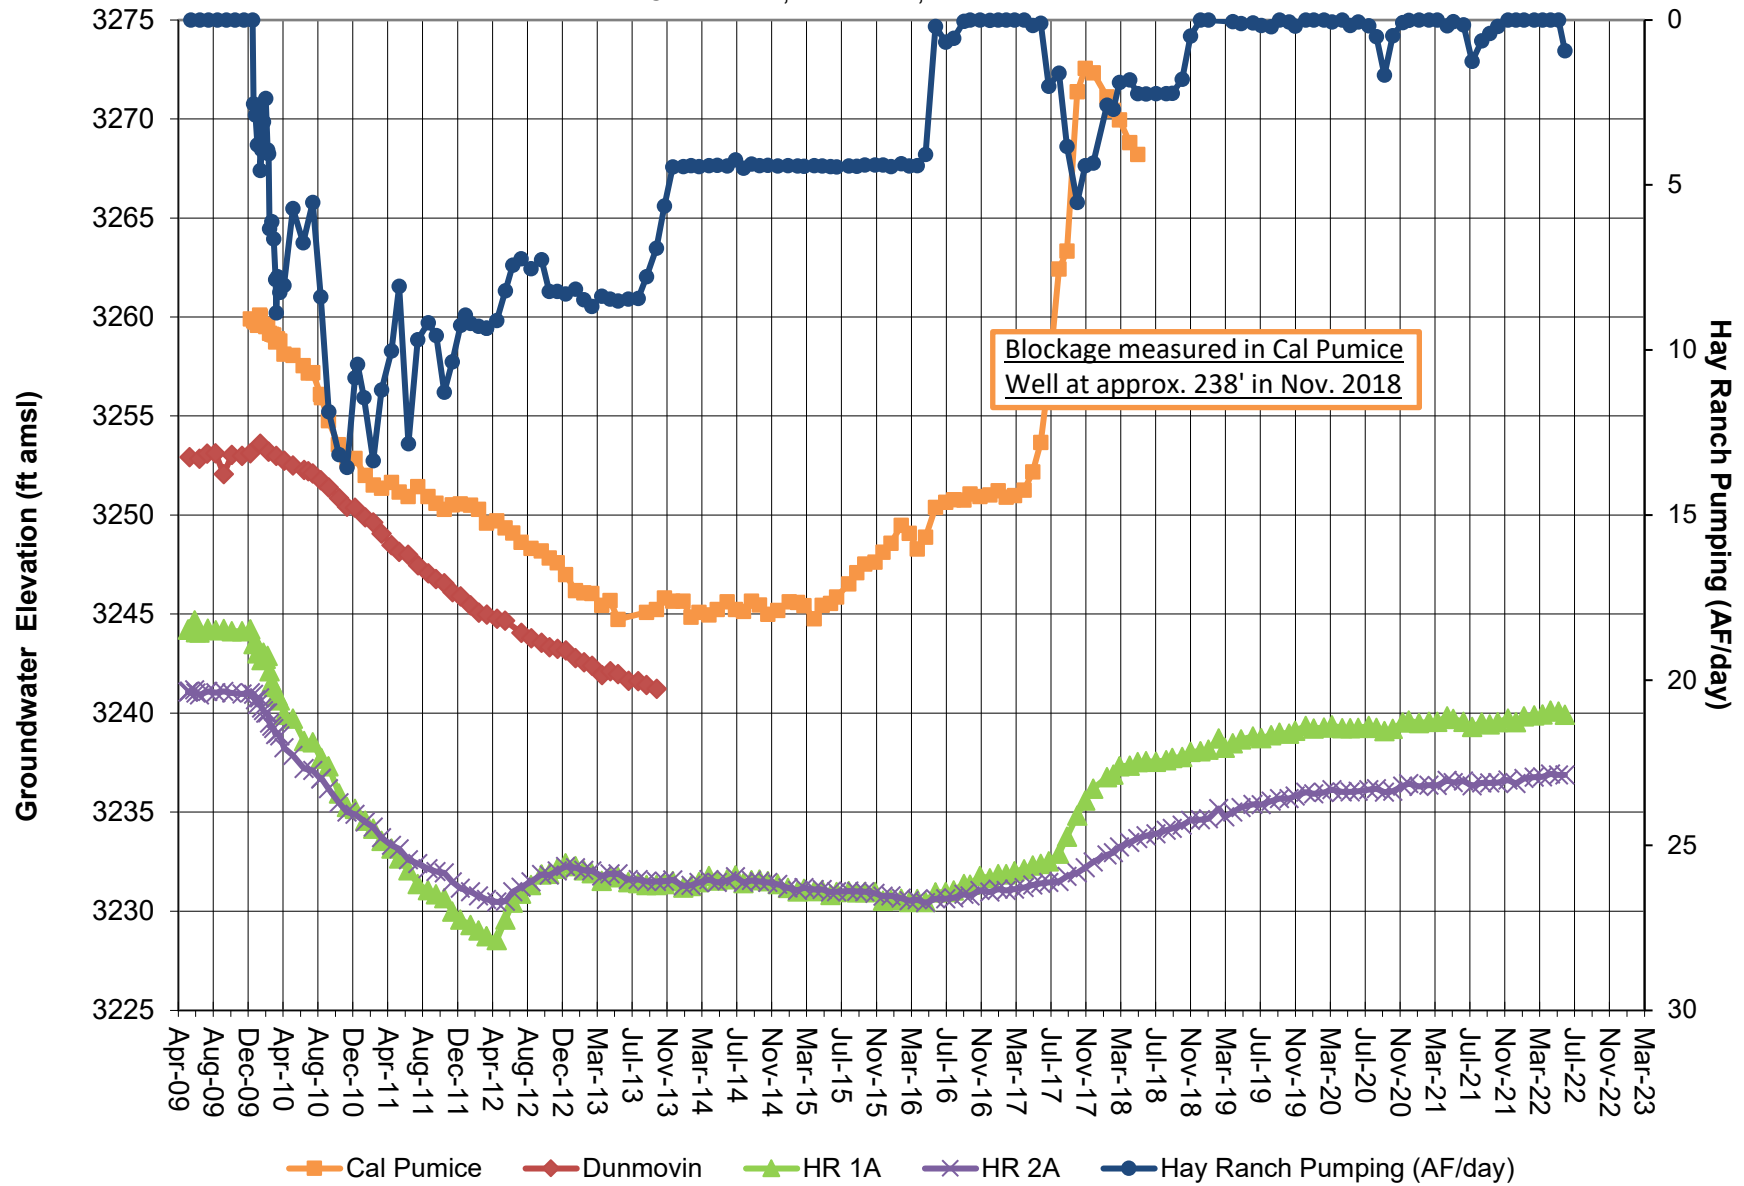
**FIGURE 3**  
GROUNDWATER ELEVATION and HAY RANCH PUMPING  
Cal Pumice, Dunmovin, HR 1A and HR 2A

Note: Groundwater elevation data based on manual depth-to-water measurements.  
Hay Ranch pumping is average acre feet per day.  
Coso Operating initiated Hay Ranch Project pumping on 12/25/09.

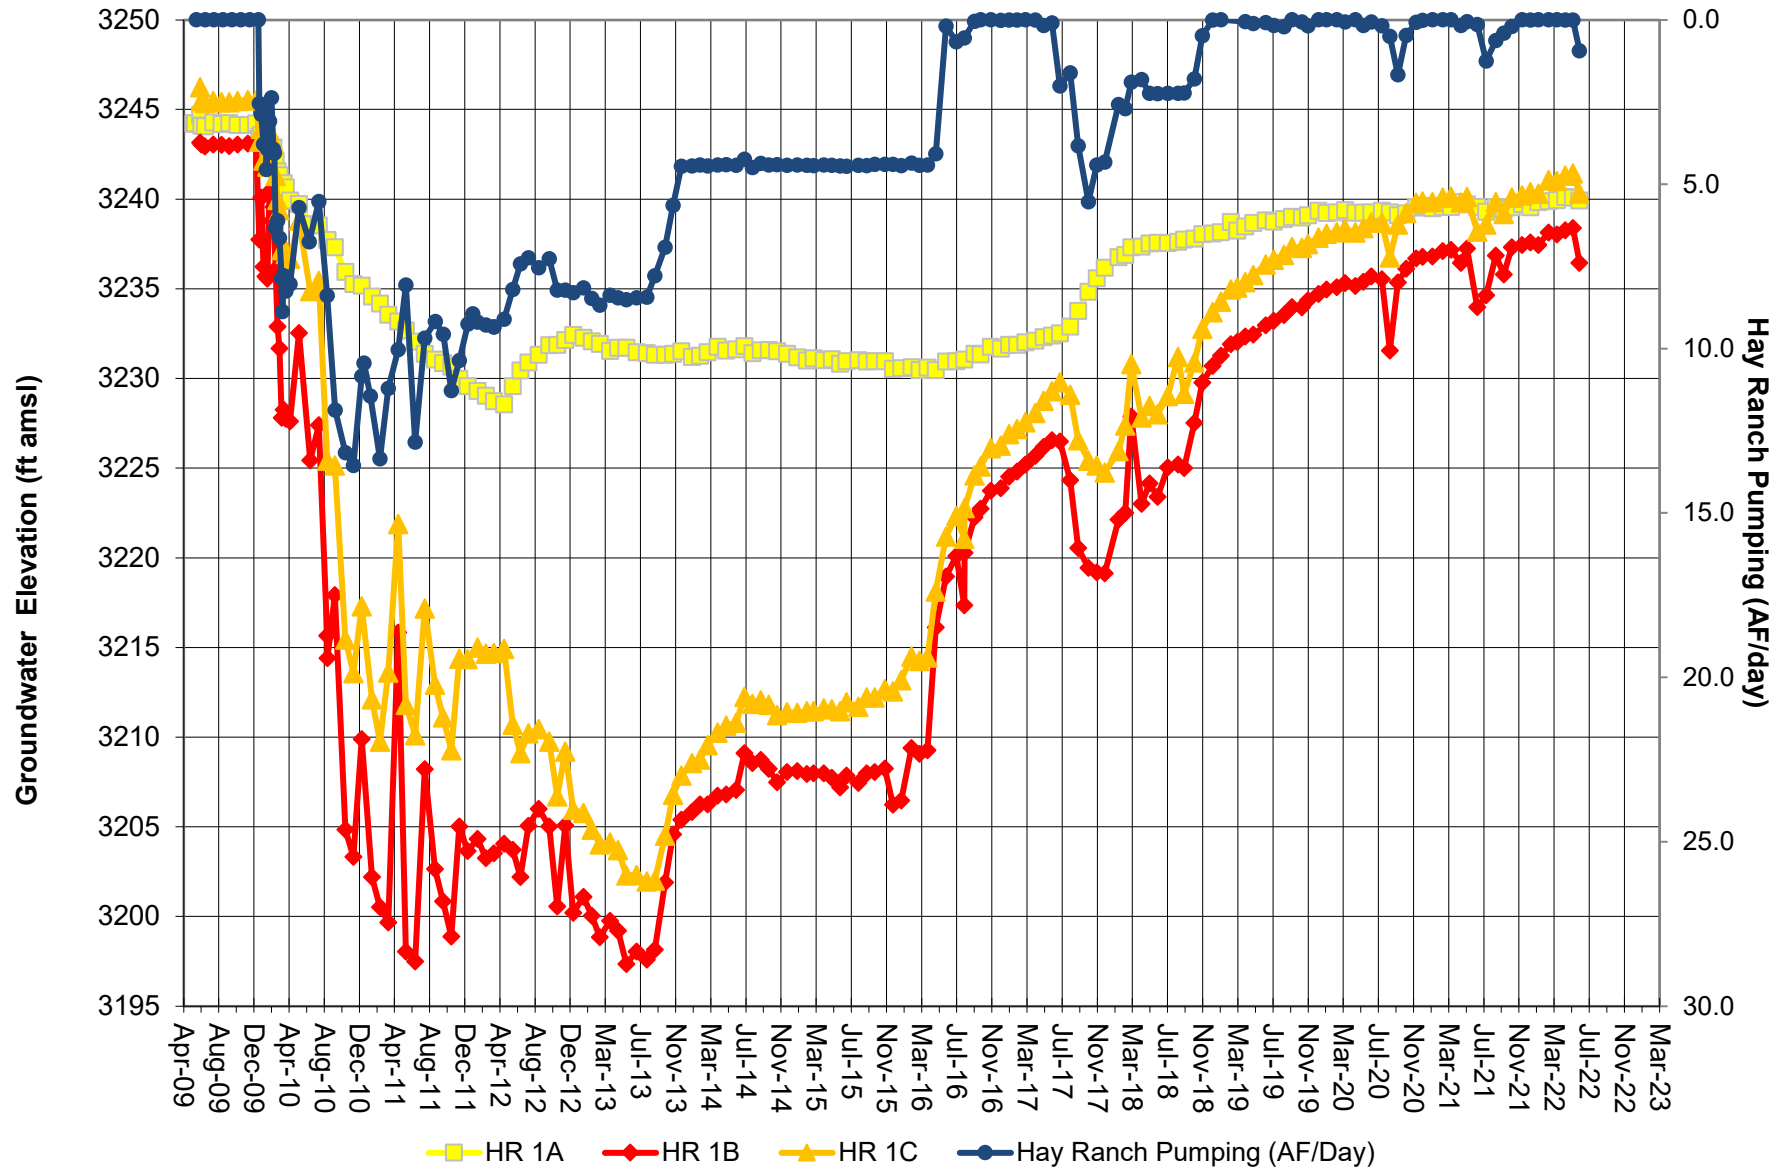
**FIGURE 4**  
GROUNDWATER ELEVATION and HAY RANCH PUMPING  
HR 1A, HR 1B and HR 1C

Note: Groundwater elevation data based on manual depth-to-water measurements.  
Hay Ranch pumping is average acre feet per day.  
Coso Operating initiated Hay Ranch Project pumping on 12/25/09.

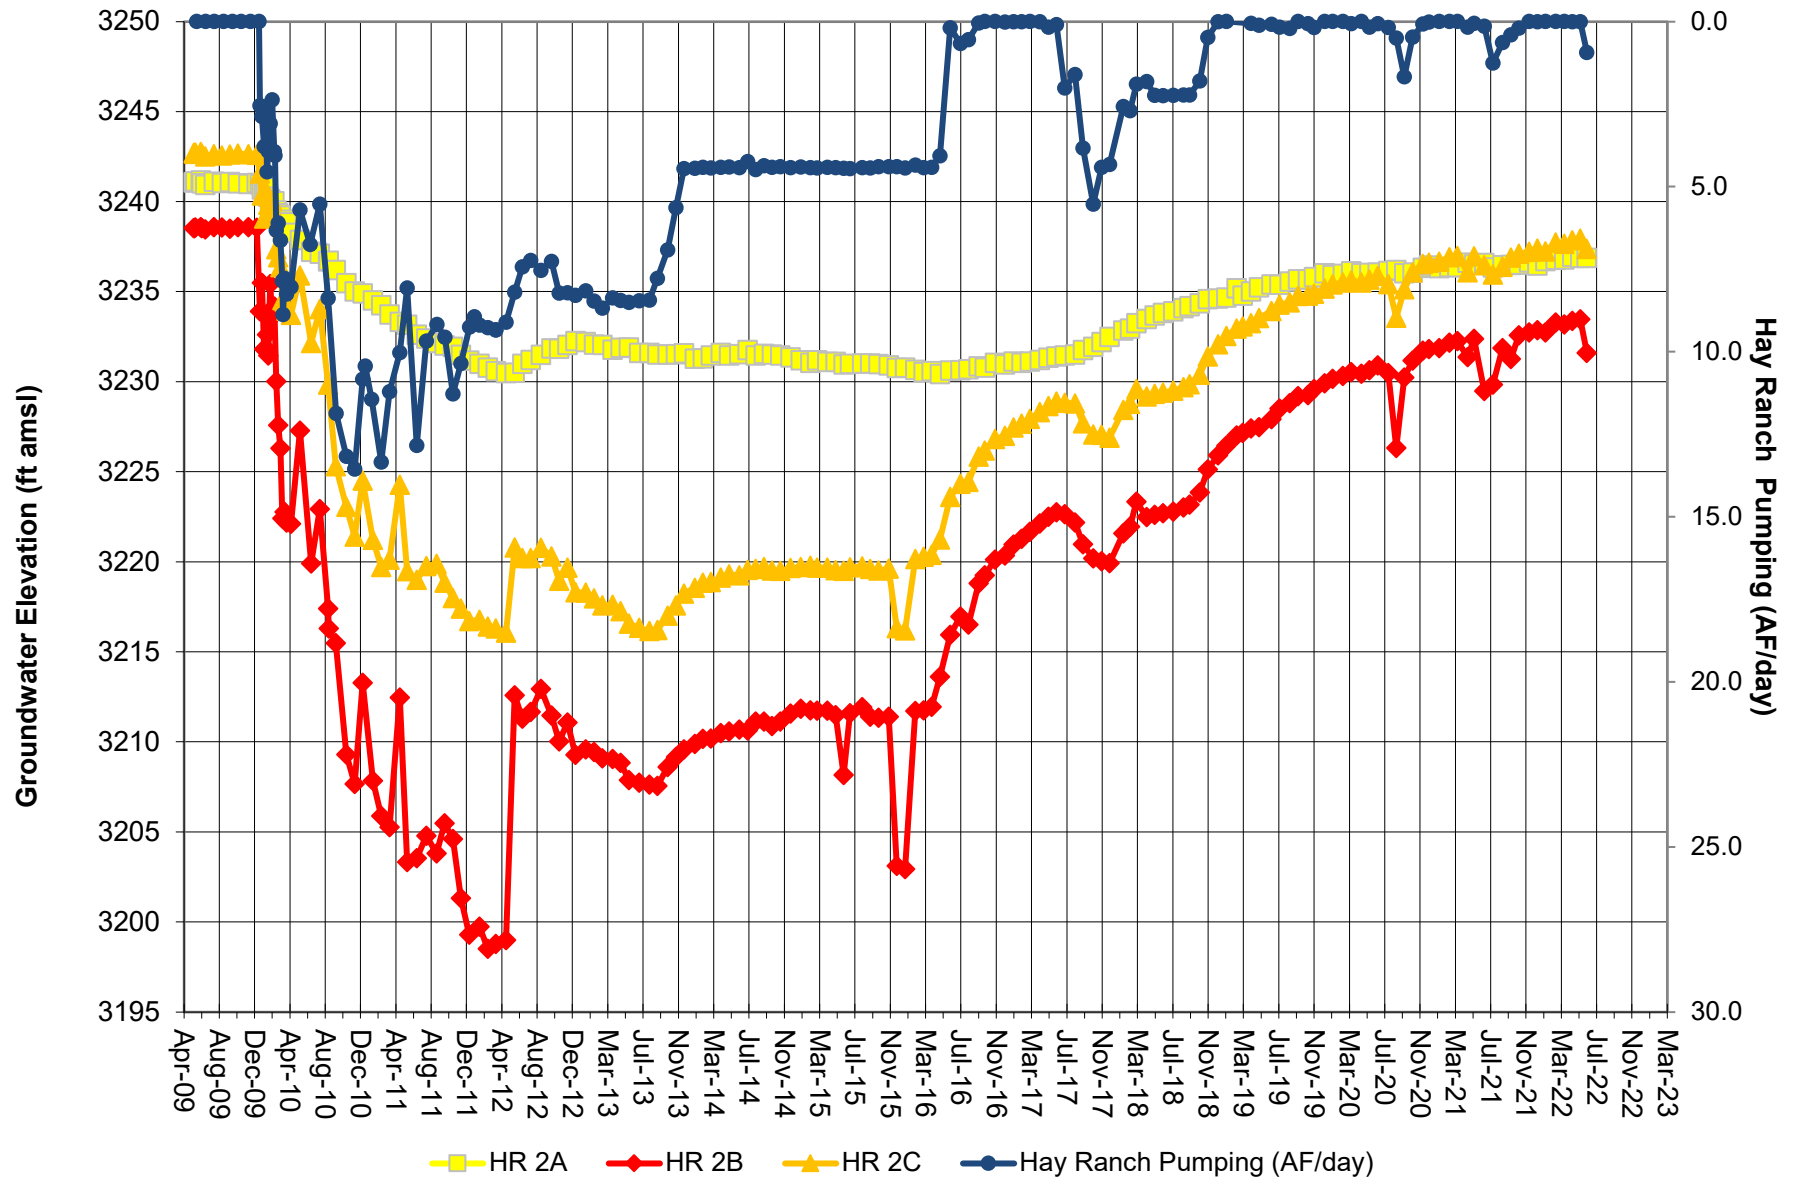
**FIGURE 5**  
GROUNDWATER ELEVATION and HAY RANCH PUMPING  
HR 2A, HR 2B and HR 2C

Note: Groundwater elevation data based on manual depth-to-water measurements.  
Hay Ranch pumping is average acre feet per day.  
Coso Operating initiated Hay Ranch Project pumping on 12/25/09.

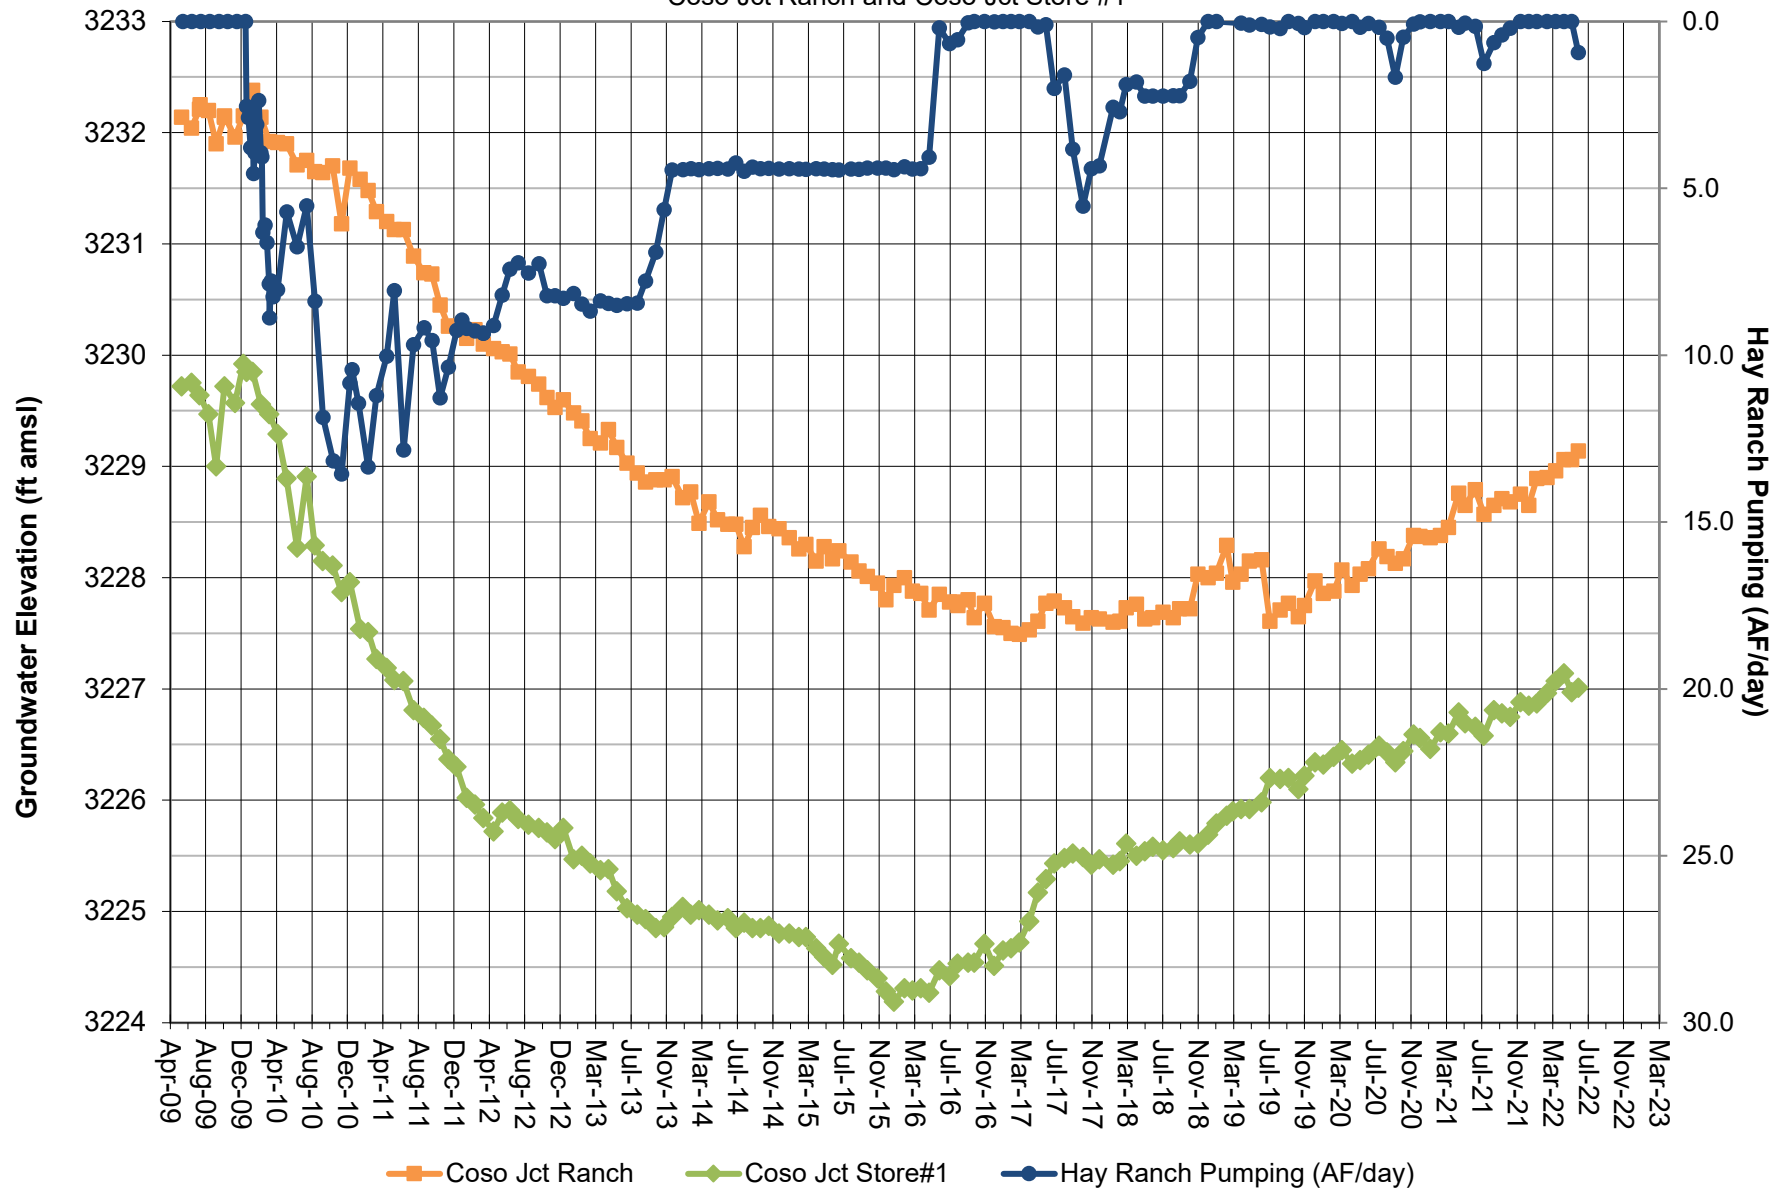
**FIGURE 6A**  
GROUNDWATER ELEVATION and HAY RANCH PUMPING  
Coso Jct Ranch and Coso Jct Store #1

Note: Groundwater elevation data based on manual depth-to-water measurements.  
Hay Ranch pumping is average acre feet per day.  
Coso Operating initiated Hay Ranch Project pumping on 12/25/09.

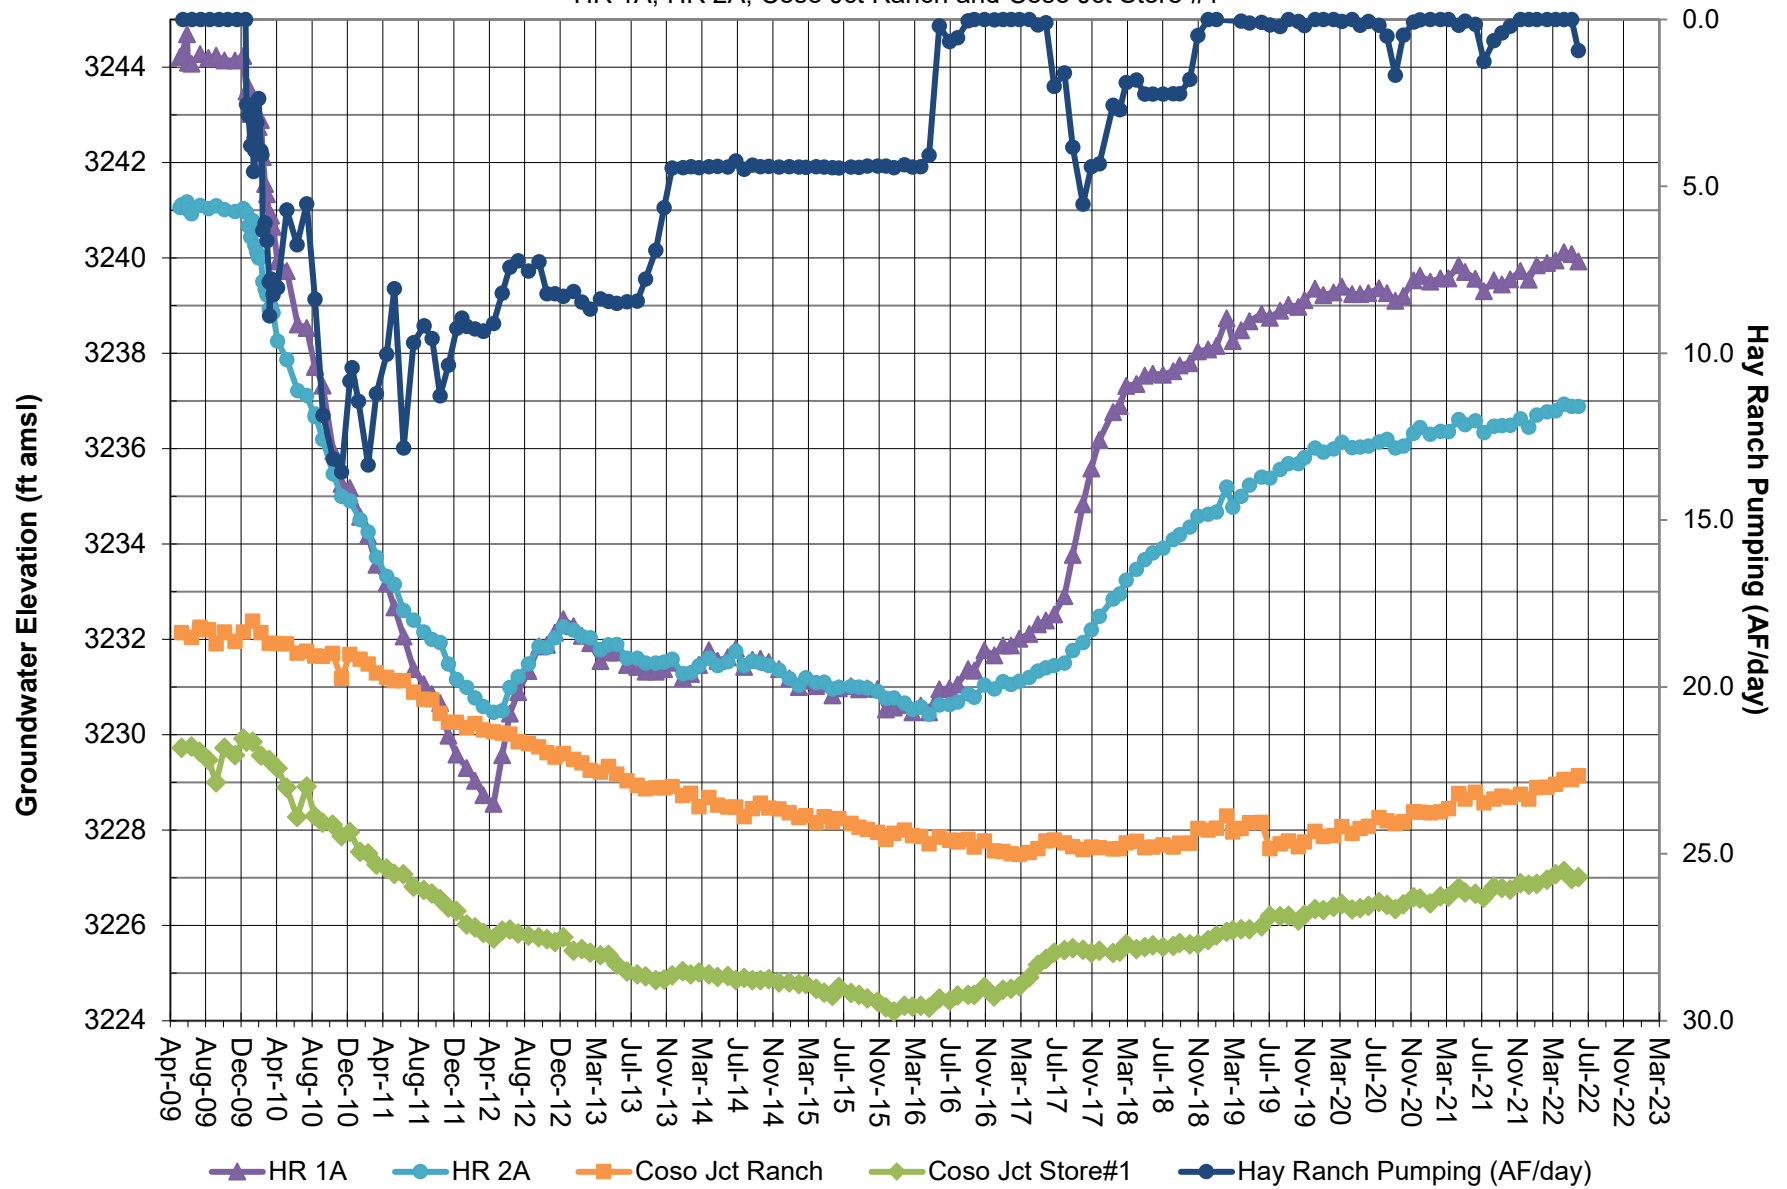
**FIGURE 6B**  
GROUNDWATER ELEVATION and HAY RANCH PUMPING  
HR 1A, HR 2A, Coso Jct Ranch and Coso Jct Store #1

Note: Groundwater elevation data based on manual depth-to-water measurements.  
Hay Ranch pumping is average acre feet per day.  
Coso Operating initiated Hay Ranch Project pumping on 12/25/09.

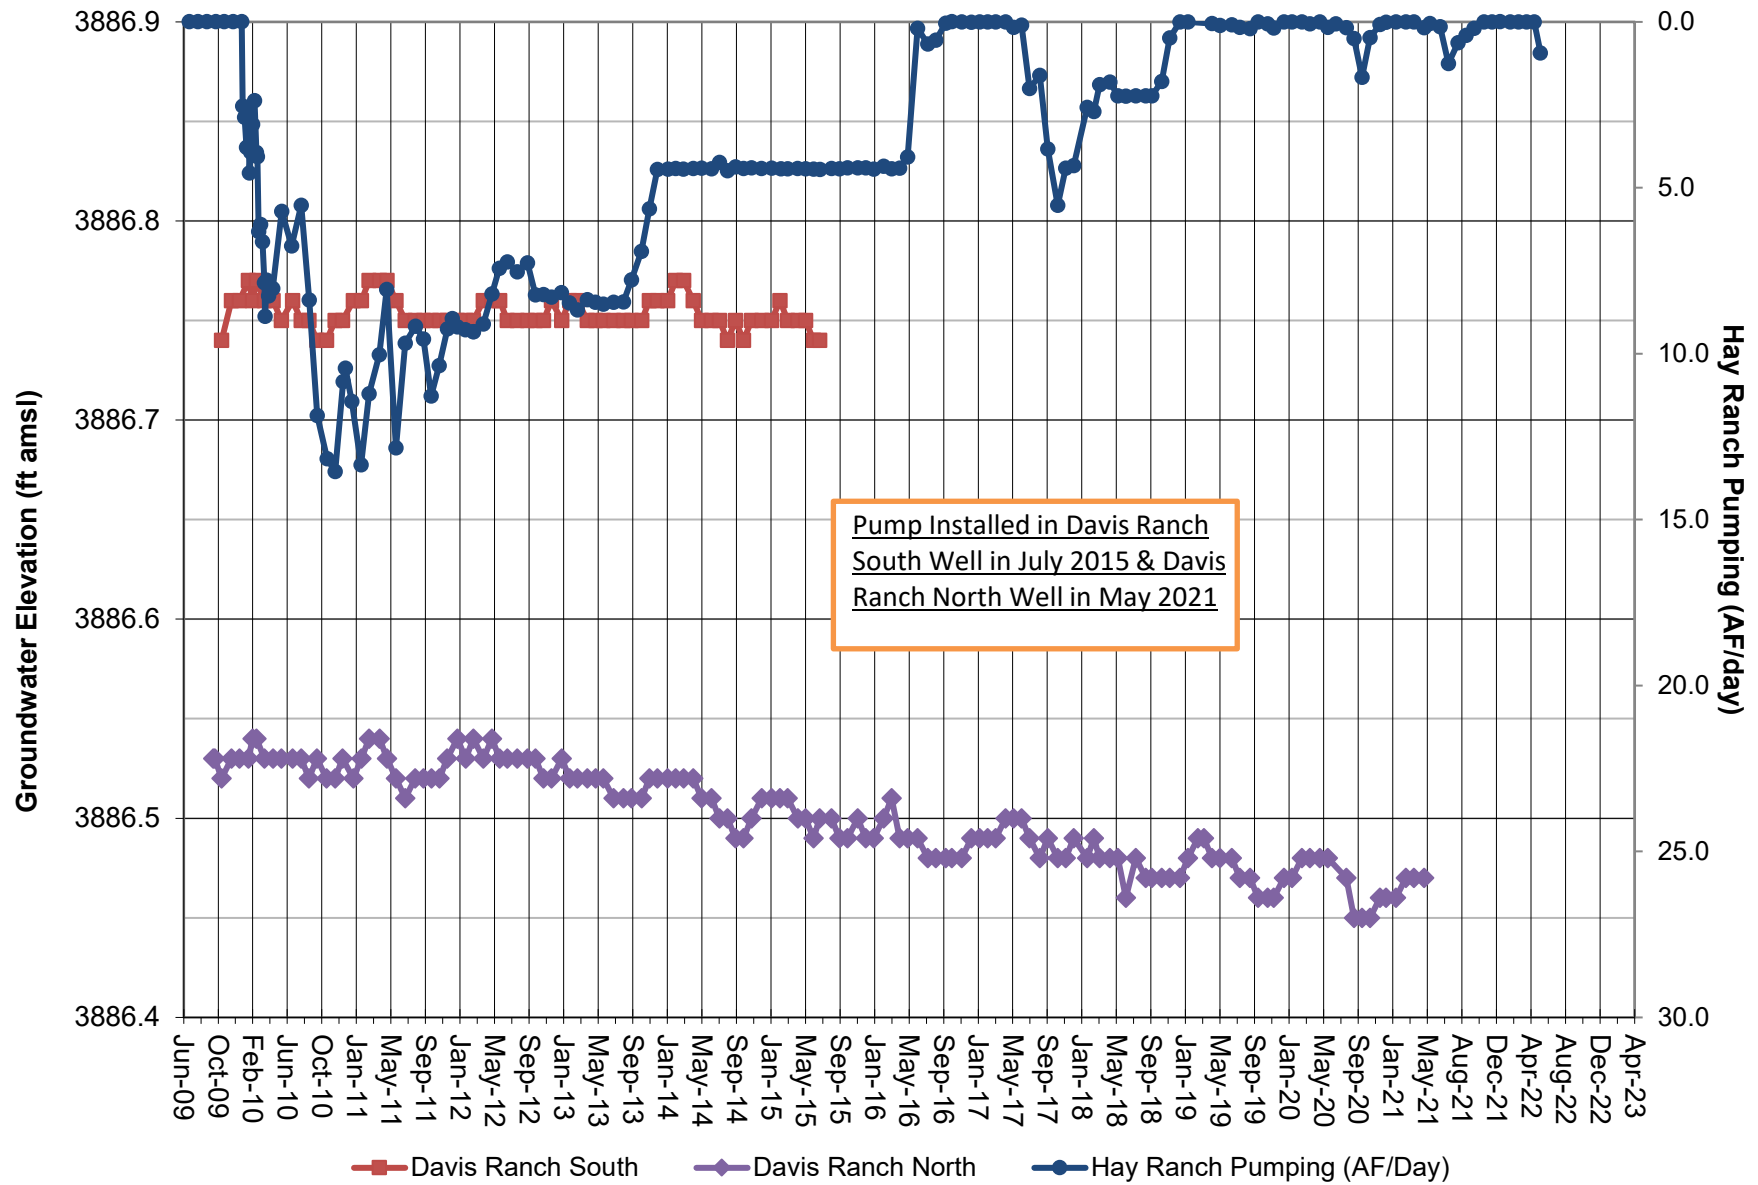
**FIGURE 7**  
GROUNDWATER ELEVATION and HAY RANCH PUMPING  
Davis Ranch North and South

Note: Groundwater elevation data based on manual depth-to-water measurements.  
Hay Ranch pumping is average acre feet per day.  
Coso Operating initiated Hay Ranch Project pumping on 12/25/09.

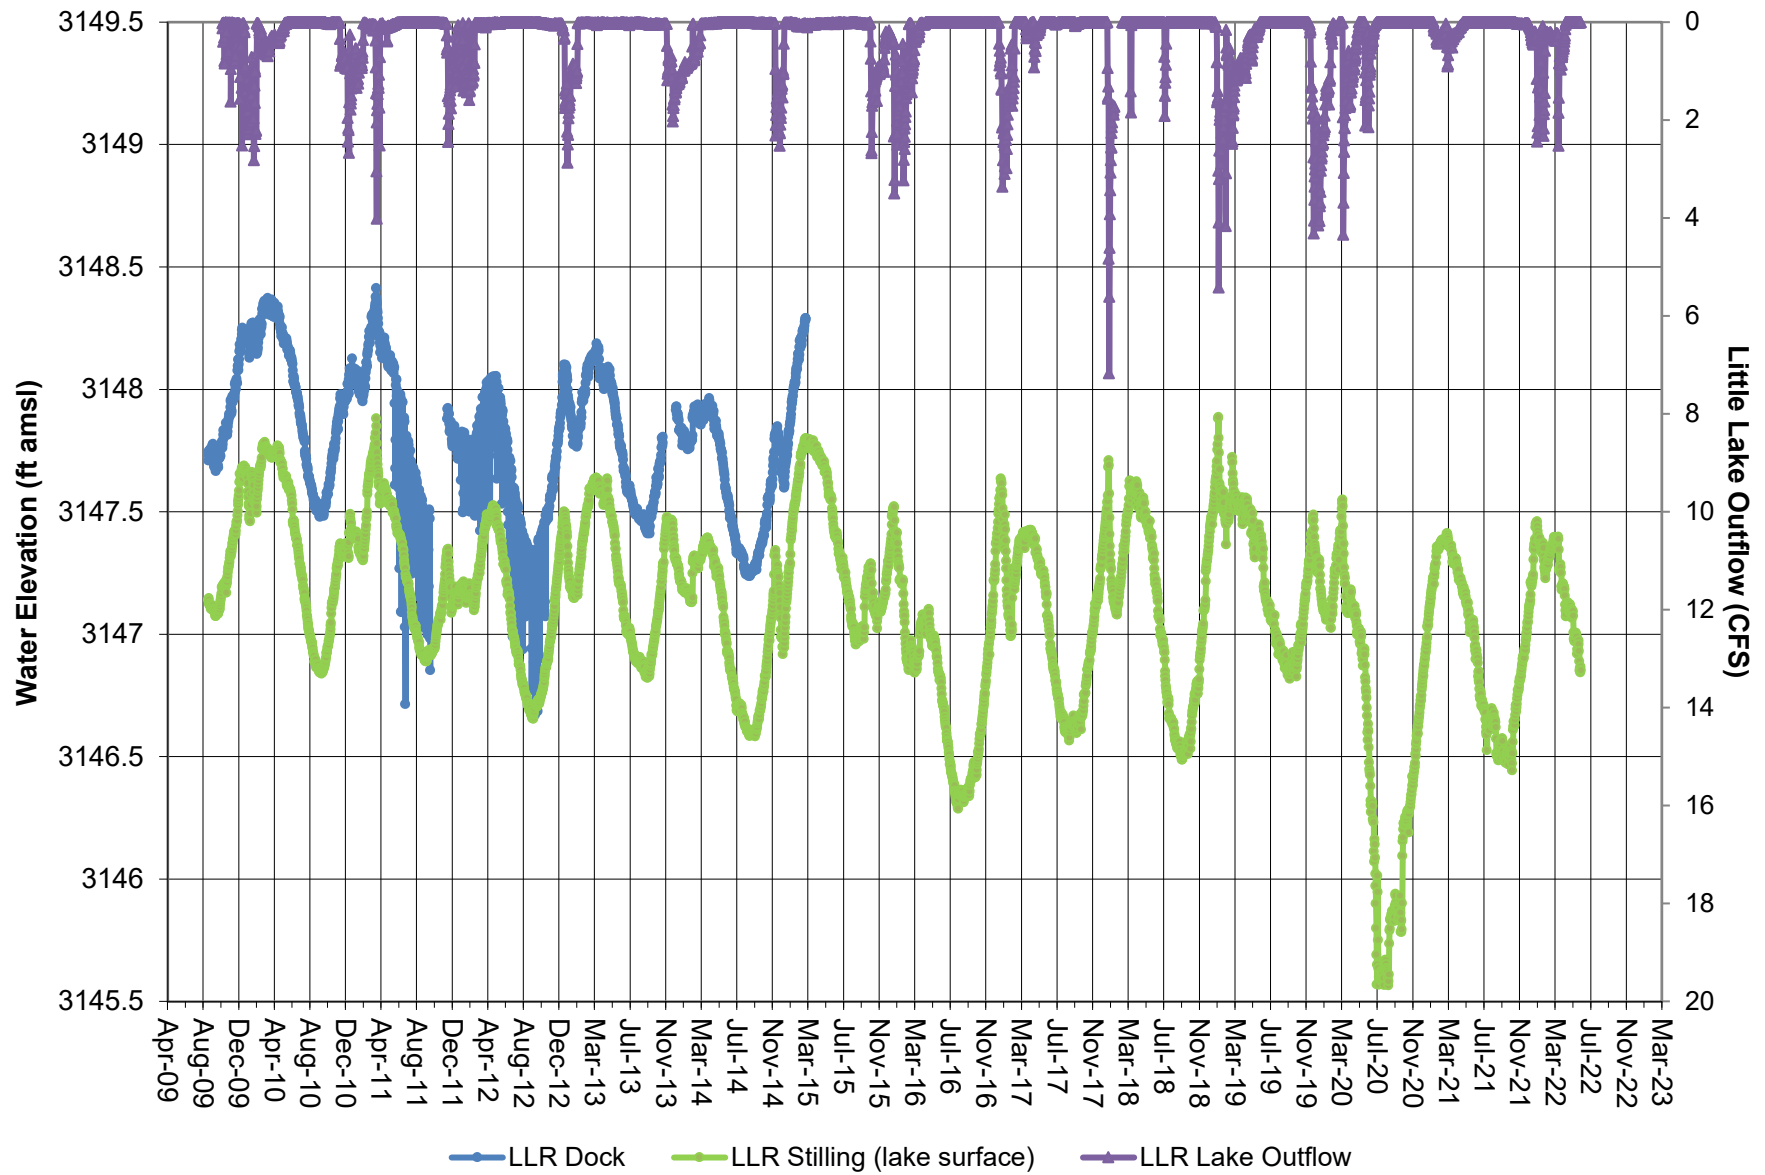
A hydrograph which compares groundwater and surface water elevations in the immediate vicinity of Little Lake to LLR Lake Outflow amounts over time is included in this report as Figure 12. Groundwater and surface water elevations at the LLR Dock and LLR Stilling Well (Little Lake surface level) are listed, in feet above mean sea level, on the left axis. Surface water outflow from Little Lake, captured by the LLR Lake Outflow flume in cubic feet per second, is listed on the right axis in inverse order. It should be noted that the LLR Lake Outflow flume has had known accuracy limitations since January 2020.

Note: Little Lake Outflow in cubic feet per second  
 Pressure transducer removed from Dock Well in March 2015

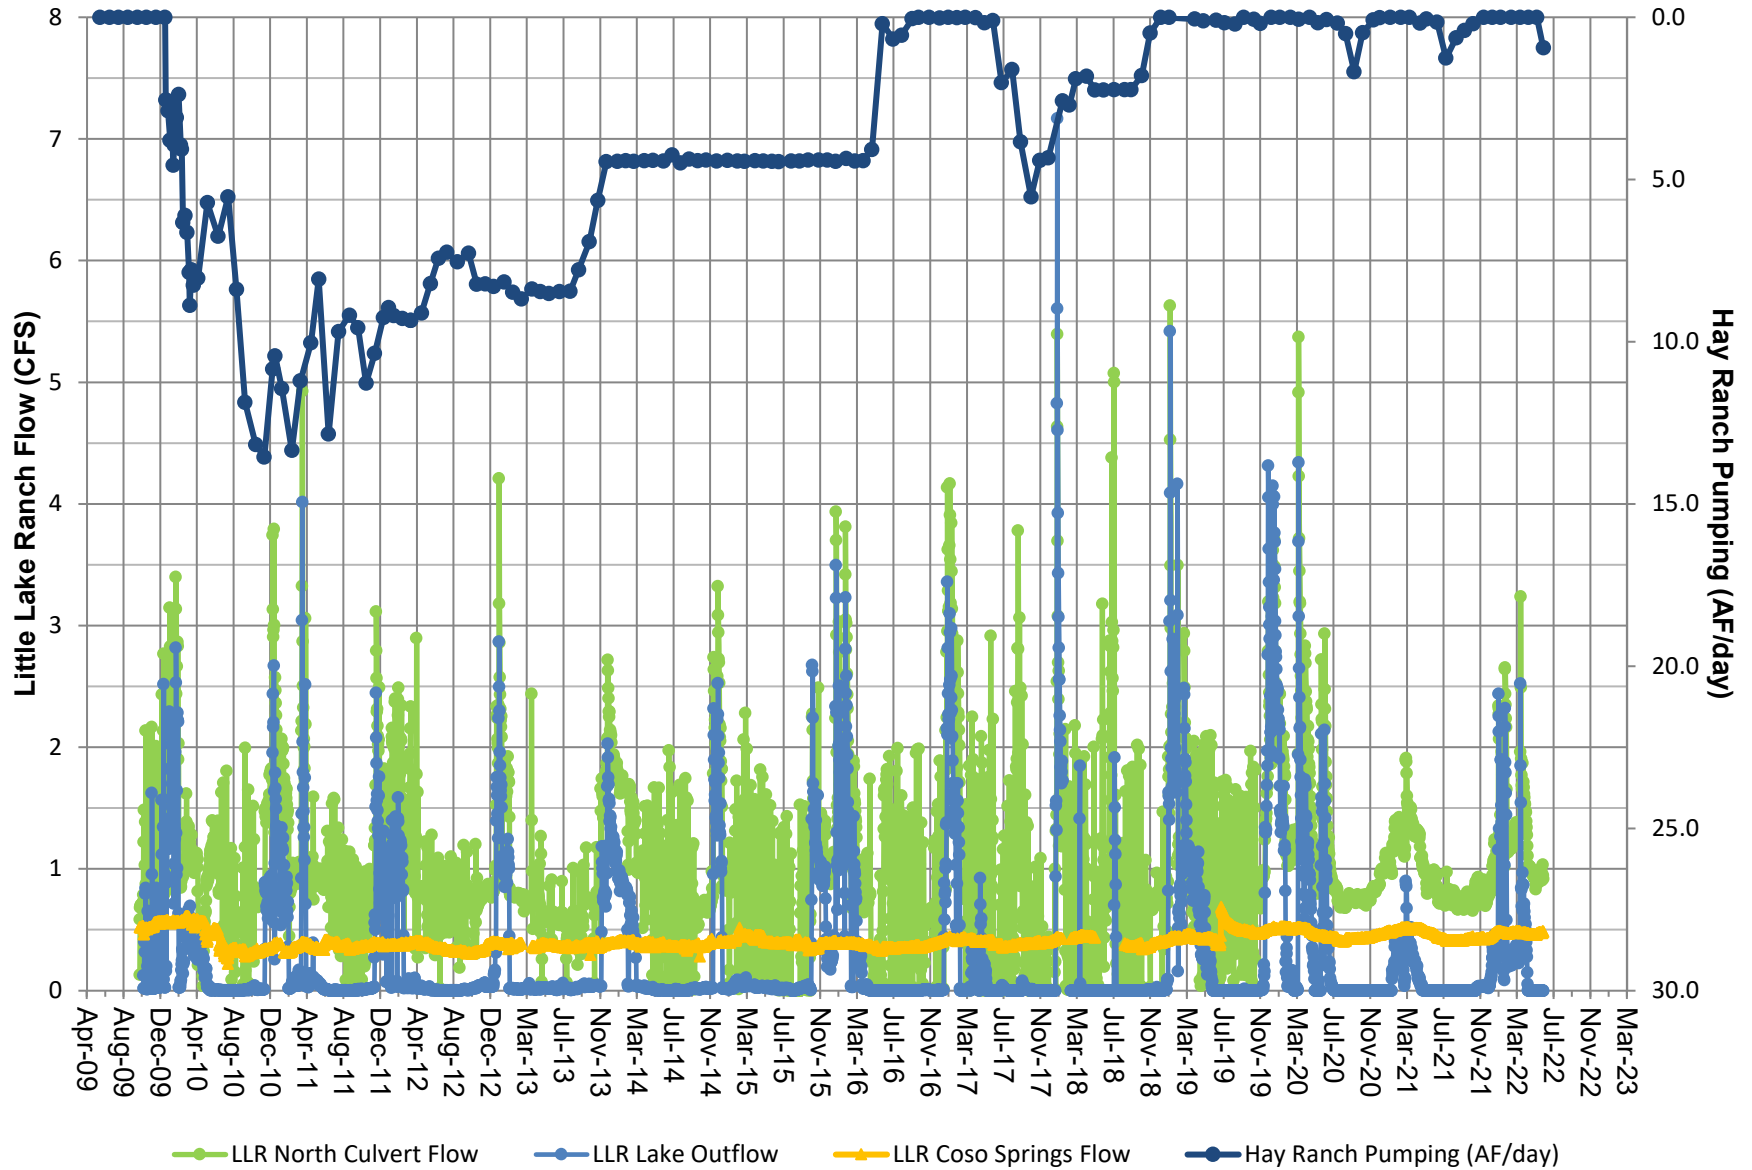
A hydrograph which compares surface water flows in the Little Lake Ranch area to Hay Ranch Project pumping rates over time is also included in this report as Figure 13. Surface water flows from Lake Outflow, Coso Springs Flow and North Culvert Flow are listed on the left axis, in cubic feet per second. Hay Ranch Project average daily pumping amounts, in acre-feet per day, are listed on the right axis in inverse order. As noted in Section 3.3, surface flow captured by the North Culvert Flow flume represents an accumulation of surface flows from Little Lake, Coso Springs and the Siphon Well flow.

Note: Little Lake Ranch Flows are in cubic feet per second.  
 Hay Ranch Pumping is in average acre feet per day.  
 Flows at Little Lake Outflow and North Culvert are influenced both by natural and water management processes at LLR.

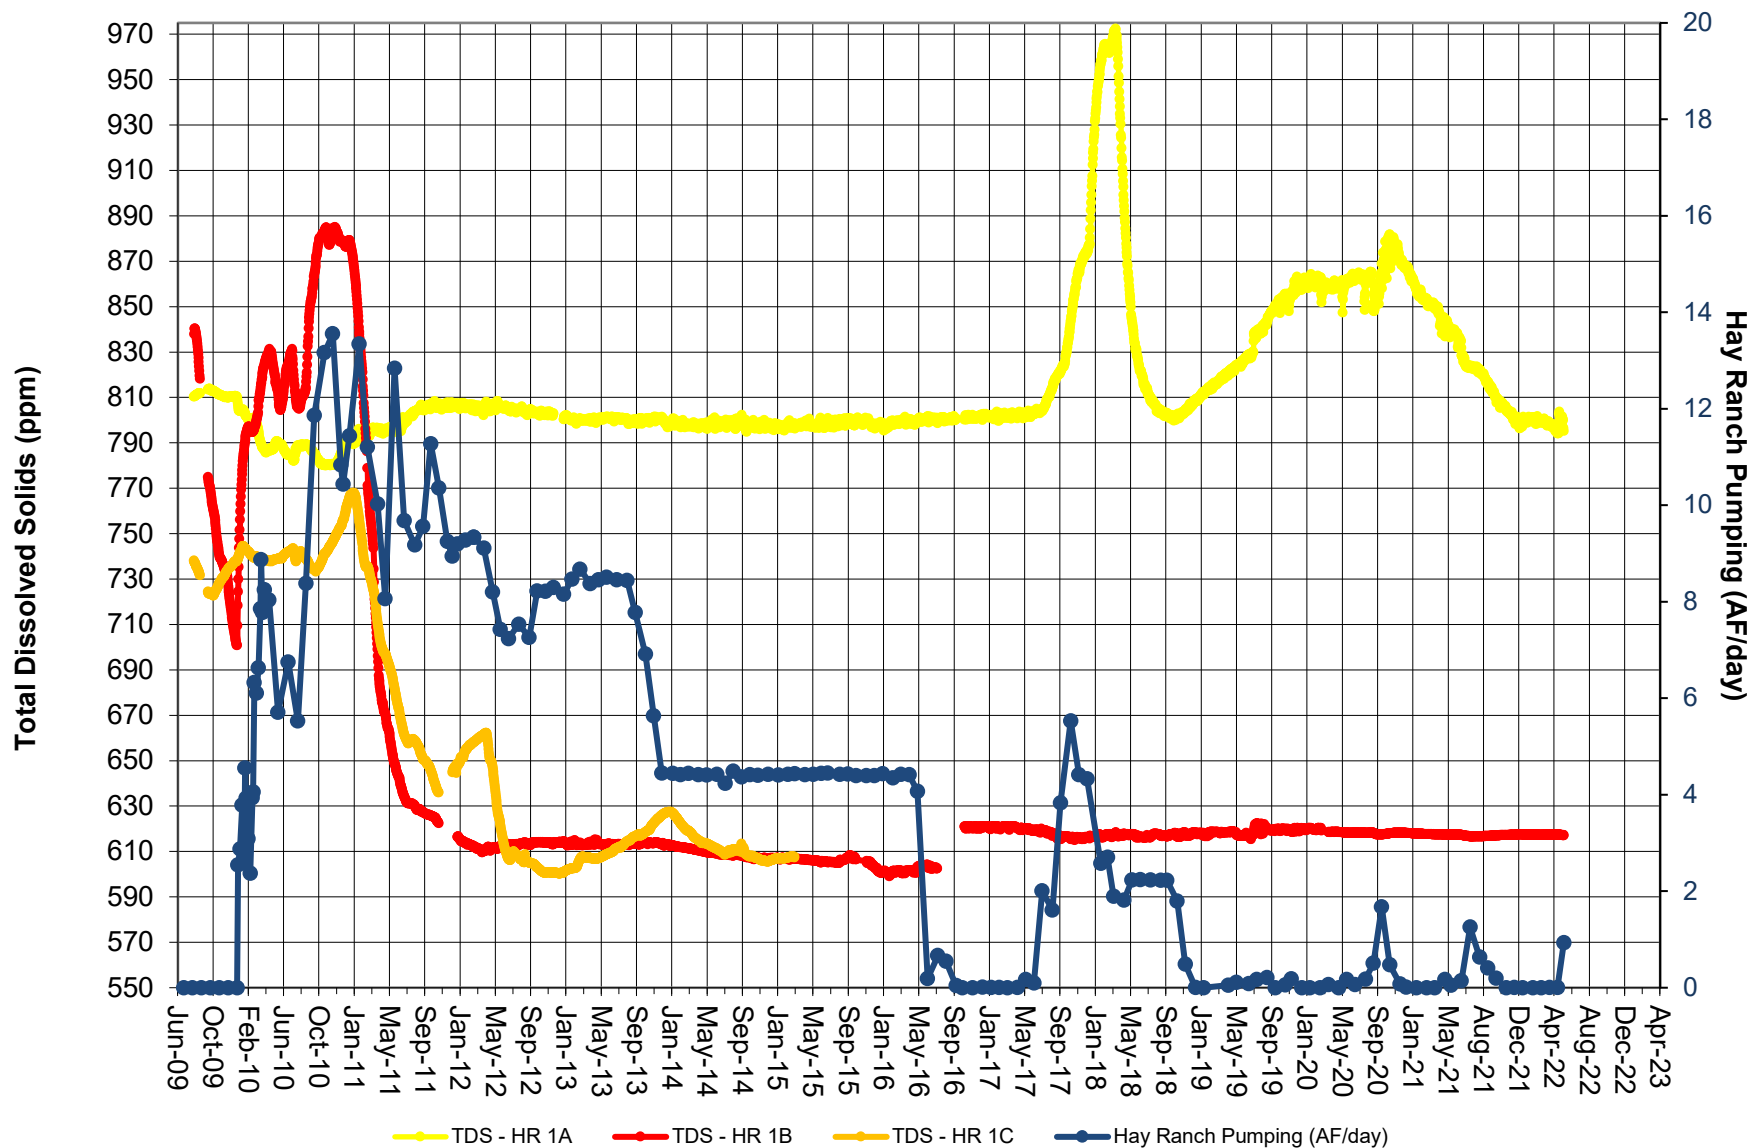
Note: TDS data from in-well transducers.  
Screened intervals: HR 1A 170-260 feet; HR 1B 490-540 feet; HR 1C 340-405 feet.  
HR 1A, 1B and 1C data gaps due to transducer malfunction or adjustment.  
PT removed from HR1C in March 2015.

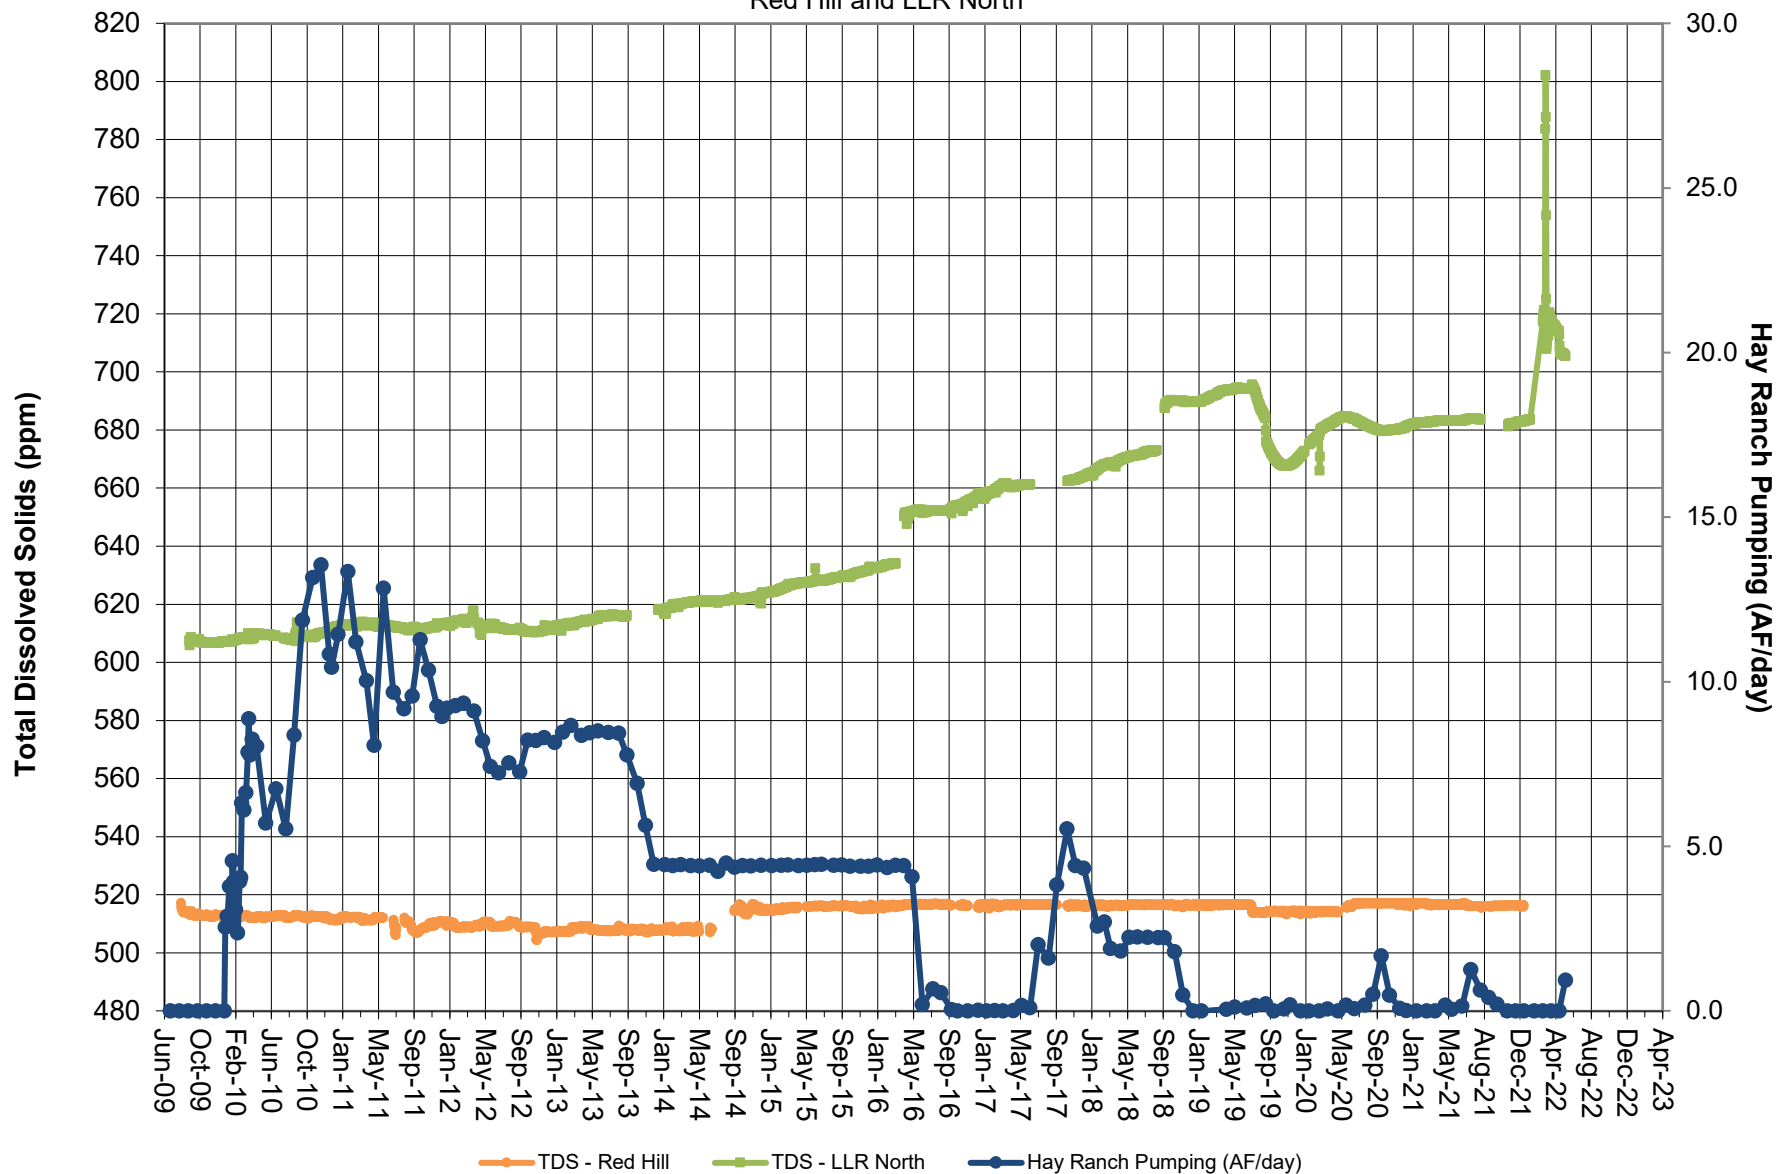
**FIGURE 16**  
TOTAL DISSOLVED SOLIDS (TDS) and HAY RANCH PUMPING  
Red Hill and LLR North

Note: TDS data from in-well transducers. Hay Ranch pumping is average acre feet per day.  
LLR North data gaps due to transducer malfunction. Transducer removed from Red Hill Well in Jan. 2022.
