# **HAY RANCH PROJECT CONDITIONAL USE PERMIT**

## **HYDROLOGIC MONITORING REPORT**

**SECOND QUARTER 2022  
INYO COUNTY, CALIFORNIA**

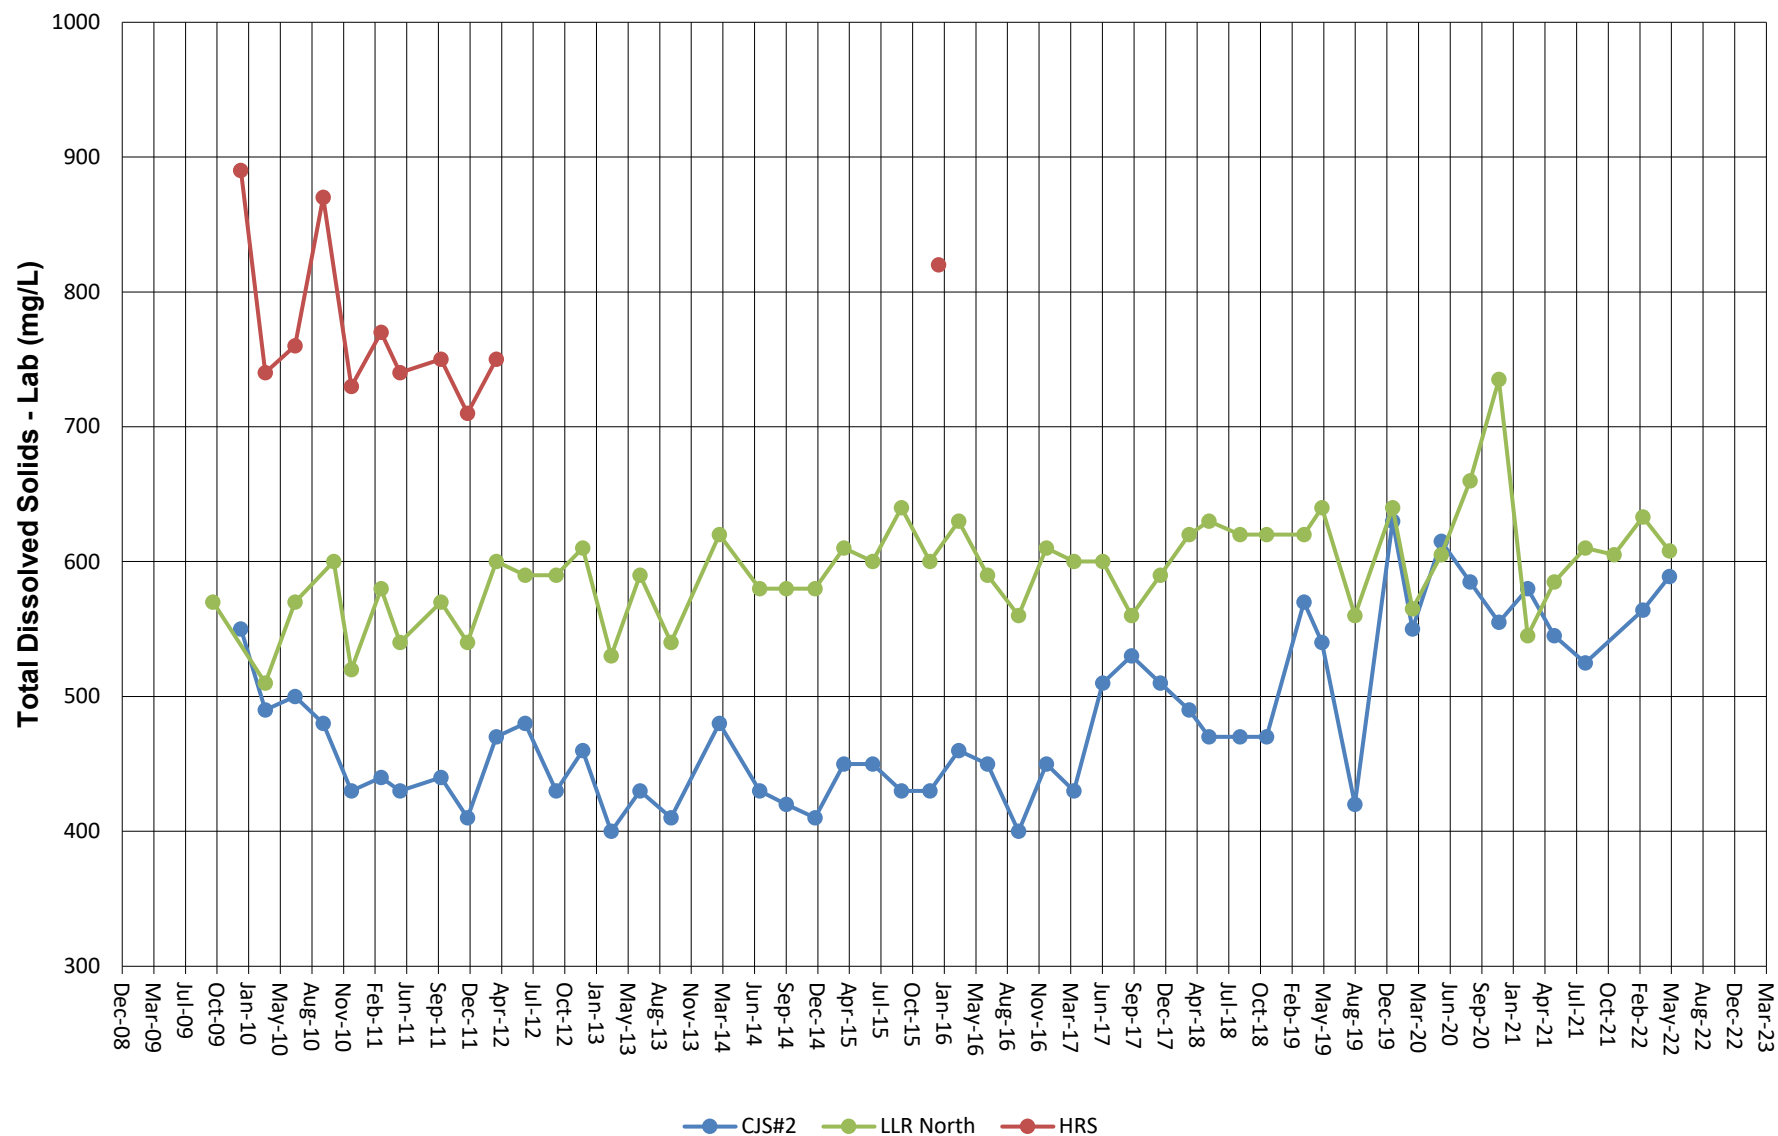
Note: TDS samples collected quarterly if accessible and pump is running.  
 COC initiated Hay Ranch Project pumping on 12/25/09.  
 Laboratory analysis conducted by Eurofins/Calscience beginning in Aug. 2019.

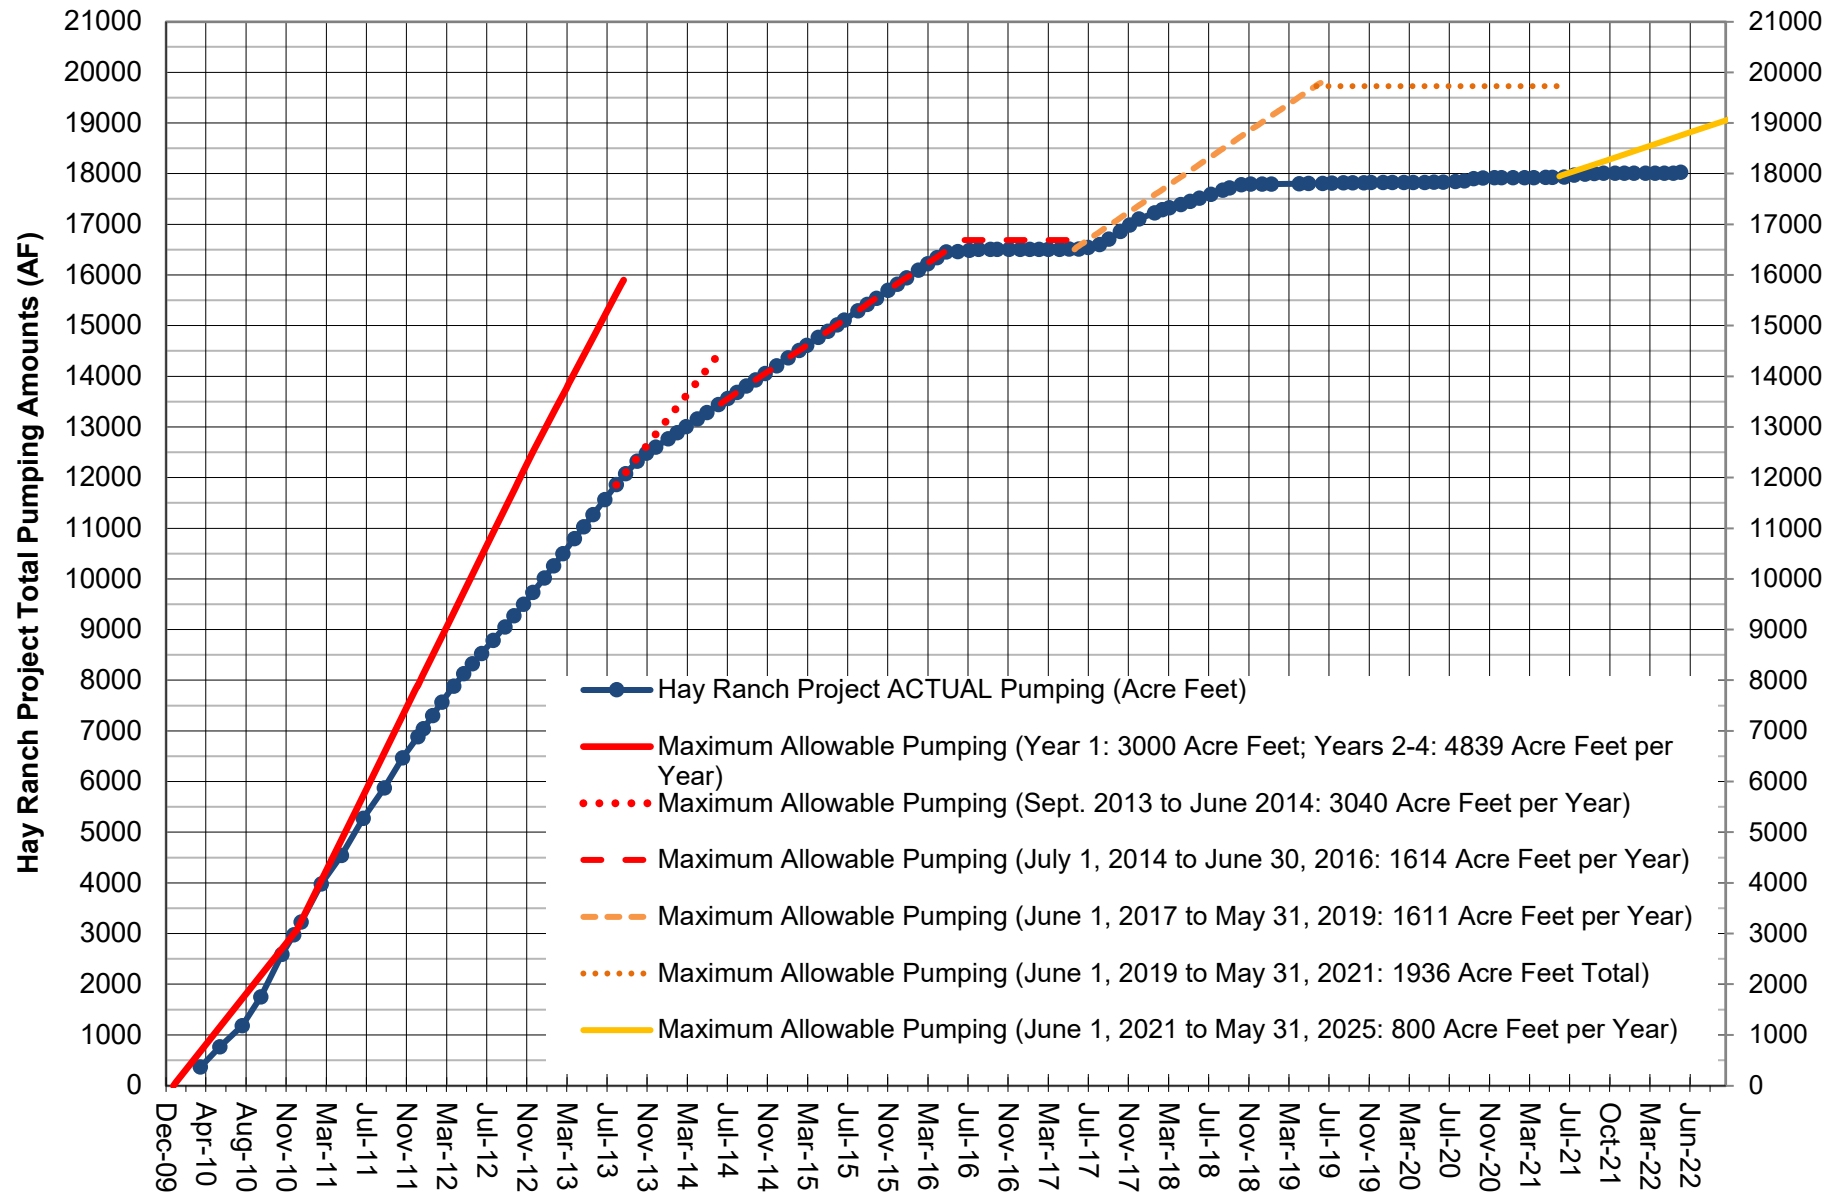
Note: The "maximum allowable pumping" is based on a pumping rate of 3000 AF/yr for 12/09 to 12/10, 4839 AF/yr for 1/11 to 8/13, 3040 AF/yr from 9/13 to 6/14, 1,614 AF/yr from 7/14 to 6/16 and 1611 AFY for 6/17 to 5/21.

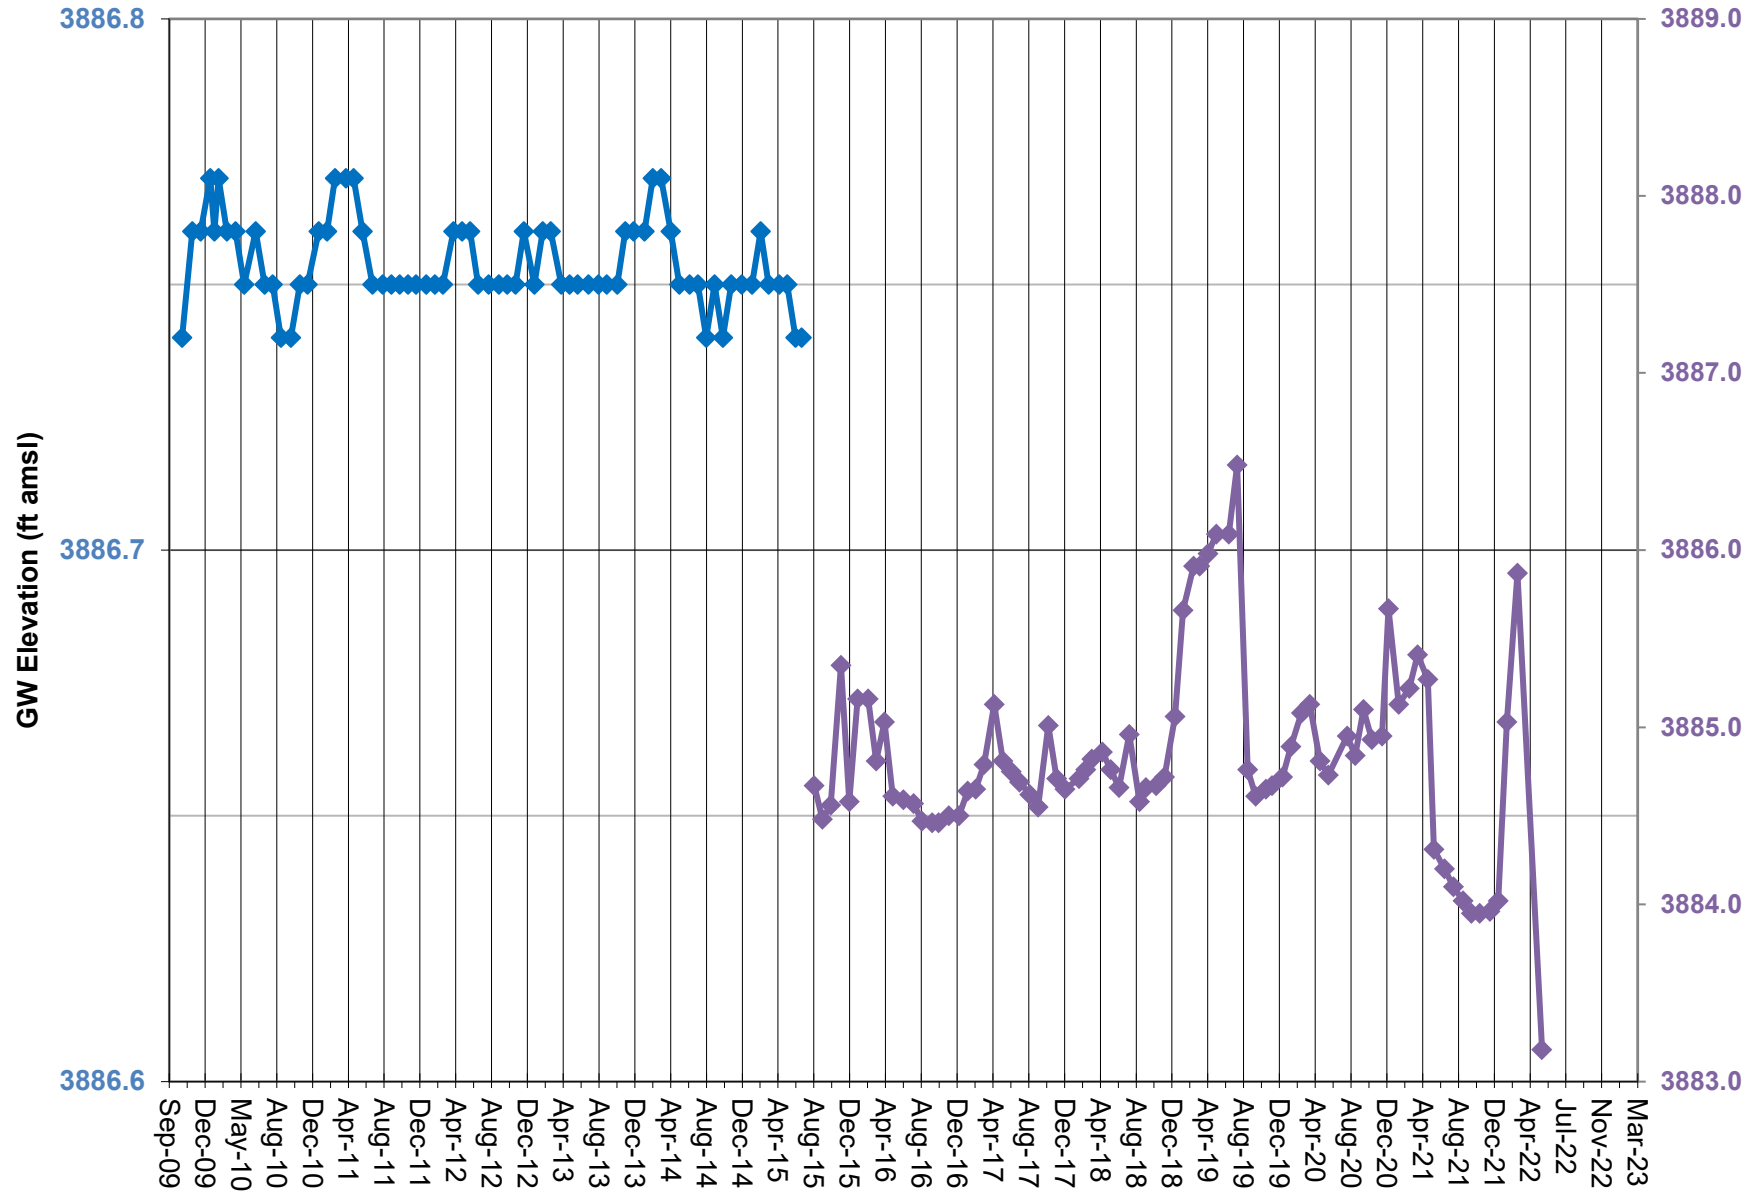
Davis Ranch North and South Wells are located just below ground surface and were observed to be artesian at the top of each well casing during Phase 1. Groundwater from these two wells flows into PVC supply pipes for use at Davis Ranch. At the Davis Ranch North Well, water from the PVC pipe flows downhill into a complicated, gravity-powered water-delivery system. Water from this North Well is used for domestic consumption and irrigation. At the Davis Ranch South Well, since July 2015, water is actively pumped (solar pump) from the well for domestic consumption or as water supply for a pond. As a result of pumping, the correlation of groundwater levels to the pressure transducer measurements in the Davis Ranch South Well may be inaccurate.

Note: Groundwater elevation data based on manual depth-to-water measurements.  
 Water-supply pump installed in DR South in July 2015.  
 Note secondary axis for GWEs post-pump installation.

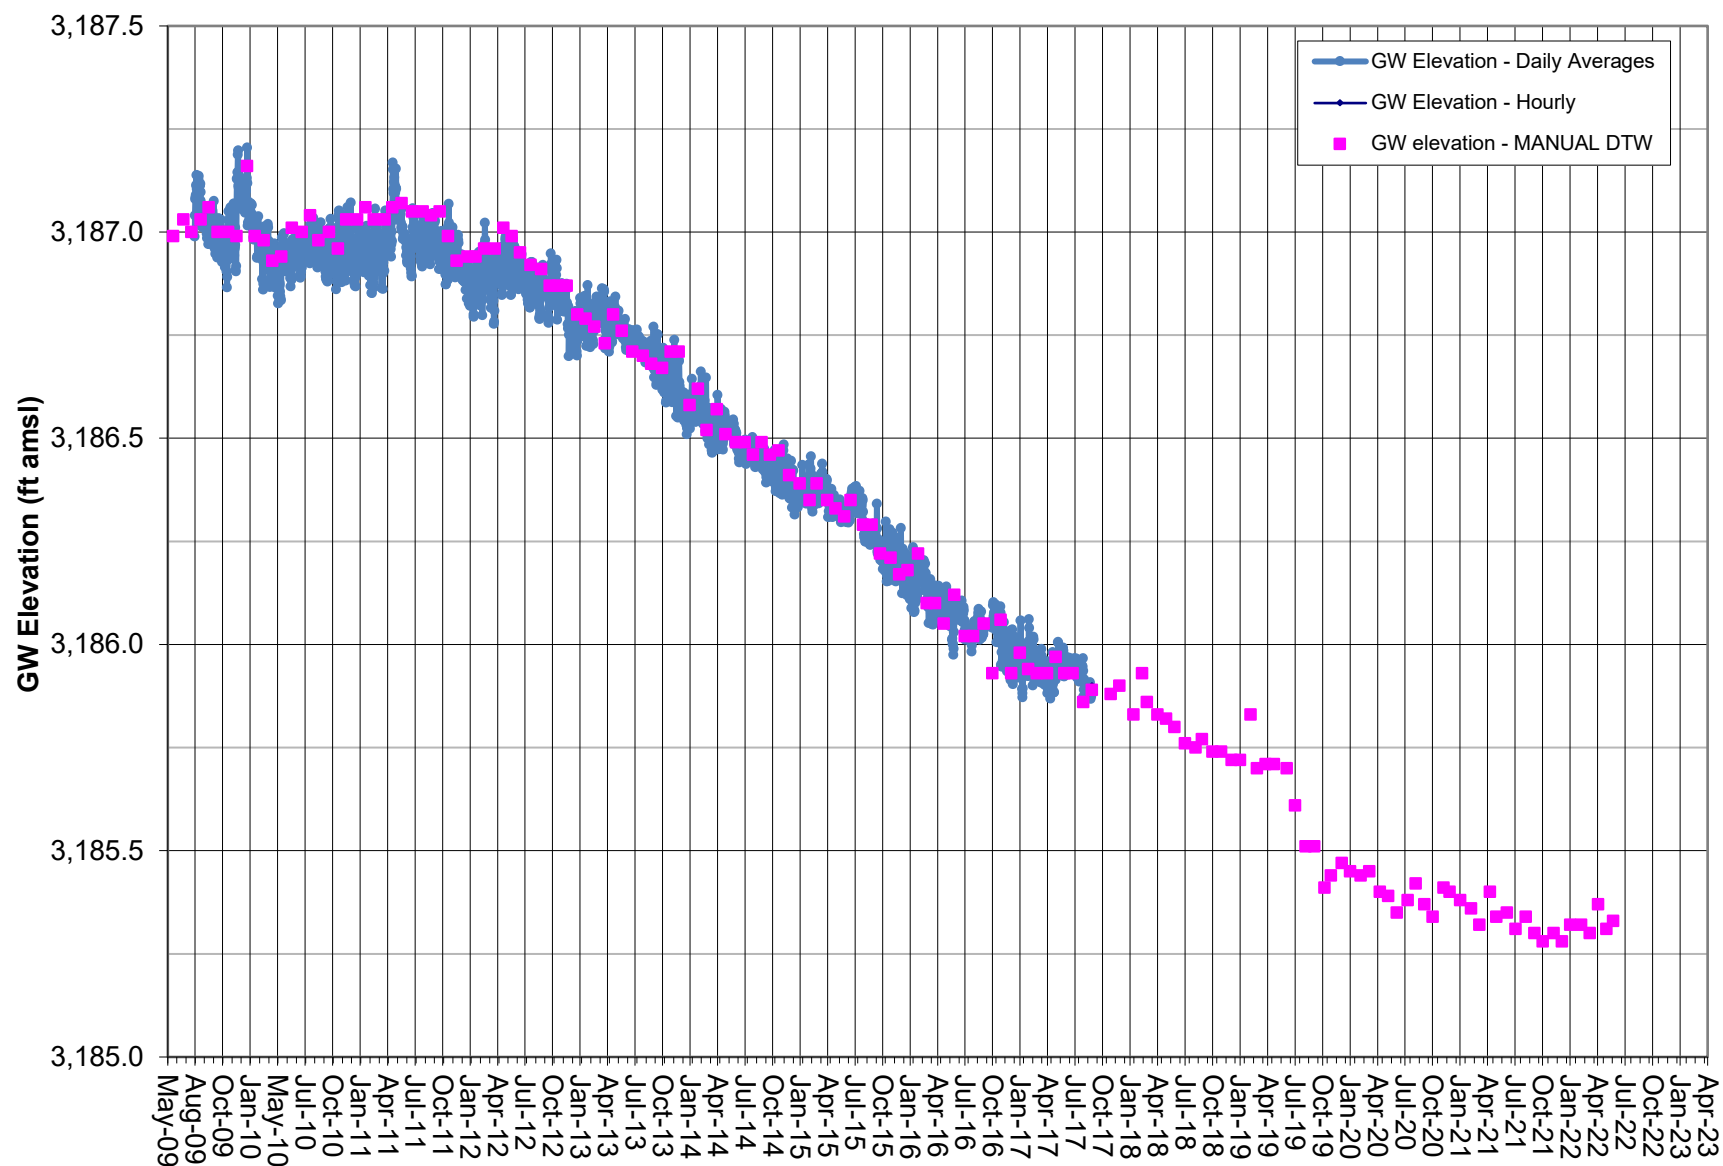
In October 2017 the box protecting the Cinder Road well was vandalized and removed from its well head. The transducer was missing and a blockage in the well prevented water level collection in October 2017. COC personnel cleared the blockage and water levels were able to be collected again in November 2017 with a slightly modified (unsurveyed) measuring point. ICWD personnel indicated that the transducer does not need to be replaced.

Note: Transducer data (absolute pressure) adjusted by data logged from BaroTroll and correlated to Manual DTW measurements. Well damaged and transducer missing on Oct. 2017.  
Coso Operating Co. initiated Hay Ranch Project pumping on 12/25/09.

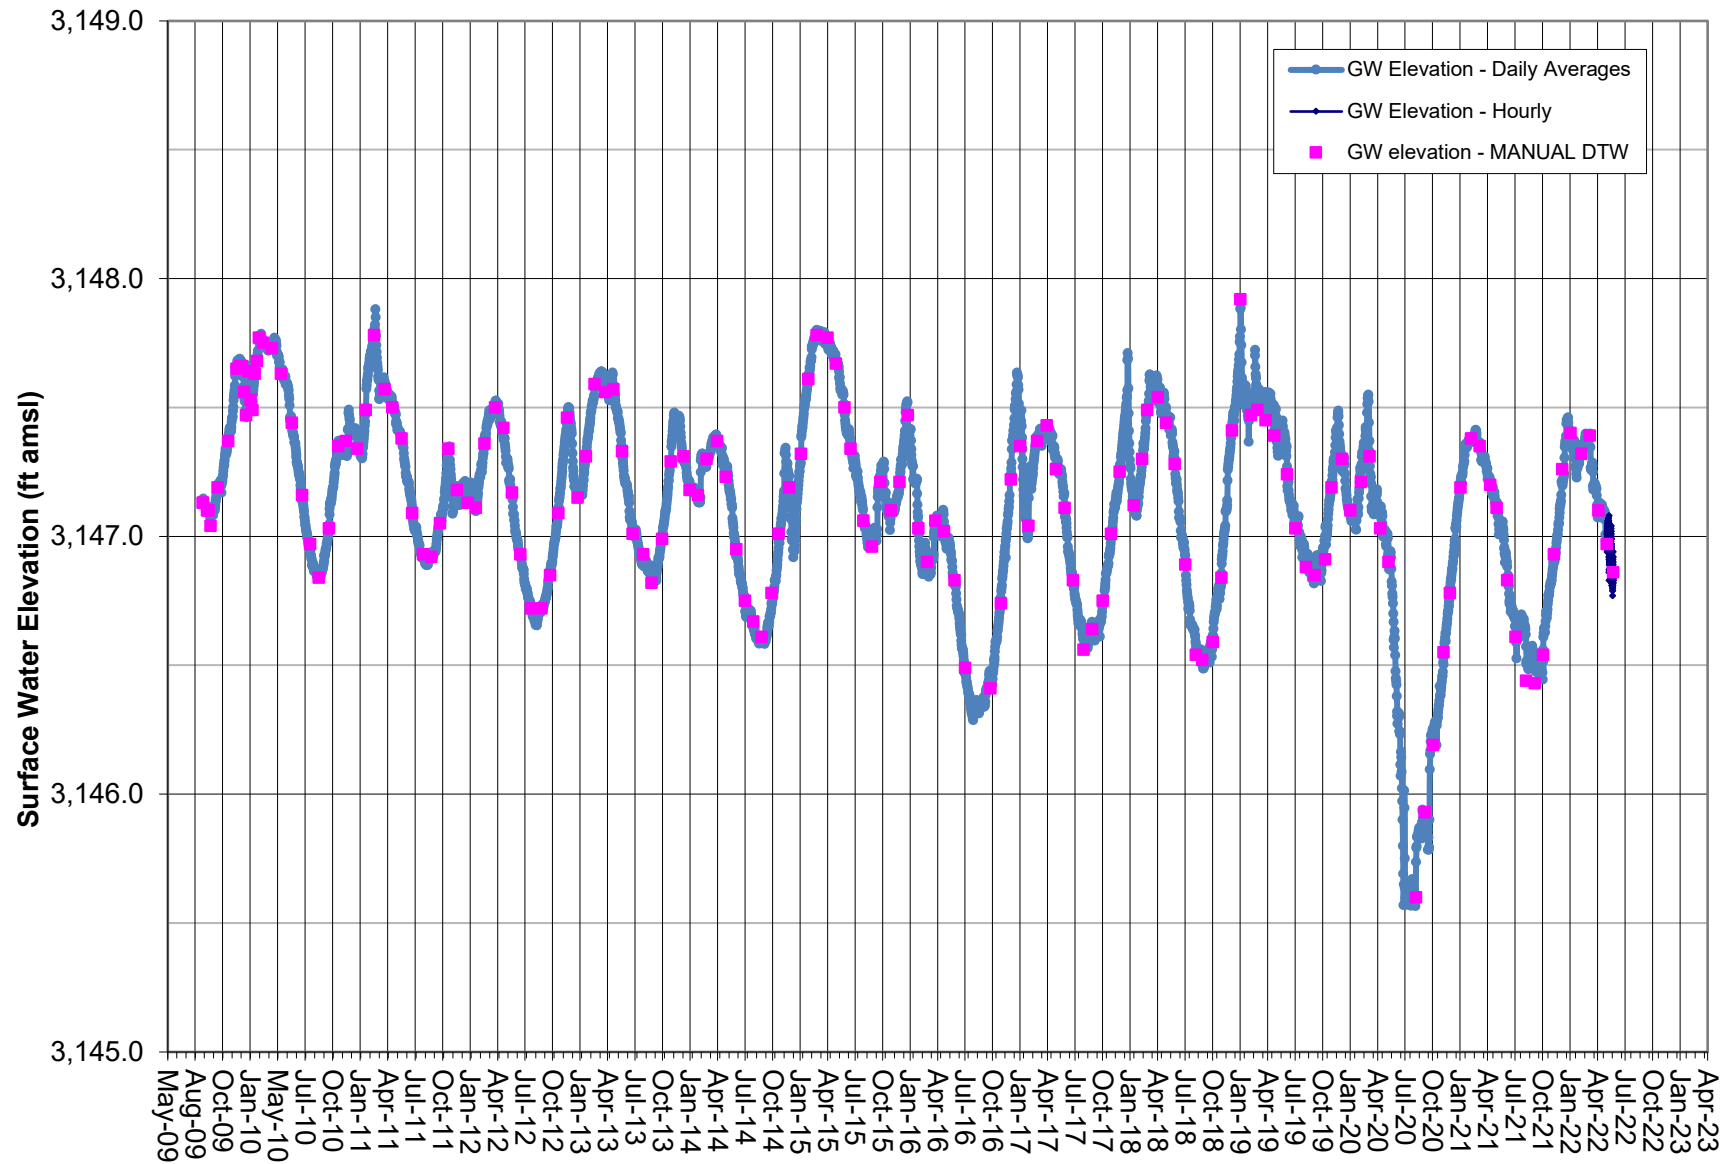
During the July 2020 monitoring event, Little Lake surface levels were drawn down low enough to make water level collection infeasible at the stilling well (RV-220). Also in July 2020, at least three areas on the lake margin were observed to have silt removed from the lake bottom and piled up on the shoreline.

Note: Vented transducer data correlated to Manual DTW measurements. Represents surface water elevation of Little Lake.  
Coso Operating Co. initiated Hay  
Lake Levels too low to measure DTW in June and July 2020.

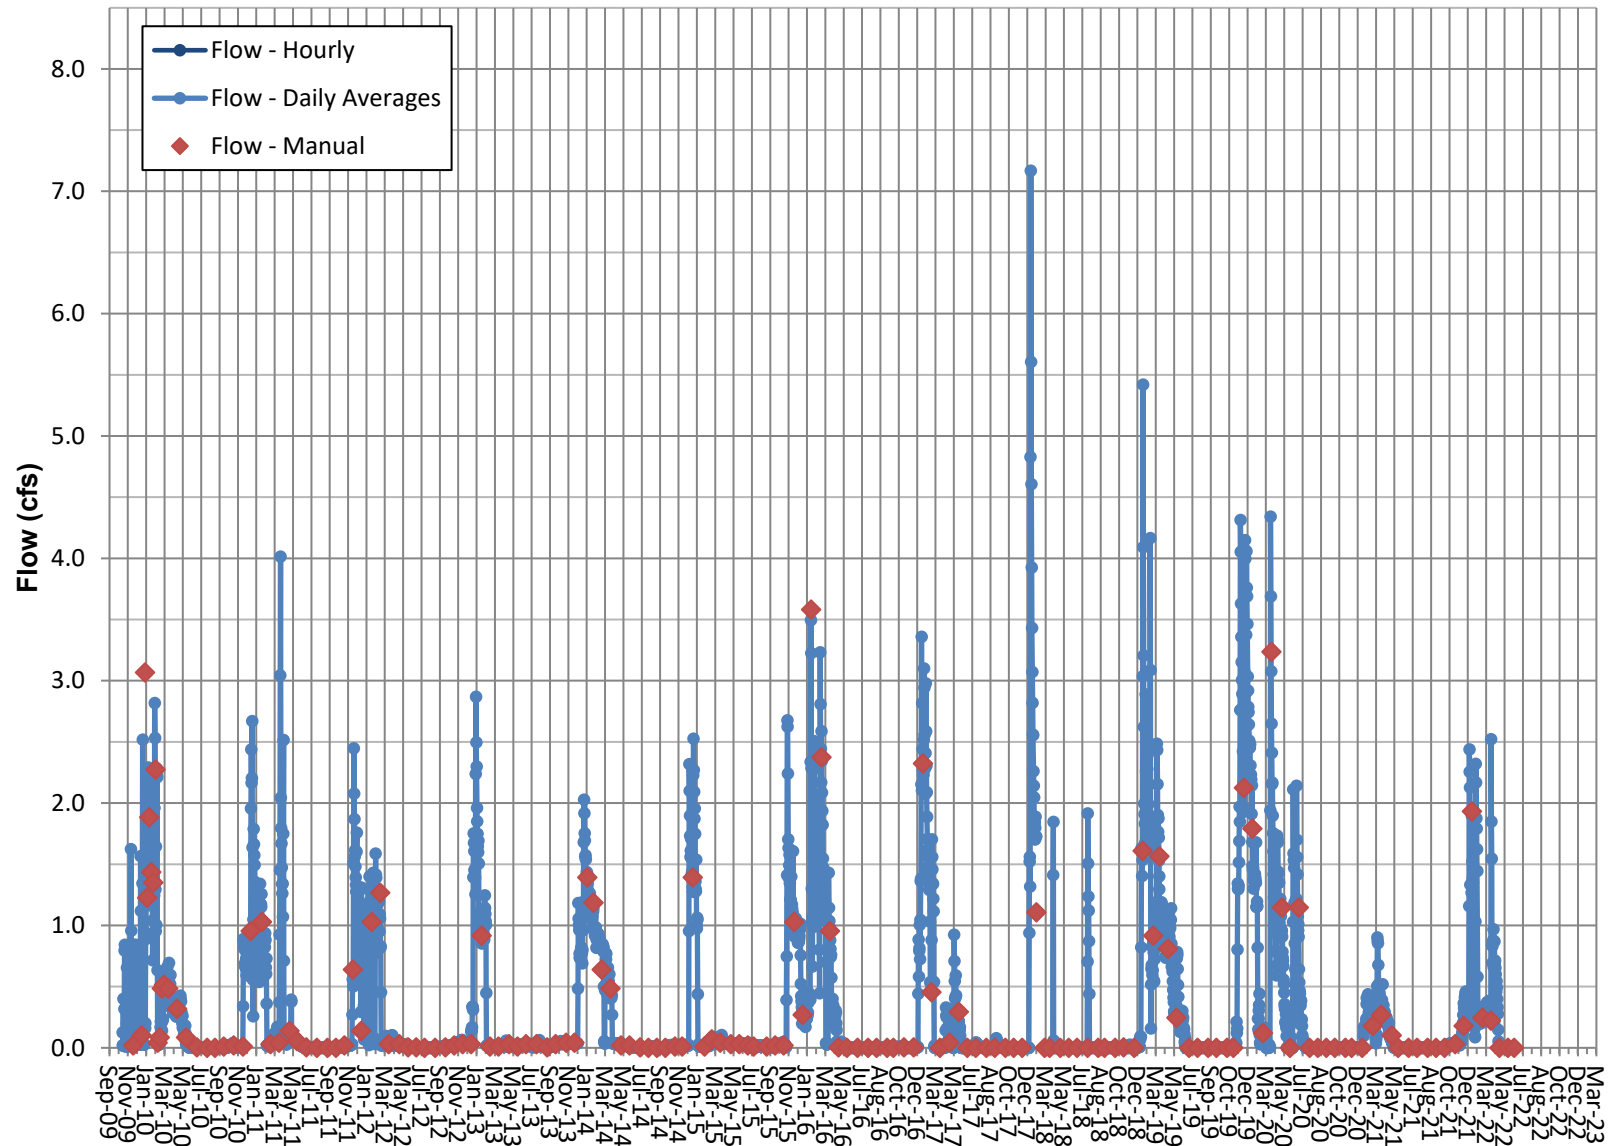
The LLR Lake Outflow flume (RV-230) has been noted to have accuracy limitations due to a restriction of flow downstream of the flume since January 2020. Maintenance has been recommended by TEAM but not scheduled to be performed due to landowner restrictions. In May 2022 modifications were made to the wellhead of the Davis Ranch South Well (RV-111), potentially altering the measuring point. There were no other significant operational issues observed during the reporting period.

Note: Flows through Little Lake Outflow are influenced by natural and water management processes at Little Lake Ranch.  
Flume has known accuracy limitations.
