# HAY RANCH PROJECT CONDITIONAL USE PERMIT HYDROLOGIC MONITORING REPORT

**FOURTH QUARTER 2019  
INYO COUNTY, CALIFORNIA**

**HAY RANCH PROJECT CONDITIONAL USE PERMIT  
HYDROLOGIC MONITORING REPORT  
FOURTH QUARTER 2019  
INYO COUNTY, CALIFORNIA**

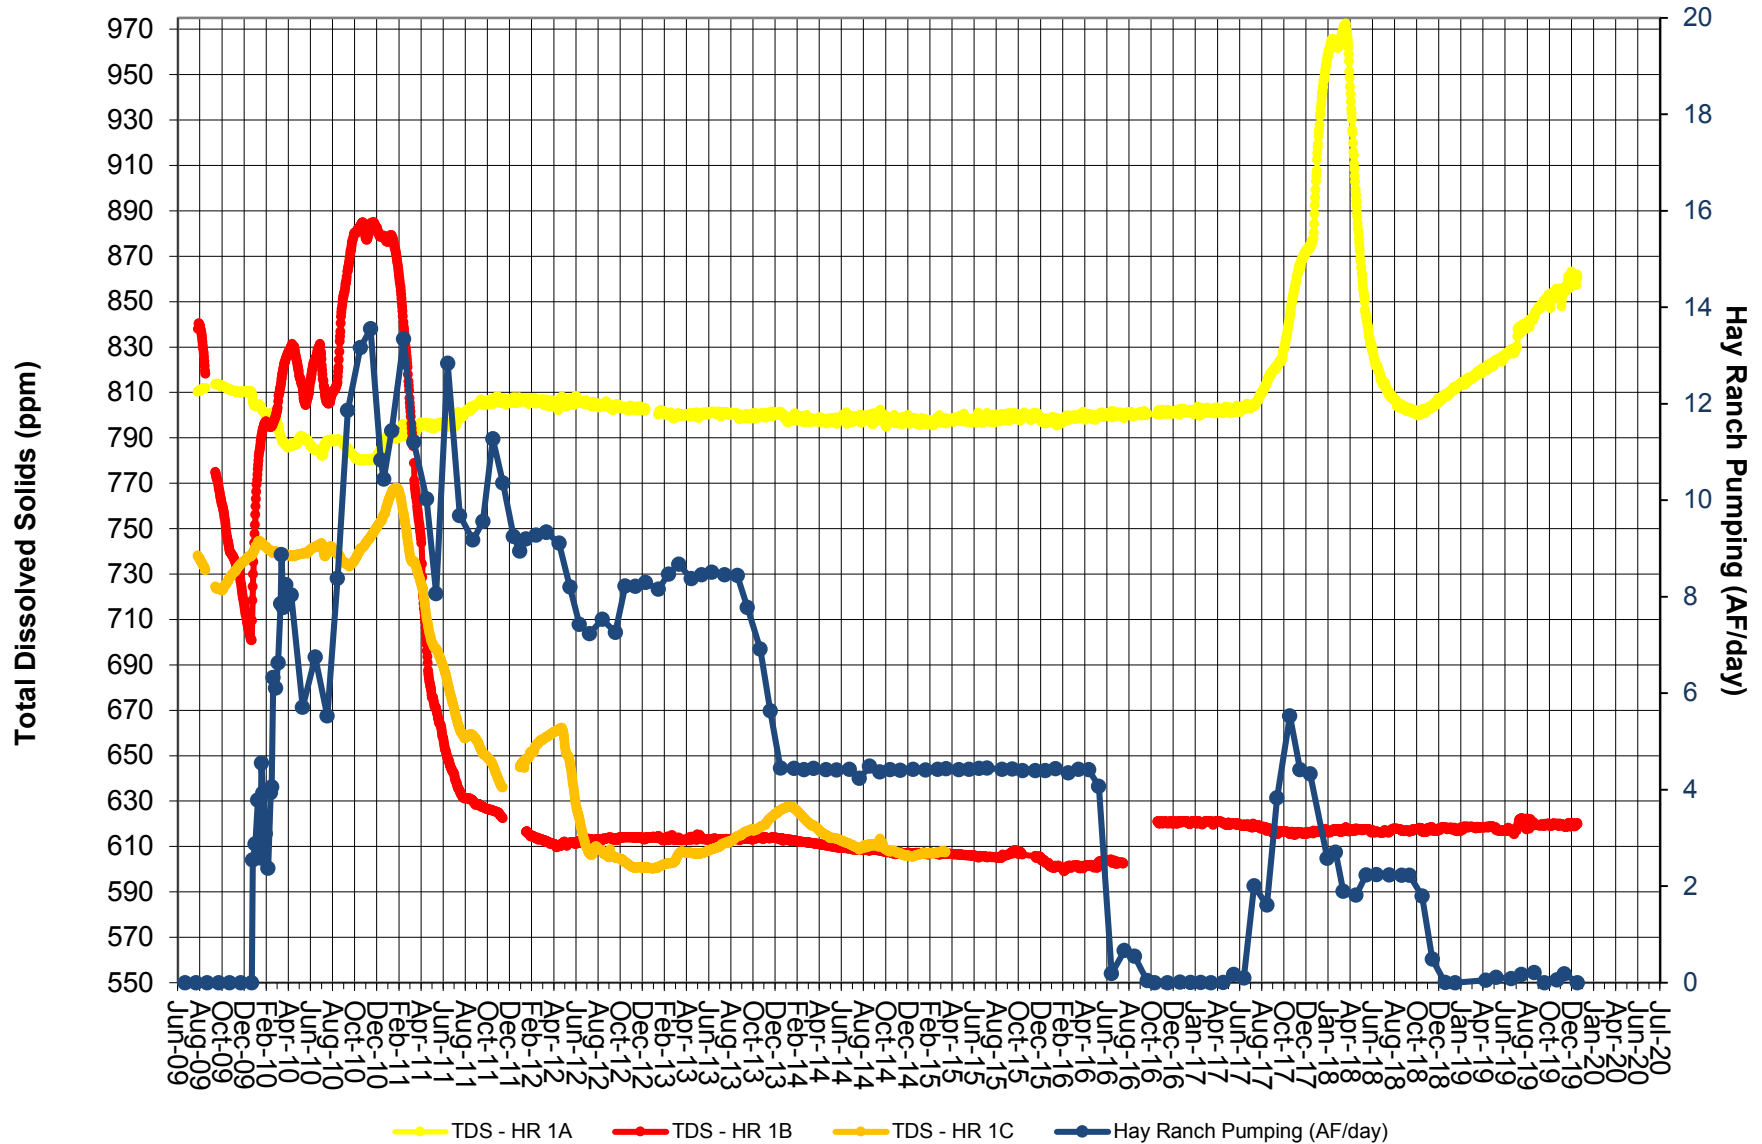
Note:  
Screened intervals: HR 1A 170-260 feet; HR 1B 490-540 feet; HR 1C 340-405 feet.  
HR 1A, 1B and 1C data gaps due to transducer malfunction or adjustment.  
PT removed from HR1C in March 2015.
