**HAY RANCH PROJECT
INYO COUNTY CONDITIONAL USE PERMIT
HYDROLOGIC MONITORING REPORT**

FOURTH QUARTER 2023

**RE: Hay Ranch Project Conditional Use Permit
Hydrologic Monitoring Report, Fourth Quarter 2023
Inyo County, California**

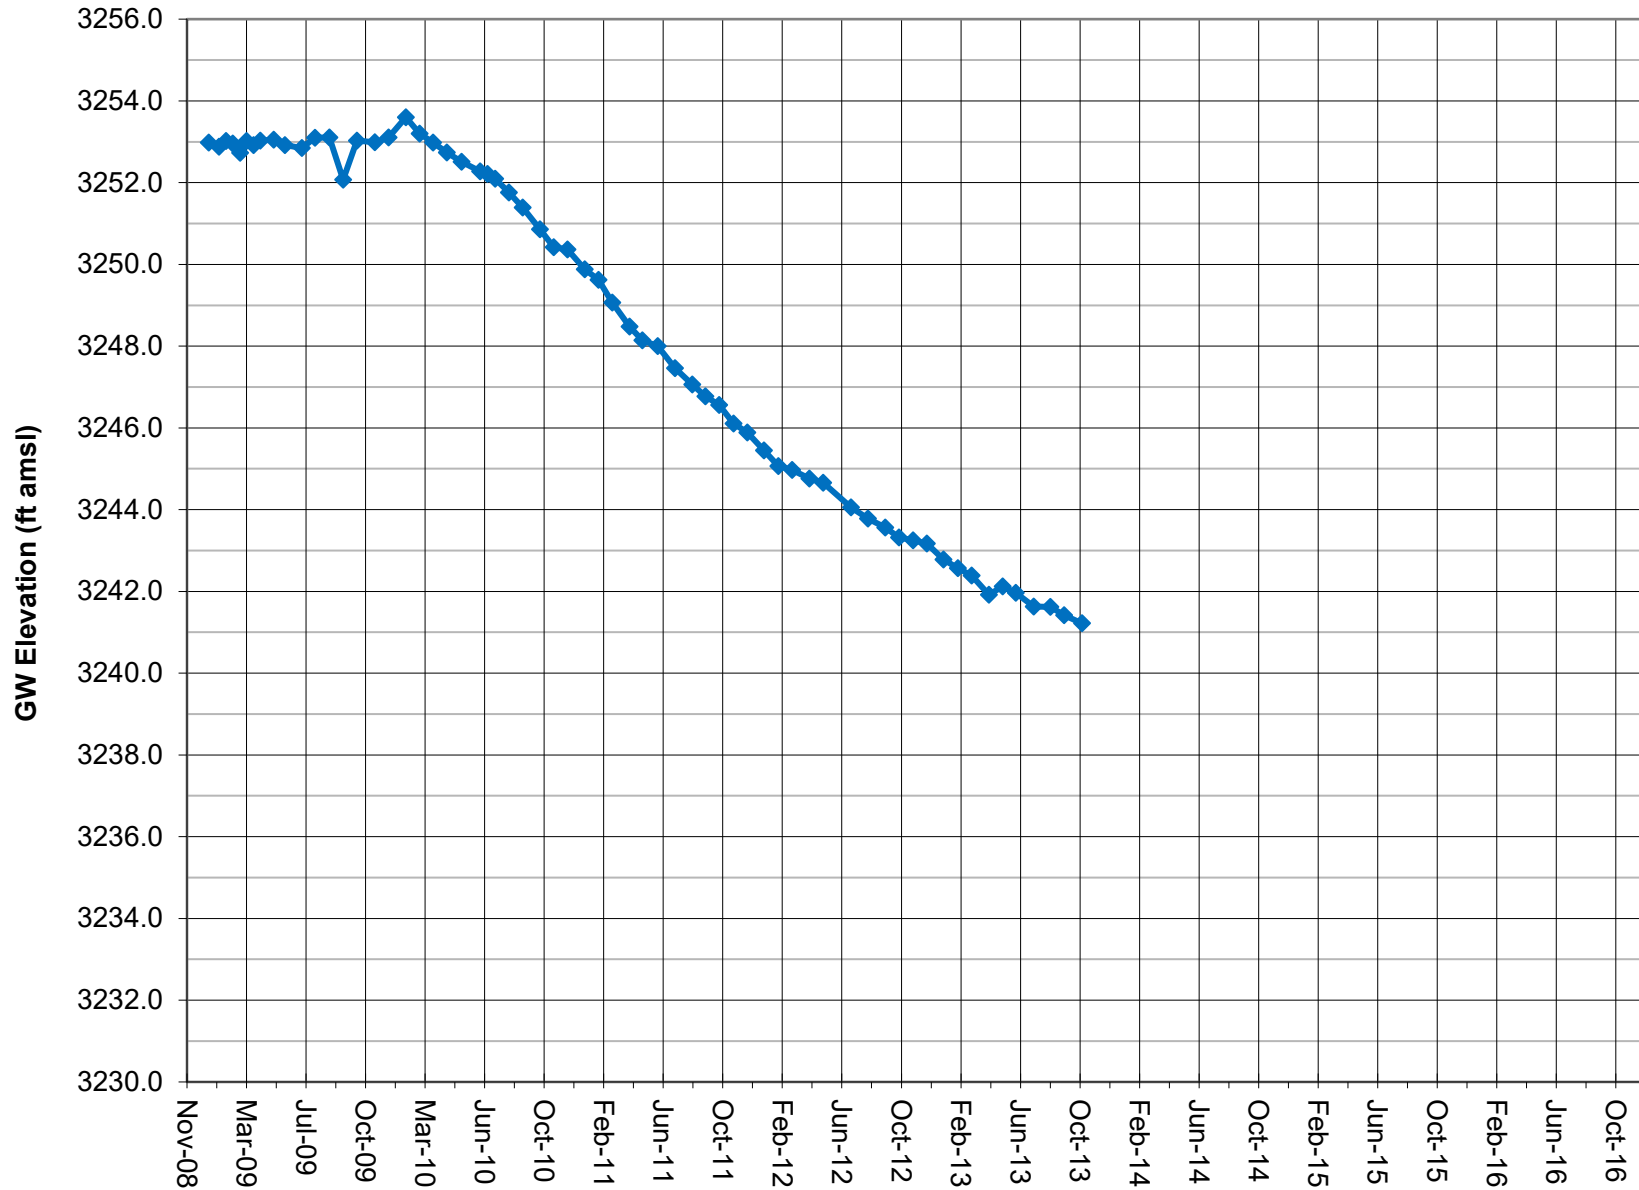
GROUNDWATER ELEVATION DATA - Long-Term (Manual) RV040 - Dunmovin Well

Note: Groundwater elevation data based on manual depth-to-water measurements.
Dunmovin Well is an active domestic supply well.
Monitoring discontinued in Oct. 2013 due to new in-well infrastructure.
