## RE: Summary of Hydrologic Monitoring Activities, June 2020

Rose Valley, Inyo County, California Hay Ranch Project Conditional Use Permit #2007-03

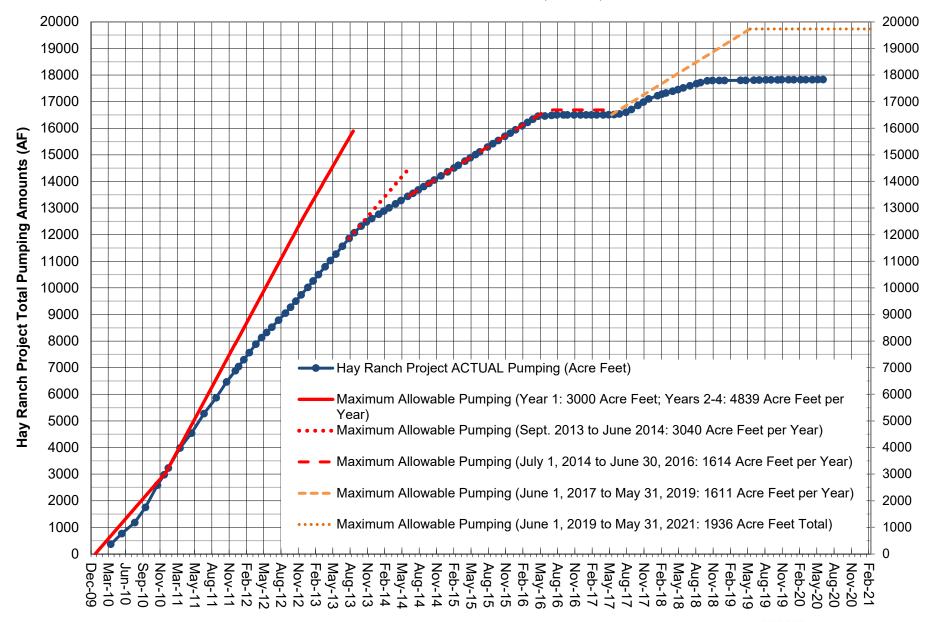
FIGURE 1
ACTUAL AND MAXIMUM ALLOWABLE PUMPING AMOUNTS (TOTALS) FOR HAY RANCH PROJECT

Figure 1 presents the combined amount of groundwater pumped from the Hay Ranch North and South wells, in acre-feet, from December 25, 2009 through June 17, 2020 compared to the maximum allowable pumping amounts. The total amount of groundwater extracted from the Hay Ranch property from December 25, 2009 to June 20, 2020 (Hay Ranch CUP project total) is approximately 17,834 AF. The maximum allowable pumping rate was 3,000 acre-feet per year (AFY) for December 25, 2009 through December 31, 2010; was 4,839 AFY from January 2011 through August 2013; was 3,040 AFY from September 2013 through June 2014; was 1,614 AFY from July 2014 through June 2016, extended by ICWD through September 2016; and is 1,611 AFY from June 2017 through May 2019, extended by ICWD through May 31, 2021.

For the current extended pumping period (November 14, 2018 to June 31, 2021) totalizers have indicated an estimated 38 AF of groundwater, of the 1,936 AF allowable, have been extracted from the Hay Ranch Property through June 17, 2020.
